ROAD SAFETY AUDIT

EXISTING ROAD

Lismore Railway Viaducts at:

November 2022

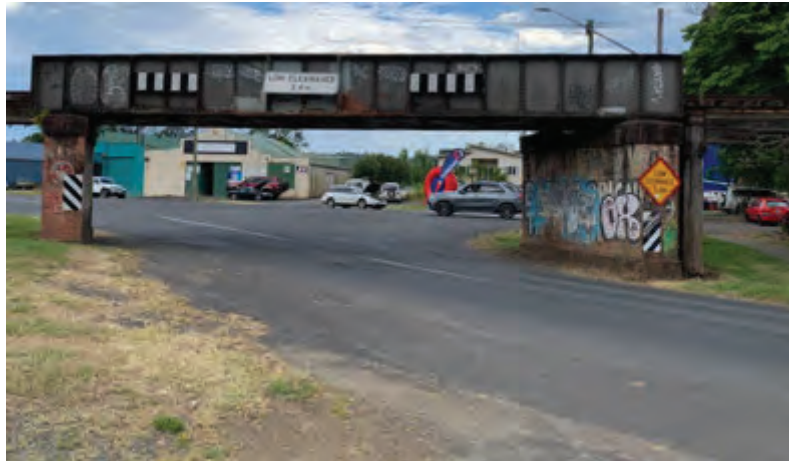
Photo 1: No edge lines - Union Street viaduct

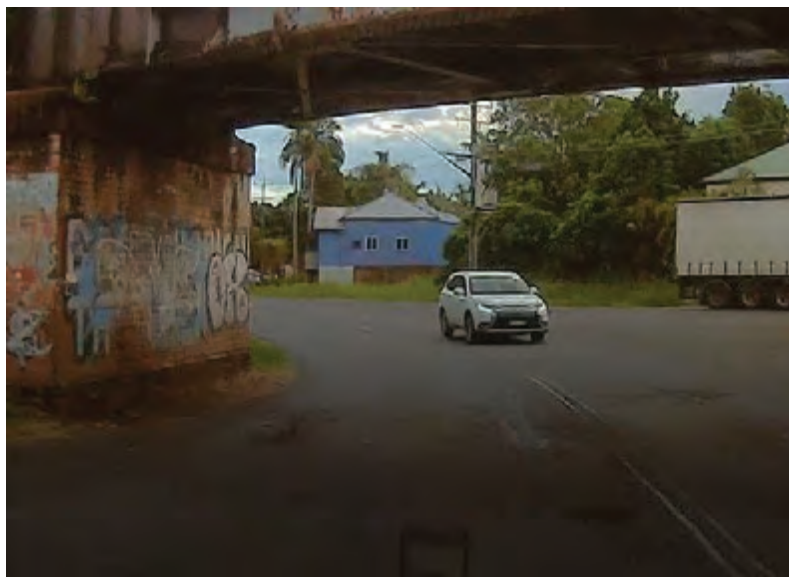
4	<p>Edge Clearances</p> <p>There is minimal clearance from edge of the road carriageway to the pylons.</p> <p>There is a risk that a vehicle could collide with a viaduct pylon.</p> <p><i>Refer to Photo 2</i></p>	<p>Likelihood: Possible</p> <p>Severity: Serious</p> <p>Risk: High</p>
5	<p>Missing Width Marker</p> <p>There is no width marker on the pylon, southbound, left-hand side.</p> <p>There is a risk that a vehicle could collide with a viaduct pylon.</p> <p><i>Refer to Photo 3</i></p>	<p>Likelihood: Rare</p> <p>Severity: Serious</p> <p>Risk: Medium</p>

Photo 2: Minimal edge clearance - Union Street viaduct

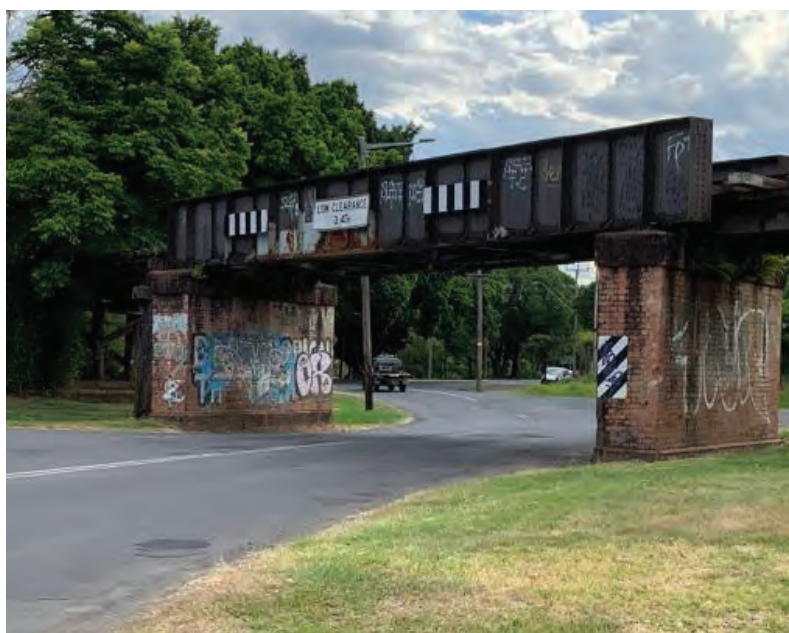
Photo 3: Missing width marker on pylon - Union Street viaduct

- Replace all damaged, vandalised, or non-reflective signs.
- At the Union Street viaduct:
 - Replace missing width marker (southbound, left-hand side).
 - Establish priority direction for one-way viaduct on Frank Street. Priority should be given to southbound traffic to reduce risk of southbound vehicles having to queue onto Union Street. Install appropriate line marking and signs to indicate priority.

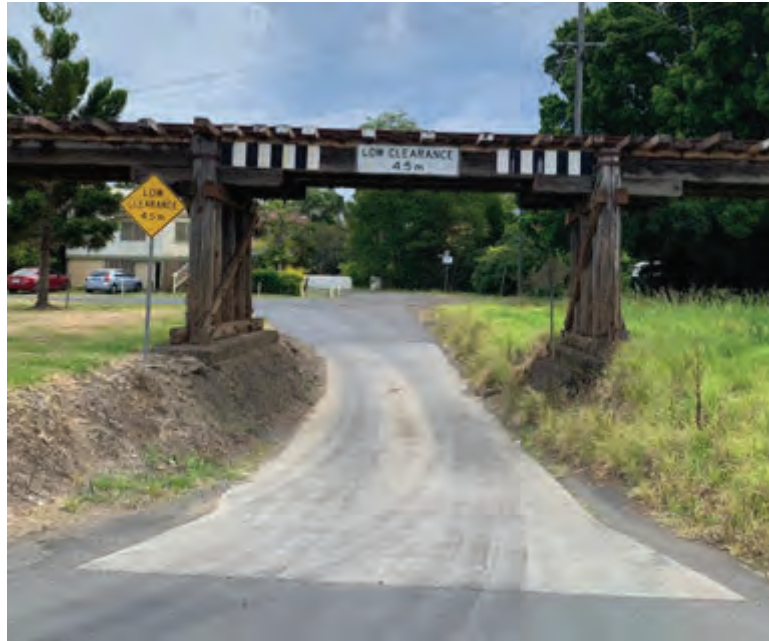
Photo 4: Road width - Frank Street viaduct

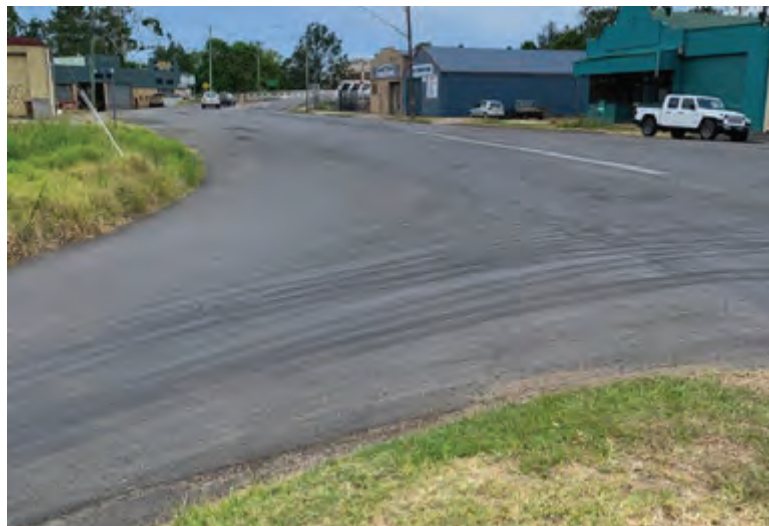
Photo 5: Lack of intersection controls - Frank St/Union St intersection

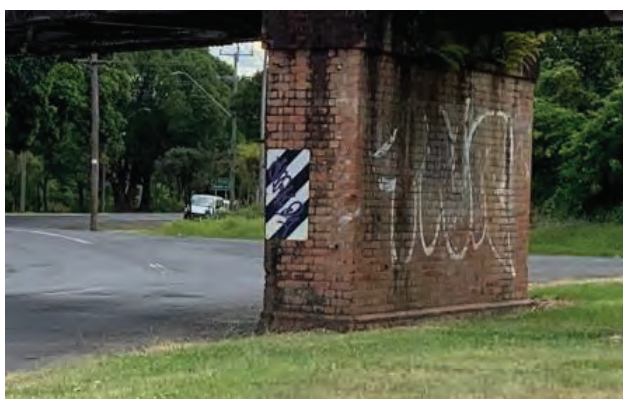
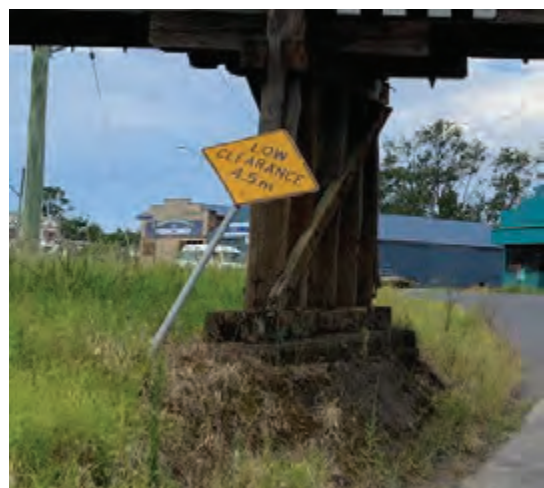
Photo 6: Damaged signs - Union Street viaduct

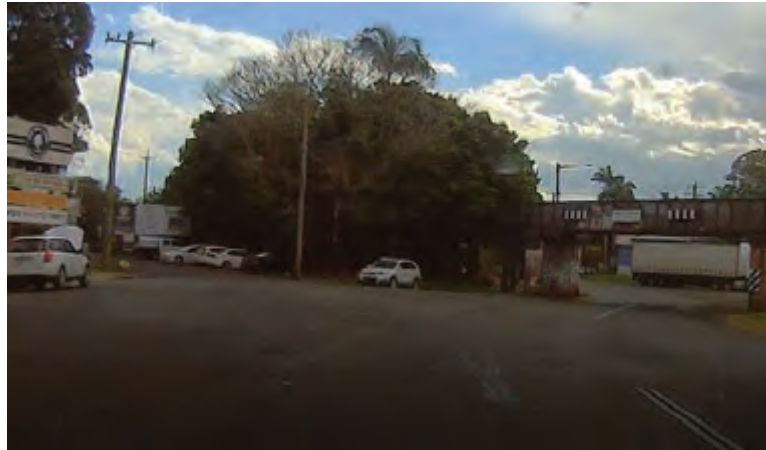
9	<p>Industrial Driveways Northern Side of Viaduct</p> <p>There is a large area of bitumen providing access to multiple industrial buildings on the northern side of the viaduct (river side of Union Street). Uncontrolled access/egress from this area was observed during the site inspection. Sight distance for vehicles exiting this area to travel north is compromised by the viaduct pylons.</p> <p>There is a risk that vehicles egressing from this area onto Union Street may collide with through traffic.</p> <p><i>Refer to Photo 7</i></p>	<p>Likelihood: Rare</p> <p>Severity: Serious</p> <p>Risk: Medium</p>
Site 2	Terania Street, North Lismore	
10	<p>No Advance Warning Signs for the Low Clearance (Westbound)</p> <p>There is no advance warning sign ('Low Clearance' or 'Low Bridge Ahead, High Vehicle Detour') westbound.</p> <p>There is a risk that a high vehicle could collide with the viaduct.</p>	<p>Likelihood: Rare</p> <p>Severity: Moderate</p> <p>Risk: Low</p>

Photo 7: Industrial driveways north of Union Street viaduct

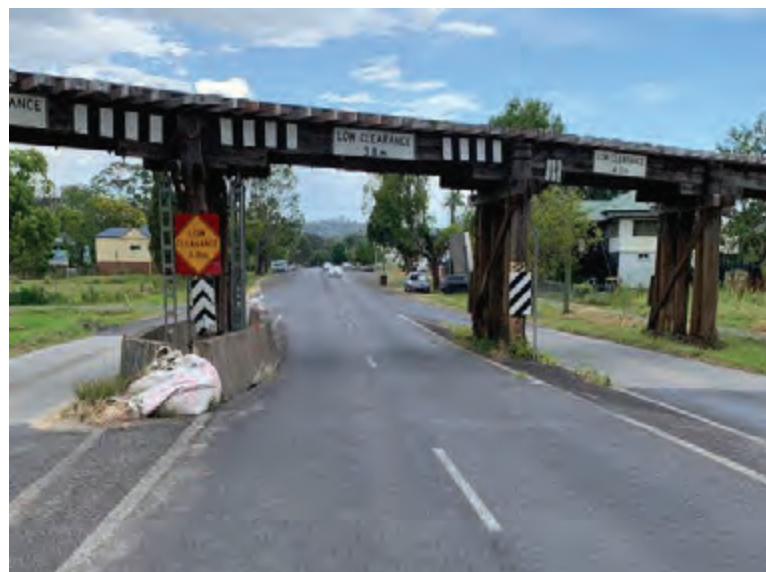
Photo 8: Narrow road width centre span - Terania Street viaduct

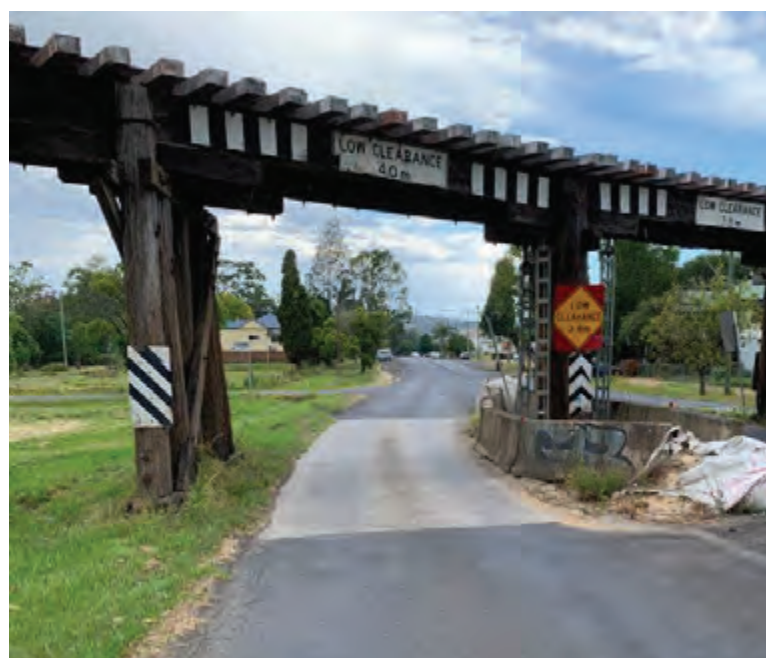
Photo 9: No edge lines - Terania Street viaduct

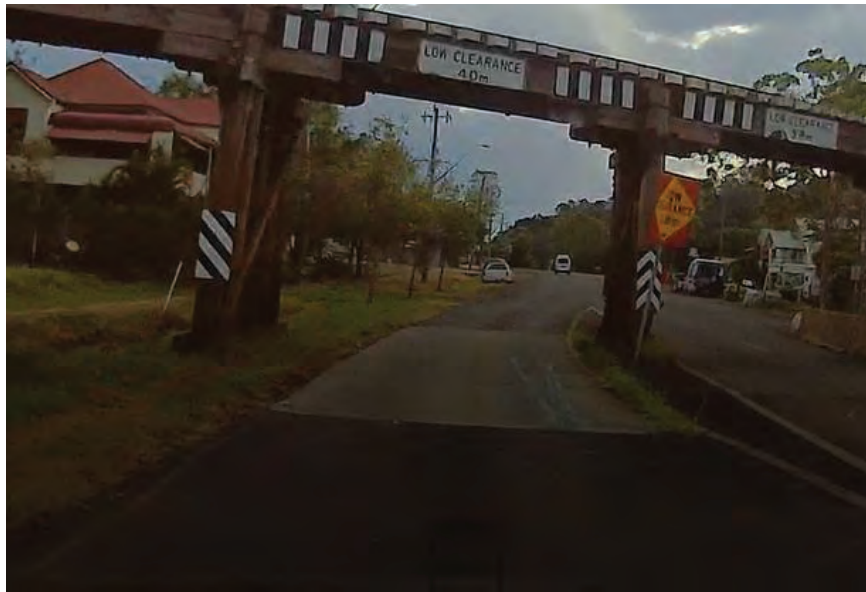
14	<p>Edge Clearances</p> <p>There is minimal clearance from edge of the road carriageway to the pylons.</p> <p>There is a risk that a vehicle could collide with a viaduct pylon.</p> <p><i>Refer to Photo 10</i></p>	<p>Likelihood: Possible</p> <p>Severity: Serious</p> <p>Risk: High</p>
15	<p>Ends of Safety Barrier</p> <p>Recent works have been undertaken to support and protect the northern pylon of the centre span. This has included the placement of a New Jersey style concrete barrier around the pylon. The leading ends are protected by large sand-filled bags (one of which is broken). Delineation and protection of the ends is inadequate.</p> <p>There is a risk that an approaching driver may not adequately perceive the barrier ends and collide with the barrier.</p> <p><i>Refer to Photo 11, 12</i></p>	<p>Likelihood: Possible</p> <p>Severity: Serious</p> <p>Risk: High</p>

Photo 10: Minimal edge clearance - Terania Street viaduct

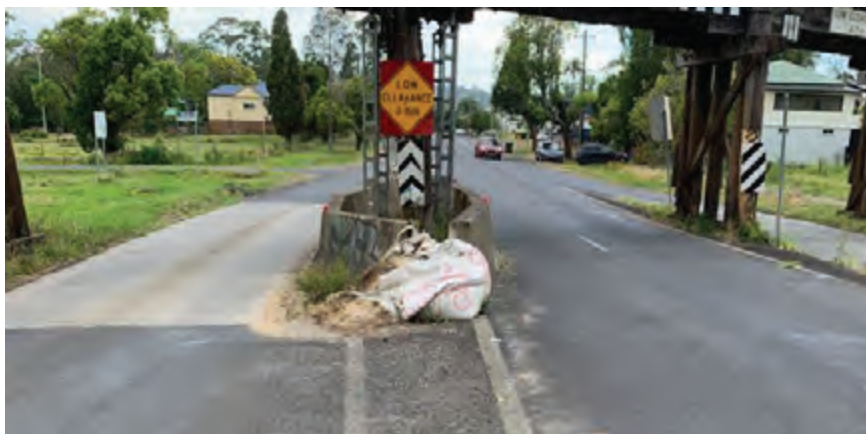
Photo 11: End of safety barrier (eastbound) - Terania Street viaduct

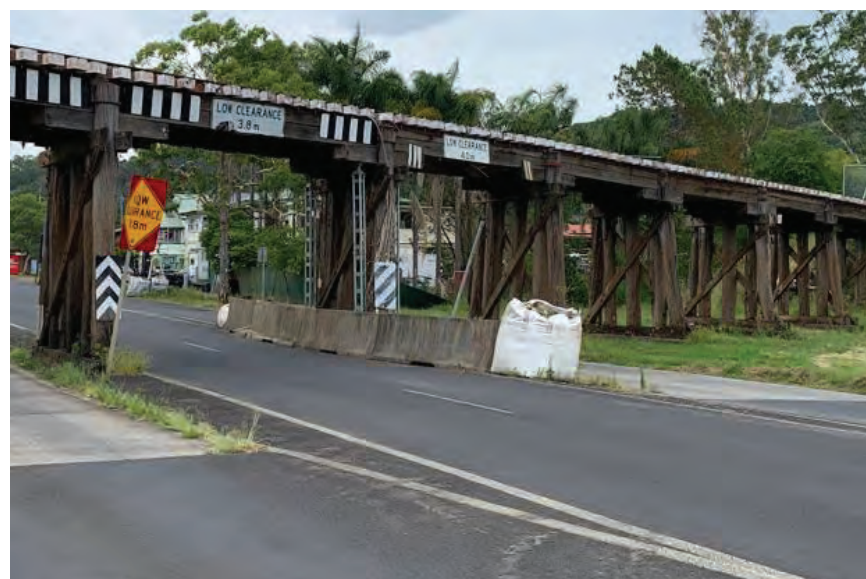
Photo 12: End of safety barrier (westbound) - Terania Street viaduct

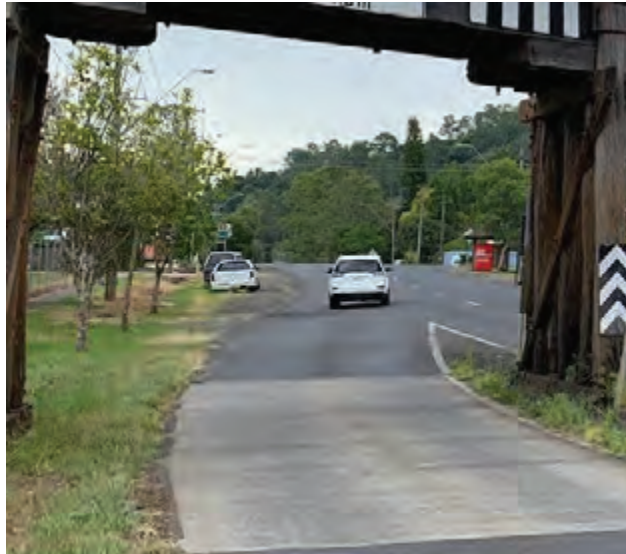
16	<p>Lane Merge Priorities Unclear</p> <p>On approach to the viaduct (from either direction), a driver can opt to pass through either the centre or outer span. On departure, merge priorities are unclear. There are no lines or signs to guide drivers.</p> <p>There is a risk of a collision when vehicles merge.</p> <p><i>Refer to Photo 13</i></p>	<p>Likelihood: Rare</p> <p>Severity: Serious</p> <p>Risk: Medium</p>
17	<p>Condition of Signs and Lines</p> <p>Some signs are in poor condition (not reflective; damaged).</p> <p>The line marking generally is badly worn in places. There are no painted chevrons in the traffic islands. The traffic island edge lines are under the concrete barriers. There are no RRPM's.</p> <p>Without adequate delineation, there is a risk that drivers could be confused by the road alignment, particularly at night, increasing the risk of a crash.</p> <p><i>Refer to Photo 14</i></p>	<p>Likelihood: Rare</p> <p>Severity: Moderate</p> <p>Risk: Low</p>

Photo 13: Lane merge priorities unclear (westbound) - Terania Street viaduct

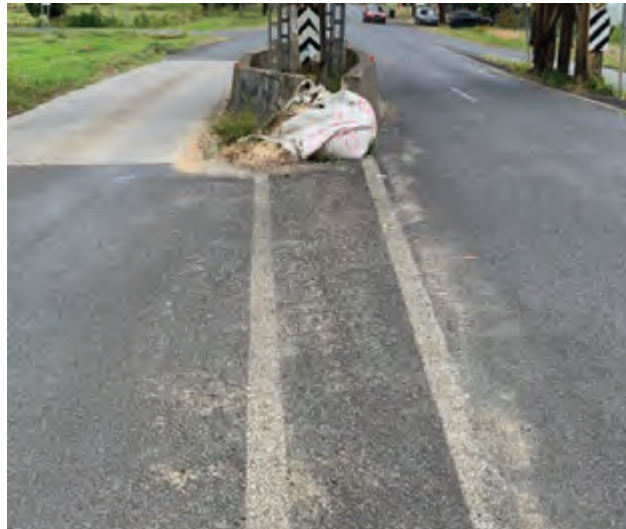
Photo 14: Poor condition and placement of lines - Terania Street viaduct

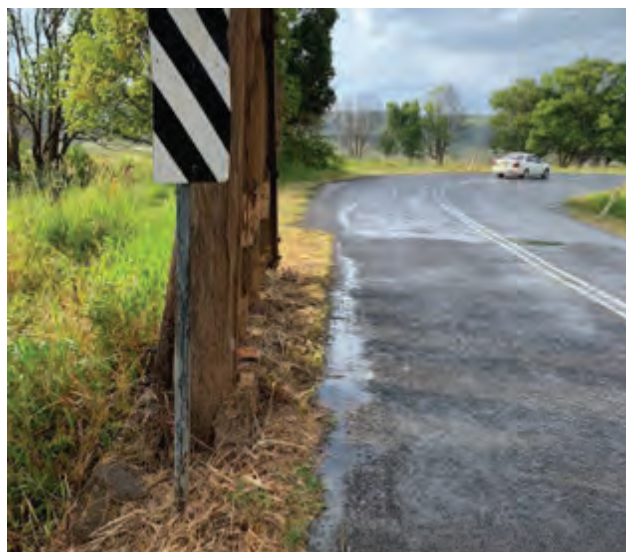
Photo 15: No edge lines and minimal edge clearance - Winterton Parade viaduct

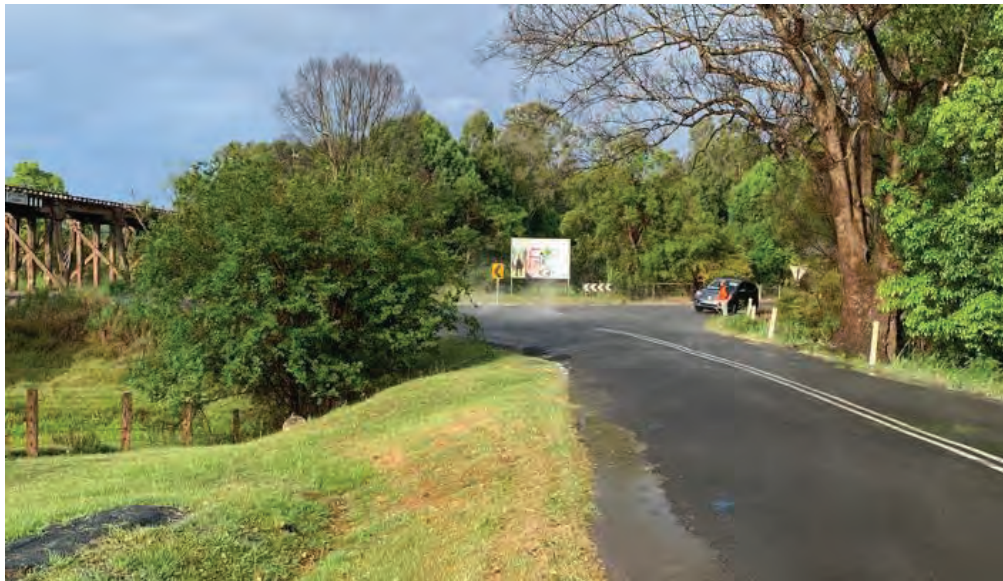
Photo 16: Inadequate definition of curve alignment – northbound approach to Winterton Parade viaduct

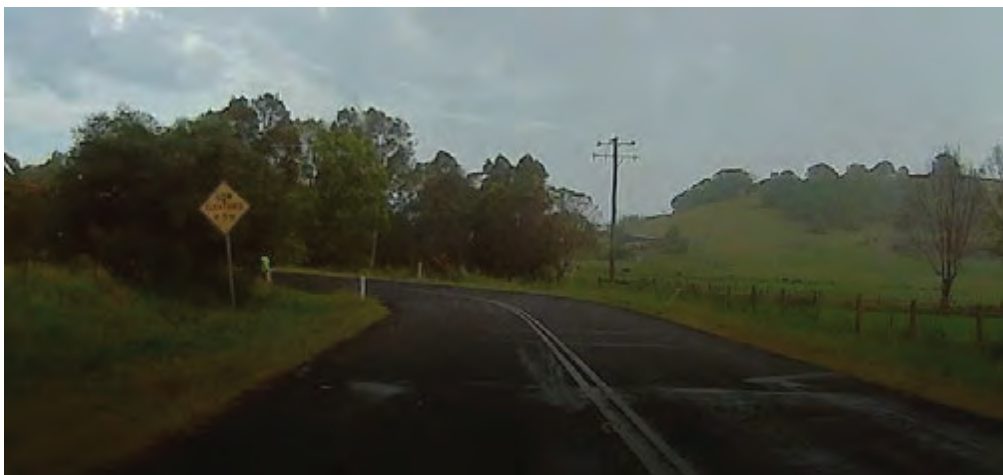
Photo 17: Inadequate definition of curve alignment – southbound approach to Winterton Parade viaduct

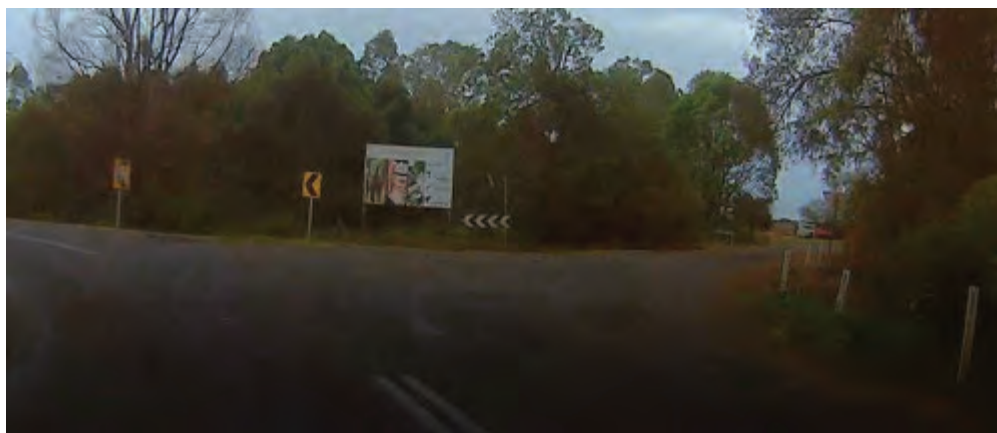
Photo 18: No signs and lines – Lismore Turf Club intersection

- At the Lismore Turf Club intersection, provide either a 'Stop' or 'Give Way' sign (depending on warrants), and the relevant hold line.
 - Roadside hazards (trees, embankments, drains) have been identified at the Winterton Parade viaduct. Assess if the hazard can be removed. If not, assess warrants for safety barriers and consider installation as required.

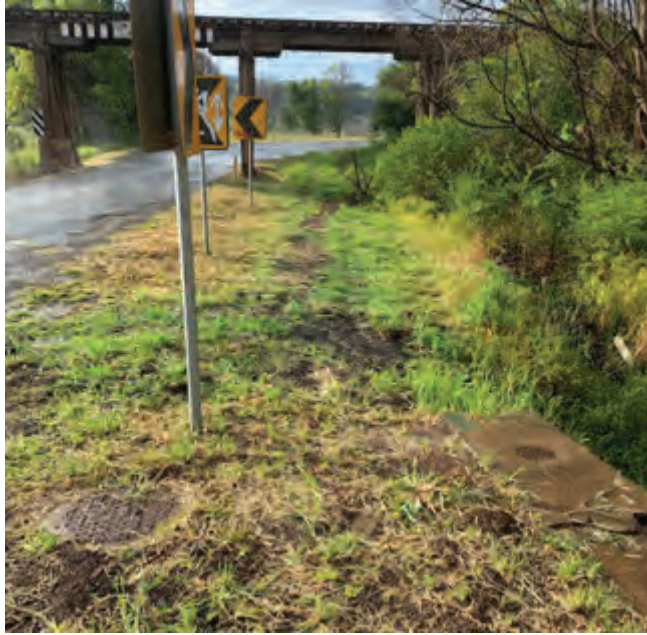
Photo 19: Roadside hazards – drain and trees on outside of bend (northbound) – Winterton Parade

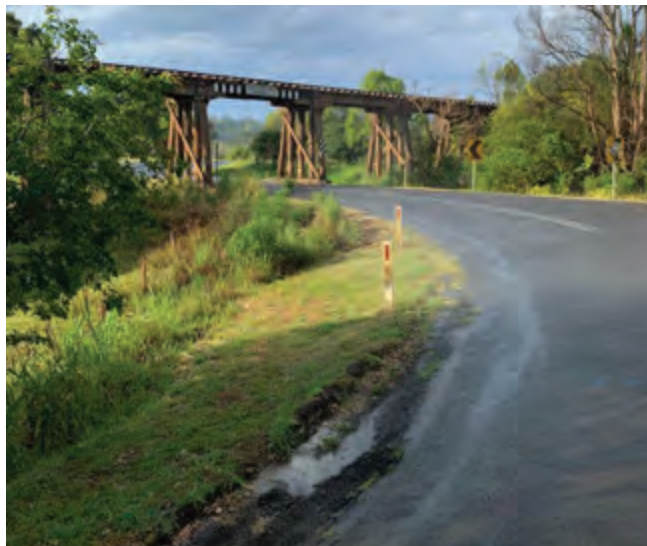
Photo 20: Roadside hazards – embankment on inside of bend (northbound) – Winterton Parade

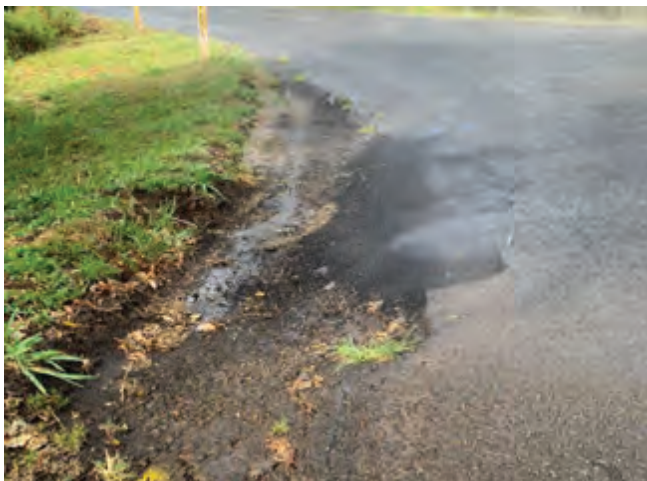
<p>26</p>	<p>Roadside Hazards</p> <p>There are numerous roadside hazards at Site 3 – steep embankments, drains, and trees (and the viaduct pylons).</p> <p>An impact with any of these roadside hazards may increase the severity of a run-off-road crash.</p> <p>There is a risk that an errant vehicle could leave the roadway, resulting in a collision with a roadside hazard.</p> <p><i>Refer to Photo 19, 20</i></p>	<p>Likelihood: Possible</p> <p>Severity: Serious</p> <p>Risk: High</p>
<p>27</p>	<p>Road Condition</p> <p>On the inside of the bend opposite the Lismore Turf Club intersection, the pavement and bitumen surface are uneven and badly damaged.</p> <p>There is a risk that vehicles will lose control on the damaged surface, resulting in a collision with a roadside hazard or another vehicle. There is a further risk to cyclists using the road.</p> <p><i>Refer to Photo 21</i></p>	<p>Likelihood: Possible</p> <p>Severity: Serious</p> <p>Risk: High</p>

Photo 21: Damaged road pavement - inside of bend (northbound) – Winterton Parade

- The damaged section of Winterton Parade opposite the Lismore Turf Club intersection is a hazard to drivers and cyclists, as noted in the Findings. Determine the reasons for damage and rectify. Recommend undertaking pavement reconstruction for this area. Any upgrade should consider including wider shoulders.

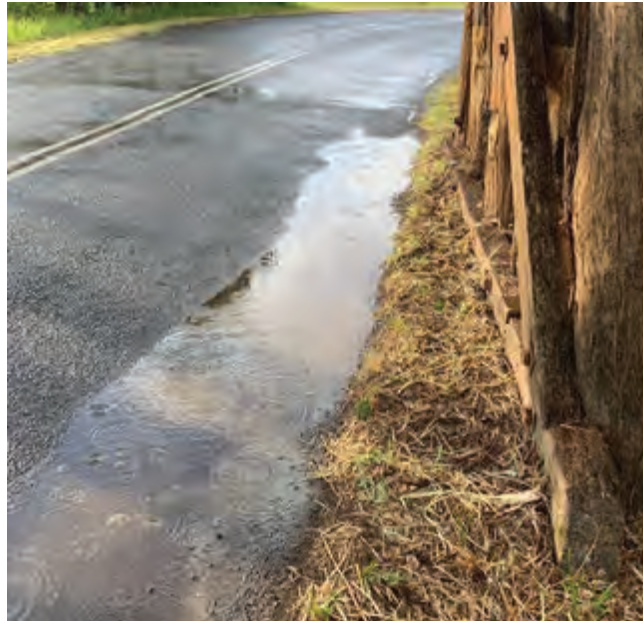
Photo 22: Roadside drainage at Winterton Parade viaduct

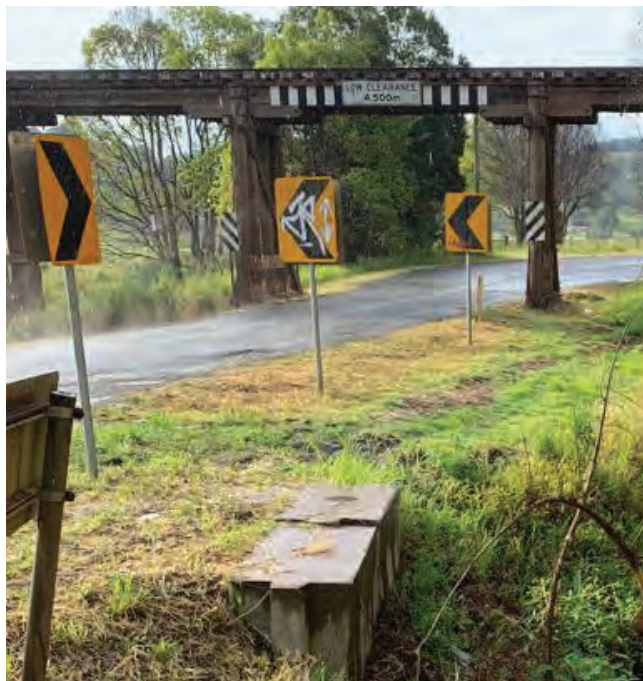
<p>28</p>	<p>Roadside Drainage</p> <p>The road shoulders are ponding water on the roadway in the approaches to and beneath the viaduct. This can lead to increased damage to pavement edges.</p> <p>There is a risk that vehicles may hit the water or damaged edges and lose control, resulting in a collision with a roadside hazard or another vehicle. There is a further risk to cyclists using the road.</p> <p><i>Refer to Photo 22</i></p>	<p>Likelihood: Unlikely</p> <p>Severity: Serious</p> <p>Risk: High</p>
<p>29</p>	<p>Condition of Signs and Lines</p> <p>Some signs are in poor condition (not reflective; damaged, vandalised). The line marking generally is badly worn in places. There are no RRPM's.</p> <p>Without adequate delineation, there is a risk that drivers could be confused by the road alignment, particularly at night, increasing the risk of a crash.</p> <p><i>Refer to Photo 23</i></p>	<p>Likelihood: Rare</p> <p>Severity: Moderate</p> <p>Risk: Low</p>

Photo 23: Vandalised signs – Winterton Parade viaduct

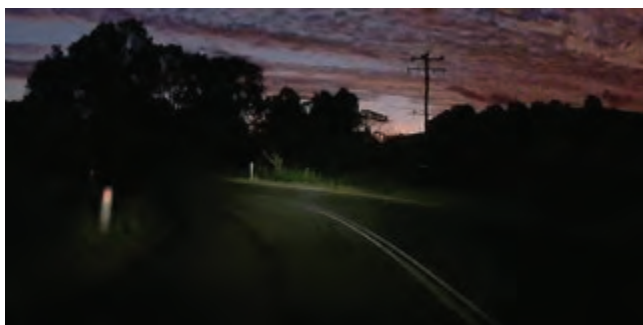
<p>30</p>	<p>Night Visibility of Bends and Viaduct</p> <p>The bends and the viaduct are poorly delineated at night. The line marking, guideposts, and delineation are inadequate. There are no RRPM's.</p> <p>Without adequate delineation, particularly at night, there is the potential for a crash on the bends or at the viaduct.</p> <p><i>Refer to Photo 24</i></p>	<p>Likelihood: Rare</p> <p>Severity: Serious</p> <p>Risk: Medium</p>

Photo 24: Night visibility - southbound approach to Winterton Parade viaduct

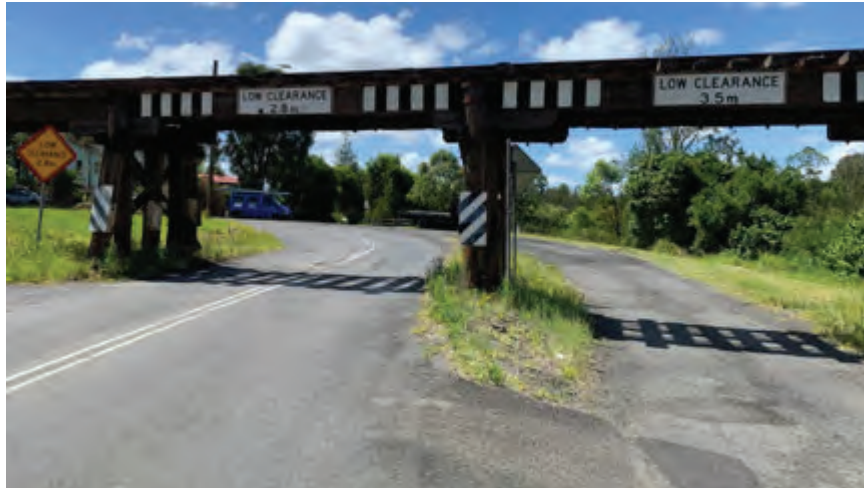
Photo 25: No edge lines and minimal edge clearance – Alexandra Parade viaduct

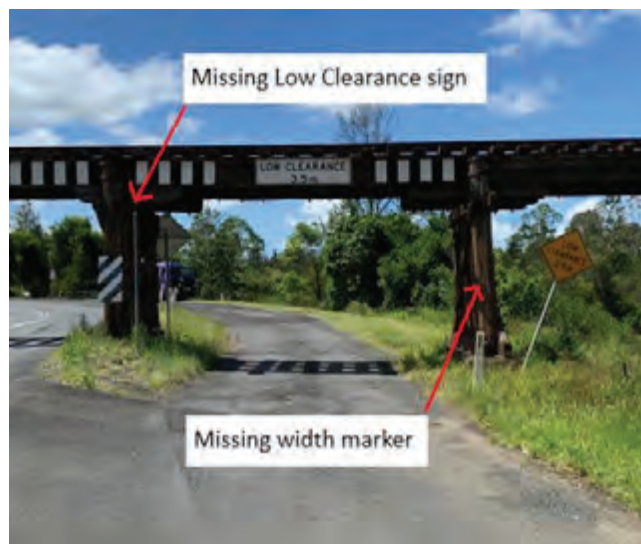
Site 4	Alexandra Parade, North Lismore	
31	<p>Inadequate Advance Warning Signs for the Low Clearance</p> <p>It is considered that the existing advance warning signs for the viaduct ('Low Clearance') are inadequate.</p> <p>There is a risk that a high vehicle could collide with the viaduct.</p>	<p>Likelihood: Rare</p> <p>Severity: Moderate</p> <p>Risk: Low</p>
32	<p>Minimal Vertical Clearance</p> <p>The vertical clearance at the viaduct is considerably less than 4.6m, which is the typical minimum for clearance over a roadway (5.4m for main and arterial roads).</p> <p>Without adequate advance warning, and suitable high vehicle detour routes in place, there is a risk that a high vehicle could collide with the viaduct.</p>	<p>Likelihood: Rare</p> <p>Severity: Moderate</p> <p>Risk: Low</p>
33	<p>No Outer Lane Delineation</p> <p>There are no edge lines on Alexandra Parade or the bypass road beneath the viaduct. Edge lines help to delineate the path of travel through the viaduct.</p> <p>There is a risk that a vehicle could collide with a viaduct pylon.</p> <p><i>Refer to Photo 25</i></p>	<p>Likelihood: Possible</p> <p>Severity: Serious</p> <p>Risk: High</p>

Photo 26: Missing width marker and Low Clearance sign – Winterton Parade viaduct eastbound

- Replace missing width markers and Low Clearance sign.
 - Establish priority direction for one-way bypass viaduct. Priority should be given to westbound traffic. Install appropriate line marking and signs to indicate priority. Check that legal access is available for eastbound traffic – consider removing a section of the BB line if appropriate.

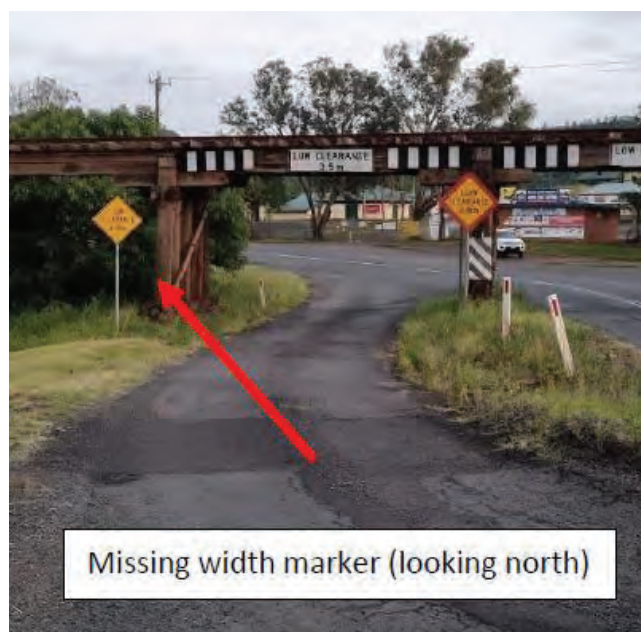
34	<p>Edge Clearances</p> <p>There is minimal clearance from edge of the road carriageway to the pylons, particularly in the main carriageway.</p> <p>There is a risk that a vehicle could collide with a viaduct pylon.</p> <p><i>Refer to Photo 25</i></p>	<p>Likelihood: Possible</p> <p>Severity: Serious</p> <p>Risk: High</p>
35	<p>Missing Signs</p> <p>There are no width markers on the western pylons (outer pylon on 3.5m clearance lane), either direction.</p> <p>A 'Low Clearance' sign is missing on the central pylon, eastbound.</p> <p>There is a risk that a vehicle could collide with a viaduct pylon.</p> <p><i>Refer to Photo 26</i></p>	<p>Likelihood: Rare</p> <p>Severity: Serious</p> <p>Risk: Medium</p>
36	<p>Bypass Viaduct Width</p> <p>The roadway width of the bypass viaduct is only suitable for one way traffic – priorities are not defined.</p> <p>There is a risk of a head-on or rear-end collision in the bypass viaduct.</p> <p><i>Refer to Photo 27</i></p>	<p>Likelihood: Rare</p> <p>Severity: Serious</p> <p>Risk: Medium</p>

Photo 27: Missing width marker – Winterton Parade viaduct eastbound

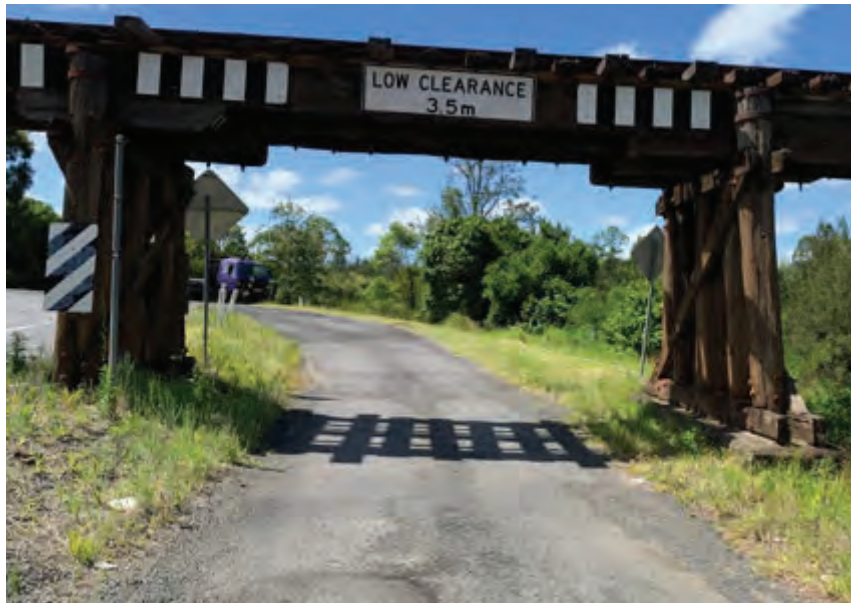
Photo 28: Road width – Alexandra Parade bypass viaduct

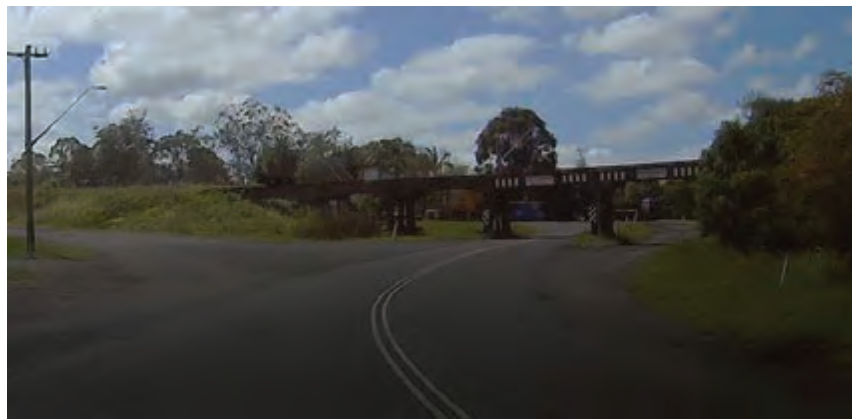
Photo 29: Eastbound approach to bypass viaduct – Alexandra Parade. Driver must cross BB lines

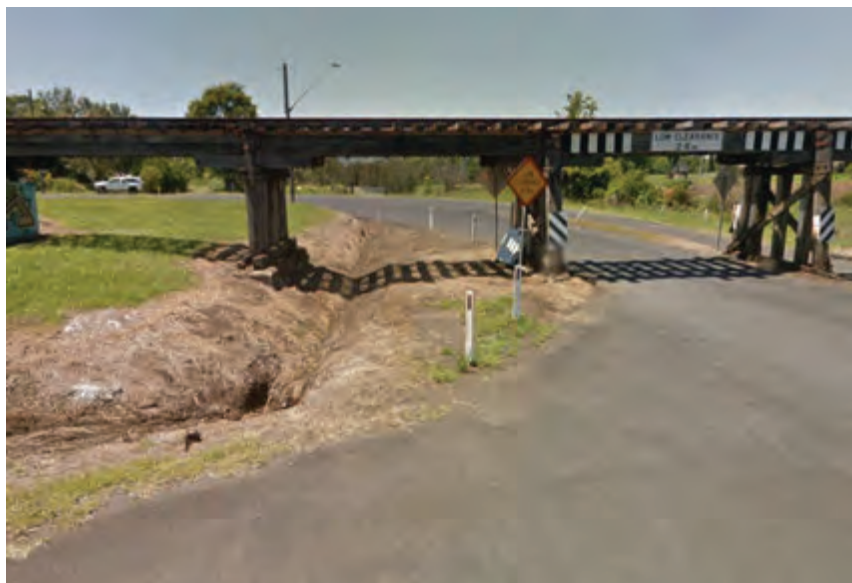
Photo 30: Sight distance from Showground access road through Alexandra Parade viaduct (courtesy Google Street View)

- Provide advance warning sign (westbound) for the Showground access road intersection.
 - The damaged section of Alexandra Parade is a hazard to drivers and cyclists, as noted in the Findings. Determine the reasons for damage and rectify. Recommend undertaking pavement reconstruction for this area. Any upgrade should consider including wider shoulders.

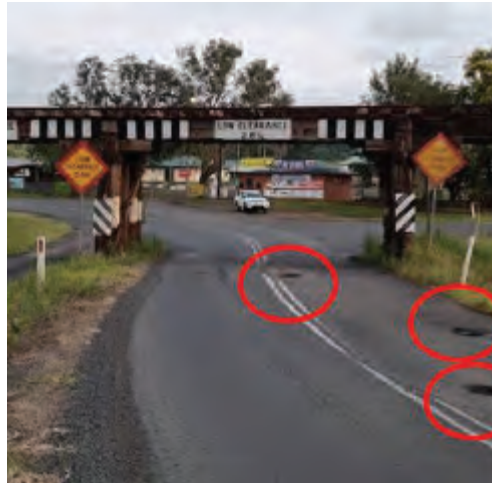
<p>40</p>	<p>Showground Access Road Intersection</p> <p>There is no line marking in the intersection, or 'Stop' or 'Give Way' signs. Sight distance to the south from the intersection (through the viaduct) is limited. (It is noted that this is probably a private road).</p> <p>There is a risk that vehicles exiting the Showground access road could collide with through traffic.</p> <p><i>Refer to Photo 29</i></p>	<p>Likelihood: Rare</p> <p>Severity: Serious</p> <p>Risk: Medium</p>
<p>41</p>	<p>Road Condition</p> <p>There are some potholes in the eastbound lane.</p> <p>There is a risk of a crash if vehicles try to avoid the potholes. There is a further risk to cyclists using the road.</p> <p><i>Refer to Photo 30</i></p>	<p>Likelihood: Possible</p> <p>Severity: Serious</p> <p>Risk: High</p>

Potholes – heading north on rhs

Photo 31: Road condition – Alexandra Parade eastbound

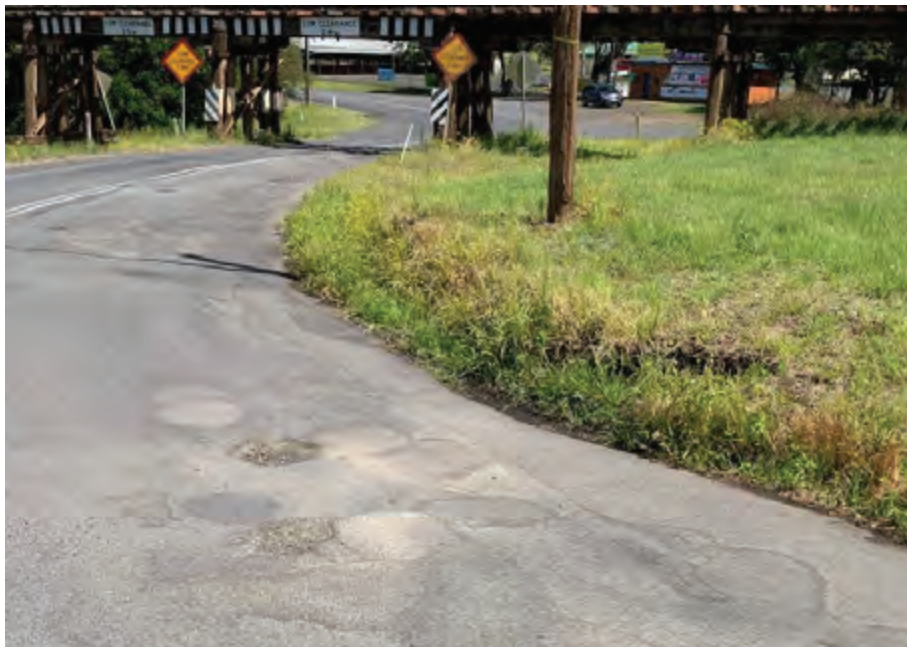
<p>42</p>	<p>Roadside Drainage</p> <p>Eastbound lane, inside of curve, on south side of viaduct – roadside drainage is inadequate. Water flows on the road edge. This can lead to increased damage to pavement edges.</p> <p>There is a risk that vehicles may hit the water or damaged edges and lose control, resulting in a collision with a roadside hazard or another vehicle. There is a further risk to cyclists using the road.</p> <p><i>Refer to Photo 31</i></p>	<p>Likelihood: Rare</p> <p>Severity: Moderate</p> <p>Risk: Low</p>
<p>43</p>	<p>Condition of Signs and Lines</p> <p>Some signs are in poor condition (not reflective; damaged). The line marking generally is badly worn in places. There are no RRPM's.</p> <p>Without adequate delineation, there is a risk that drivers could be confused by the road alignment, particularly at night, increasing the risk of a crash.</p> <p><i>Refer to Photo 32</i></p>	<p>Likelihood: Rare</p> <p>Severity: Moderate</p> <p>Risk: Low</p>

Photo 32: Lack of roadside drainage – Alexandra Parade eastbound, south of viaduct

- Measures to improve roadside drainage should be investigated, to ensure surface water flows away from the road surface.

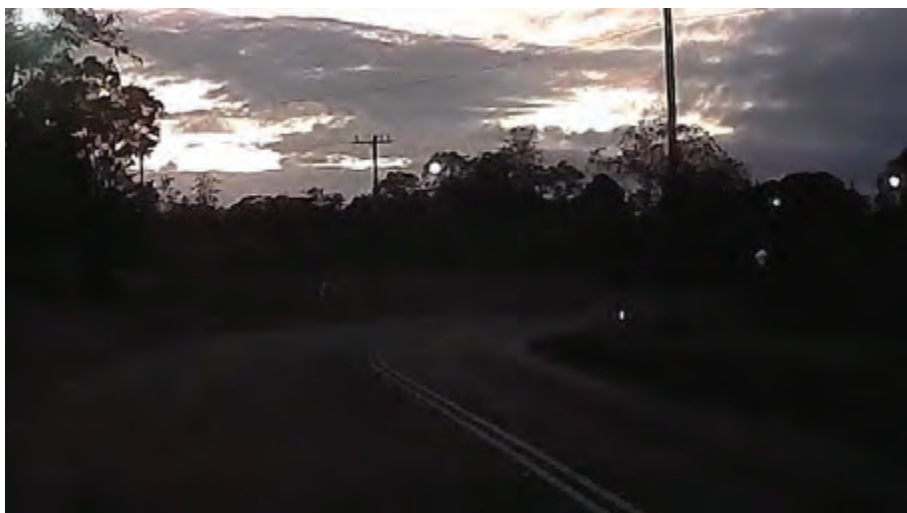
<p>44</p>	<p>Night Visibility of Bends and Viaduct</p> <p>The bends and the viaduct are poorly delineated at night, in particular eastbound. The line marking, guideposts, and delineation are inadequate. There are no RRPM's.</p> <p>Without adequate delineation, particularly at night, there is the potential for a crash on the bends or at the viaduct.</p> <p><i>Refer to Photo 33</i></p>	<p>Likelihood: Rare</p> <p>Severity: Serious</p> <p>Risk: Medium</p>

Photo 33: Night visibility - eastbound approach to Alexandra Parade viaduct
