ix. Hull plating / main sheerstrake

2. DISCUSSION

c. Identification of the Shipwreck: Comparison with SS *Nemesis*

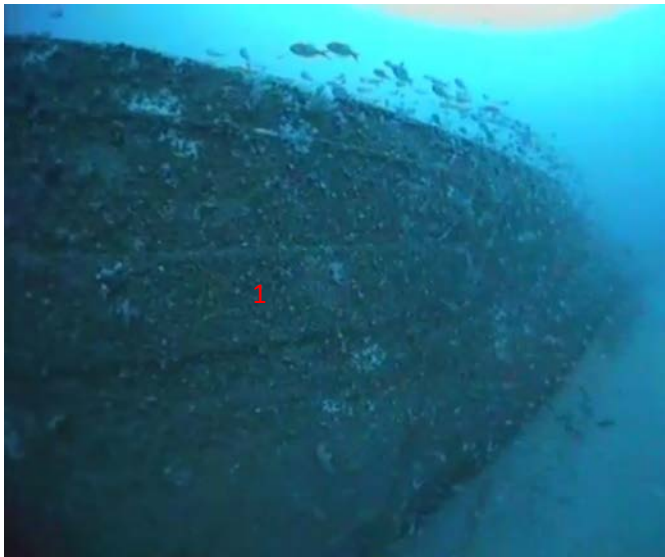
The vessel's hull consists of overlapping metal plates, suggesting the vessel is rivetted and therefore predates c 1930s when welding was first introduced to Australia. Earlier welding was introduced internationally in c 1920s but was not widely used in Australia until after the 1930s. The vessel exhibits a prominent sheerstrake (a band used to reinforce the vessel longitudinally) at the main deck level. This is particularly evident in the bridge area where the hull is most intact (Figure 83).

Hewitt (pers comms) has suggested that the thickness of the sheer strake is highly unusual, and that it may be a reinforcing strake, for instance at the wind and water line, or a doubler where there has been abrasion or damage from fendering. Hewitt states that he has never seen a sheerstrake this thick in his experience studying and researching vessels of this period.

Figure 83: Main sheerstrake hull plating (1) on starboard side below the bridge (Image: CSIRO 2023 - Lapped Hull Plating Side cam)

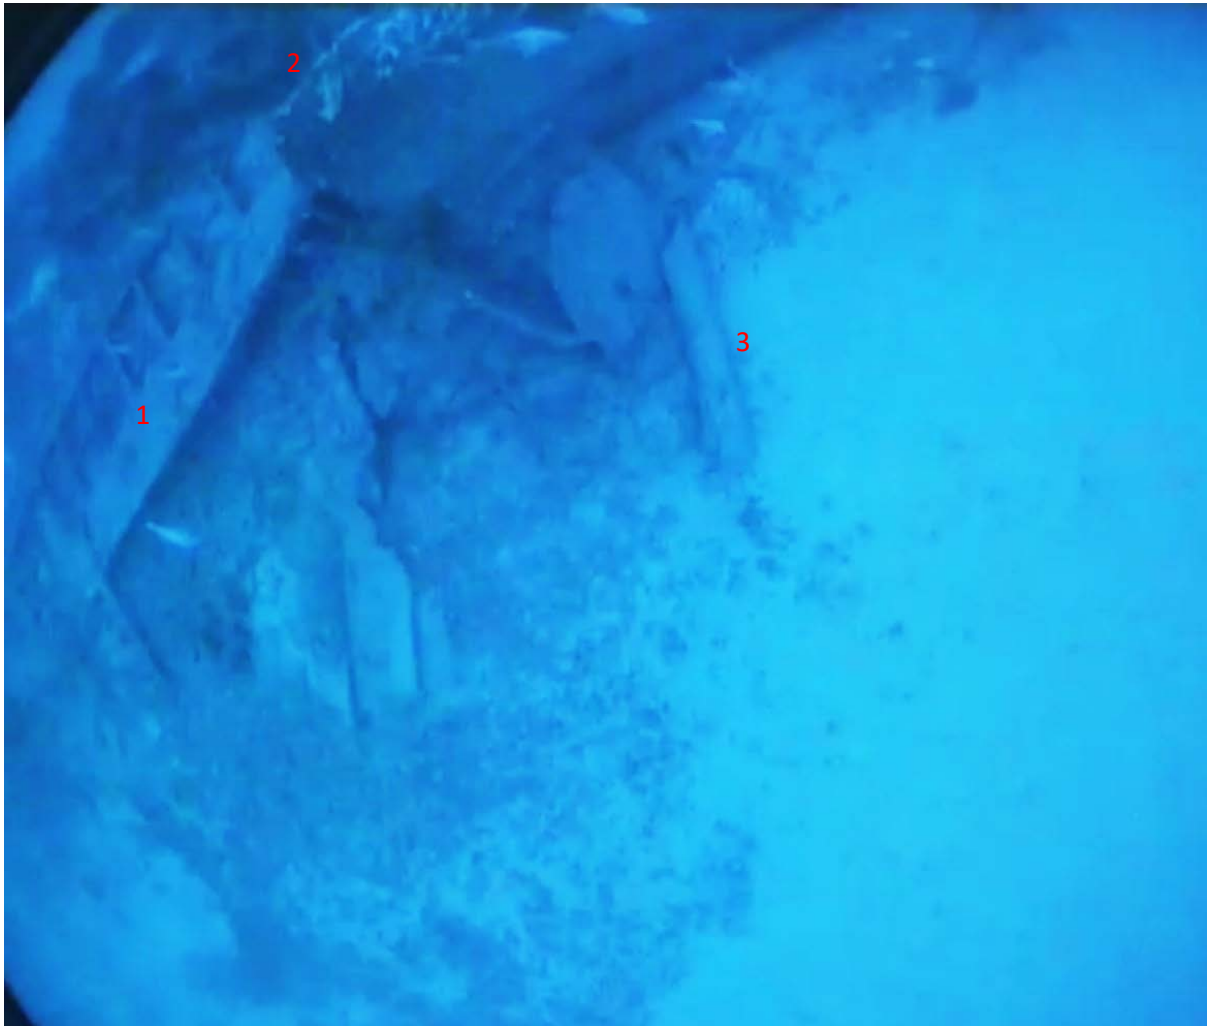
The vessel has collapsed again aft of the engine room bulkhead, which appears to be intact. The hull after this section has collapsed and the aft main deck beam stringer plate is still attached to the hull at the forward section but has collapsed onto the seabed further aft just before the aft of the end of the aft hatchway (see below).

Figure 85: Starboard side collapsed stern main deck beam stringer plate (1) aft of engine room bulkhead (2). Note the remains of probable derrick crane on seabed (3) (Image: CSIRO 2023 - 07414)

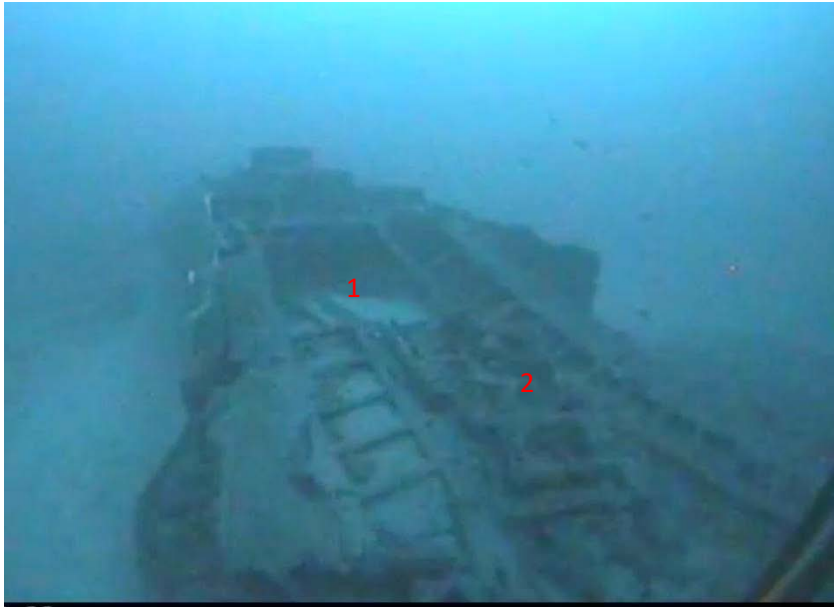
A few metres aft of the engine room bulkhead is another cargo hatchway which has collapsed (Figure 86, Figure 87). The hatchway has a raised coaming and is of similar dimensions to the forward cargo hatchway. On the port side of the hatchway the decking is still intact, and a set of bitts are still in situ, whilst the on the starboard side the deck is missing.

Figure 86: View aft hatch looking forward showing hatchway (1) and mast step (2) (Image: CSIRO 2023 -)

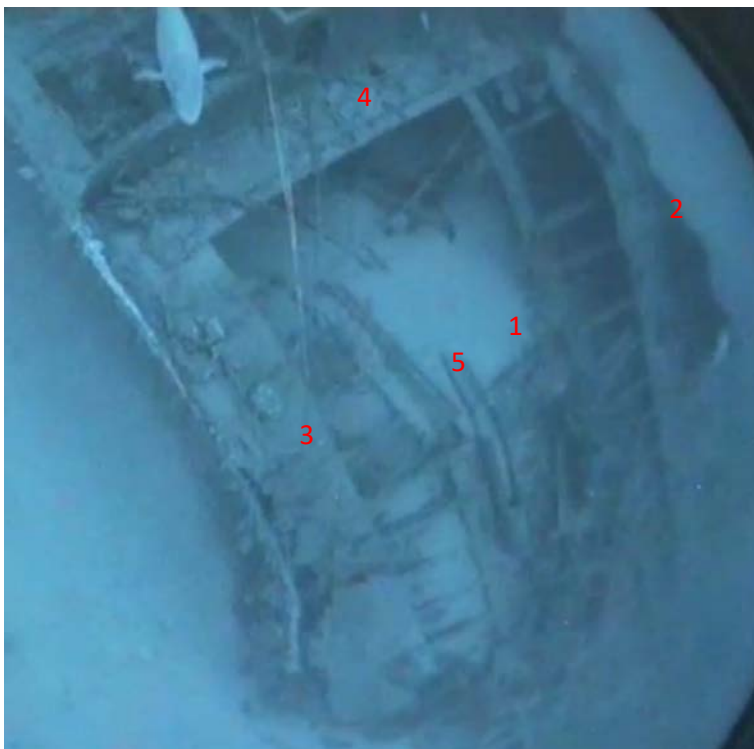
Figure 87: Rear hatch (1) with collapsed main decking around coaming on starboard side (2). Note the bitts (3) on port side, the engine room decklight coaming (4), and possible section of a collapsed derrick crane or propeller shaft (5) (Image: CSIRO 2023 - e 2368)

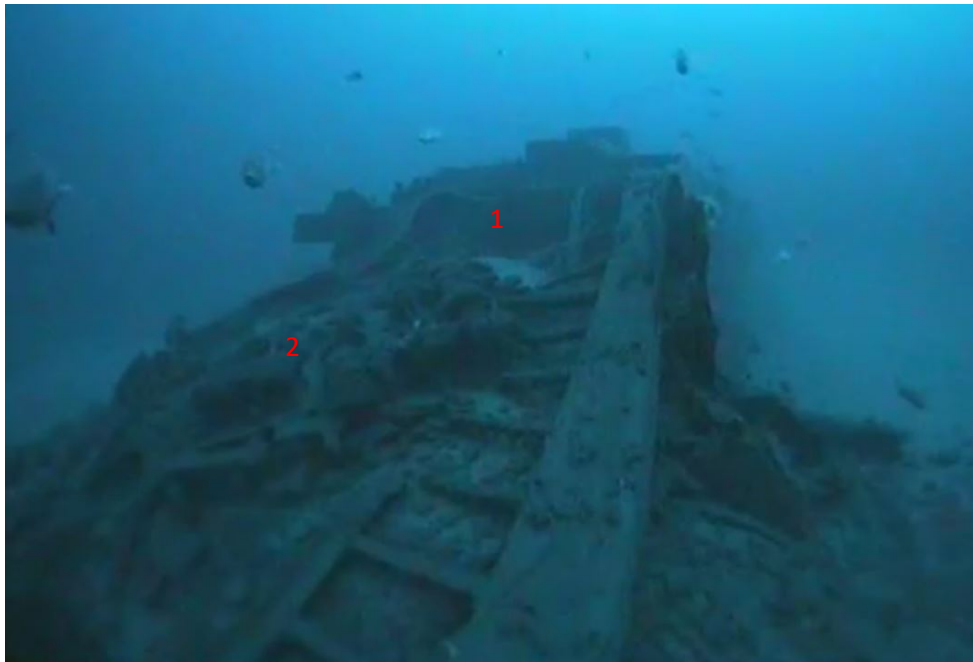
Aft of the main deck hatchway, the entire hull has collapsed onto the seabed. On the deck on the starboard side, there are section of what appears to be an inverted section of deck where the rear derrick crane mast once connected penetrated the deck through the mast partners. Part of this section also shows what appears to be a person sized access hatchway that goes through the deck. At the other end of this section is what appears to be a cargo winch (Figure 88, Figure 89, Figure 90).

Figure 88: View facing forward toward rear hatch (1). Note remains of machinery or a section of inverted deck with attached cargo winch mast partners and access hatchway attached on deck (2) probably associated with a derrick crane (Image: CSIRO 2023 - side cam)

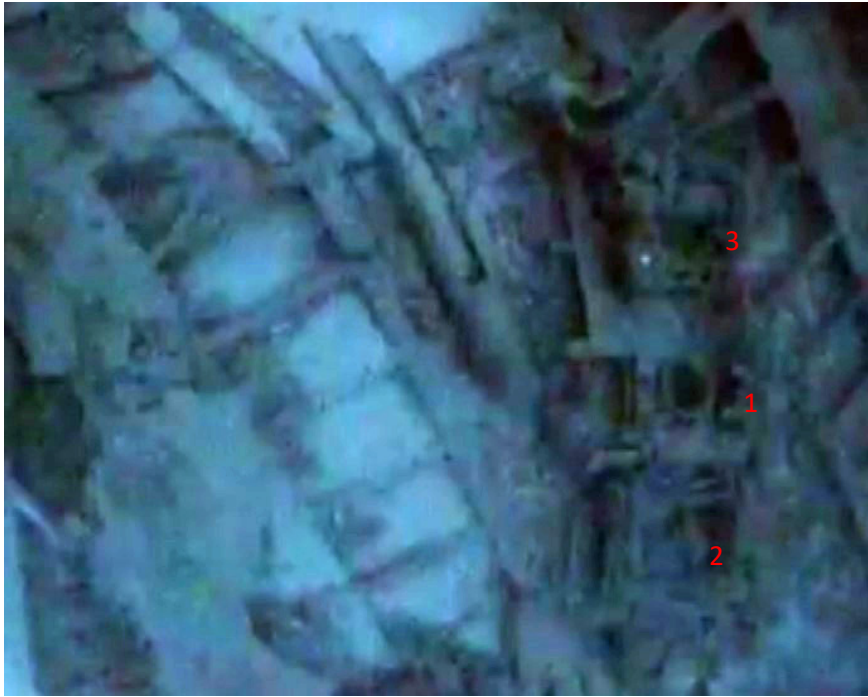
Figure 89: Derrick crane mast collar in deck (1) with access hatch (2) on aft side and cargo winch (3) on forward side (Image: CSIRO 2023 - 2266)

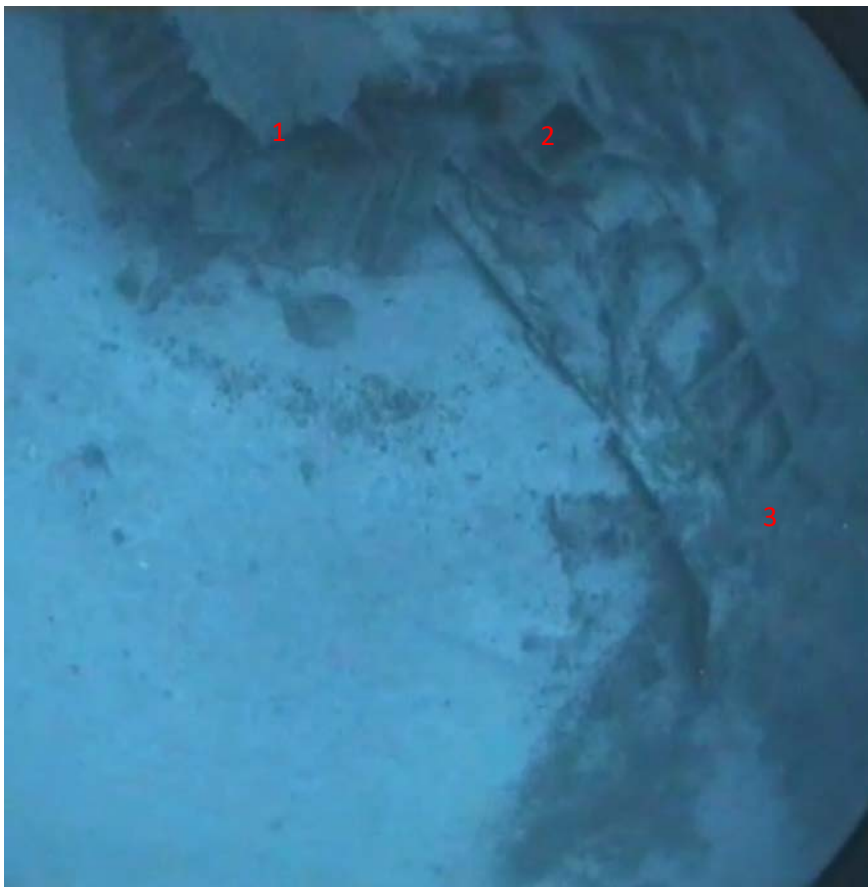
Figure 90: Rear extremity of the remaining port side of the stern hull deck beam stringer plating (1) showing possible hatchway or mast step (2). Note the lower hull framing extending to the coal pile (Image: CSIRO 2023 -)

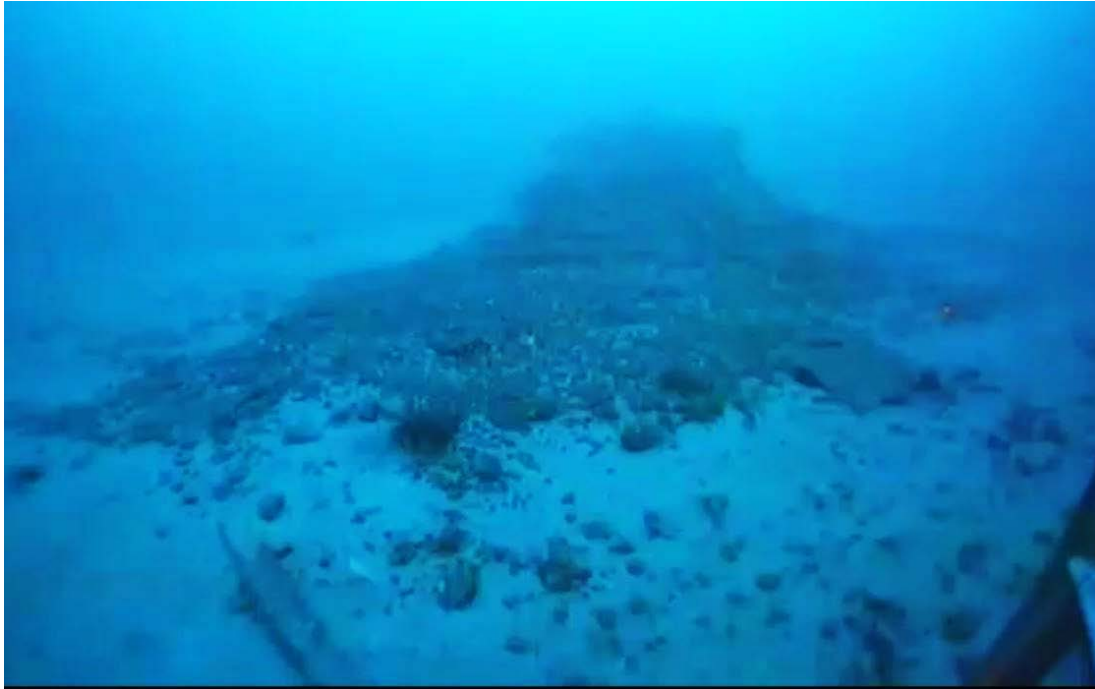
At the extremity of the site, the hull and deck plating finishes and is replaced by an extensive area of aggregate (that appears to be coal). At the very end of this pile is a cylindrical object (Figure 91, Figure 92) but it is unclear if this piping, a length of derrick crane or possibly part of the drive shaft or propeller shaft. There is an extensive scatter of aggregate which covers the entire width of the vessel, and which extends out to the port side. It appears that the entire stern section of the vessel has snapped off or collapsed during the wrecking event and is missing from the site (Figure 93).

Figure 91: Stern extremity of the wreck facing forward. Note the lack of any sternpost, rudder or propellor (Image: CSIRO 2023 - Stern extent facing forward - side cam)

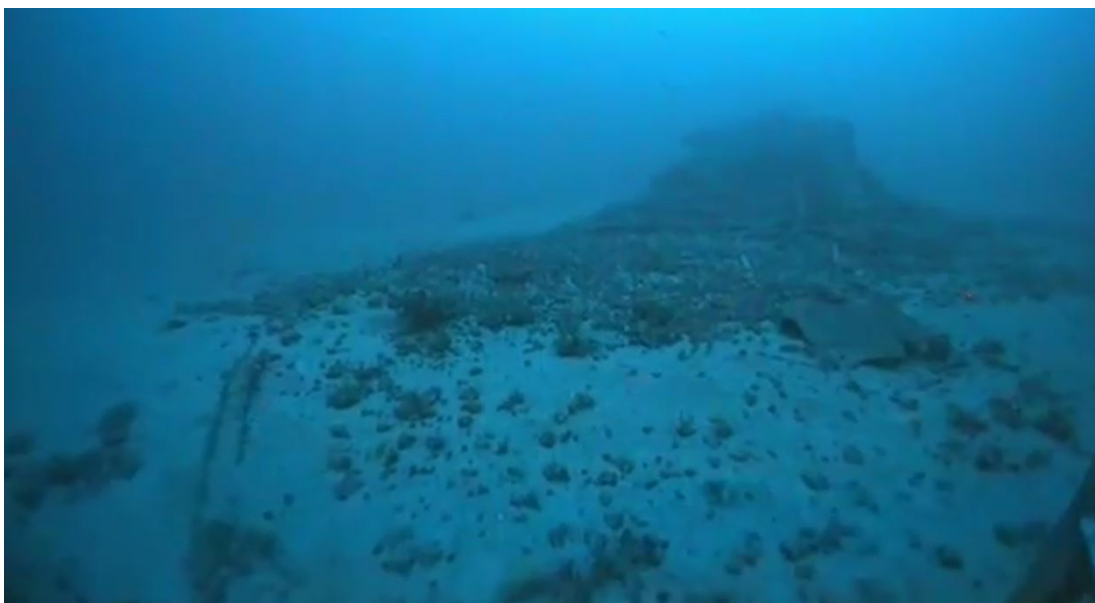
Figure 92: Stern extremity of the wreck facing forward. Note the lack of any sternpost, rudder or propellor, and the remains of either a derrick crane or possible drive shaft (Image: CSIRO 2023 - Stern extent facing forward - side cam2)

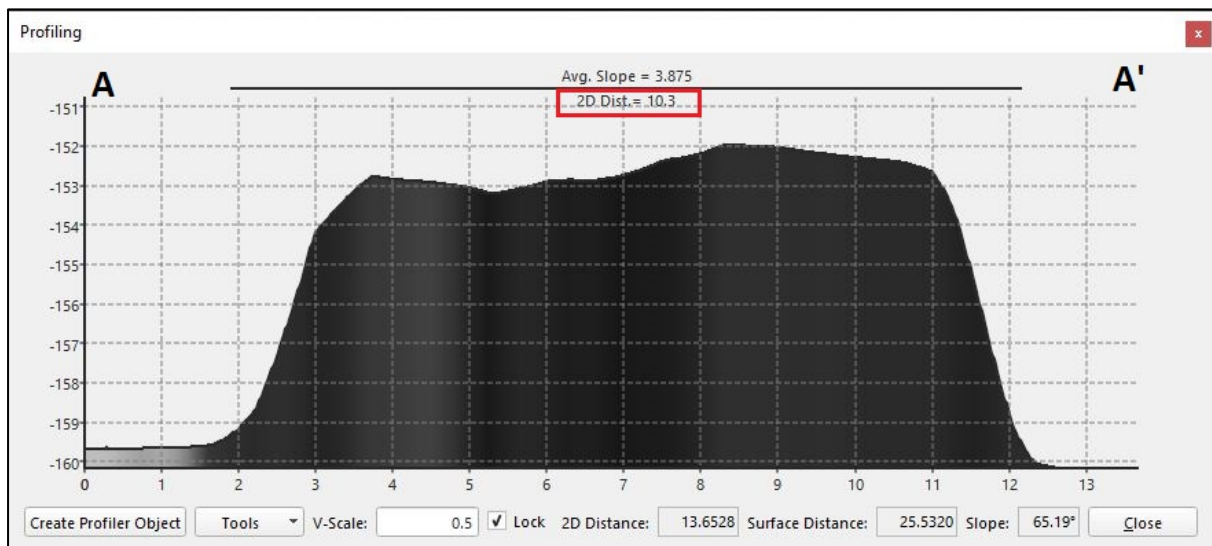
Figure 96: Cross section profile of the wreck showing height and approximate width of the wreck (Image: CSIRO 2023 - 2023).

The initial dimensions obtained using multibeam sonar (73.2m long x 9.4m wide x c 7.5m high) are consistent with the SS *Nemesis* (historically known measurements are: 73.21m long x 10.37m beam x 5.471m depth), which was sunk by in a gale in 1904. However it must be noted that the multibeam sonar longitudinal measurements are partially based on the extent of the debris field around wreck site, and not necessarily on in situ or intact known sections of the wreck.

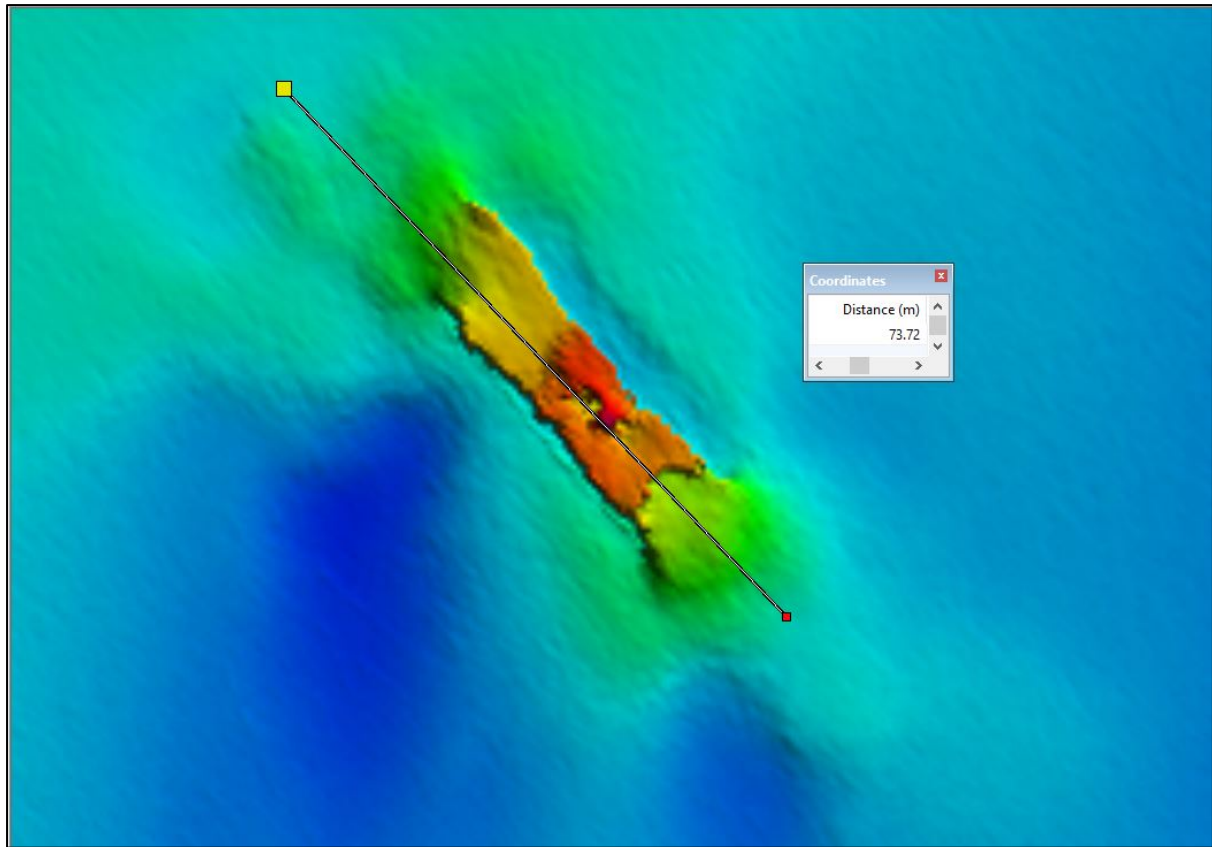
Figure 97: Multibeam image of wreck showing the length of the wreck (Image: CSIRO 2023 - 2023).
