URGENT REPAIRS TO SEAWALLS AT 44 & 48 CHILDE STREET, BELONGIL

Prepared By

21st December 2016

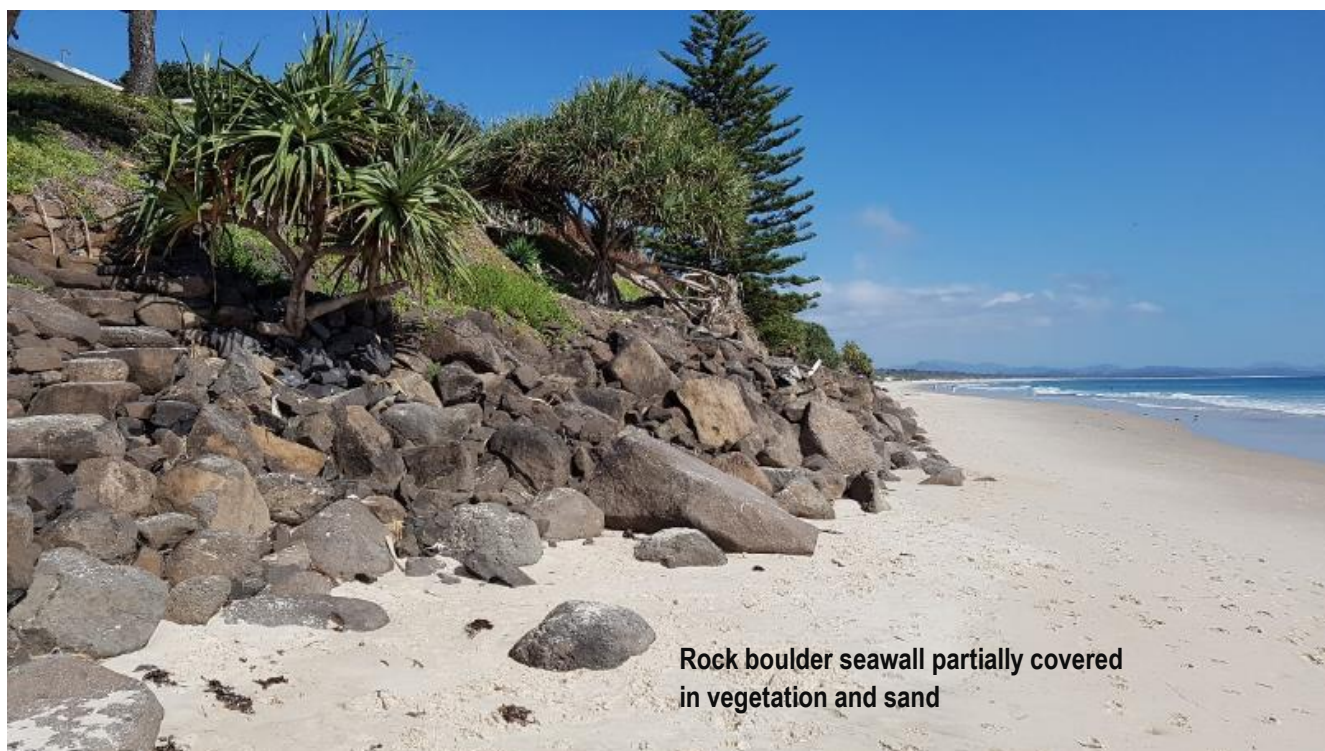
Figure 2 44 Childe Street (ICM 13/10/16)

At present, the wall is partially covered by sand but loose rocks are evident (Figure 2 and Figure 3). During erosion events these rocks and concrete blocks can be 2-3m above sand level and there is a risk of them falling. During eroded beach conditions beach users may be forced to use the beach close to the wall and could be at risk.

- The proposed works are to make safe existing works by restacking of the wall to restore a stable slope without loose rocks that could be dislodged during erosion events.
- The proposed works will make public access safer by moving dislodged rock from the base of the existing wall and replacing these on the repaired slope.
- The completed repair works will improve public access along the beach.
