# REPAIRS TO SEAWALL AT 6B CHILDE STREET

## RESPONSES TO RFI BY NSW COASTAL PANEL

**RE: NO 6B CHILDE ST, BELONGIL**

**REF DOC 17/8231**

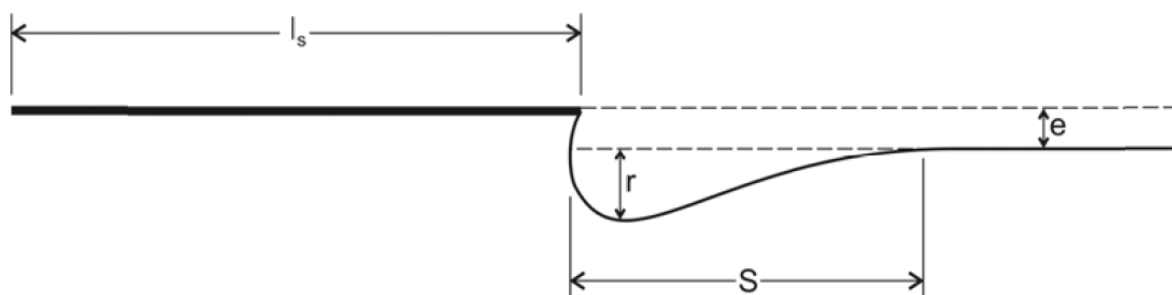
Figure 1

**Response:** An assessment of such effects was provided in the original application. McDougal et al 1987 provided the following diagram for end effects of seawalls on a straight beach:

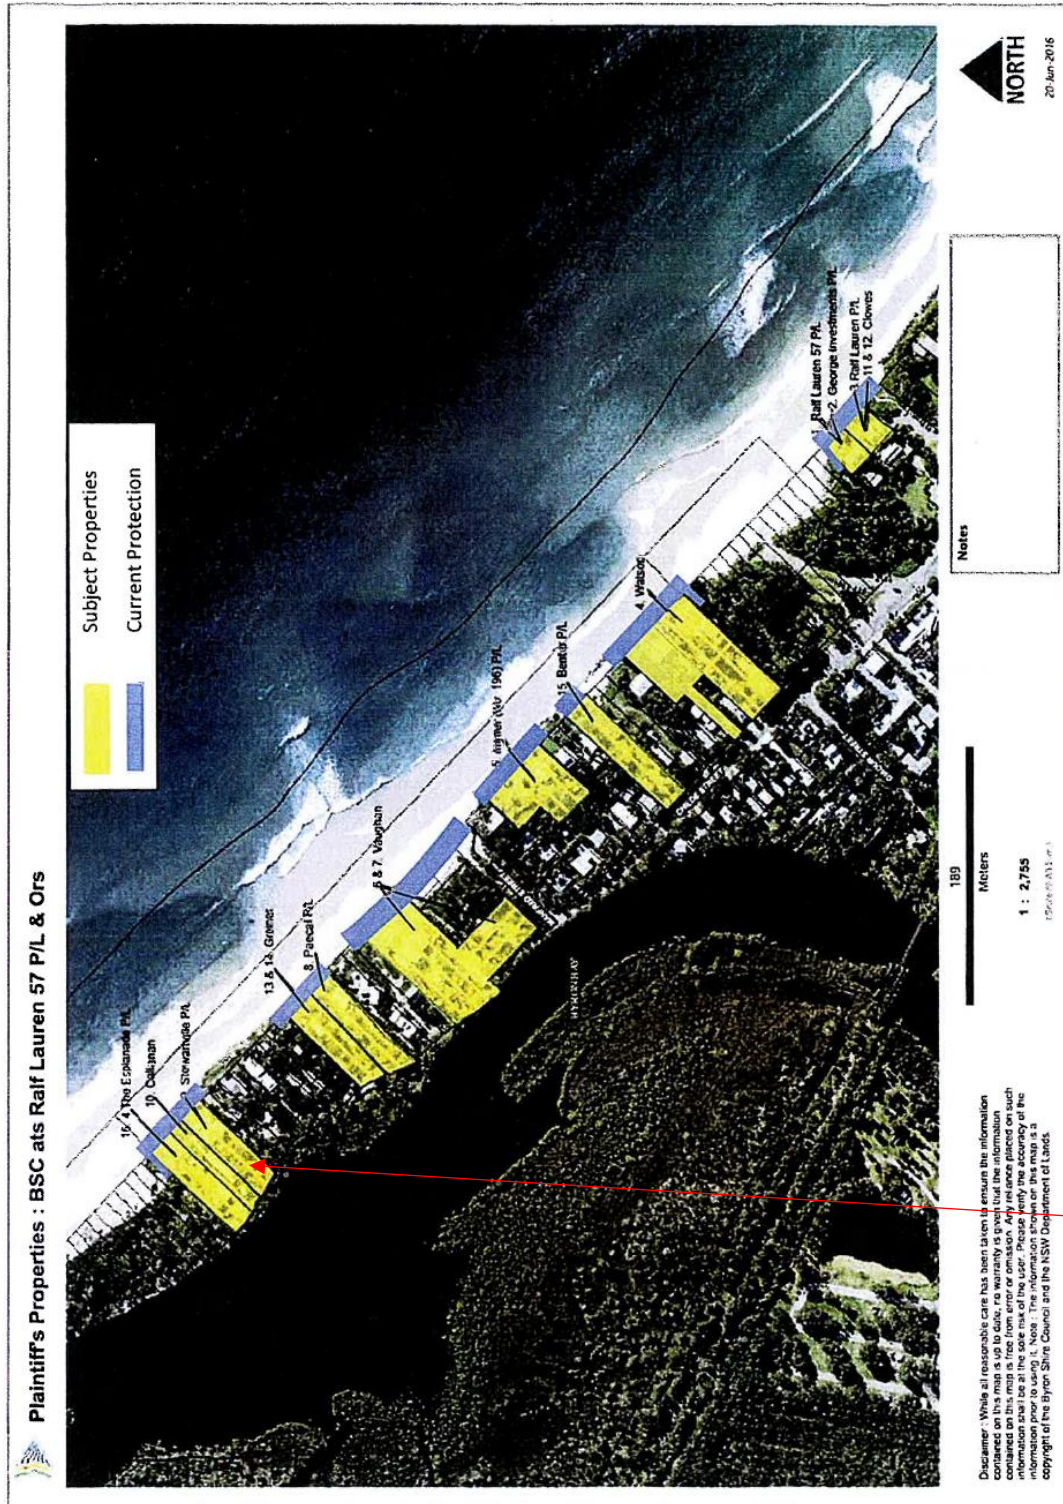
Figure 2 Schedule 1 from Court Orders

The proposed repair works will NOT result in failure of works on adjoining properties. The Supreme Court of NSW Orders show the extent of the current protection for the subject properties to be repaired as extending to either side of the subject properties – see drawing following extracted from Court Orders. This overlap was included in the current protection to be repaired as the adjacent walls provide protection to the subject properties. The repaired walls will be smoothly transitioned into the adjacent walls to avoid a weak area at the boundaries or adverse impacts on the adjacent walls during repairs. This was already explained in the original application.
