# **URGENT REPAIRS TO SEAWALLS AT 6 CHILDE STREET, BELONGIL**

**International  
Coastal  
Management**

21<sup>st</sup> December 2016

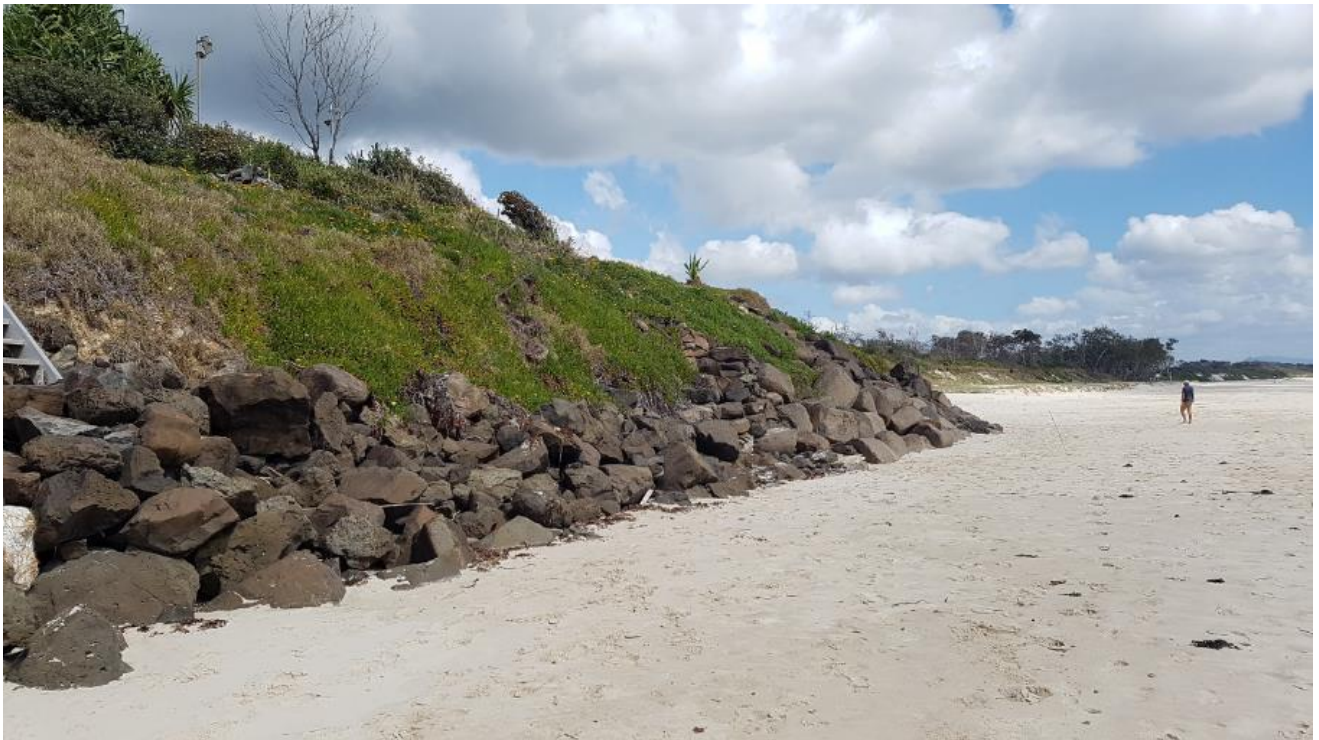
At present, the wall is partially covered by sand but some loose rocks are evident (Figure 2 and Figure 3). During erosion events these rocks can be 2-3m above sand level and there is a risk of them falling. During eroded beach conditions beach users may be forced to use the beach close to the wall and could be at risk.

Figure 2 Rock seawall along 6 Childe Street, 6A Childe Street; and No. 4 The Esplanade (ICM 13/10/2016)

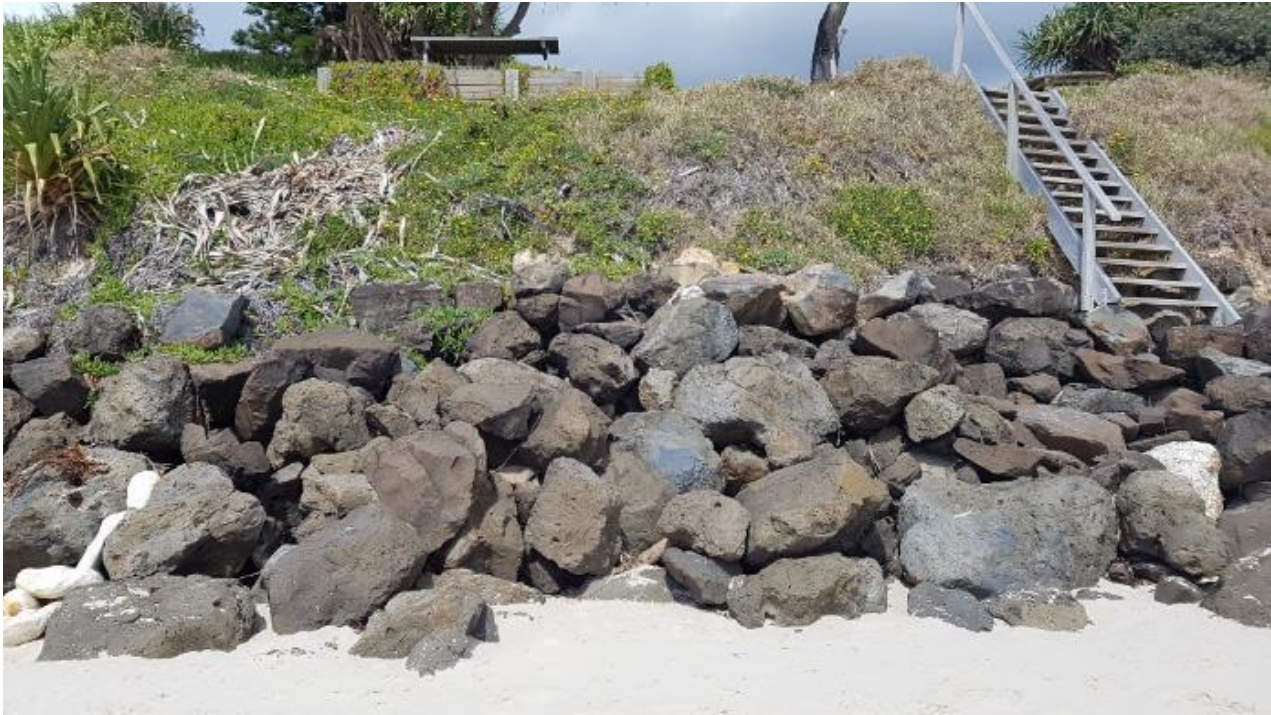
**Figure 3 Rock seawall at 6 Childe Street (ICM 13/10/2016)**

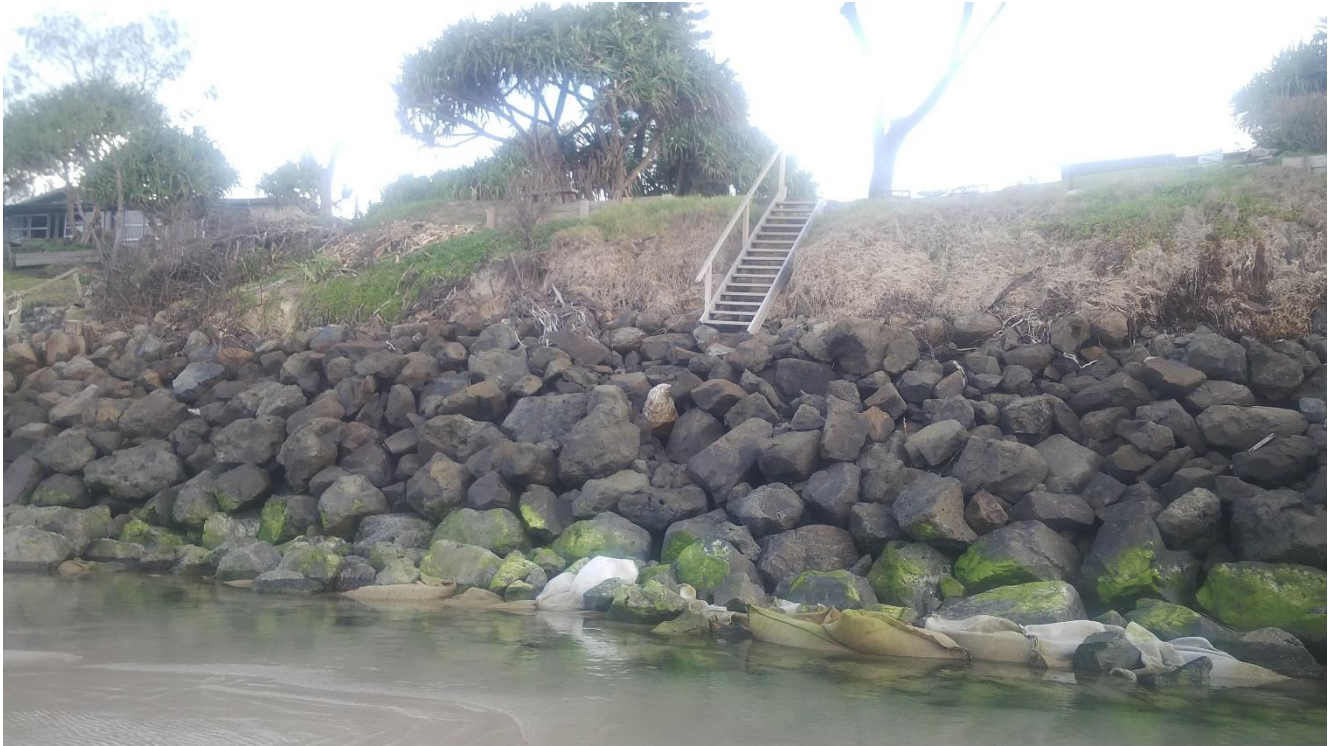
The historical photos show rocks from the slope have been dislodged and during erosion events there is a wider toe than originally constructed that can adversely impact on beach amenity and safety during major erosion events (Figure 4). These displaced rocks will be removed to the mid and upper slope in a stable configuration during repairs.

**Figure 4 Toe and adjacent wall to southward exposed during erosion in 2013 (ICM photo)**

- The works shall be carried out in 10 – 15m sections starting from the NW end.
  - The toe of the existing wall will be excavated with a 20-30t hydraulic excavator to about -1m AHD and re-profiled to the original stable slope of about 1V:1.5H with the repaired crest at +6m AHD.
