Geotechnical Investigation

Arrawarra Beach Caravan Park

Astoria Group P/L

June 2016

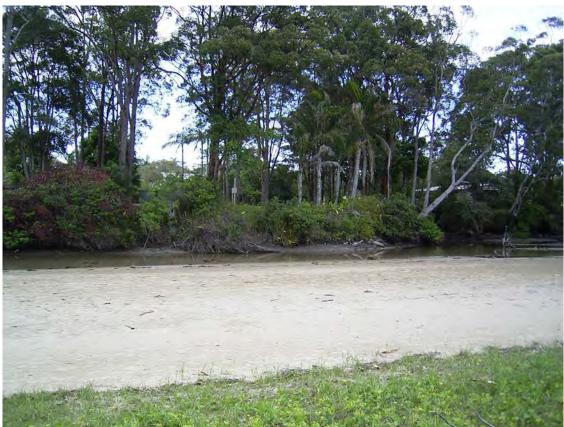
The Yarrawarra Creek bank to the north is the highest at approximately 3 metres. Other than some toe protection offered by the gabions at the eastern end, the bank is only protected by vegetation. Significant scour, erosion and undercutting are present.

Photo 1 – Yarrawarra Creek bank, Ch 40 to 80 m

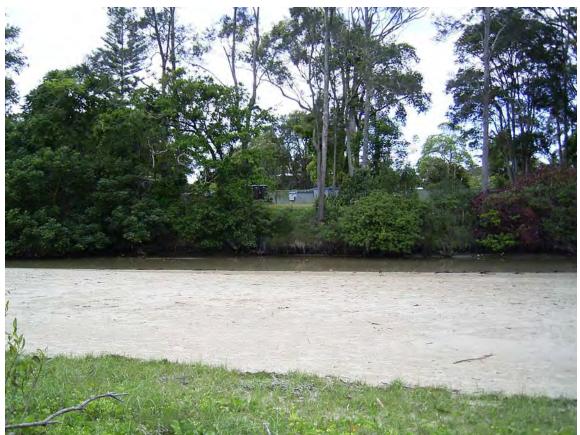
Photo 2 – Yarrawarra Creek Bank, Ch 80 – 140 m

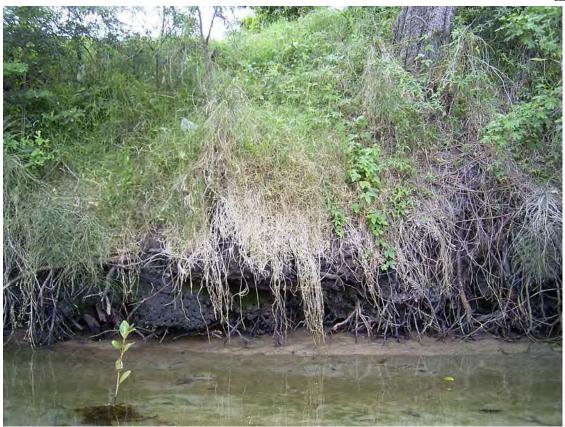
Photo 3 – Bank at Ch 80 m.

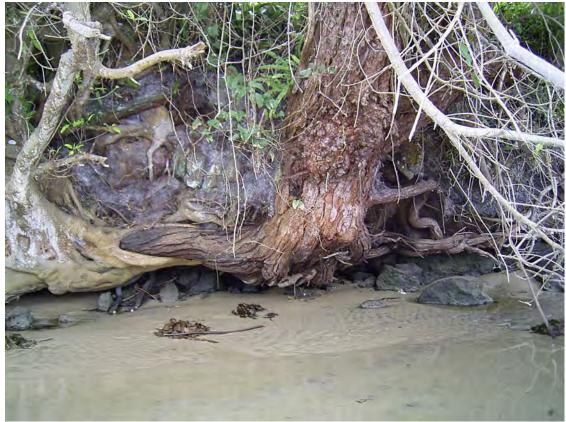
Photo 4 – Base of large trees at Ch 125 m, note under cutting.

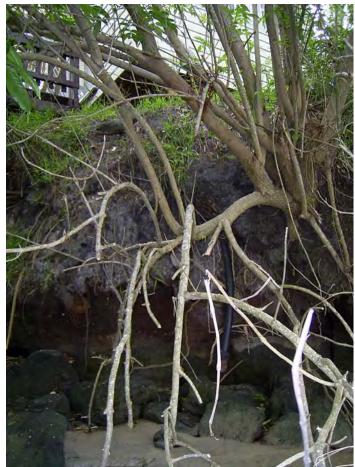
A band of weakly indurated sand (coffee rock) is evident along the Yarrawarra Creek bank from about RL 0.5 m to 1.5 m AHD. It is assisting in maintaining the bank's near vertical face but is being undercut and eroded. Its strength is very weak and/or it is discontinuous as its penetration was not detected in the boreholes other than by the colour of the sand.

Photo 5 – Ch 155 Note coffee rock at base.

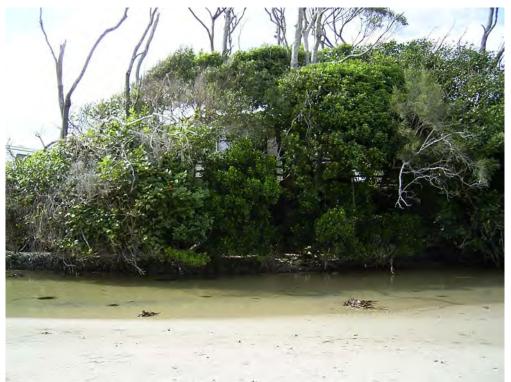
Photo 6 – Ch 170, Note start of gabion baskets at toe of bank.

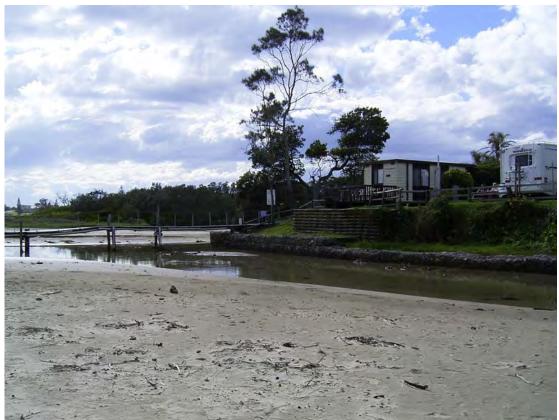
Photo 7 – Ch 190 to 210 m.

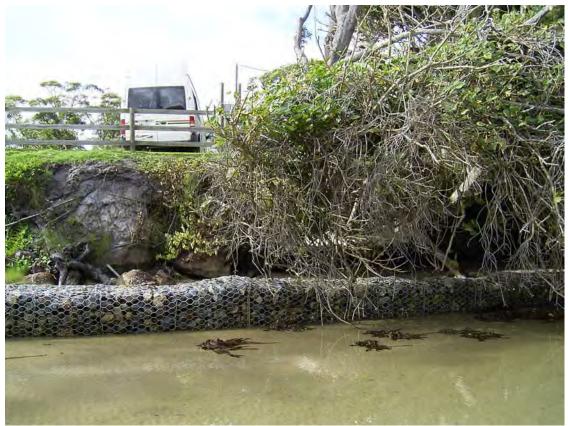
The existing creek banks show signs of scour and erosion, particularly that facing Yarrawarra Creek to the north. The previously installed gabion wall along the eastern bank is deteriorating. Gradual failure with loss of stones can be expected in the coming years if no preventative action is taken.

Photo 8 – Ch 185, Note scour and erosion to bank behind the gabion toe.

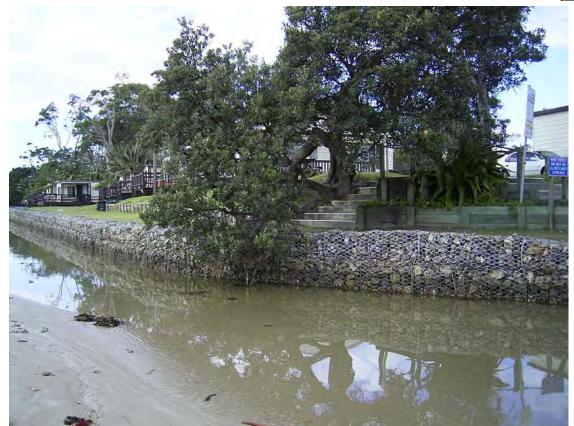
Photo 9 – Arrawarra Creek, Ch 220 on.

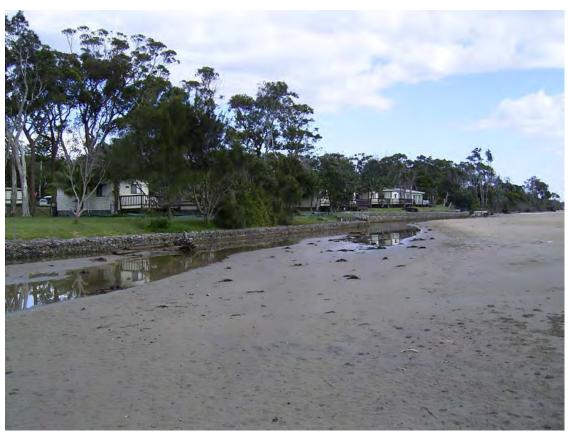
Photo 10 – Arrawarra Creek looking downstream from Ch 350 m to 220 m.

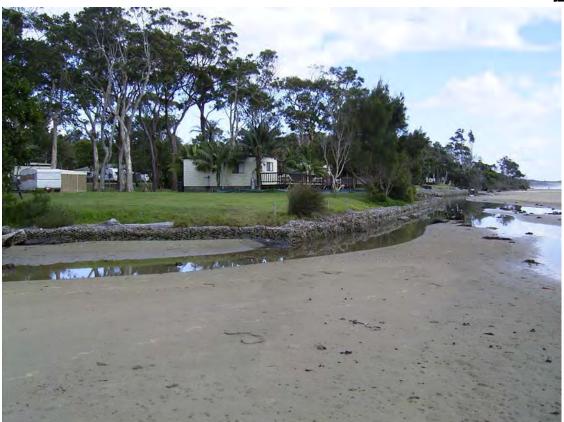
Photo 11 – Ch 370 m.

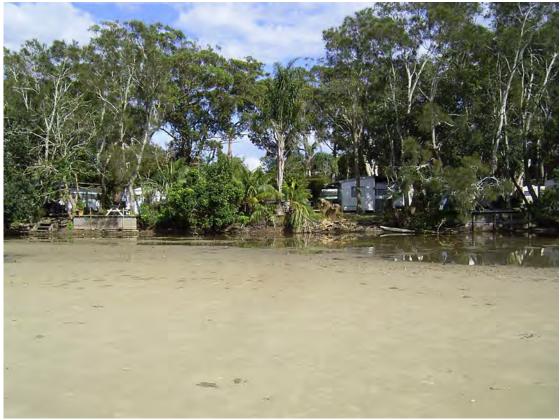
Photo 12 – Ch 420.

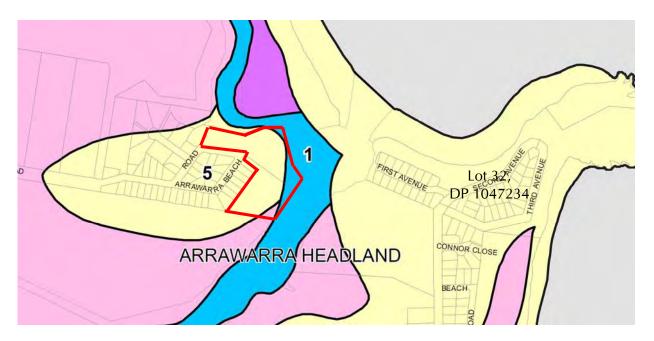
Figure 1: Extract from Coffs Harbour LEP Mapping

According to Coffs Harbour City Council mapping, the majority of the site is listed as being Class 5 ASS. However a low lying portion land in the north-eastern corner of the property is recorded as Class 1 ASS, as can be seen in the figure below.
