# **URGENT REPAIRS TO SEAWALLS AT 44 & 48 CHILDE STREET, BELONGIL**

**International  
Coastal  
Management**

21<sup>st</sup> December 2016

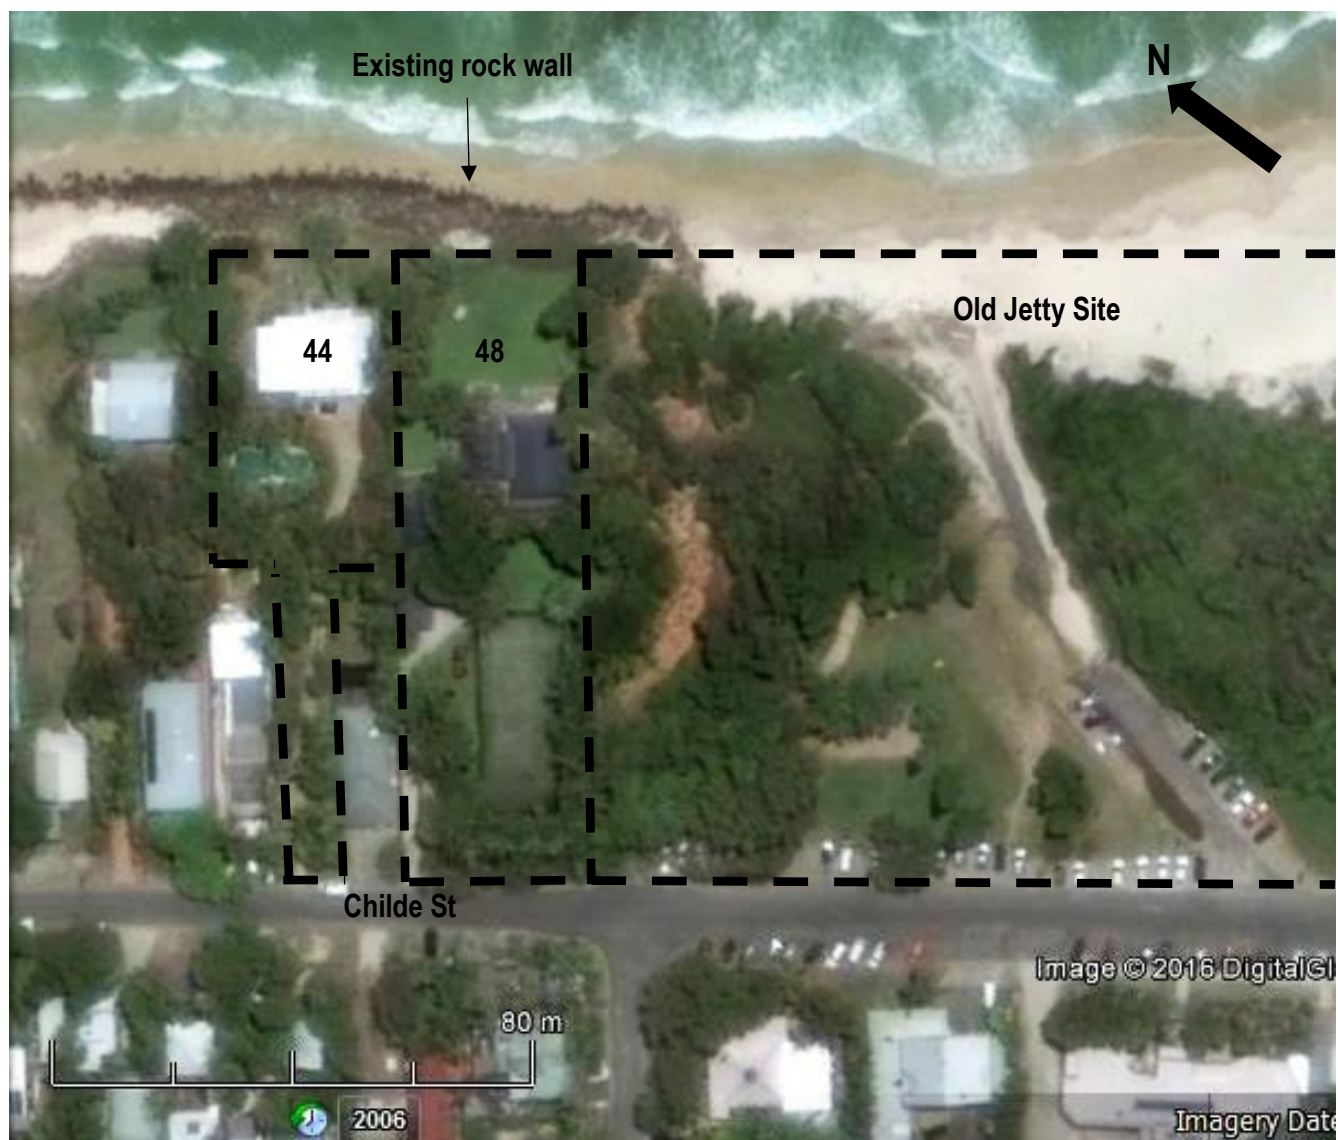
The existing erosion protection works consist of rock along the seaward boundary of the subject properties and extending both to the NW and wrapping around the south-east boundary (Figure 1). The property to the NW is private property and the property to the SE is the old jetty site, State owned public lands.

Figure 1 Site location. Rock rubble wall partly visible.

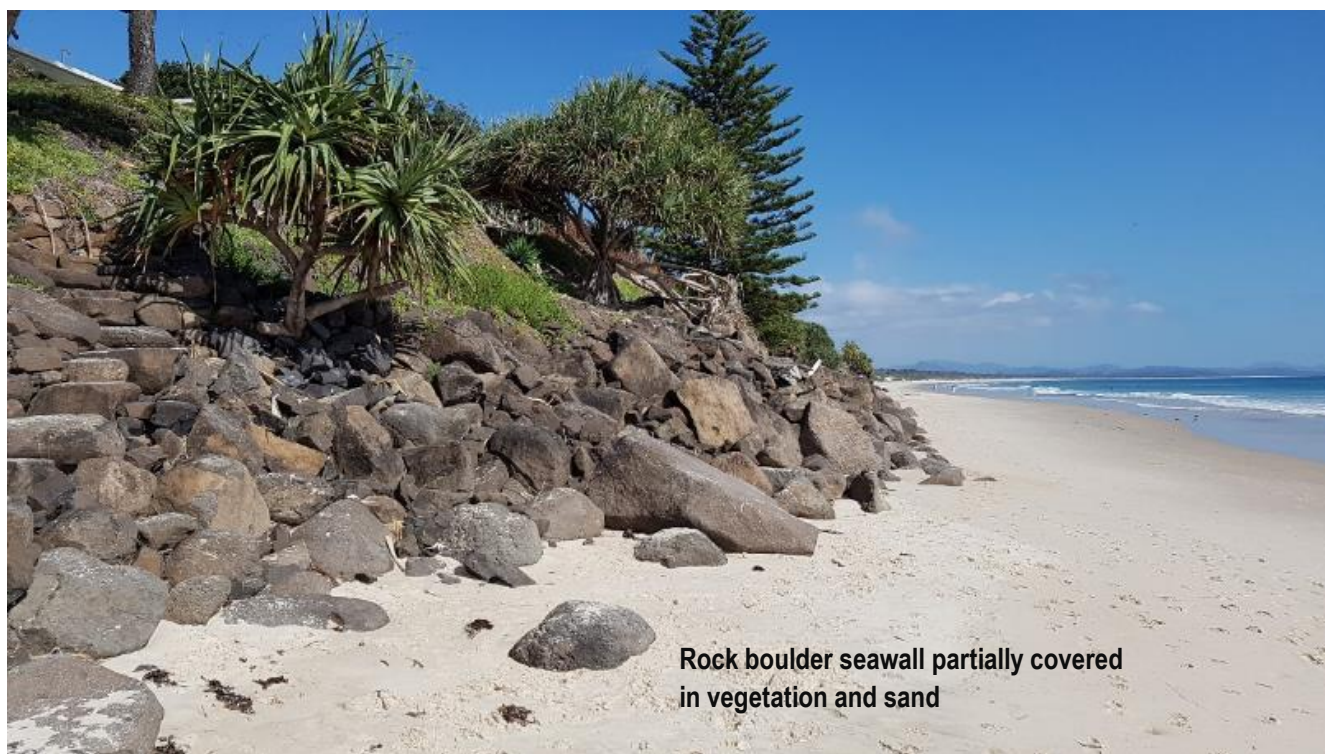
Figure 2 44 Childe Street (ICM 13/10/16)

At present, the wall is partially covered by sand but loose rocks are evident (Figure 2 and Figure 3). During erosion events these rocks and concrete blocks can be 2-3m above sand level and there is a risk of them falling. During eroded beach conditions beach users may be forced to use the beach close to the wall and could be at risk.

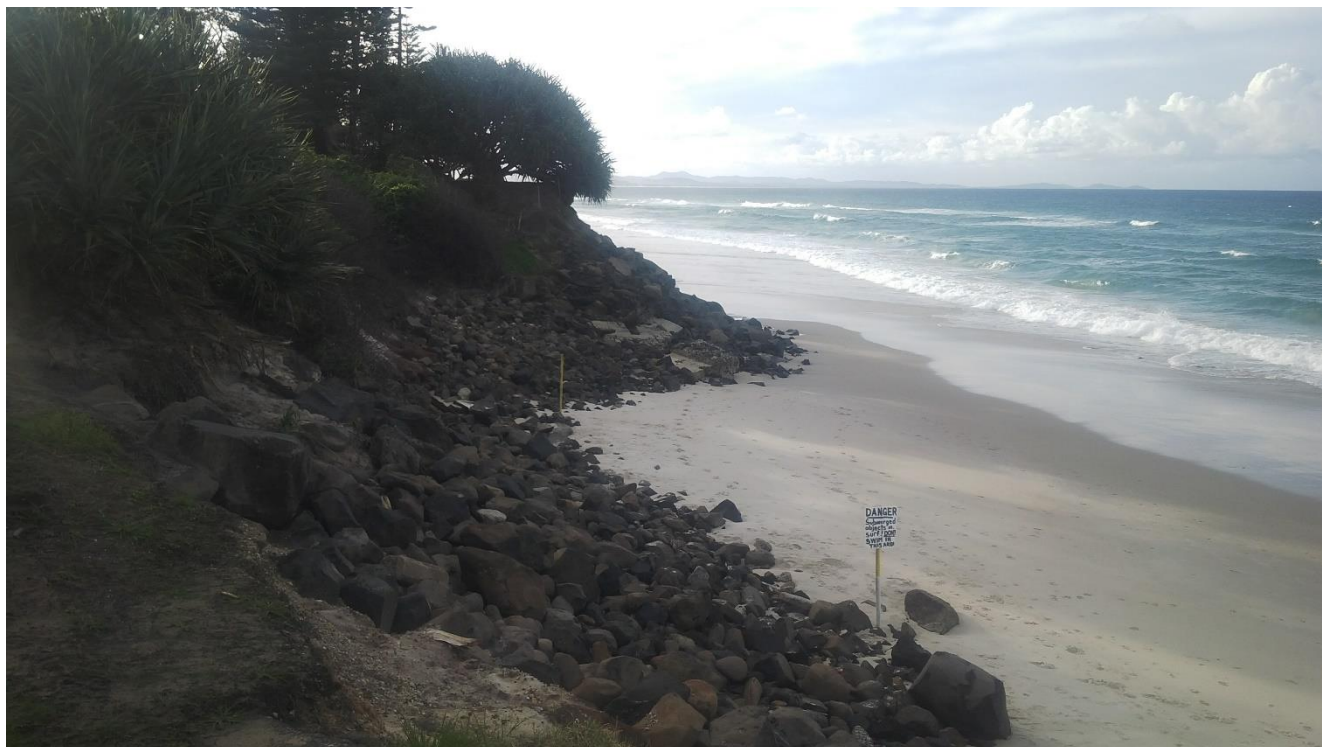
The historical photos show rocks and concrete blocks from the slope have been dislodged and during erosion events there is a wider toe than originally constructed that can adversely impact on beach amenity and safety during major erosion events (Figure 4). These displaced rocks will be removed to the mid and upper slope in a stable configuration during repairs.

**Figure 4 Toe and adjacent wall to southward exposed during erosion in 2013 (ICM photo)**

- The proposed repair works will restore a stable slope. Large loose rocks at the toe will be moved landward onto the steeper mid and upper slope of the wall. The footprint of the repaired wall will be smaller and will not extend as far seaward. The repaired wall face will also be less reflective during erosion events. As a result, any impacts on the beach and adjacent land will be the same, or less, than at present. Thus, any repairs will not cause “any increased erosion of the beach or adjacent land”.
- The proposed repair works will also reduce the risk of erosion and a breakthrough of the Belongil Spit at this site. A breakthrough would result in:
  - Damage to adjacent properties and Childe Street with the associated public infrastructure to westward of the subject property.
