REPAIRS TO SEAWALLS AT 6B CHILDE STREET, BELONGIL

URGENT WORKS

**International
Coastal
Management**

August 2017

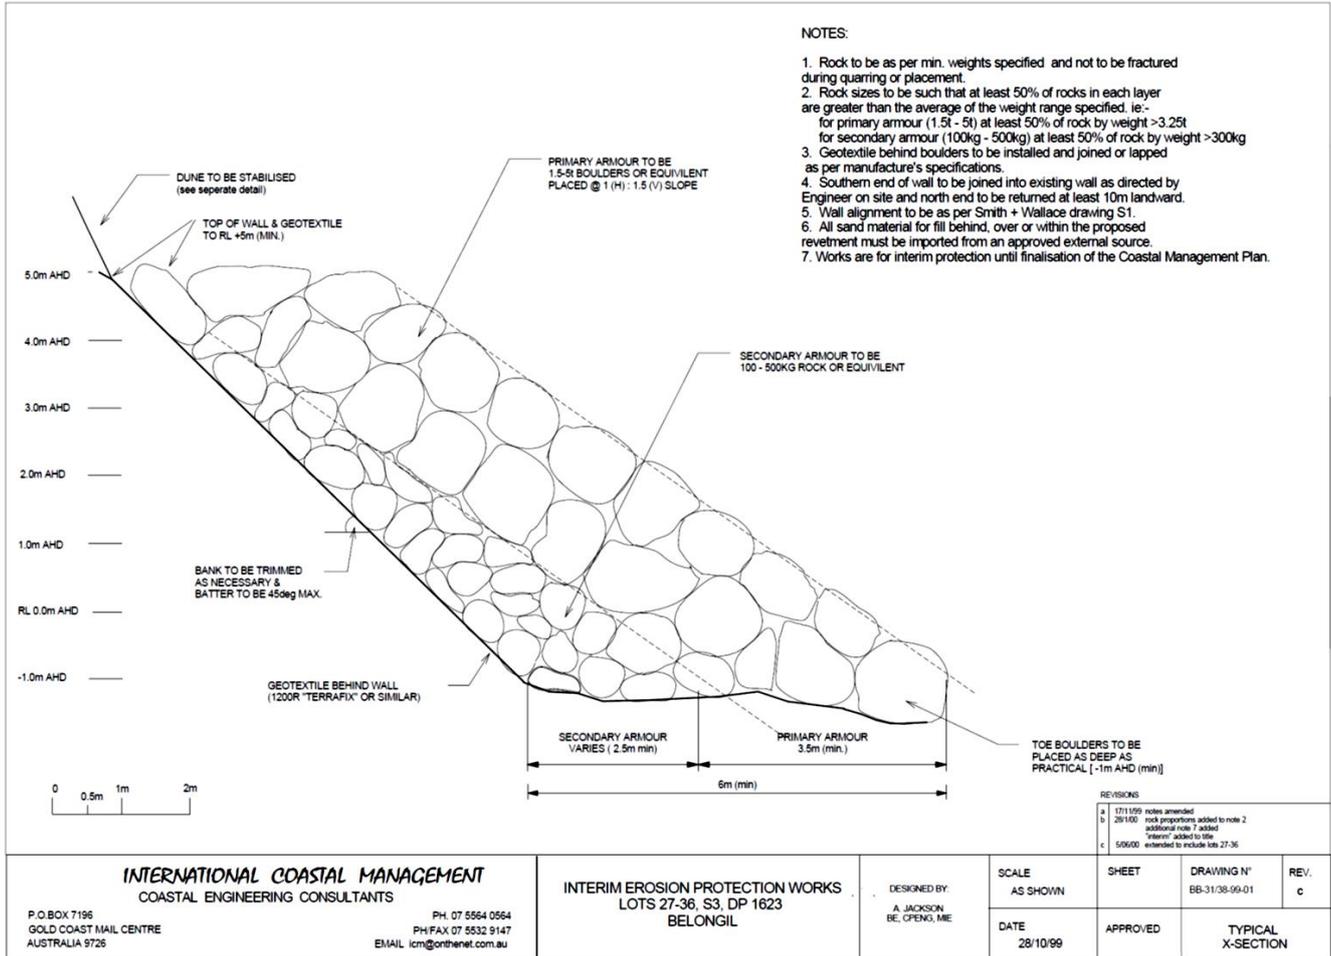
Figure 2 ICM 1999 Seawall design

The wall design (Figure 2) is well documented and the exposed face should be 1.5-5t boulders, well interlocked at a slope of 1.5 (horizontal) to 1 (vertical). The historical photos show some armour rocks

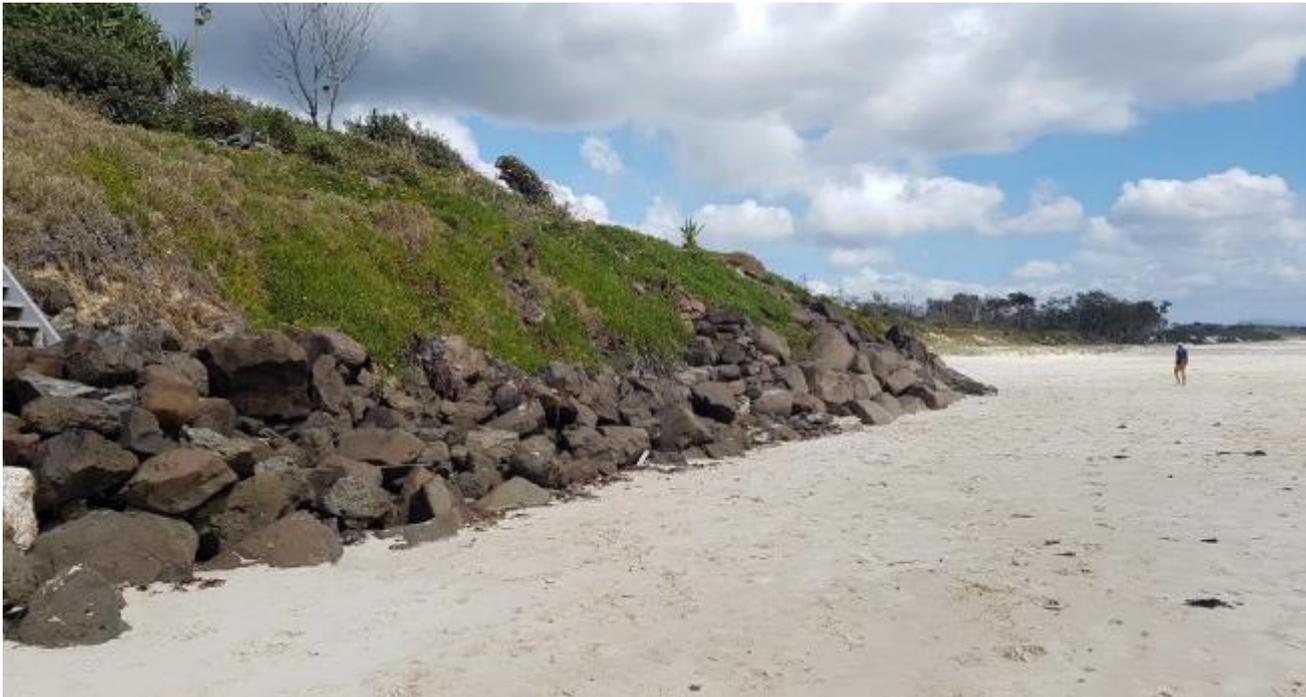
- the subject wall was partially covered by sand and was landward of high tides and wave action.
- some loose rocks are exposed on the exposed seaward face that are of a lesser size than required for stability (Figure 5 and Figure 6). During erosion events, these rocks can be 2-3m above sand level and there is a risk of them falling.
- The crest height has slumped by about 1m (Figure 6).

Figure 5 Continuous rock seawall along 6B Childe Street, 6A Childe Street and No. 4 The Esplanade (ICM 13/10/2016)

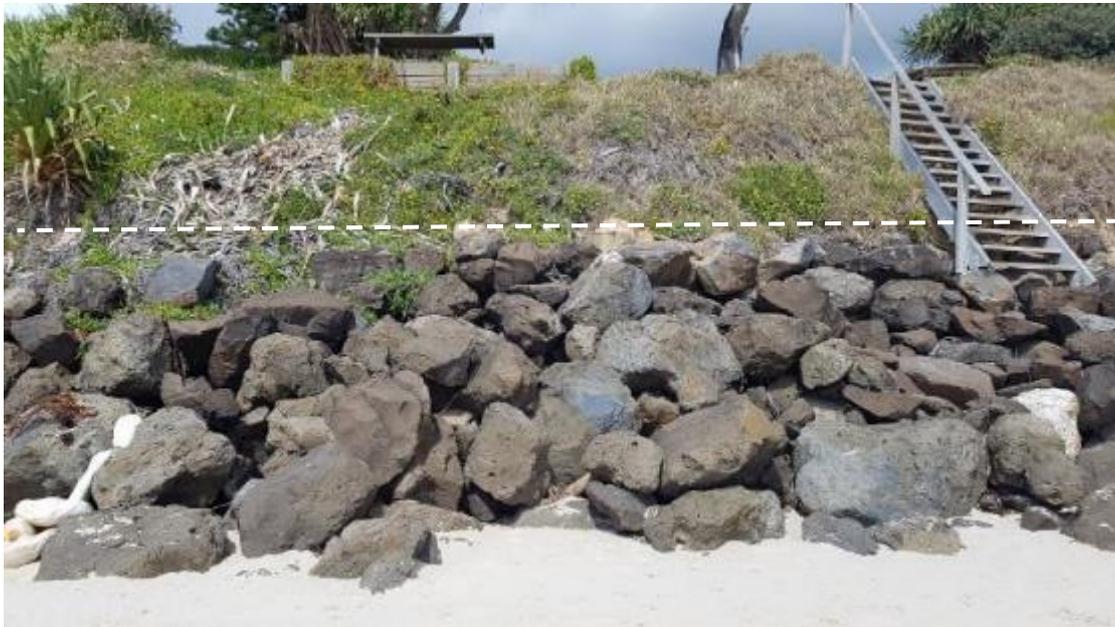
Crest height
at about +4m
AHD (1m
low)

Figure 6 Rock seawall at 6B Childe Street (ICM 13/10/2016)

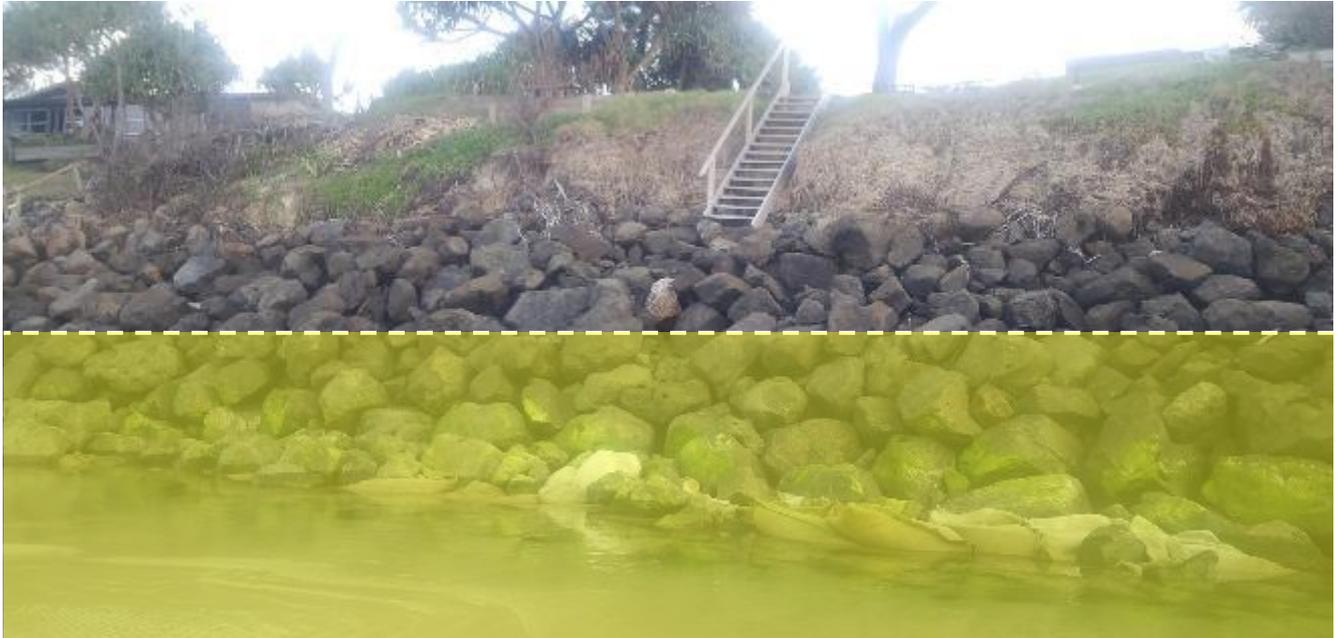
from the slope have been dislodged and there is a deep toe (Figure 7). The slumped upper section of the wall has some of the smaller secondary armour exposed.

Figure 7 Toe and adjacent wall to southward exposed during erosion in 2013 (ICM photo). Dotted white line shows approx. present sand level (about +1.8m AHD). Sand bags placed along original toe are exposed.

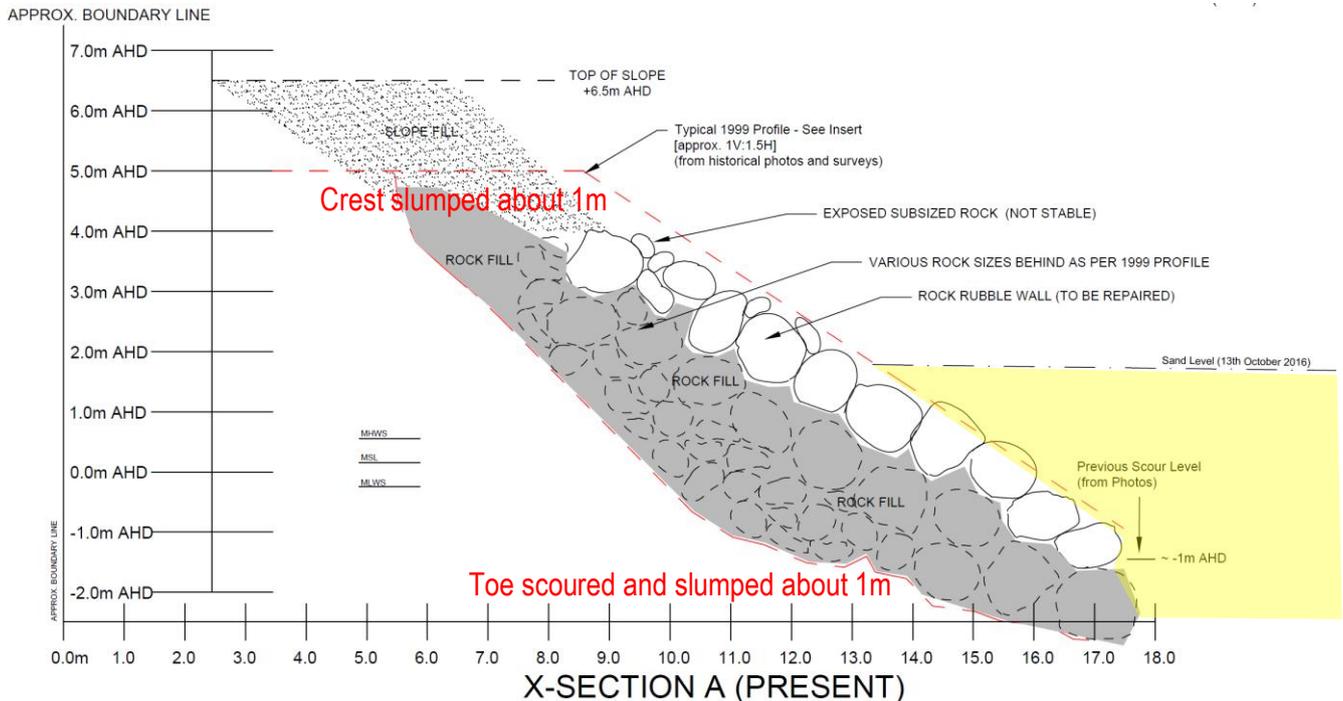
Some of the rocks now exposed on the seaward face are smaller than 1.5-5t. These rocks will not be hydraulically stable in conditions when the wall is exposed to storm wave impacts.

Figure 8 Present condition of wall

The present typical x-section of the wall has been determined from the survey and photographic data available (Figure 8). The seaward face of the rock wall is exposed from about +2m AHD (present beach level) to about +4m AHD (crest).

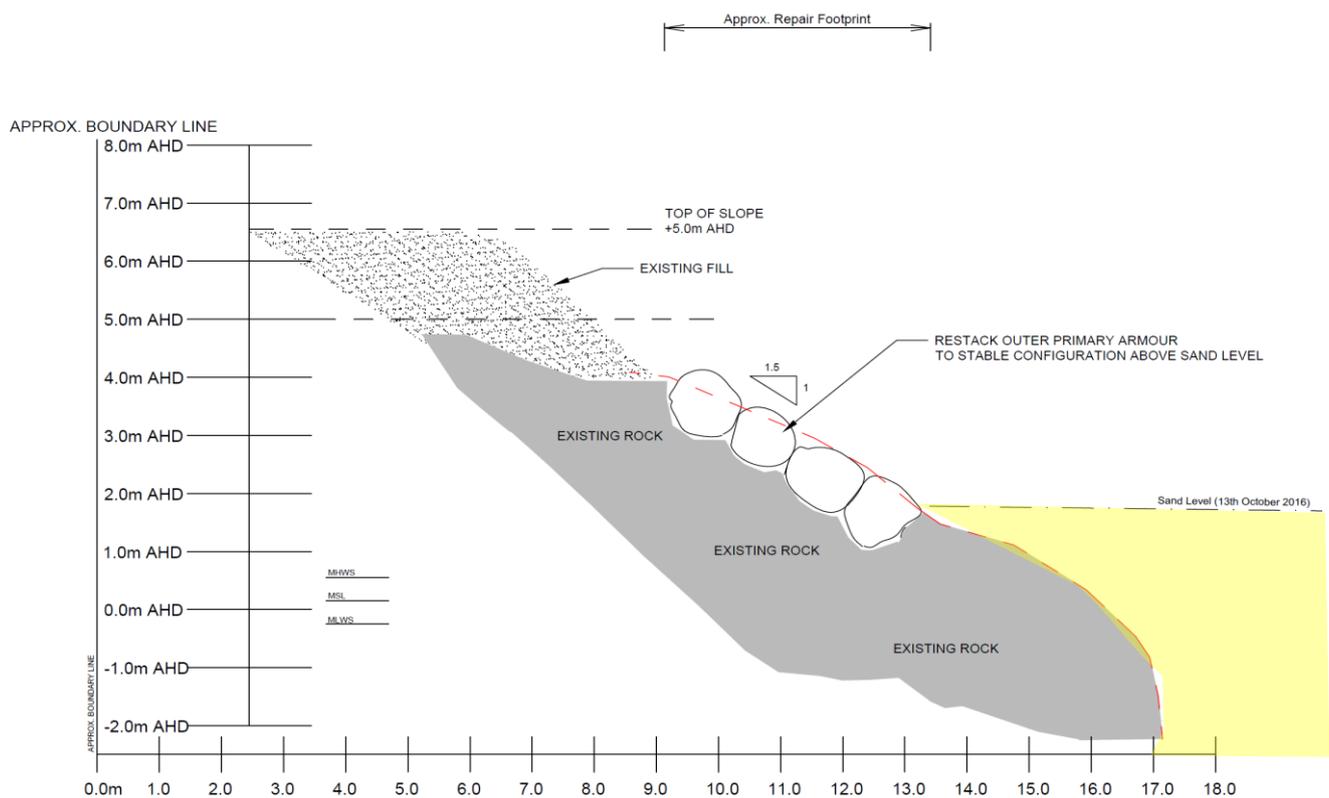
Figure 9 Urgent repair works

The works proposed for the full repair (January 2017 DA) will restore the wall to its original stable slope and crest height. The urgent repair works now requested (August 2017 DA) are of a much lesser extent and will only restack the primary armour layer above sand level to present crest level (about 2m height) to a stable configuration without excavation. The restacking will achieve at least 3 points of contact for each rock. Undersized secondary armour rocks that are presently exposed will be placed in the voids under the primary armour layer.

Some limited additional rock, in the 1.5-5t size grading rock will need to be imported to make up any deficit.
