# **REPAIRS TO SEAWALLS AT 44-48 CHILDE STREET, BELONGIL URGENT WORKS**

**International  
Coastal  
Management**

August 2017

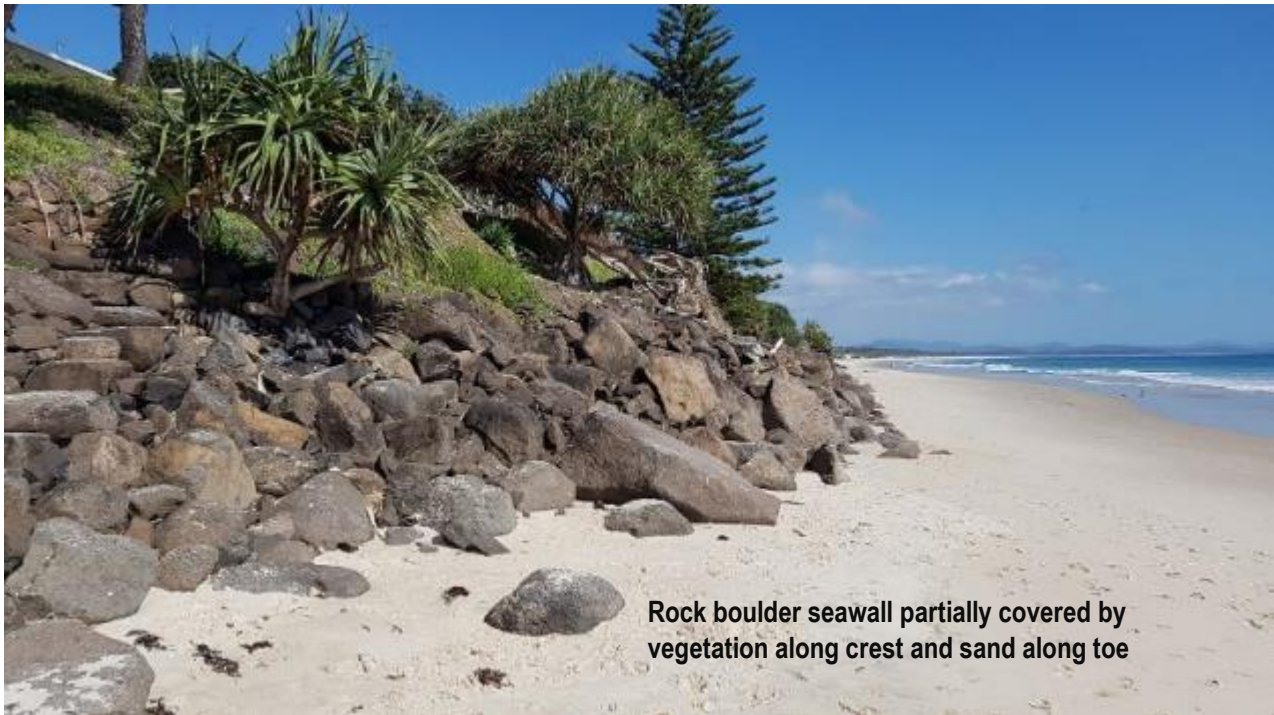
Figure 5 44 Childe Street (ICM 13/10/16)

- the subject wall was partially covered by sand and was landward of high tides and wave action (Figure 5 & Figure 6).
- some loose rocks are exposed on the exposed seaward face that are of a lesser size than required for stability (Figure 5).
- The repairs needed are restacking and replacement of displaced rocks so that the wall face is stable.

Some of the rocks now exposed on the seaward face are smaller than 1.5-5t. These rocks will generally not be hydraulically stable in conditions when the wall is exposed to storm wave impacts.

Technical drawings for the urgent repair works (August 2017 DA) have been prepared (See Attachment A). As per the technical drawings, the repairs will restack existing unstable rocks on the exposed seaward face above beach level (about 2m high) to a stable slope and configuration (Drawings 004 and 006 in Attachment A). This work will be adequate to increase the structural stability of the wall and restack unstable, or potentially, unstable rocks above the present sand level in a safe and stable configuration.

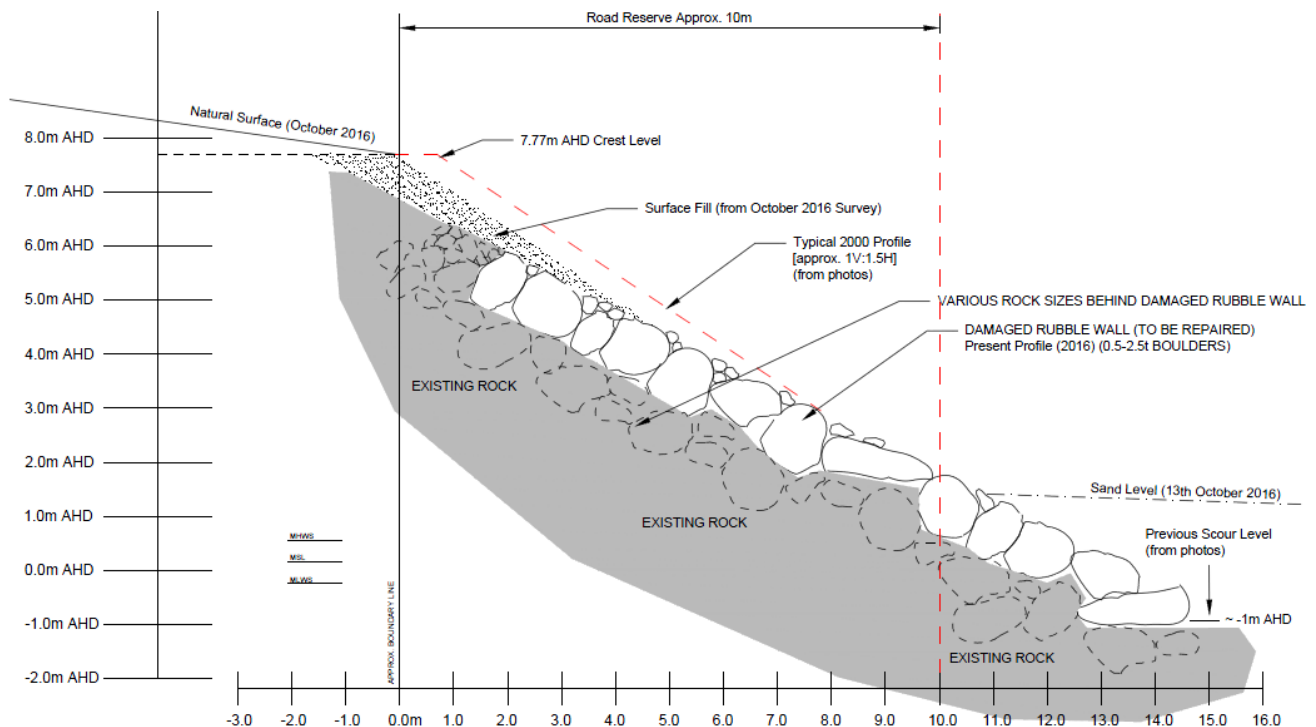
Figure 7 Existing profile

From the data available, the Belongil walls have generally been constructed with primary armour rocks with a grading of 1.5-5t with a smaller secondary armour layer and clay filter layers under the primary armour. The walls were located along the seaward face of the historical storm erosion scarps that are landward of normal high water. The continuous wall acts as a terminal seawall that not only protects public and private beachfront properties and infrastructure during major erosion events but also provides environmental benefits as it mitigates the risk of a breakthrough of Belongil Spit that, if allowed to occur, would have large adverse impacts on Belongil Creek and the Belongil wetlands (Figure 3).

The typical cross-section of the wall is shown in Figure 7.
