RESPONSES TO QUESTIONS BY NSW COASTAL PANEL

RE: REPAIRS TO SEAWALL AT 28 & 28A CHILDE ST, BELONGIL
REF: DOC17/82318

Belongil Seawall Repairs

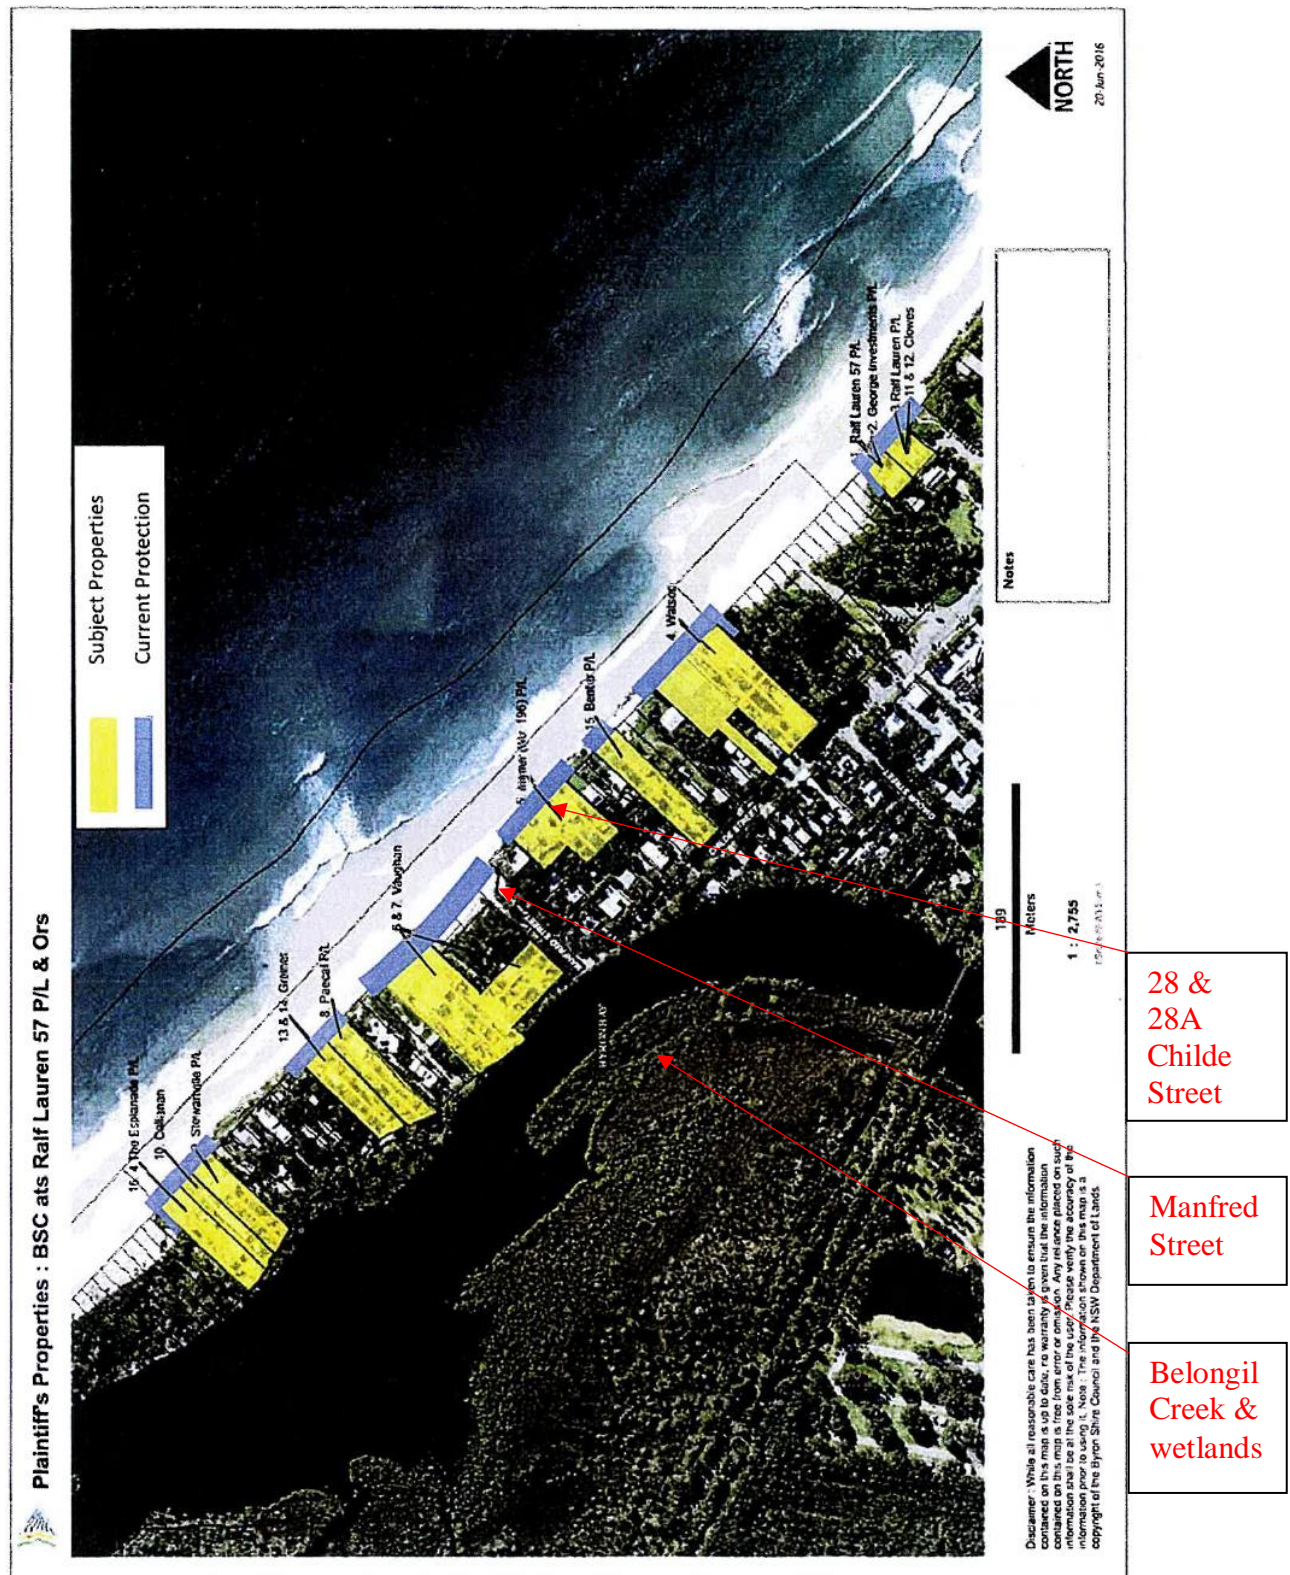
Figure 1 Schedule 1 from Court Orders with site, Manfred St and Belongil & wetland locations added.

The Supreme Court of NSW consent orders show the extent of the wall for the subject property to be repaired as extending in front of the adjacent properties (Figure 1). This overlap was provided to allow a smooth transition of the repaired walls into the adjacent walls to avoid a weak area at the boundaries or adverse impacts on the adjacent walls during or after repairs.

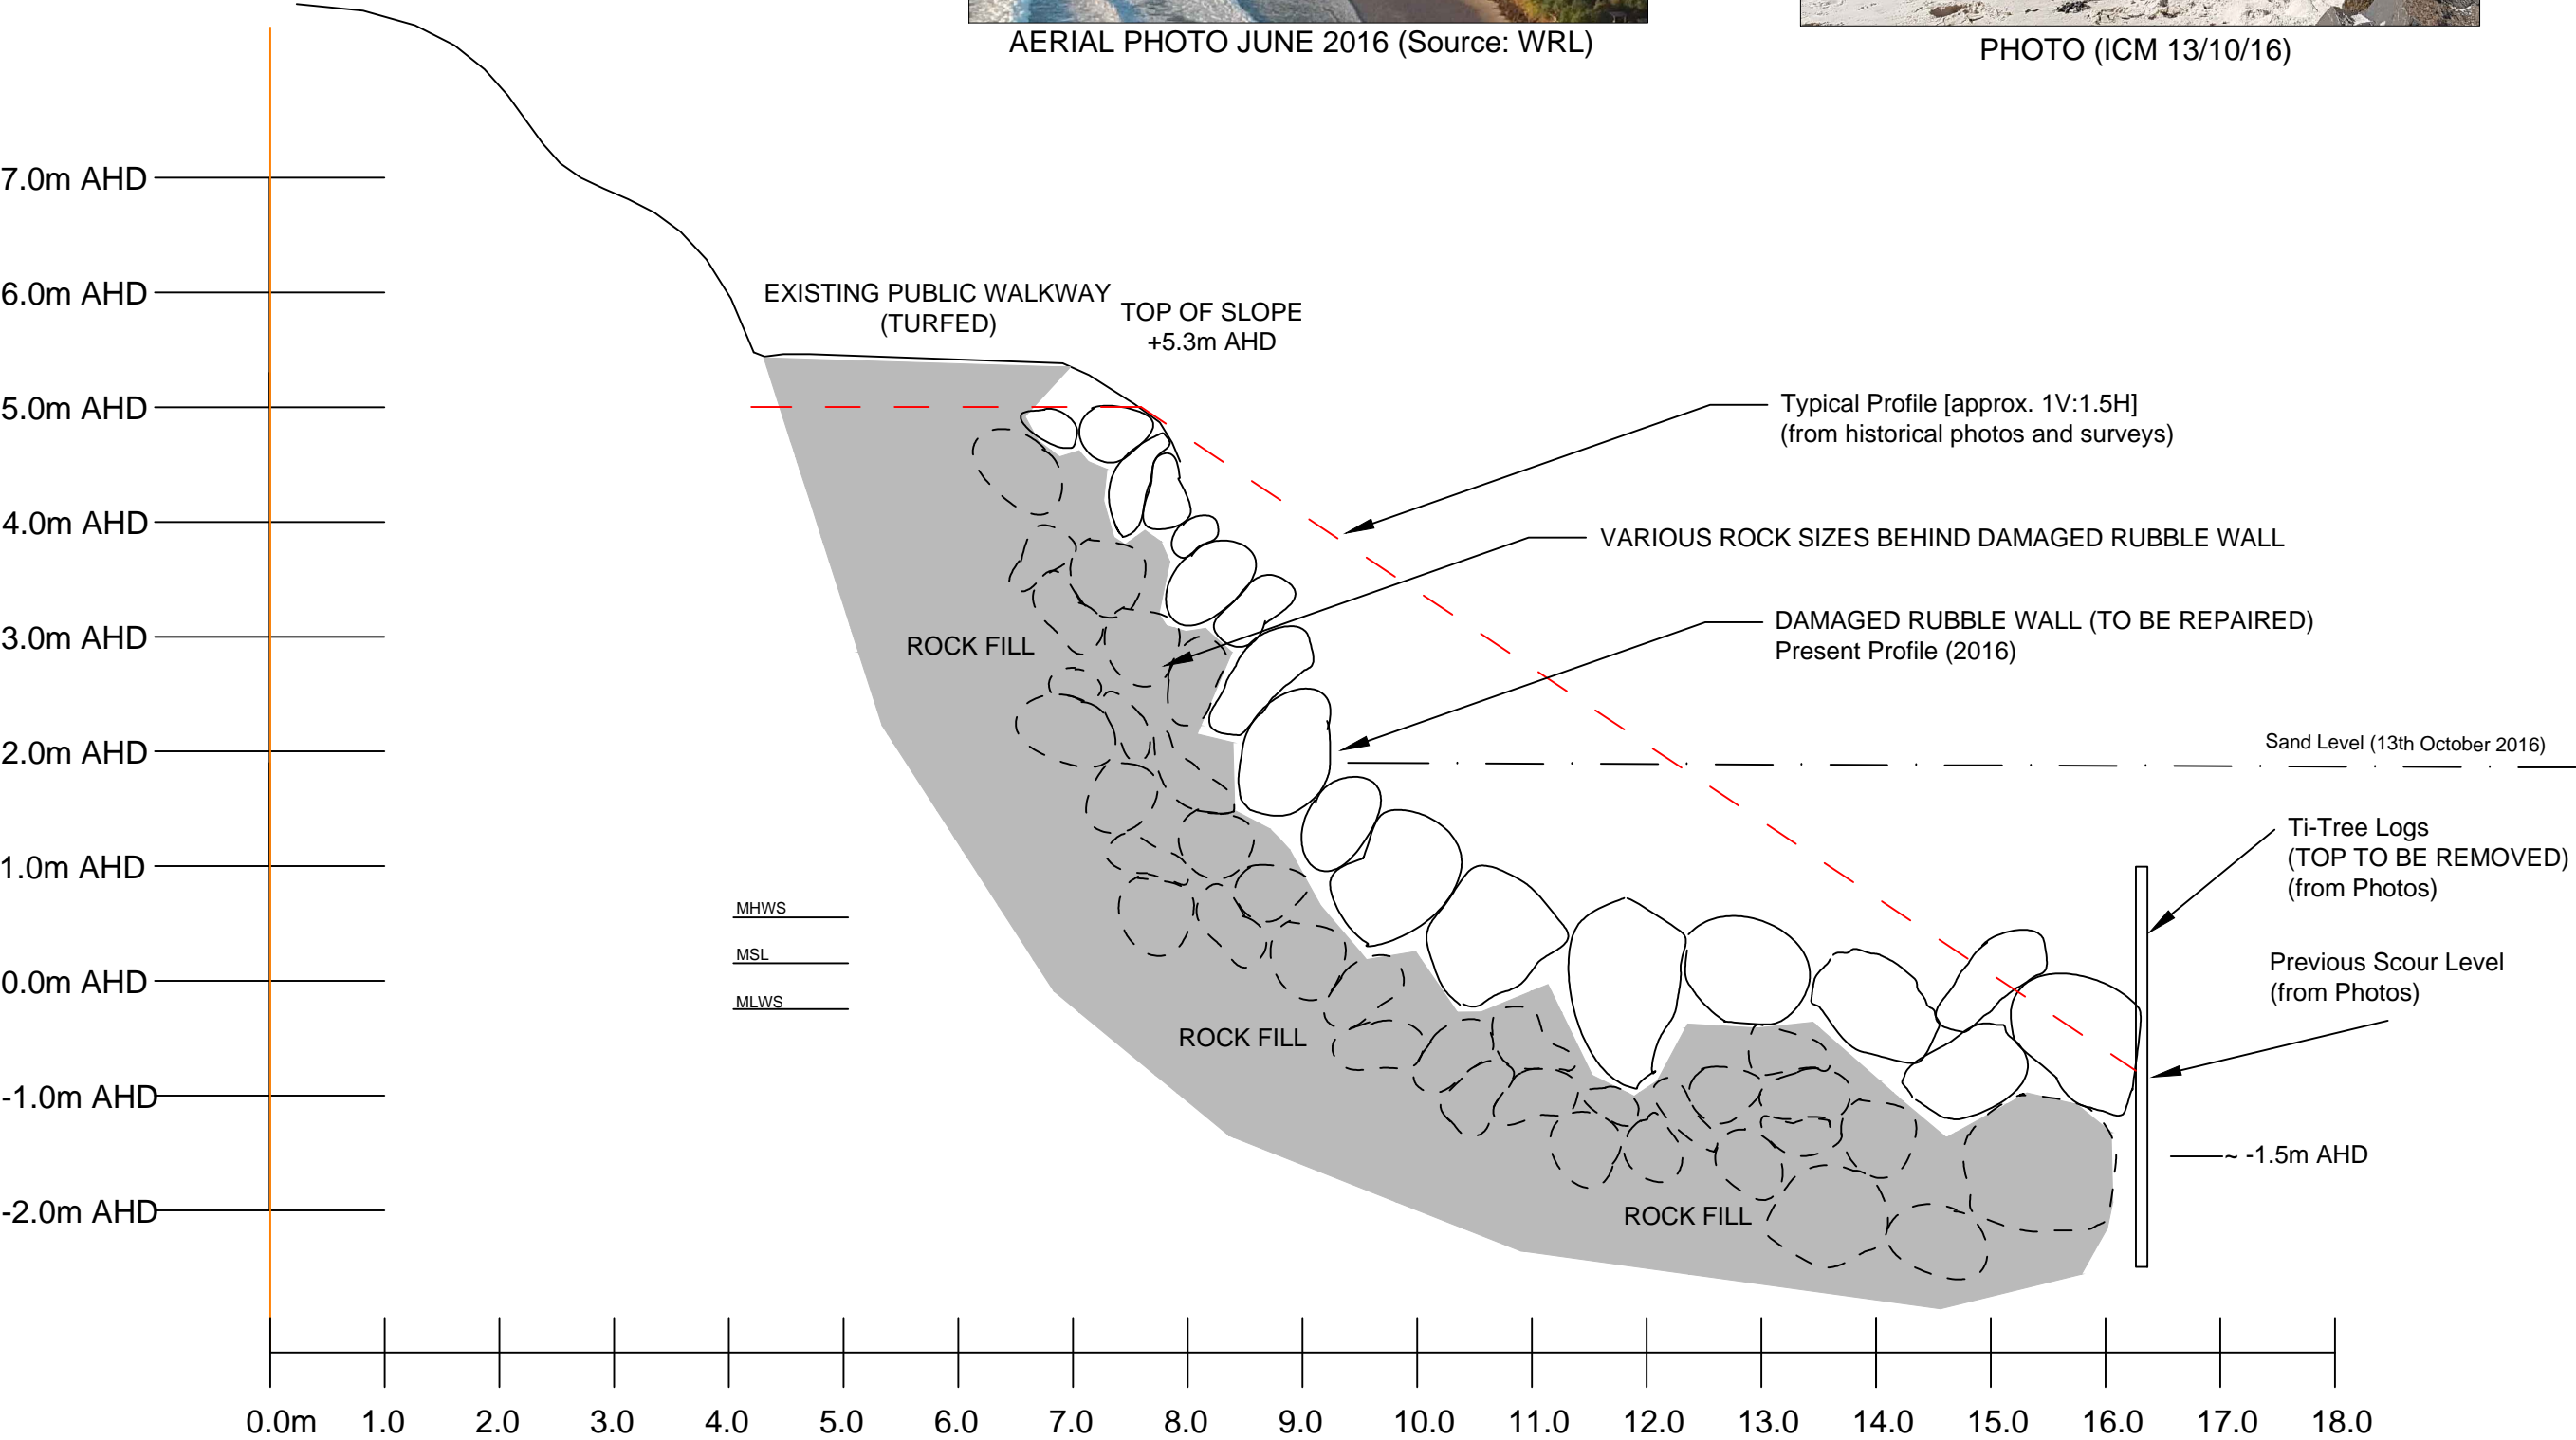
X-SECTION A (PRESENT)

Response: The existing wall have largely accommodated toe scour over its life. The typical scour levels are shown in the x-sections in drawings 003 and 005 (Attachment A).

Response: The boulders in the existing wall have provided adequate hydraulic stability over the life of the wall to date – over 40 years. Some of the larger boulders (>2.5t) have been displaced and will be replaced. Thus, the repaired wall will have adequate hydraulic stability.

Response: The existing wall is now well founded with the toe below -1m AHD due to past toe scour and subsidence. Once repaired, some rocks on the seaward face are anticipated to be displaced during erosion events > 1 in 10yr ARI and will need to be replaced on the face as routine maintenance. Such maintenance is required for any rock wall.
