URGENT REPAIRS TO SEAWALLS AT 40 CHILDE STREET, BELONGIL

August 2017

1. OVERVIEW

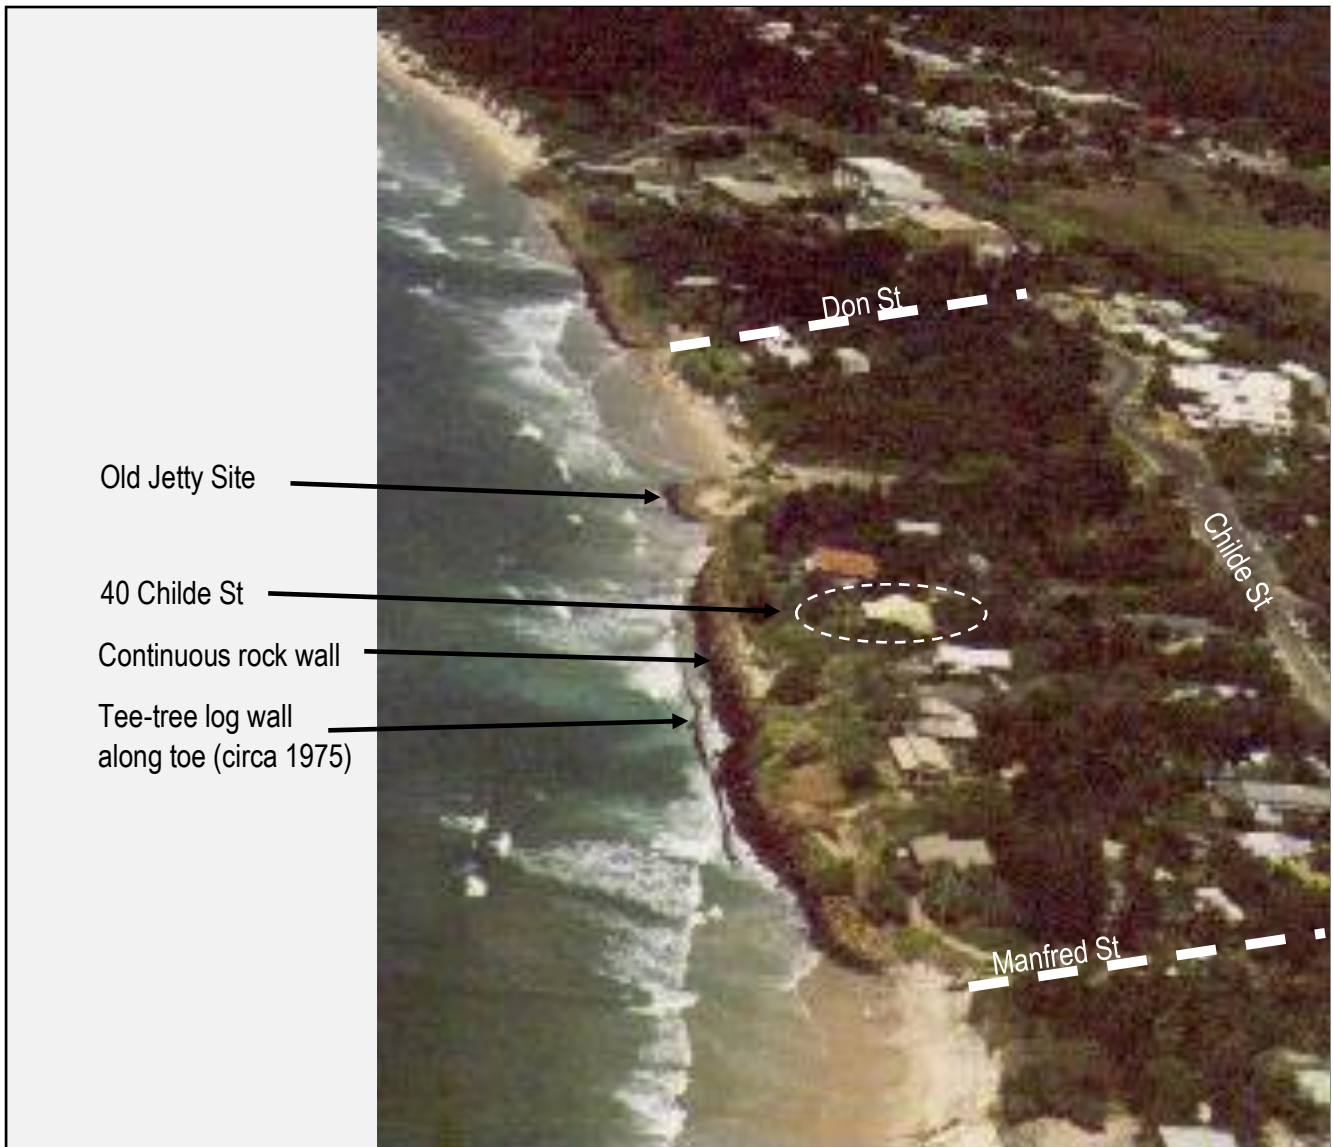
Figure 4 Aerial showing continuous rock seawall between Old Jetty Site and Manfred Street prior to damage of section at and adjacent to 40 Childe St (Circa 1980)

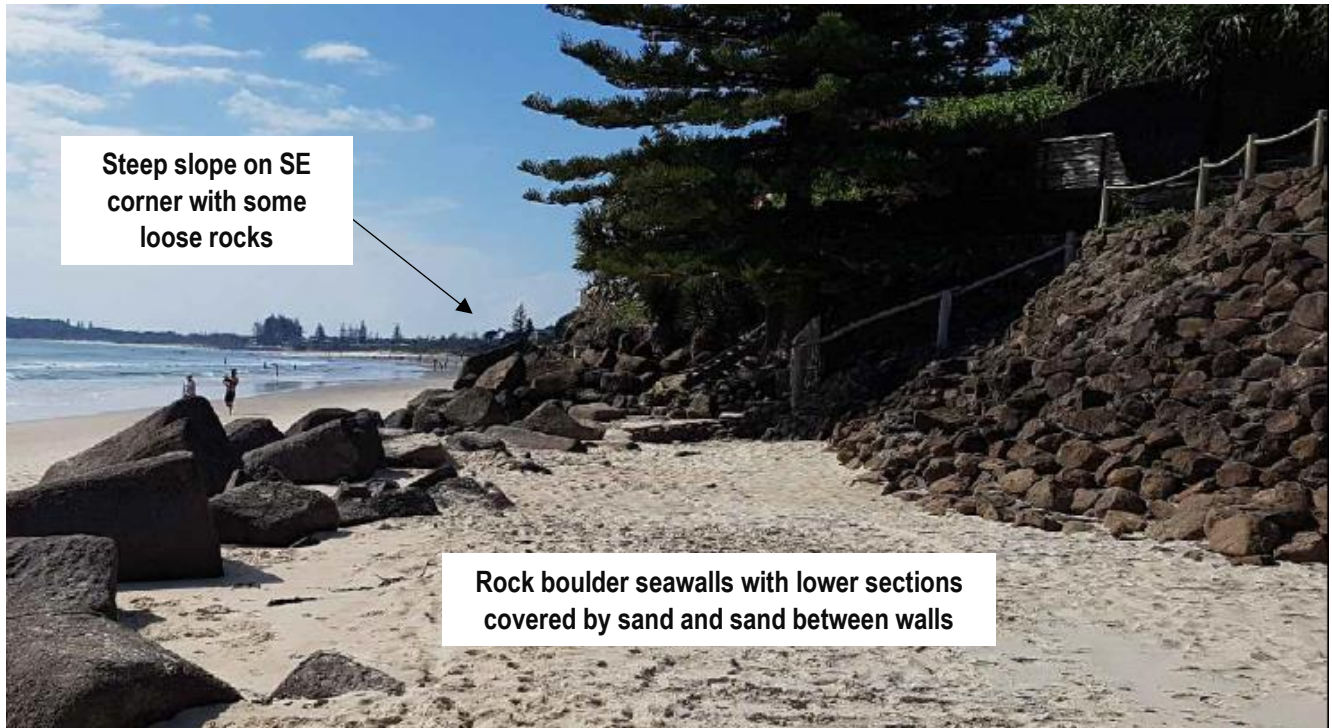
- the sections of the walls lower than 2m were covered by sand and was landward of high tides and wave action (Figure 7).
- the seaward wall sloped down steeply from a crest height of about +6.5m on the SE end (No 44 – that is to be made safe under separate DA for 44-48 Childe St) to about +2m over a length of about 5m. (Figure 8)
- The repairs needed are restacking and replacement of displaced rocks on the SE section (Figure 8) face so that the wall face between 40 and 44 is at a stable slope of 1:1.5 with stable rocks.

Figure 7 Buried existing wall

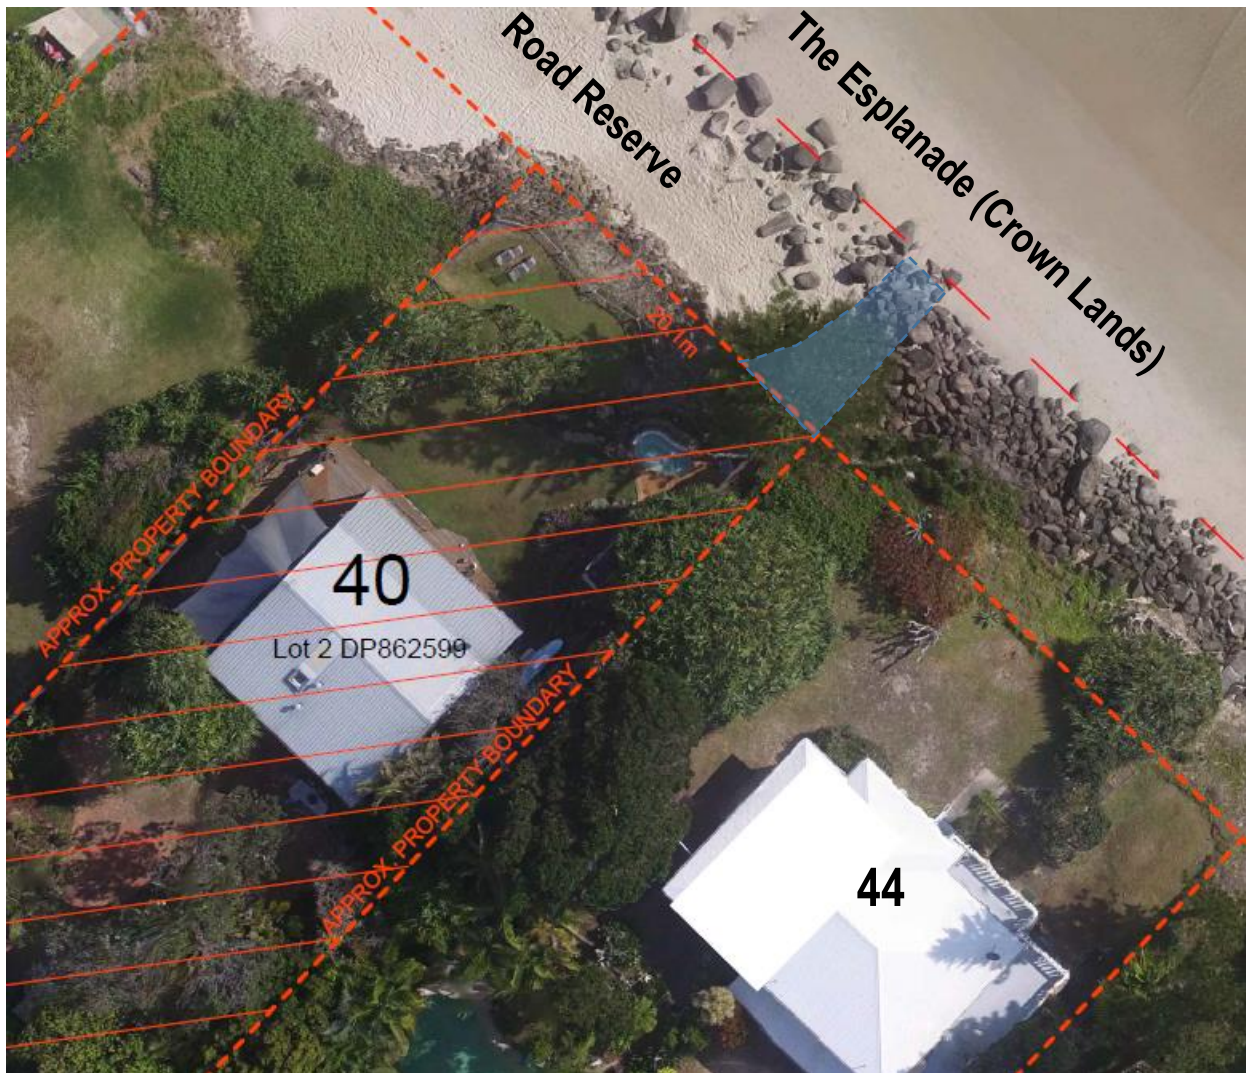
Figure 8 Section of wall to be made safe

- the small rocks and steep slope on the seaward face of the southernmost 5m of the wall
- wall.
- The low crest for the remaining 15m of the wall

The most urgent works are to restack any unstable rocks on the exposed (above beach level) seaward face of the wall in a stable configuration in the SE section as marked. To achieve this, some additional rocks may be required. This will not change any characteristics, such as void ratio and energy dissipation.

The seaward wall will be partially repaired with the crest of the seaward wall topped up to +4m AHD using selected large rocks placed in areas subject to the highest wave forces. The beach amenity will not be reduced.

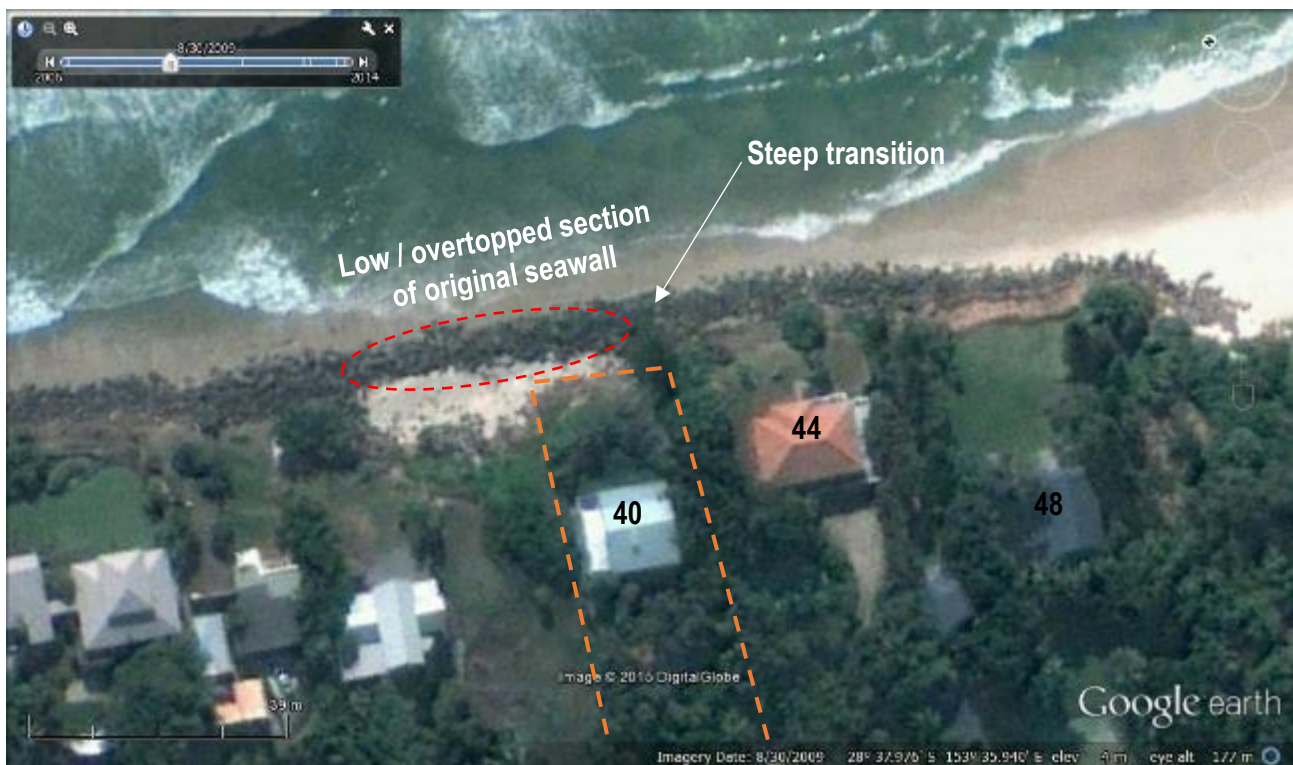
The existing structure has been damaged due to overtopping but the adjacent walls have proven to be structurally adequate over the life, to date, of about 40 years (Figure 9 and Figure 4).

Figure 9 Aerial photo during erosion 2009 (Google Earth August 2009)

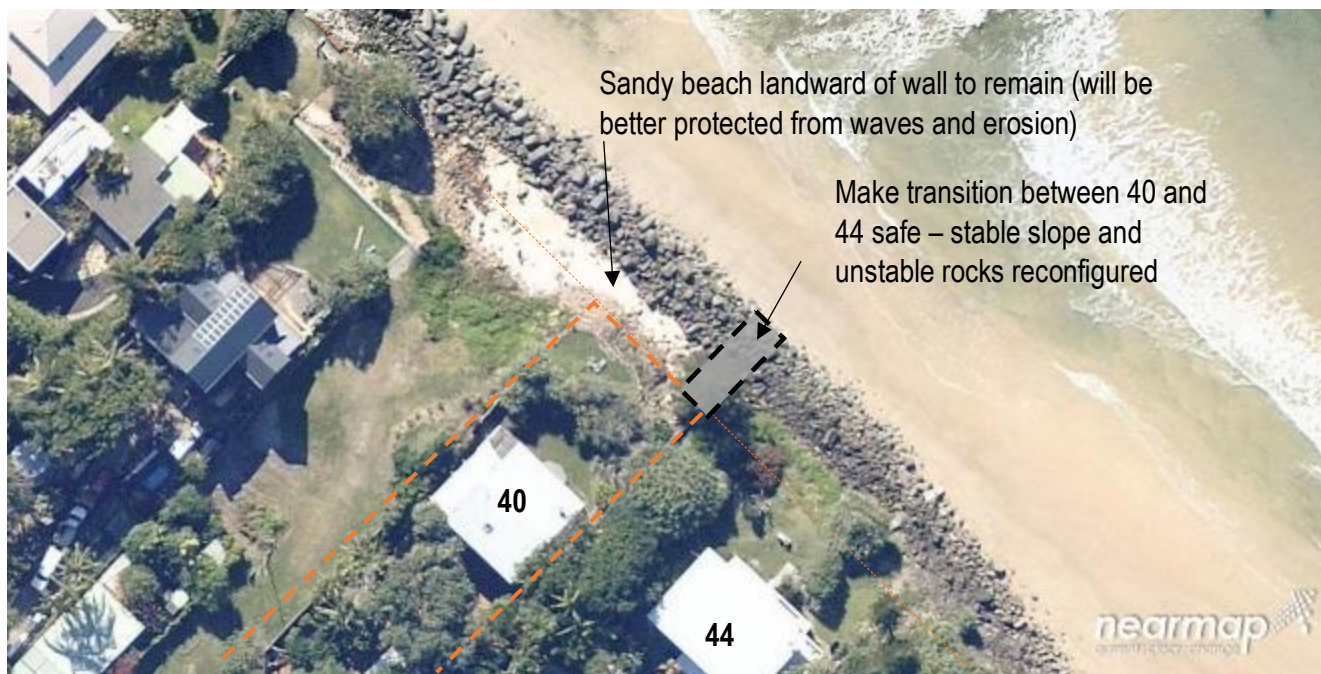
Figure 10 Proposed repairs superimposed on eroded beach aerial photo (Nearmap July 2012)

These investigations confirmed that the works are in need of repair. Drawings of the extent of repair works have been prepared and the proposed alignment and footprint of the repaired wall is as per

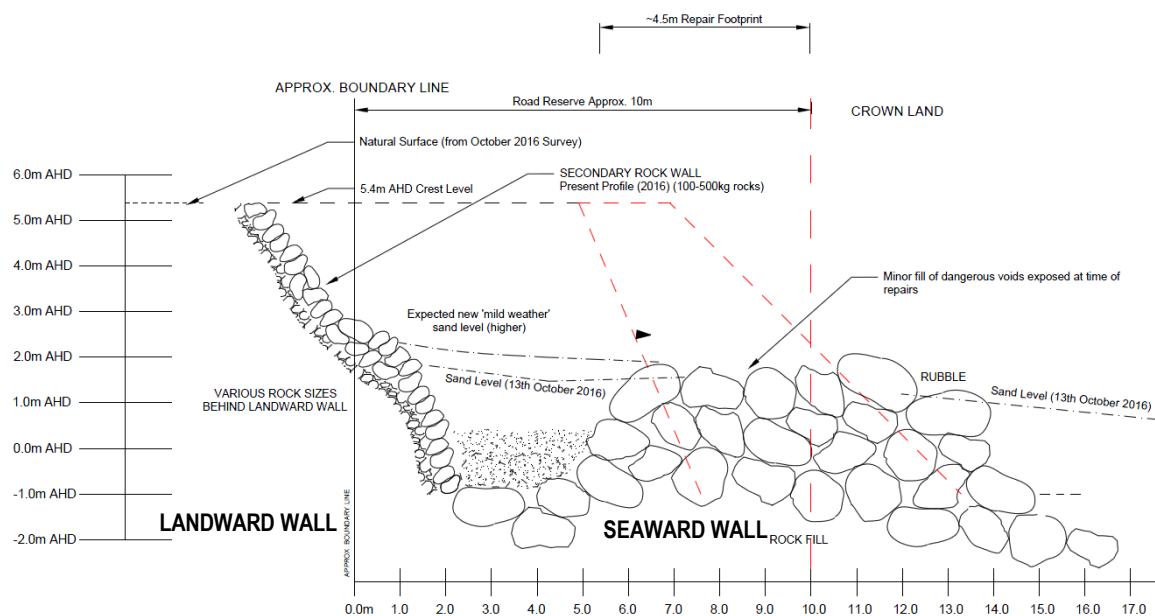
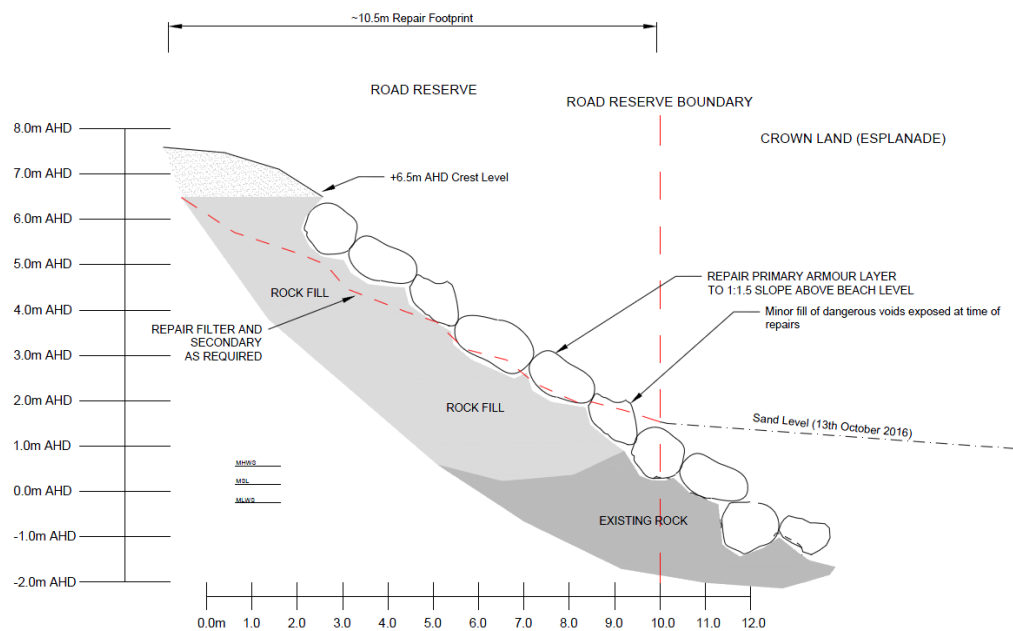
Figure 11 Proposed repair – typical x-section
