GEOMORPHIC IMPACT ASSESSMENT

Geomorphic Impact Assessment For Proposed Seawall, Arrawarra Caravan Park, Arrawarra, NSW.

P0601565JR01_v3
January 2007

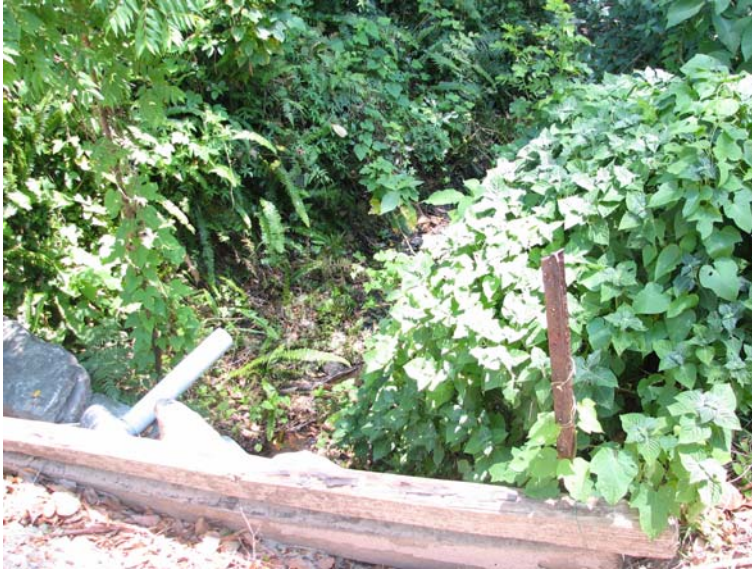
Plate Number	1
Chainage	0
Description	Storm water pipe and pit
Date	28/11/06
View Direction	North

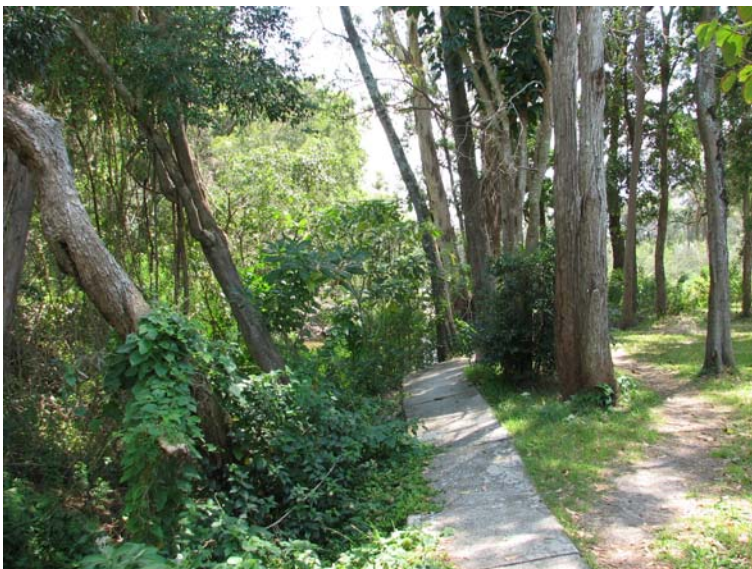
Plate Number	2
Chainage	20
Description	Footpath at top of right bank of Yarrawarra Creek. Tree slumping indicating bank failure.
Date	28/11/06
View Direction	East

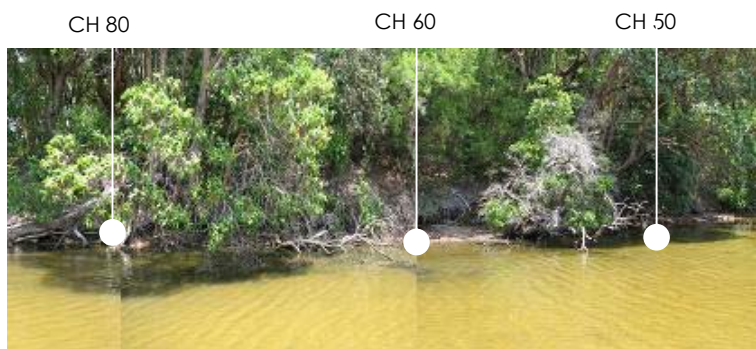
Plate Number	5
Chainage	50-80
Description	Bank failure and tree slumping
Date	28/11/06
View Direction	South west

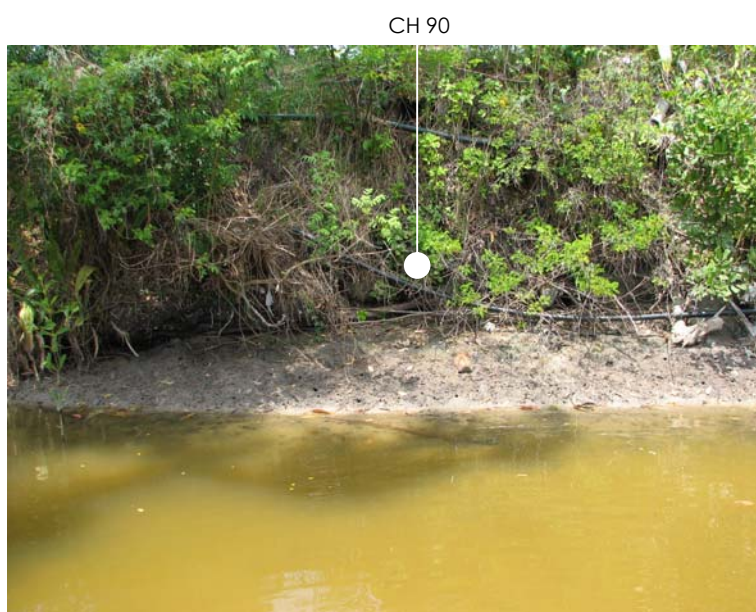
Plate Number	6
Chainage	90
Description	Bank undercutting and reworking of material by tidal flow
Date	28/11/06
View Direction	South

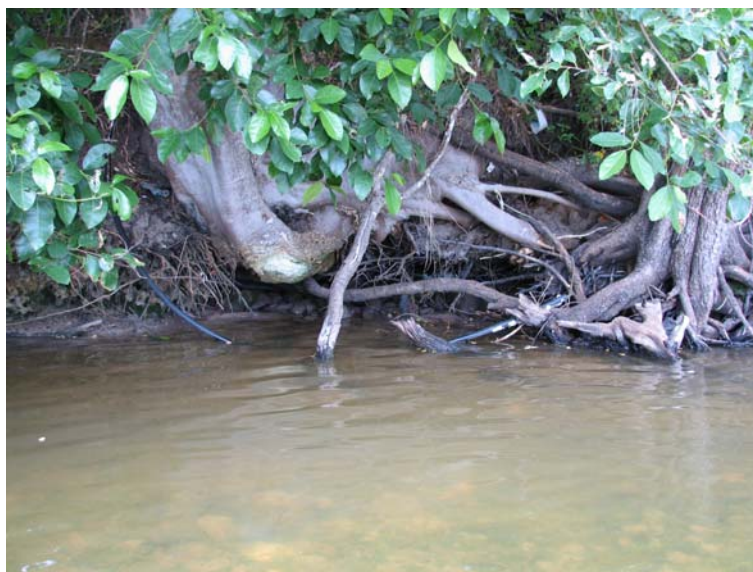
Plate Number	7
Chainage	100
Description	Root exposure and tree destabilisation indicates erosion.
Date	28/11/06
View Direction	south

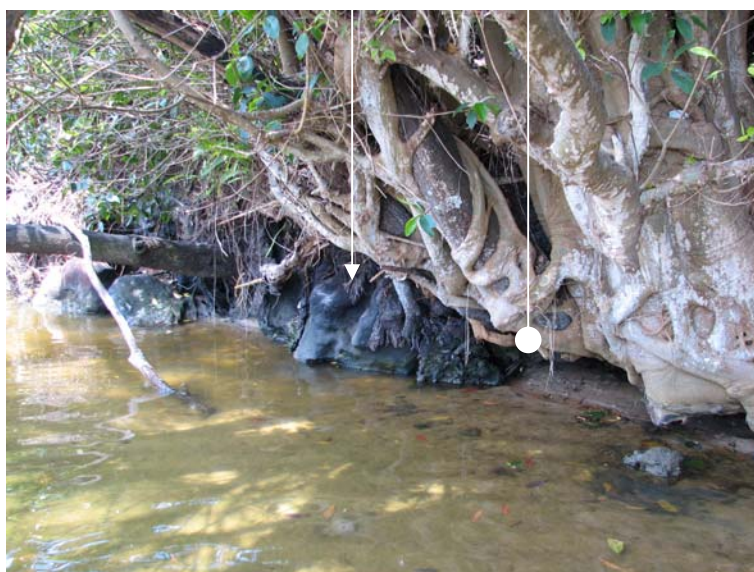
Plate Number	8
Chainage	120 - 220
Description	Highly weathered coffee rock exposed along base of the bank.
Date	28/11/06
View Direction	south

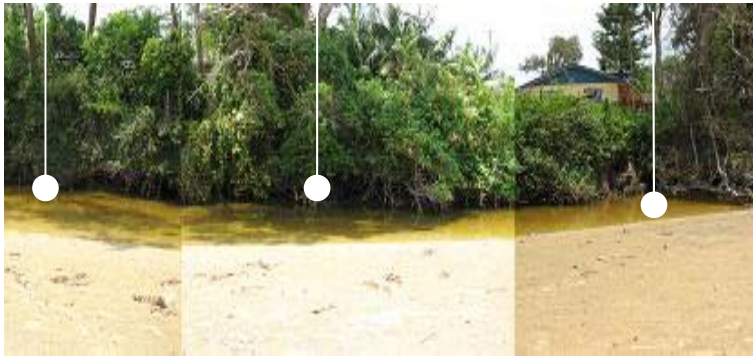
Plate Number	9
Chainage	140-160
Description	Figs and Melaluca's slumping. Underlying coffee rock supporting banks
Date	28/11/06
View Direction	South west

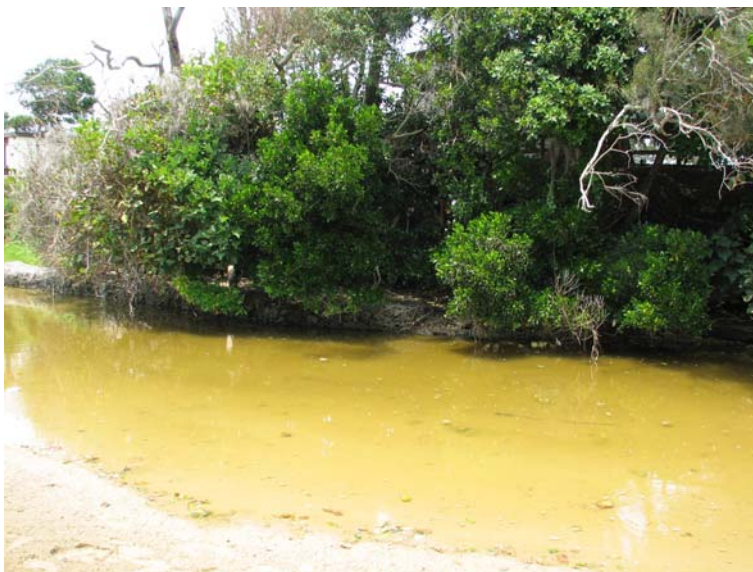
Plate Number	10
Chainage	160-170
Description	Slumping trees on top of underlying coffee rock.
Date	28/11/06
View Direction	South east

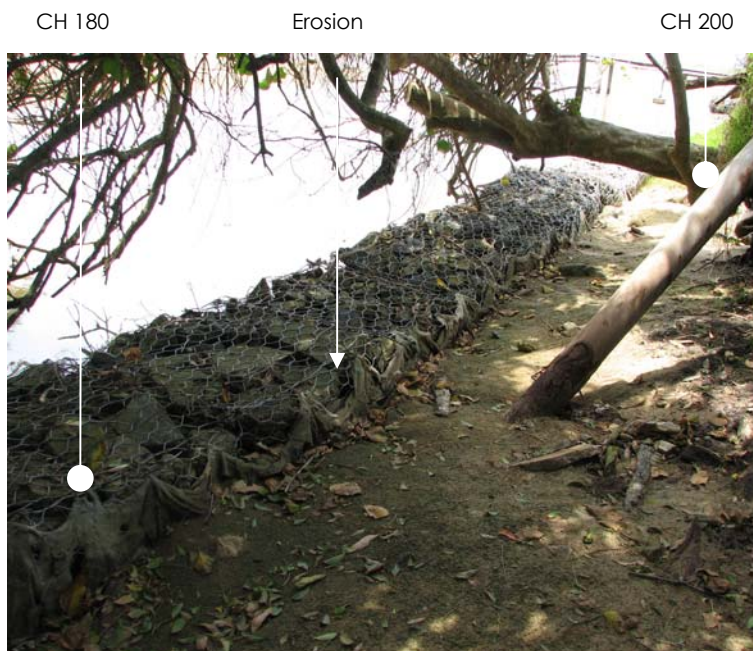
The current revetment structure is made up of rock gabion baskets that extend from chainage 175m to 380m. This wall has begun to deteriorate and in some places has completely corroded freeing rip rap. Some warping and settlement is also occurring as a result of wave attack sediment redistribution at the wall toe and tidal influences.

Plate Number	11
Chainage	175-210
Description	Start of rock gabion seawall. Erosion occurring behind wall
Date	28/11/06
View Direction	North East

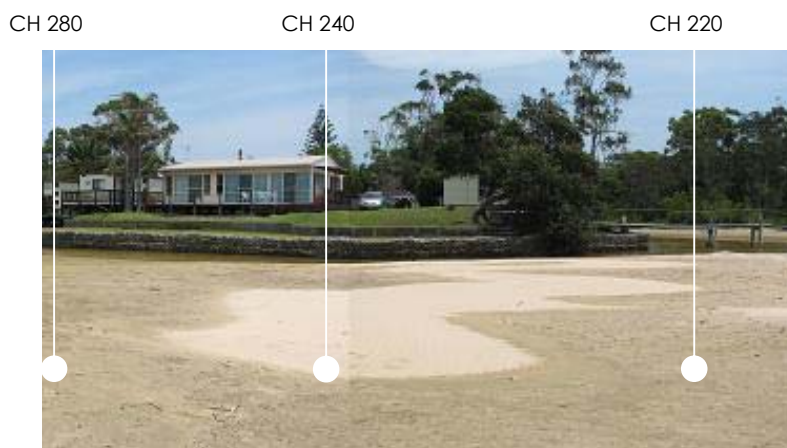
Minor bed sediment erosion (toe scour) was observed along parts of the gabion wall particularly along the eastern boundary where Arrawarra Creek flows entirely along the wall. Small bed scour pools were observed at each end of the existing wall, notably on the Arrawarra reach. Scour behind the existing gabion wall was observed between chainages 175 to 210. Erosion is localised and no impacts were observed at distance from the existing sea wall. However, erosion indicates that the present wall will need to be replaced sometime in the near future.

Plate Number	12
Chainage	210-280
Description	Rock gabion sea wall on eastern boundary of site. Yarrawarra Creek running along wall.
Date	28/11/06
View Direction	West

210-380	Current gabion seawall retained and maintained.	Protection from erosion caused by fluvial influences.	Toe scour, wave run up and overtopping without construction of a larger wall.	None required. However, wall replacement and redesign is recommended to protect site.
380-480	Retain riparian vegetation and place larger rocks at base of banks where required.	Added protection from toe scour and undercutting where required. Allows the retention of important riparian species.	Tree slumping and bank failure, toe scour and undercutting.	<ul style="list-style-type: none"> o Continued maintenance and monitoring ensures areas experiencing erosion are given added protection.

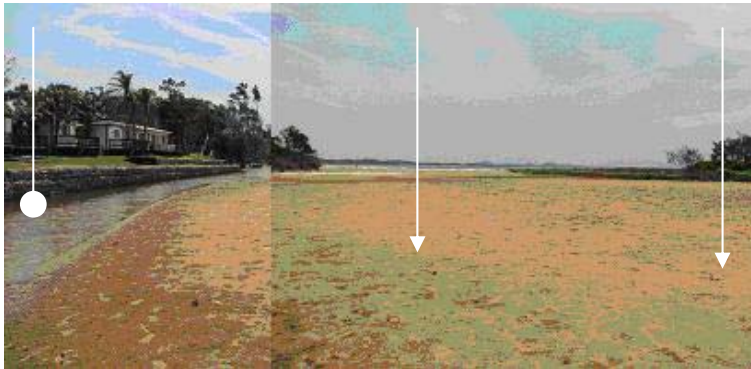
Plate Number	13
Chainage	330
Description	Flood tide delta with sand deposit blocking tidal flow to
Date	28/11/06
View Direction	North east

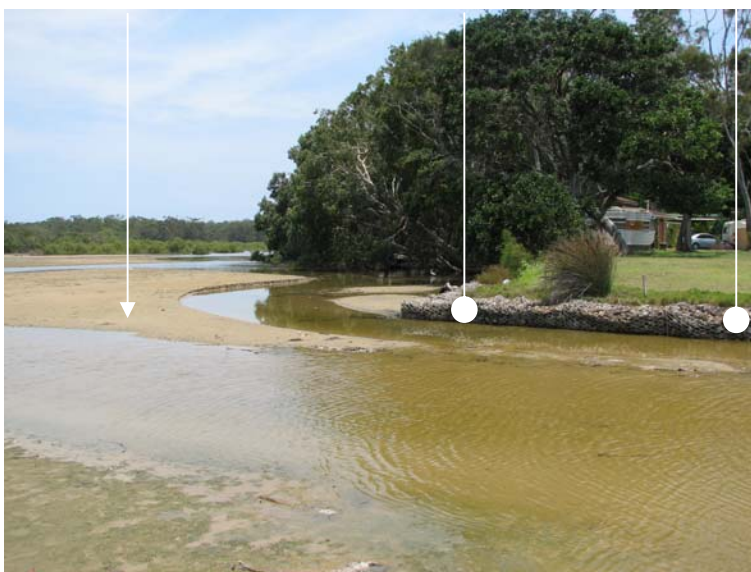
Plate Number	14
Chainage	340-360
Description	End of eastern seawall. Arrawarra Creek entrance
Date	28/11/06
View Direction	South West

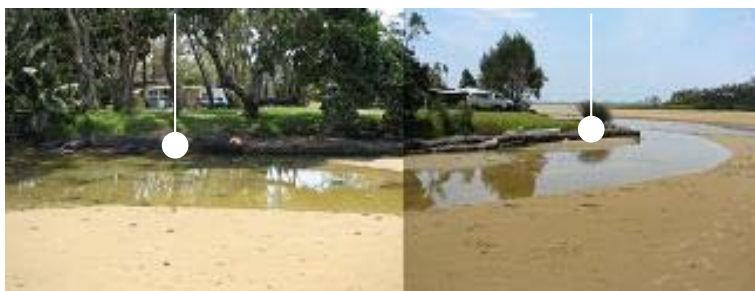
Plate Number	15
Chainage	360-380
Description	Southern boundary of site. End of rock gabion wall at chainage 380
Date	28/11/06
View Direction	North East

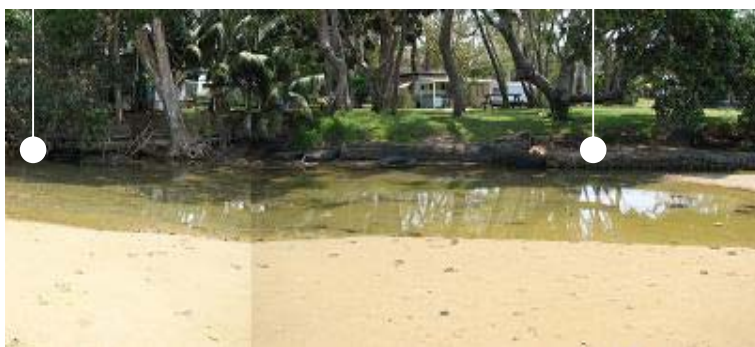
Plate Number	16
Chainage	380-420
Description	Arrawarra Creek left bank. Rock gabions finish on north east end, then riparian vegetation only
Date	28/11/06
View Direction	North.

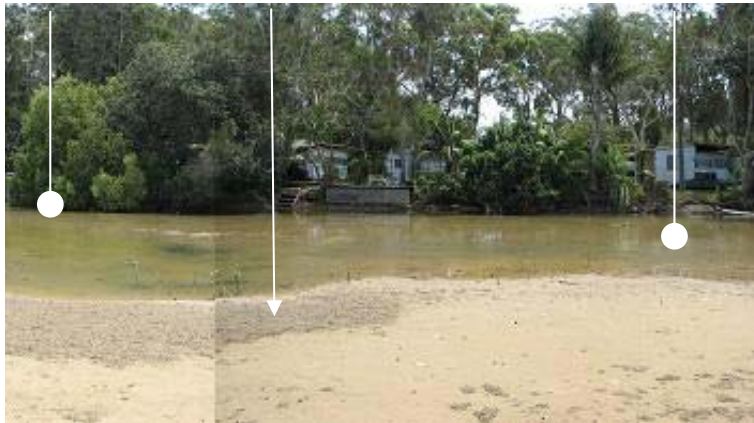
Plate Number	17
Chainage	420 - 480
Description	Arrawarra Creek left bank. End of Caravan Park site. Intertidal flat communities noted including
Date	28/11/06
View Direction	North west
