URGENT REPAIRS TO SEAWALLS AT 1 & 2 DON STREET, BELONGIL

OFFSITE EROSION MANAGEMENT PLAN

**International
Coastal
Management**

13th January 2017

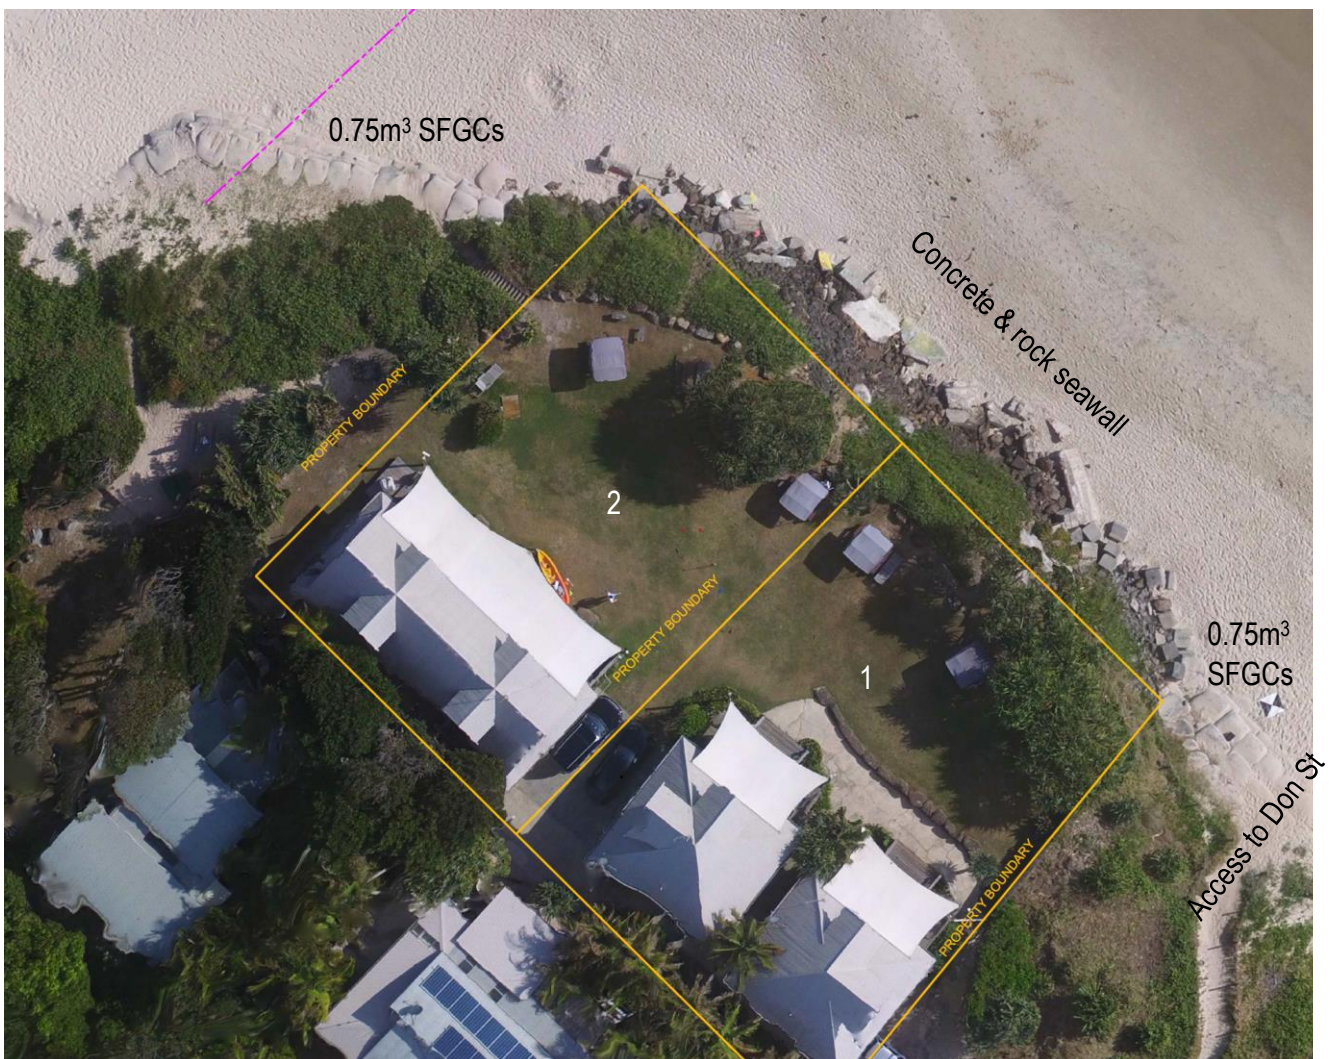
Figure 1 Aerial of site (ICM 13/10/16)

The existing erosion protection works at, and adjacent to, 1 and 2 Don Street have been damaged by erosion and wave action (Figure 1). These works have been in a state of chronic disrepair for some time. Interim protection works were implemented on either side of this property by BSC in about 2001 under consent orders to protect public lands from erosion. The interim walls are also in a poor state of repair.

The existing erosion protection works consist of concrete blocks and rock rubble along much of the seaward boundary of the subject property. The interim protection works on either side of the property were constructed by BSC using 1.5t sand bags and they were connected into the concrete block and rock protection works as shown in Figures 1 and 2. The property to the NW of the subject property is
