URGENT REPAIRS TO SEAWALLS AT 44 & 48 CHILDE STREET, BELONGIL

OFFSITE EROSION MANAGEMENT PLAN

**International
Coastal
Management**

13th January 2017

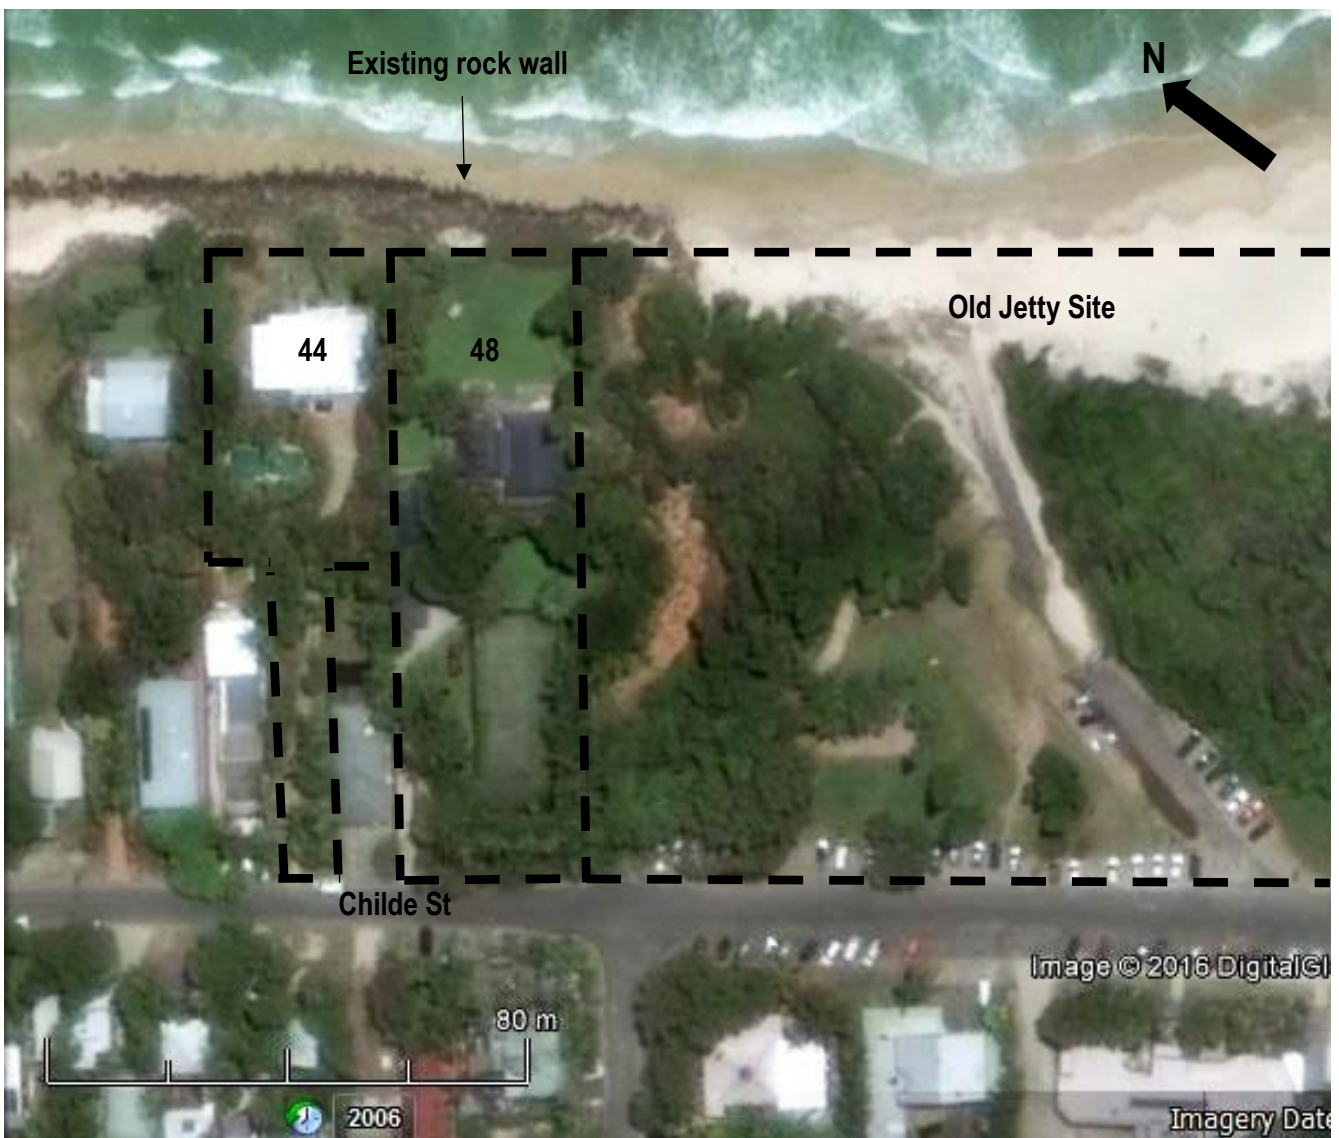
The existing erosion protection works at, and adjacent to, 44 & 48 Childe Street have been damaged by erosion and wave action. These works have been in a state of disrepair for some time.

The existing erosion protection works consist of rock along the seaward boundary of the subject properties and extending both to the NW and wrapping around the south-east boundary (Figure 1). The property to the NW is private property and the property to the SE is the old jetty site, State owned public lands.

Figure 1 Site location. Rock rubble wall partly visible.
