URGENT REPAIRS TO SEAWALLS AT 6 CHILDE STREET, BELONGIL

OFFSITE EROSION MANAGEMENT PLAN

**International
Coastal
Management**

13th January 2017

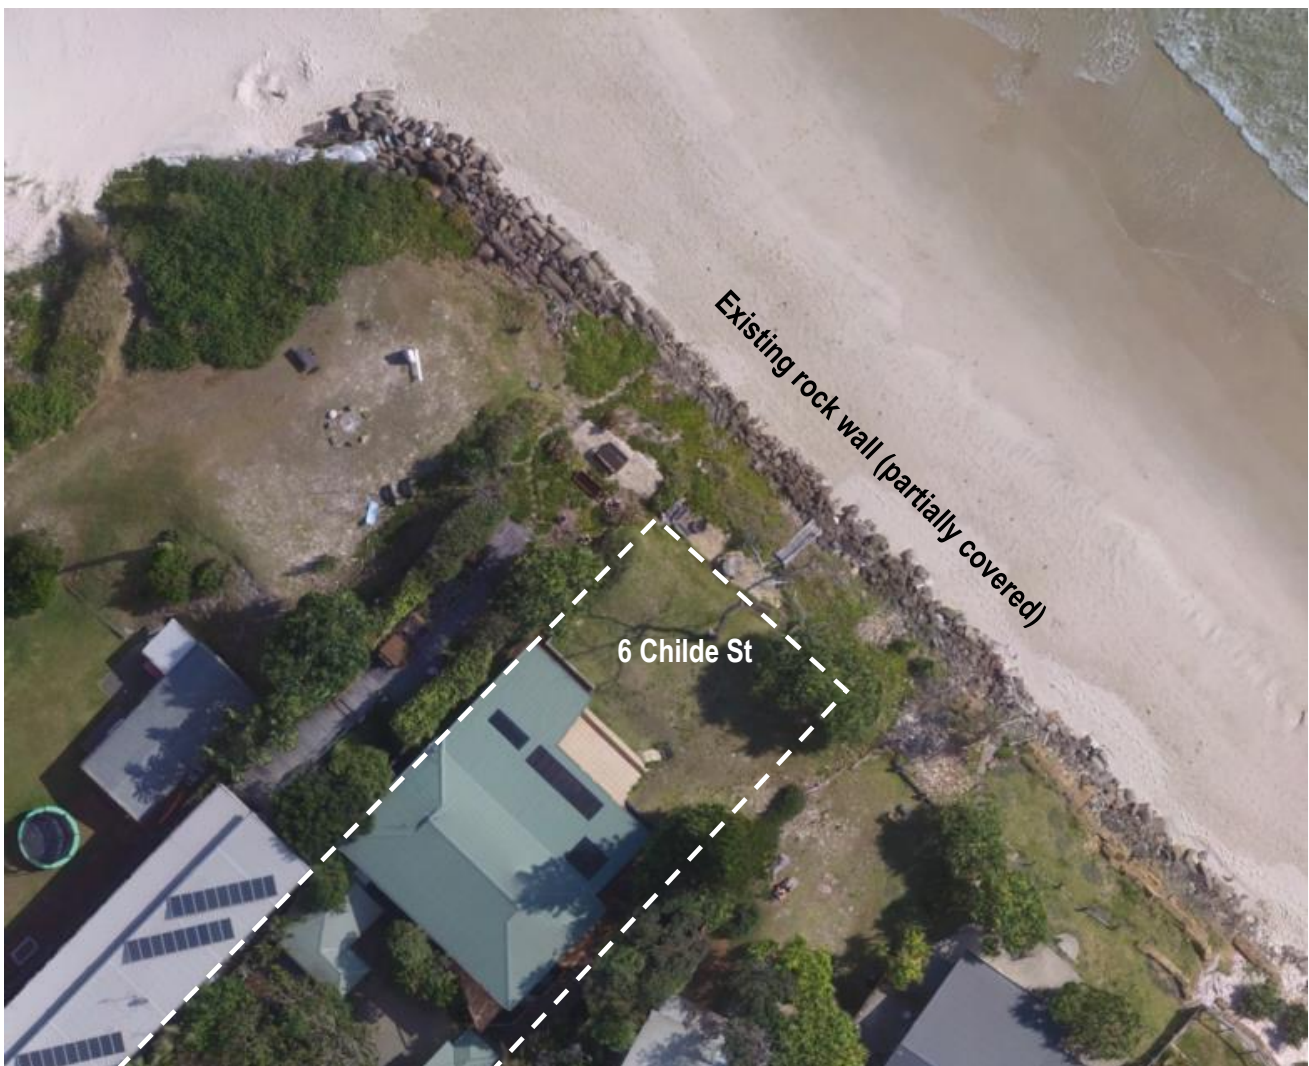
Figure 1 High definition aerial image of 6 Childe Street (ICM 13/10/16)

The subject property is 6 Childe Street consisting of lots 32 & 33 Section 3 DP 1623. The existing erosion protection works at, and adjacent to, the subject property have been damaged by erosion and wave action. These works have been in a state of disrepair for some time.

The existing erosion protection works consist of a rock along the seaward boundary of the subject property. The rock protection works extend along the seaward boundaries of private properties to the NW and SE (Figure 1).
