# An Assessment of Potential Unexploded Ordnance (UXO) Aboard the *M24* Japanese Midget Submarine (1942)

Prepared by Dr Brad Duncan and Tim Smith

Maritime Heritage Program  
Heritage Division  
Office of Environment and Heritage  
Parramatta February 2017

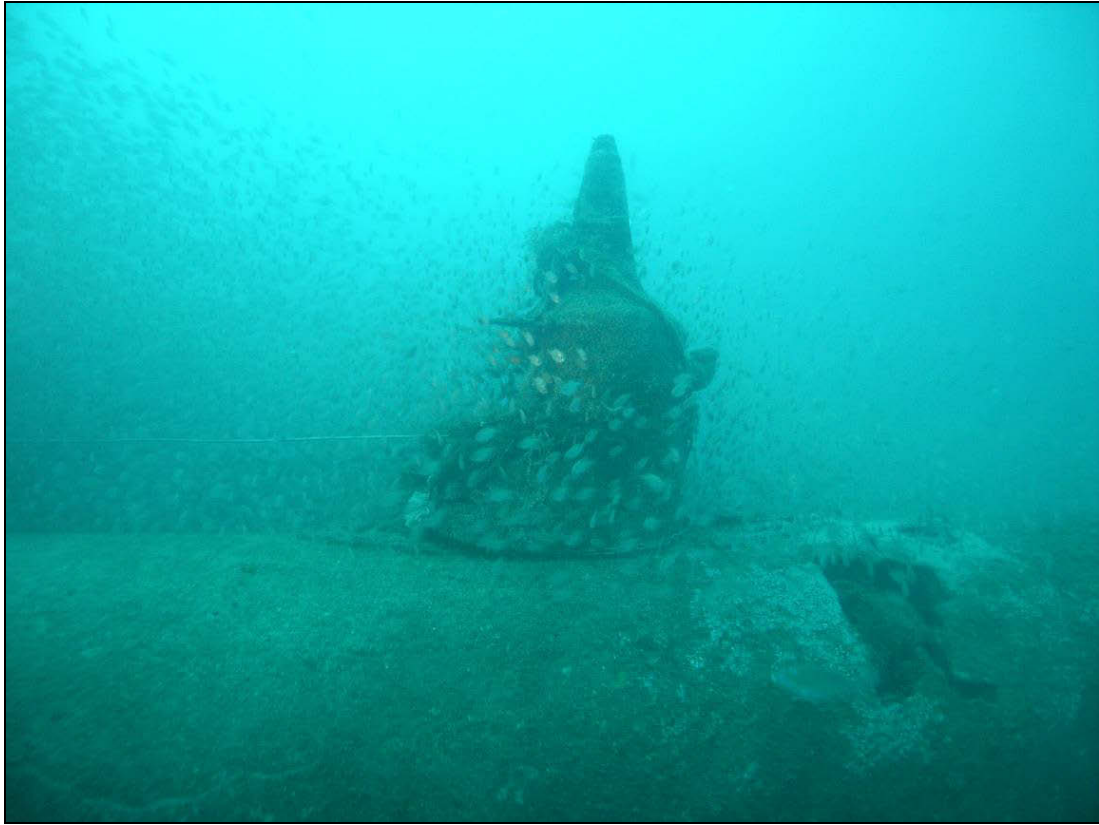
On 20 November 2006, the (then) Department of the Environment, Water, Heritage and the Arts was advised by the Department of Defence of the reported discovery of the wreck of the missing Japanese midget submarine *M24* by divers from the No Frills Divers off Sydney's Northern Beaches (offshore from Mona Vale Headland/Bungan Head, Newport – Figure 3). The submarine was found intact, with some damage to the conning tower and bow sections caused by fishing net entanglement (see Figures 4 and 5).

Figure 4: Intact *M24* midget submarine on seabed (Image: No-Frills Divers).

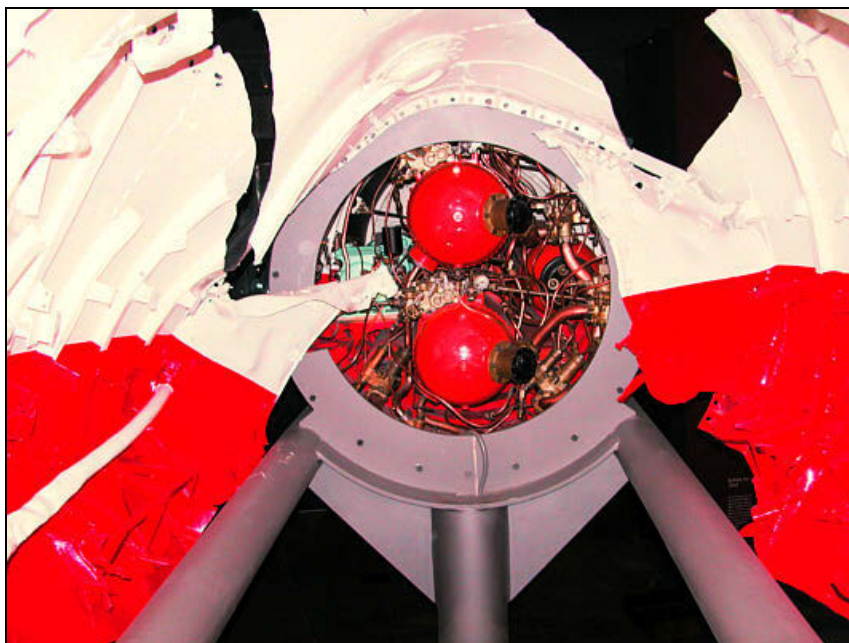
Figure 15: Impact of the detonation of the forward charge on *Ha-14* visible on the displayed hull section, Australian War Memorial, Canberra (Australia). This section is the same view as those shown in Figures 12 and 13 (above), except that the bulkhead between the forward battery and torpedo rooms has been removed. The silver sections are frameworks of the display mountings. Note the original interior paintwork scheme which was discovered during restoration works at Cockatoo Island <sup>73</sup> (Photo: Tim Smith).

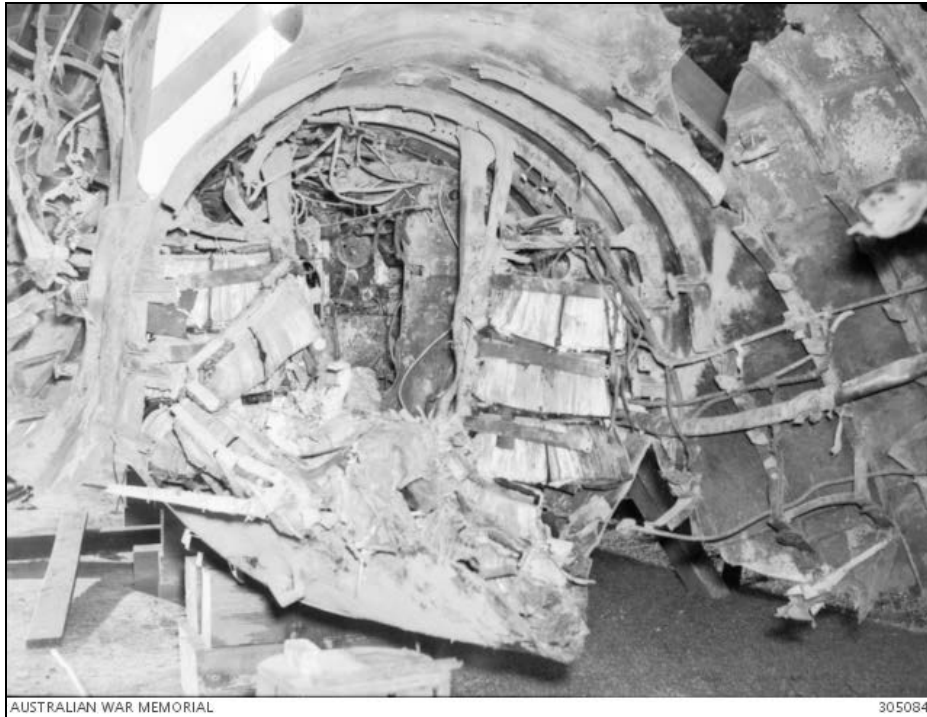
However examination of an historical image taken not long after the submarine was recovered (Figure 16) reveals extensive damage in the battery bank partition wall area just forward of the hatchway door. It appeared from this image that the blast explosion has occurred in an area approximately one battery bank forward of the after most section of the battery bank stacks, as all batteries forward of this area have been blasted out and away from aft bulkhead. The presence of the still extant battery bank might explain why the current control room bulkhead is in relatively good condition, as the batteries appear to have shielded it from the main force of the blast. Tears in the hull originate at approximately 3 frames forward of the control room bulkhead, indicating that the demolition charge (at least in the forward battery room) was placed close to the aft end of the battery banks. This observation was supported by Smith's 2007 photographs of the inspection of the *Ha-14* hull at AWM, where it can be seen that the explosive breaks in the side and bottom of the hull are centred approx. 3-4 frames forward of the control room (Figure 17), where the hull has exploded outwards and bent backwards. There is also massive shearing of the hull upwards and downwards at this location, suggesting it was just forward of the epicentre of the blast.

Figure 16: View of detonation area in forward battery compartment of *Ha-14* looking aft to control room (Image: AWM 305084, AWM Collection).

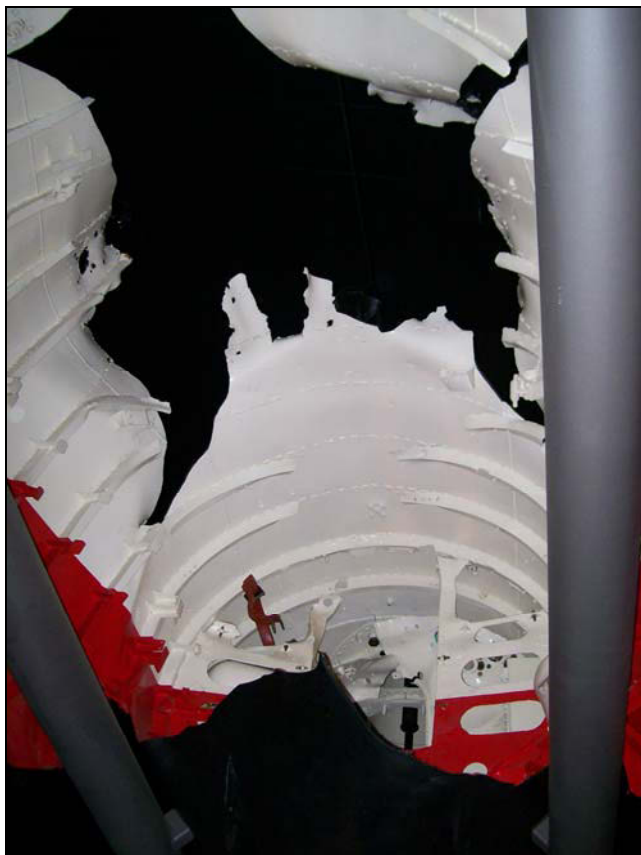
Figure 17: Inside *Ha-14* aft battery room facing aft control room compartment bulkhead. Note the dark section of hull bent upward and inwards at the bottom of the image. On display at AWM, Canberra (Image: Tim Smith).

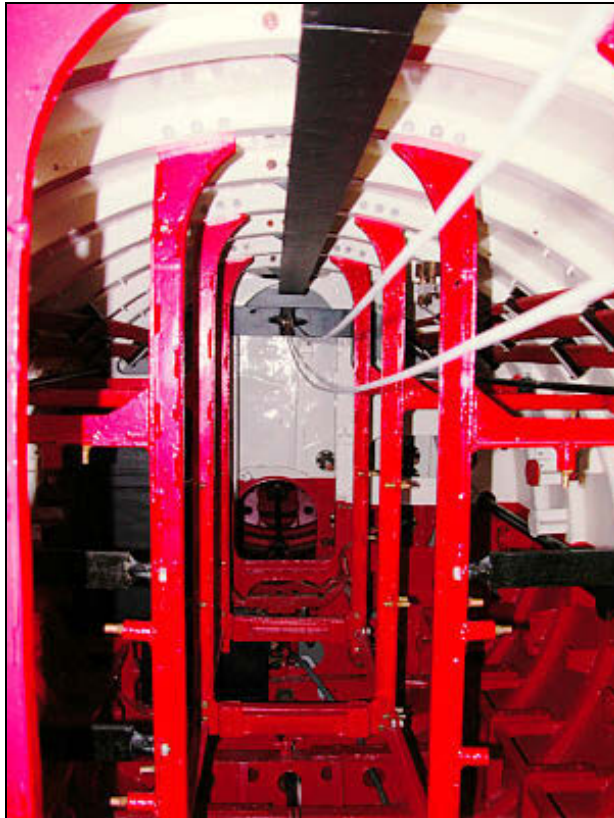
Figure 18: Aft battery room inside remains of *Ha-21* (Australian War Memorial, Canberra. The aft scuttling charge is considered to have been placed within the floor passageway, possibly close to the control room bulkhead. The remains of the battery bank shelves are located either side of the companionway (Photo: Tim Smith).

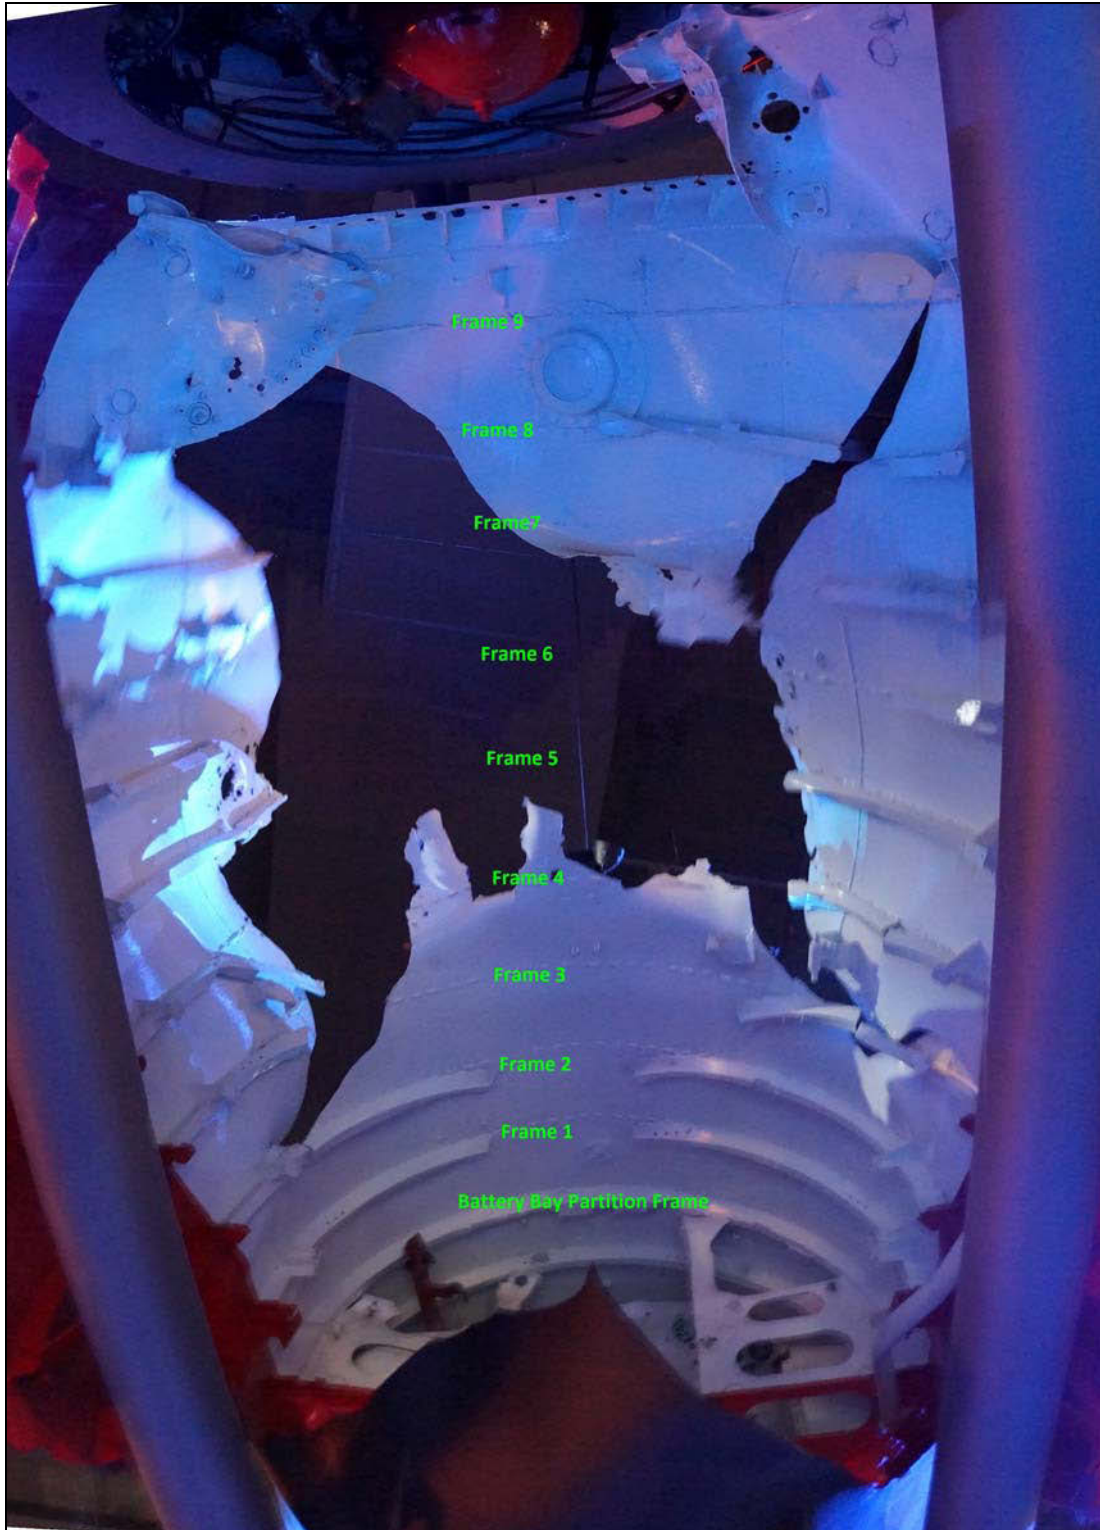
From the observations presented above, it is therefore probable that the blast was concentrated between frames 3-5 of the forward battery bank compartment, suggesting that this was the probable location for where the demolition charge was placed in the forward battery compartment. Although it is probable that the placement of the aft charge was mirrored in the aft battery compartment (i.e. placed a similar distance from the control room), it has not been possible to conclusively demonstrate that this was the case due to a lack of documentary records. Therefore the location of the demolition charge in the aft battery compartment is at this stage speculative.

Figure 21: Interior of *Ha14* hull looking aft toward battery bank partition frame. Note tearing of hull starting at frames 2 and 9 on either side; and shrapnel holes / out hull bending upwards between frames 4-6: and the upwards deformation of the exterior bottom hull (dark grey at bottom of picture) which is partially obscuring the battery bay partition in the middle of the image (Image: After Photomosaic by B. Duncan, Heritage Division).

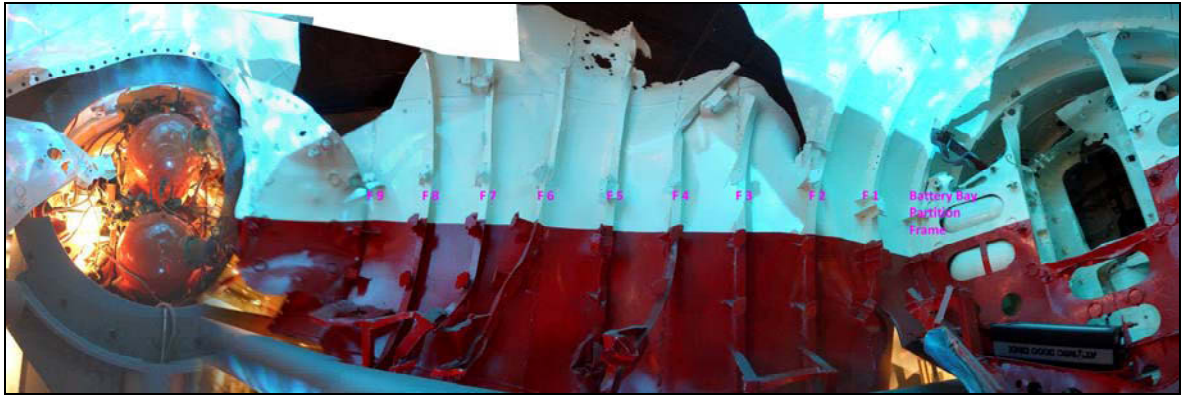
Figure 22: Starboard interior of *Ha 14* hull. Note battery bank stand and frames are deformed between frames 4-7, shrapnel holes between frames 4-6; and hull tearing starting at frame 2 (Image: After Photomosaic by B. Duncan, Heritage Division).

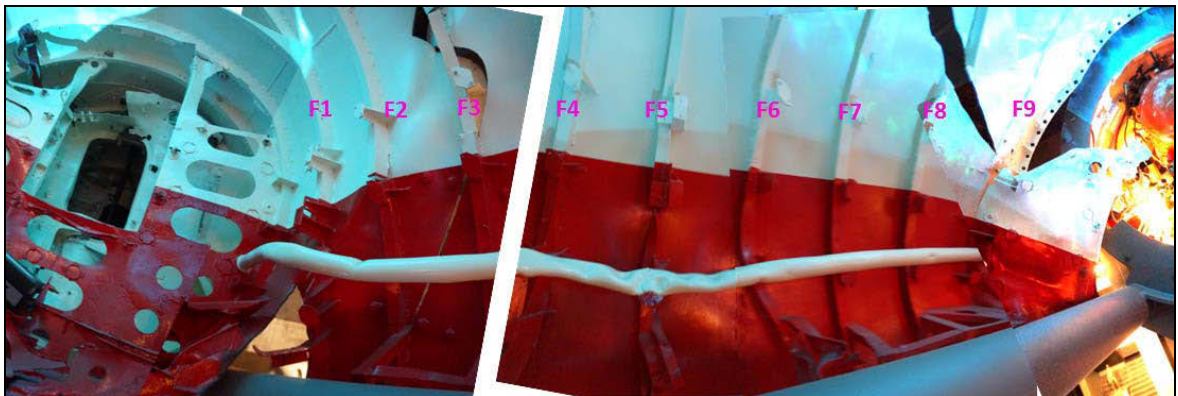
Figure 23: Port Interior of *Ha 14* hull. Note battery bank stand missing and pipe badly damaged between frames 4-6, and hull tearing starting at frames 3 and 9 respectively (Image: After Photomosaic by B. Duncan, Heritage Division).

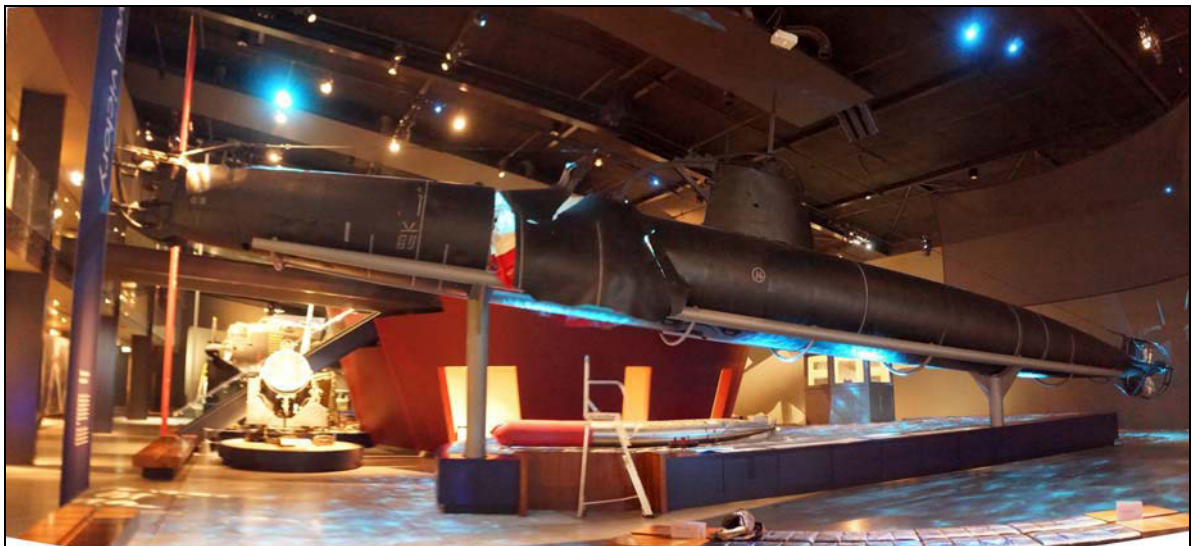
Figure 24: Composite hulls of *Ha 14* and *Ha 21* pieced together for a display at Australian War Memorial. (Note blast of charge below conning tower net-cutter in approximate, proposed location of forward battery room charge. (Image: B. Duncan, Heritage Division).

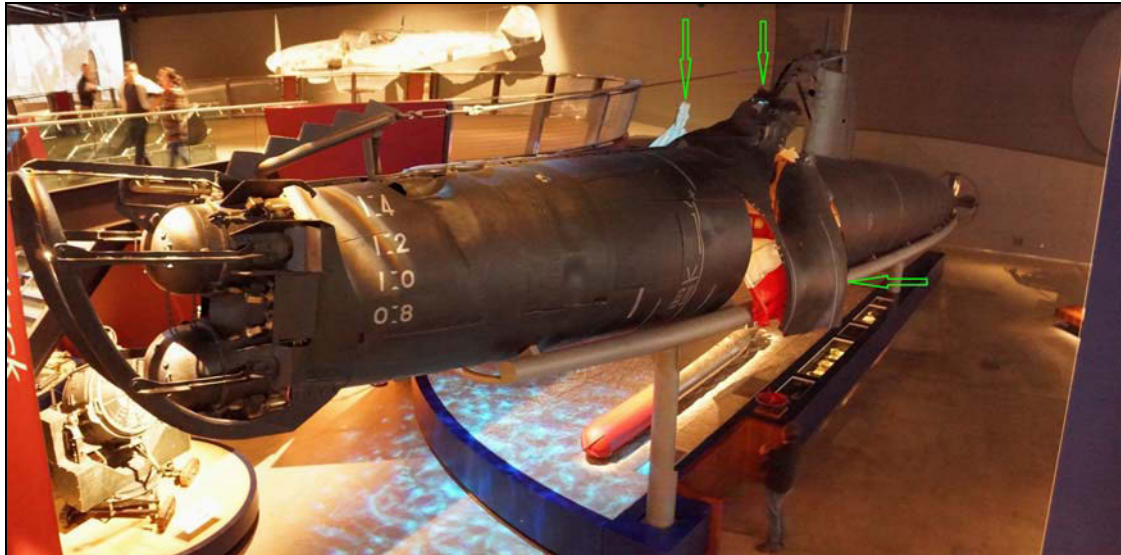
Figure 25: Bow section of *Ha 21* and attached hull of *Ha-14* hull looking aft. Note the evidence of upward explosion near conning tower (green vertical arrows) between frames 4-6 forward of the net-cutter. The athwart explosion is evidenced by a bulging/ bubbling with a distinct vertical line of the outer hull plates, which corresponds to frame 4 on the interior of the hull –see horizontal arrow. (Image: After Photomosaic by B. Duncan, Heritage Division).

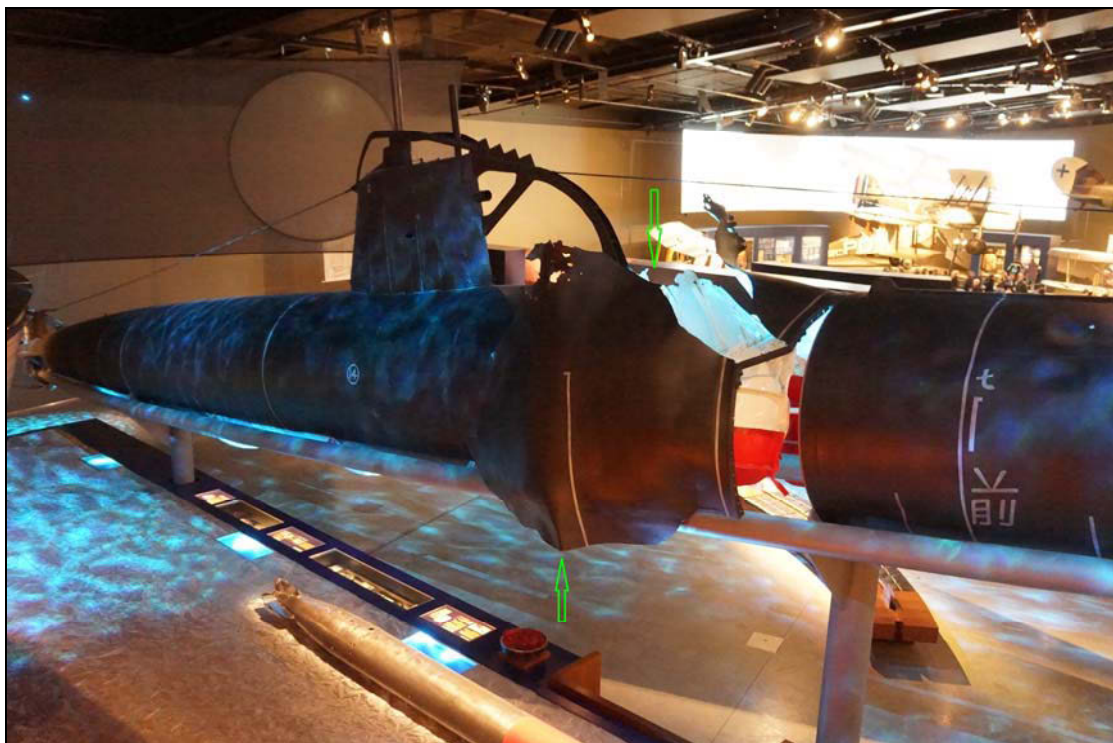
Figure 26: Hull of *Ha-14* hull looking aft on the starboard side. Note the evidence of upward explosion near conning tower (green downward vertical arrow) between frames 4-6. Note that shrapnel and upwards explosion is evident by protruding hull plate aft of the net-cutter frame (located above frame 4). The athwart explosion is evidenced by bulging/ bubbling line of the hull plate (Image: B. Duncan, Heritage Division).

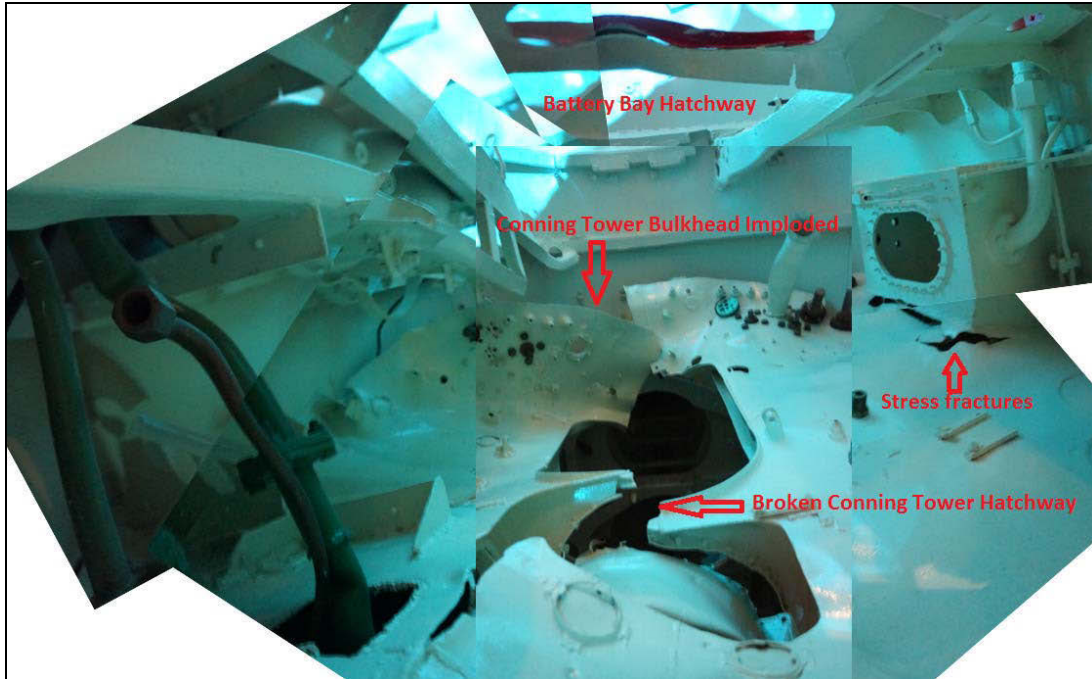
Figure 27: Conning Tower Bulkhead of Ha 14 looking through escape hatch in floor. Note extensive damage to the conning tower hatchway and bulkhead, where plating has become detached (Image: B. Duncan, Heritage Division).

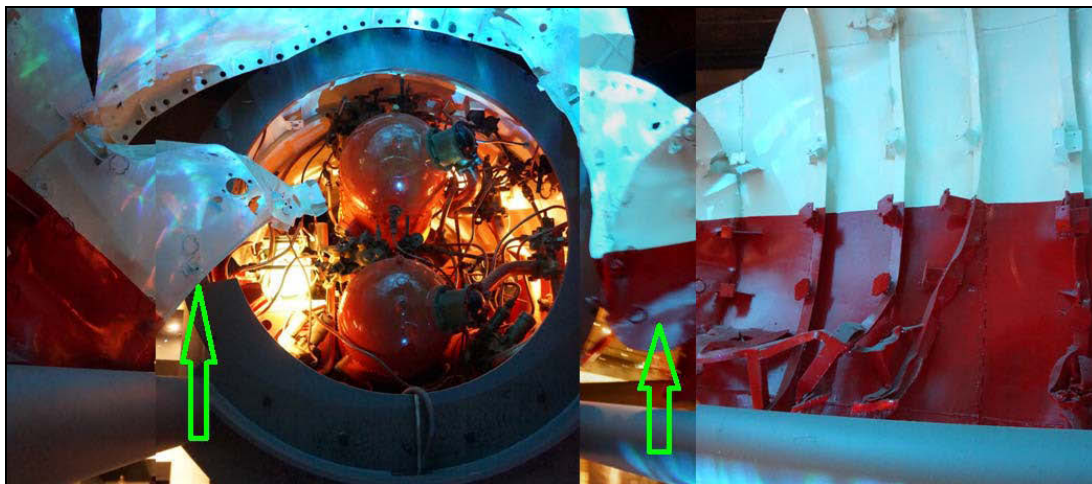
Figure 28: Torpedo Room Bulkhead remains as indicated by arrows (Image: B. Duncan, Heritage Division).

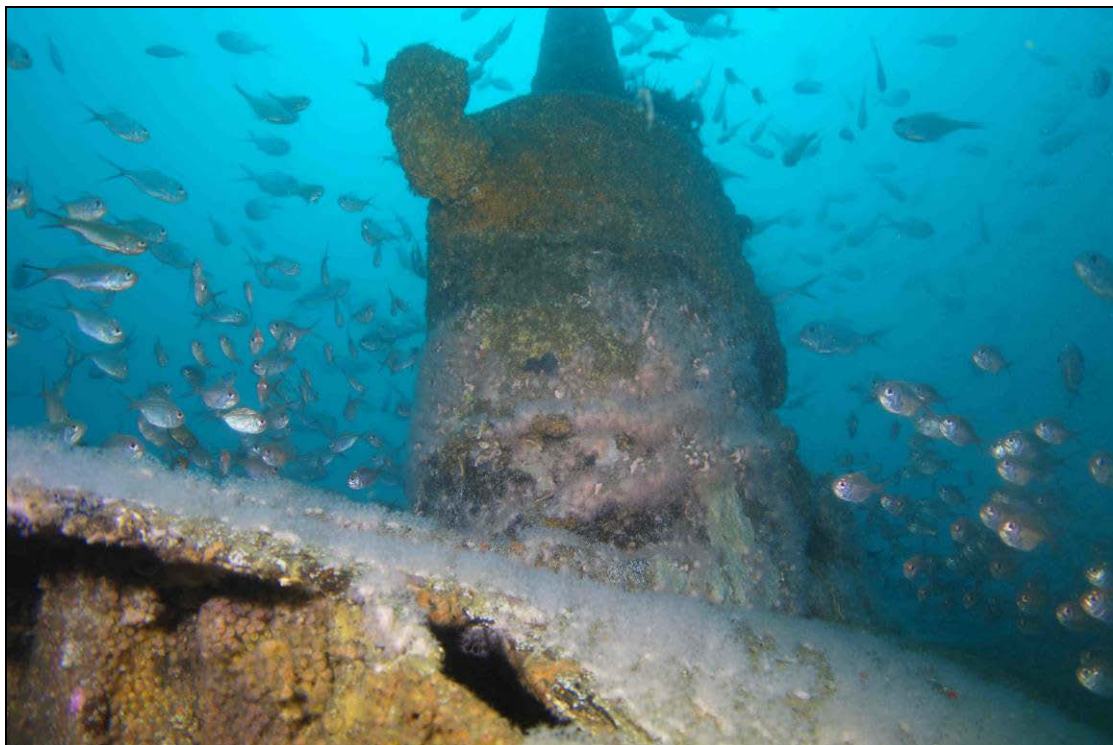
It does appear that there has been some discrepancies in the sand levels inside the aft battery compartment over time, indicating that sand may be moving in and out of this area.

Figure 50: Conning Tower of *M24* midget Submarine from Starboard side showing the hull breach into the battery room on left hand side (Image: Venturoni 2015 Survey).
