## 7. RISK MANAGEMENT OF UXO SITES

## 8. RECOMMENDATIONS

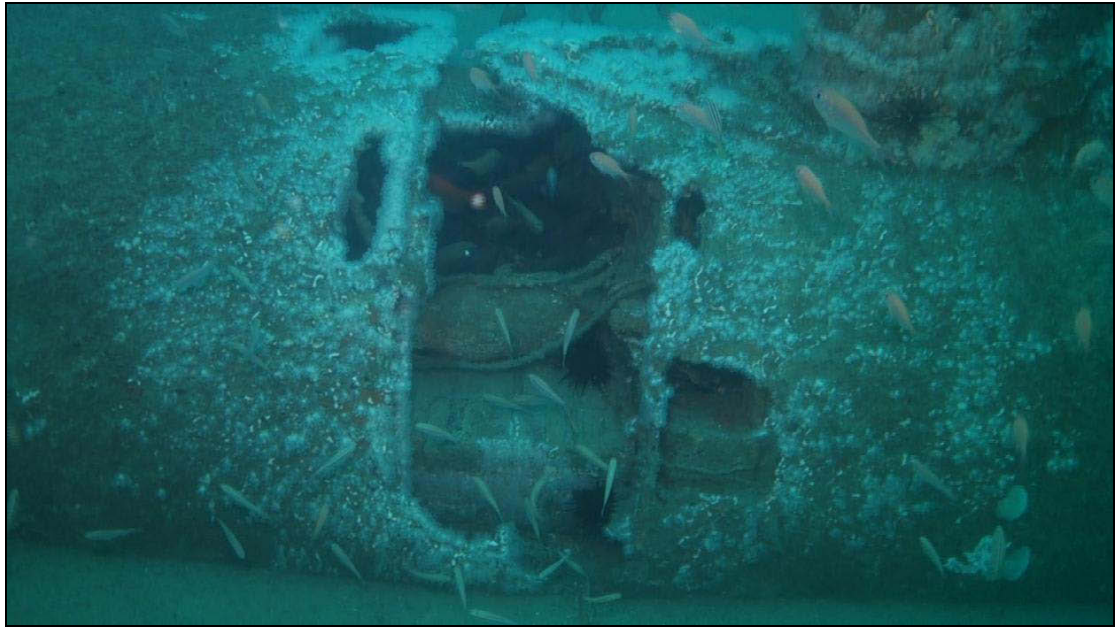
**Figure 51: Hole in aft battery compartment in possible area of demolition charge. Note batteries and possible water heater in gap (Image: Venturoni 2015 Survey).**

Consideration should be given to blocking access to the interior of the submarine in the aft battery compartment, possibly by placing sandbags or netting over this area, or filling the interior with sand (the latter would require sealing up external plate openings).

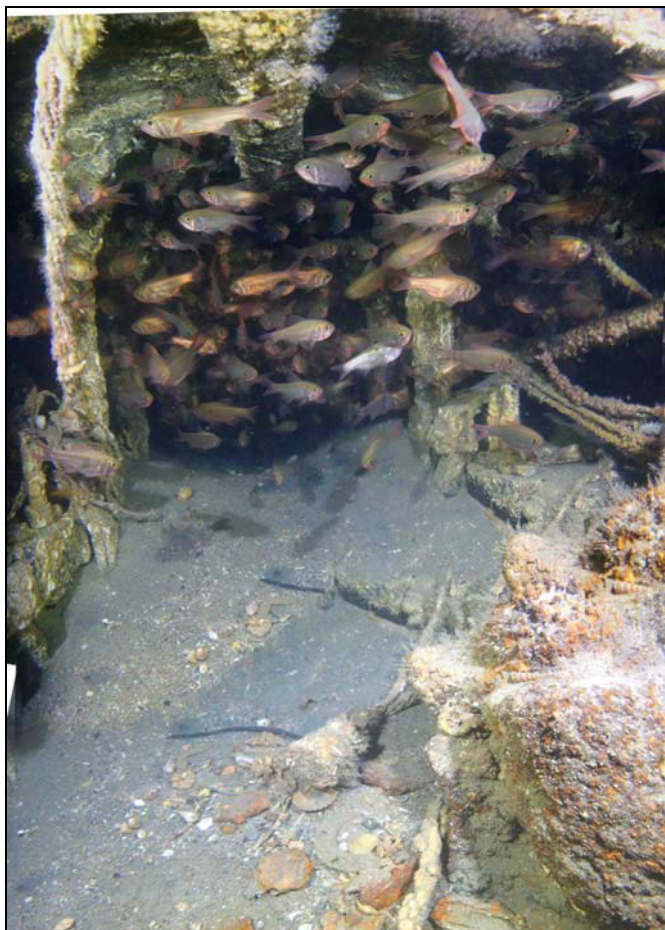
**Figure 52: Panorama of Interior of M24 Stern Battery Compartment. Note central longitudinal overhead rail at top and battery bays to either side. This is the approximate area of the aft demolition charge, and is comparable to the area shown in Figure 18 (Image: Panorama after Venturoni 2015 Survey).**

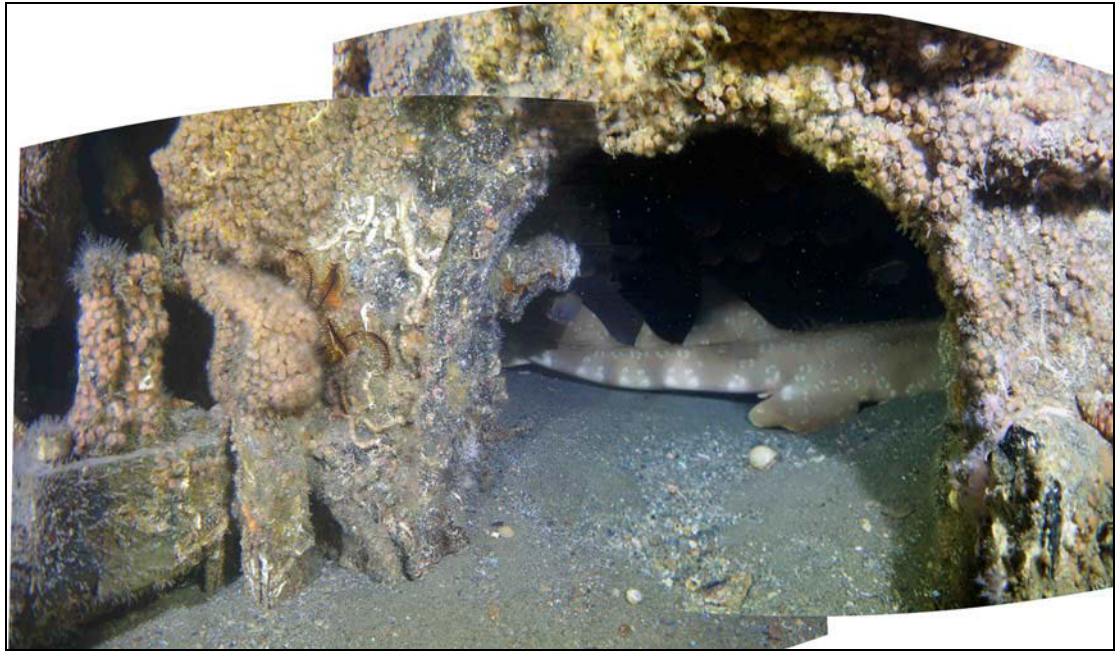
**Figure 53: Stern Battery Compartment looking through the battery bay bulkhead into the Control Room. Note Battery and Box on left. (Image: Panorama after Venturoni 2015 Survey).**

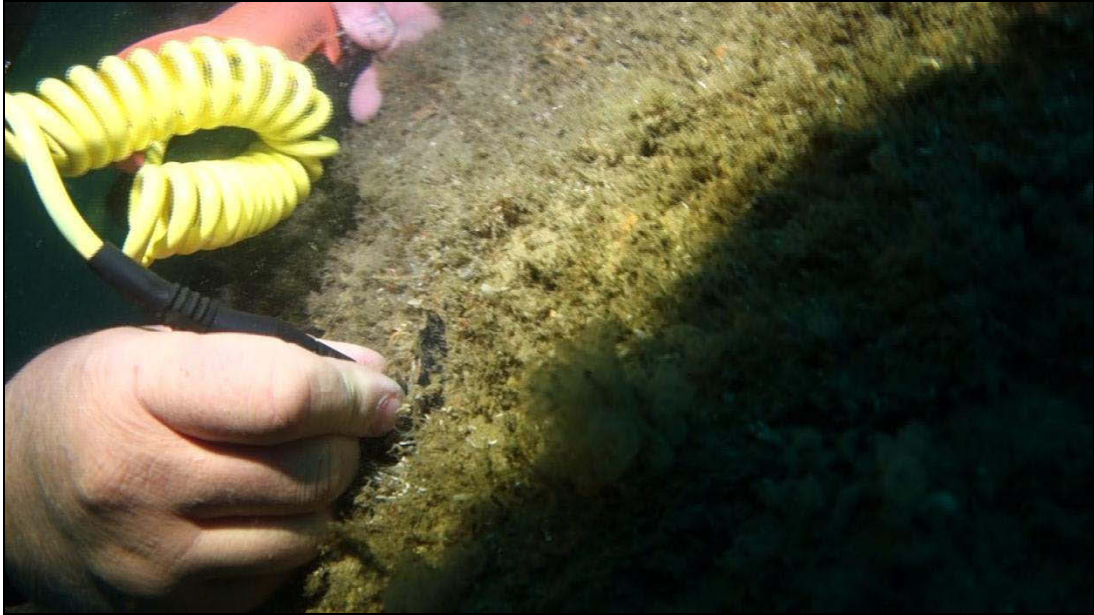
A corrosion survey undertaken by Professional Diving Services in January 2015 using an ultrasonic thickness meter (Figure 54) and a corrosion meter unit (supplied courtesy of Vicki Richards - Western Australian Museum). This survey was undertaken after consultation with UXO experts and other heritage management specialists who had been dealing with similar sites<sup>190 191 192</sup> who advised that as it involved minimal invasive testing on the outside of the hull, there was a negligible danger of disturbing the UXO contained inside the submarine. This survey revealed that the hull of the vessel is currently very thin and is actively corroding. Hull thickness measurements were 8.1 - 8.4mm forward, 6.2 - 7.1mm mid ships and 5.8 - 6.4mm aft (Venturoni 2015). Unfortunately the corrosion survey of the wreck could not be completed as the corrosion meter accidentally flooded. With the permission of the Heritage Division and after consultation with the Japanese Consulate, an anode was installed on the stern section of the vessel in an attempt to reduce the corrosion rate across the site (Figure 55).

The ongoing active corrosion on the site has demonstrated the fragility of the wreck structure, which could potentially suffer a catastrophic collapse at any time, particularly if exposed to an intense East Coast Low storm event (which are regular events along this coastline).

Figure 54: Diver taking ultrasonic thickness readings of the pressure hull (Image: Venturoni 2015 Survey).

This report proposes that full corrosion surveys of the site should be undertaken on a regular basis, with a view to eventual installation of a network of anodes around the site (if considered safe to do so). It is envisaged that a pod of anodes in a similar array to those used on the *AE2* submarine wreck site in the Dardanelles, Turkey<sup>193</sup> (see Figure 56) be considered as an economically viable and safe system for deploying this type of technology at this depth.

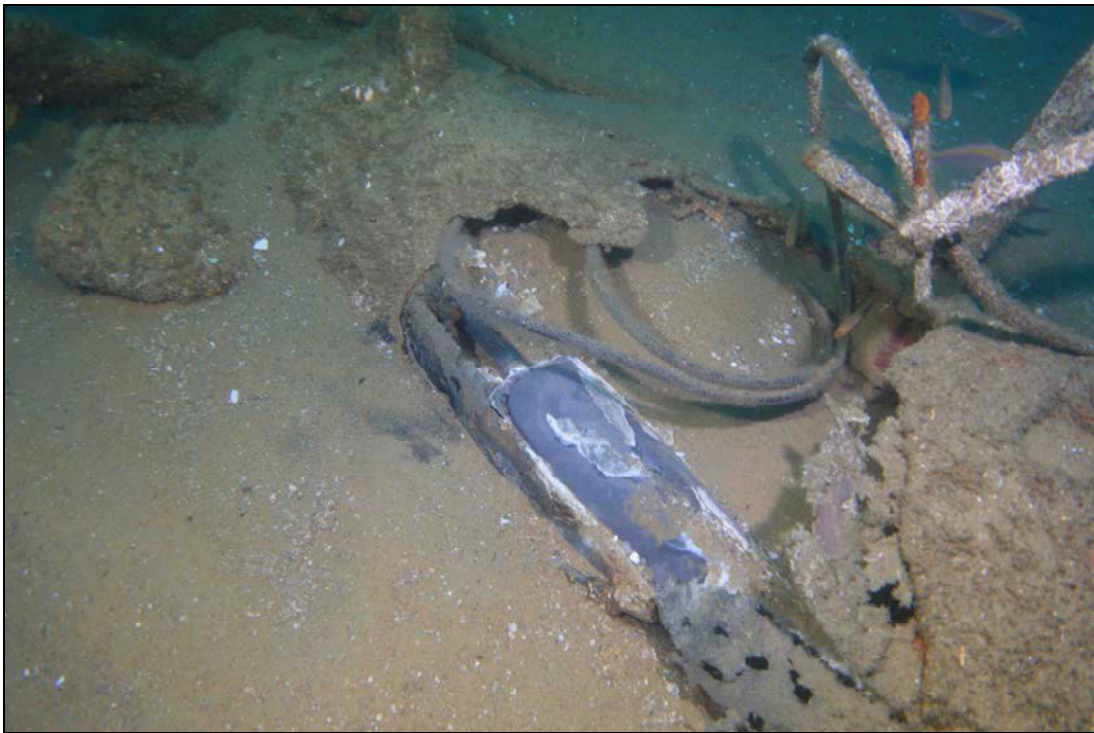
Figure 55: Anode placed inside the engine room compartment. Node silver anode in centre and attached cables and clamp on right (Image: Venturoni 2015).

The wreck site of the *M24* is actively corroding and in time is likely to experience catastrophic failure (i.e. total collapse), which will lead to the contents of the wreck (including the ordnance and the remains of the submariners) being exposed and/or strewn around the site (although there is currently no data to predict the likely timeframe of this occurring). If it is determined by suitably qualified and experienced UXO specialists that conservation works can be undertaken safely on site (see discussion below), then a project to undertake complete and ongoing corrosion surveys should be commenced ASAP at the site. These works are in anticipation of the potential installation of a pod of anodes being installed at the site (of a suitably modified design to those used on the *AE2* wreck site in Turkey). Anode installation will provide greater protection of the site through partial reversal of previous corrosion processes and will likely extend the life of the wreck by reinforcing its structural integrity. External funding sources should be investigated to potentially fund the anode installation project (e.g. DFAT Australia- Japan Foundation Grant Program).

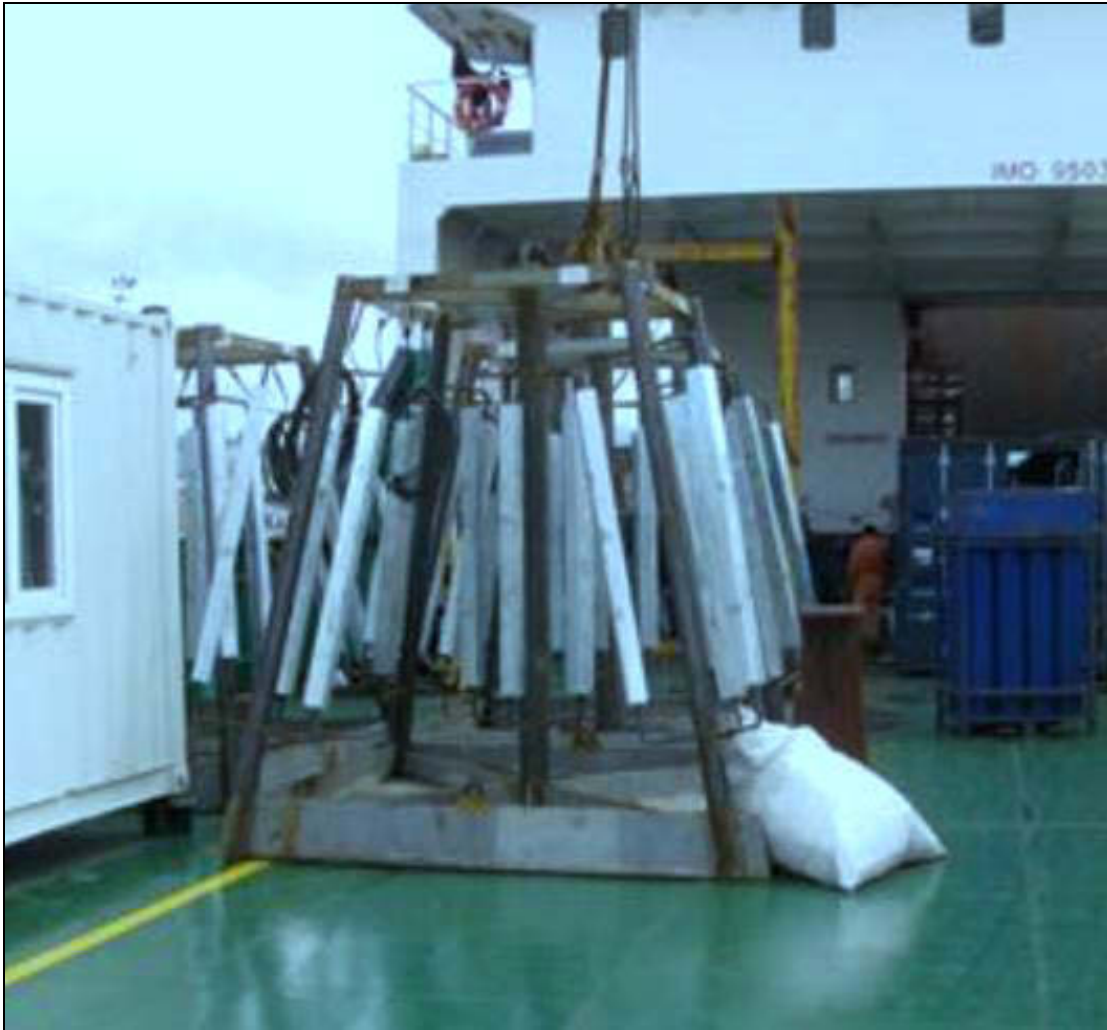
Figure 56: Anode Pod deployed on *AE2* submarine wreck, Turkey (Image: After MacLeod 2015, Project Silent ANZAAC).

However, given the heavy swell and surge conditions in this area, the design of any anode pod would need to be reconsidered to ensure that the pod was of low enough relief to ensure it could not be knocked over in big seas. A flatbed array which would sit low on the seafloor would present the best design for these environmental conditions.
