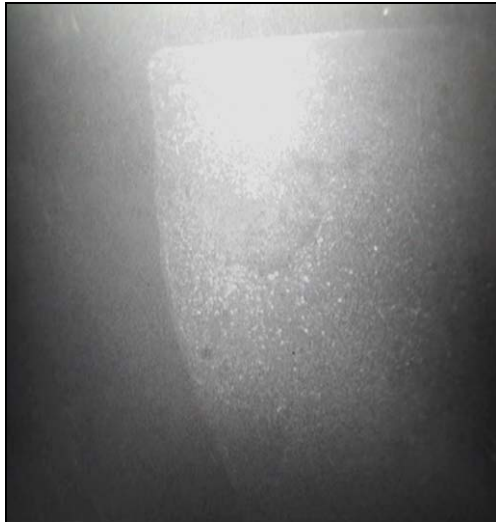
- Bow Section and Starboard Side Features: The stem post of the wreck is very fine in profile, and exhibits a pronounced turn to aft approximately 2m vertically from the keel. The stem post showed signs of fresh corrosion and scraping, which might be consistent with damage attributed to commercial fishing nets and ropes scraping over the hull (see Figures 30, 31). A mooring port is visible approximately 1 metre aft of the bow at deck level on the port side.

Figure 30: Photomosaic of starboard stem and keel of bow (Photomosaic: Brad. Duncan after DMS 2007)

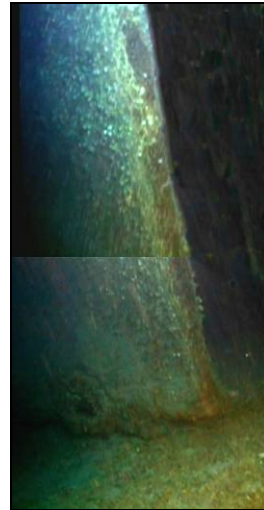
Figure 31: Photomosaic view of port bow and mooring port, showing recent corrosion probably caused by net abrasion (Photomosaic: Brad Duncan after DMS 2007)

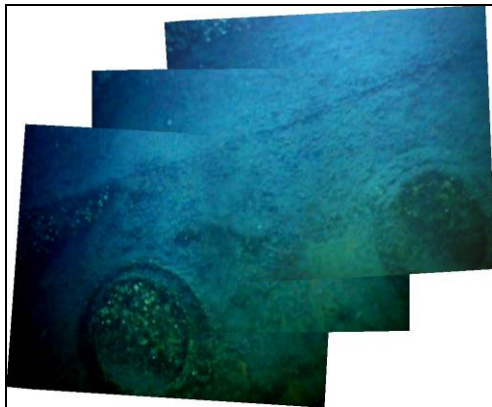
- Two large hawseholes are located on the starboard side approximately 2-3m aft of the stem post (see Figure 32). No mooring port was visible on this side as it appears that this area is partially buried in shallow silt. A distinct band of oysters and/or barnacles were evident still adhering along the former waterline edge in this area of the bow.

Figure 32: Hawse pipe in bow section (Photomosaic: Brad Duncan after DMS 2007)

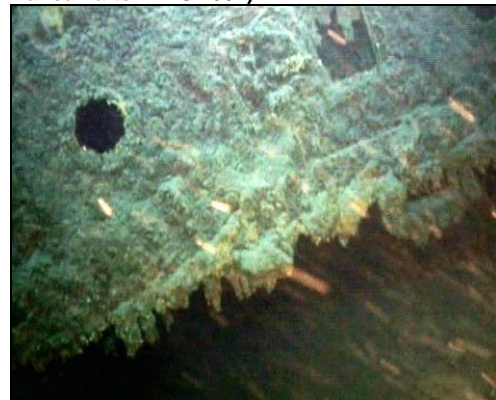
- The first of six scuttles were sighted approximately 8m aft of the last hawsehole, with the scuttles spaced approximately 2 m apart along the hull side approx 0.5m below the deck. A square escape hatch was visible approximately 1m to aft, with what appears to be a fairlead on the deck above, followed by another scuttle (see Figure 33).

Figure 33: Starboard deck edge with scuttles and escape hatches, fairlead and rusticles (Photo: DMS 2007)

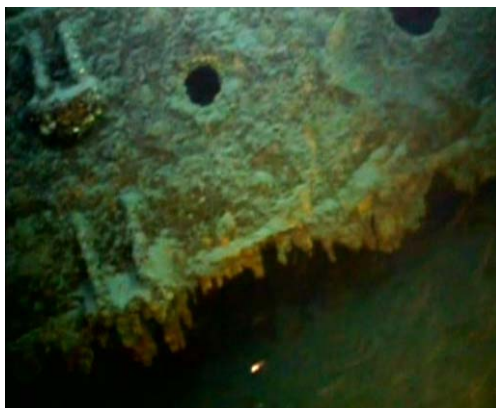
- Two mounts for an antisubmarine net or boarding/ landing stage support were noted approx 2m from the scuttle, followed by an undersized and two regular scuttles (see Figure 34).

Figure 34: Landing stage bracket supports, starboard side (Photo: DMS 2007)

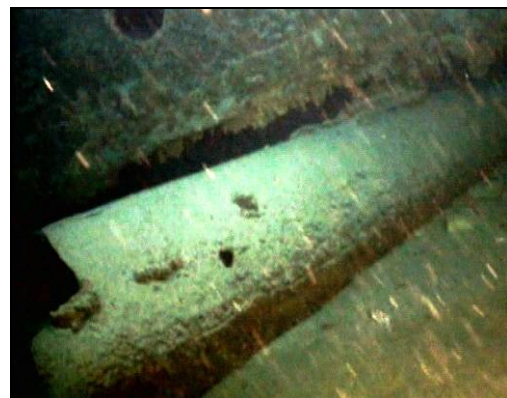
- Below the last scuttle, the end of a hollow cylindrical iron/steel mast with an internal ladder was observed protruding approximately 3m horizontally from underneath the hull at an angle of approximately 45 degrees towards the bow. This mast is probably the vertical mast from the forward mast tripod (see Figure 35).

Figure 35: Part of forehead tripod mast trapped under the hull on starboard side (Photo: DMS 2007)

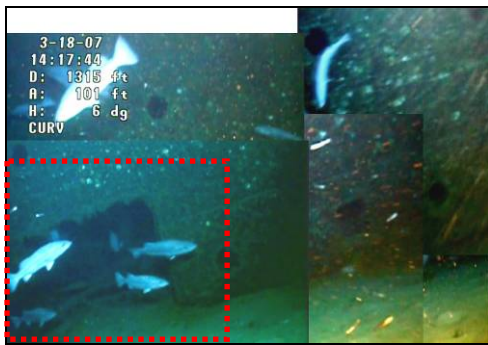
- Stern Scuttling Holes: A large rectangular shaped hole approximately two- three metres square was evident cut at deck level in the hull at a depth of 1315 ft (394m), with two scuttles evident approximately 1m directly above and to the right side of the opening (see Figure 36). A progression of a scuttle, and an escape

hatch followed by two more scuttles were evenly spaced just below the deck level on the right side of the inverted hull. The large hole is consistent with one of two scuttling holes known to have been cut between the P and Q gun mounts (located amidships) which were cut into the hull and deck to allow air to escape from the hull during scuttling were observed. Identification of these features in a contemporary photograph of the scuttling show that the scuttling hole is located just aft of the amidships funnel. A section of overlapping/protruding hull plates were observed just aft of this area approximately 2m higher on the hull, as were several rusticles and freshly rusted areas at a depth of 1316ft (395m).

Figure 36: Scuttling hole in hull at deck level (Photomosaic by Brad Duncan after DMS 2007)

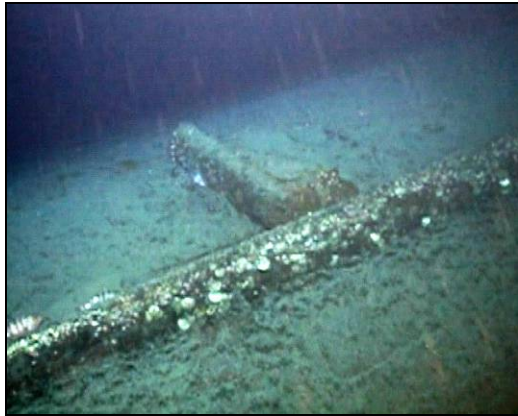
- Stern Area – Torpedo Tube/ Cruiser Stern: A section of bilge keel extends longitudinally for at least 10-15m towards the stern on the hull. A section of possible stern tubing is also evident on the inner side of this feature at the torpedo tube end, probably from the inner starboard propeller (see Figures 37, 38).

Figure 37: A section of bilge on the aft section of the wreck (Photo: DMS 2007)

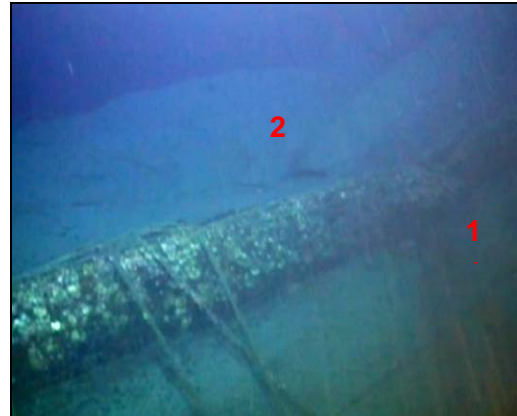
Figure 38: Possible bilge keel for propeller at stern end. Note broken/ creased section (1) and a stern tube (2) (Photo: DMS 2007)

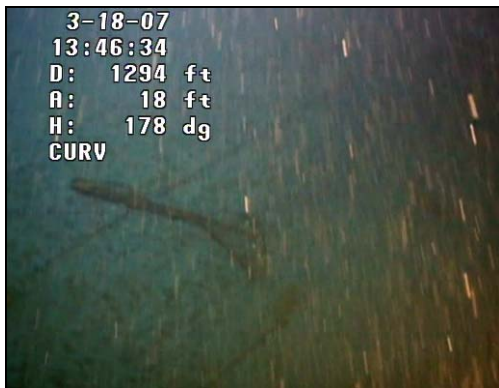
- A small attached section of iron on the port stern side at 1298ft (389m) may be the remains of the port propeller stay (see Figures 39, 40). Sections of what appears to be a collapsed walkway (evidenced by what appears to be stanchioned handrails) lie further aft close to the edge of the hull (see Figure 41).

Figure 39: Port propeller stay (Photo: DMS 2007)

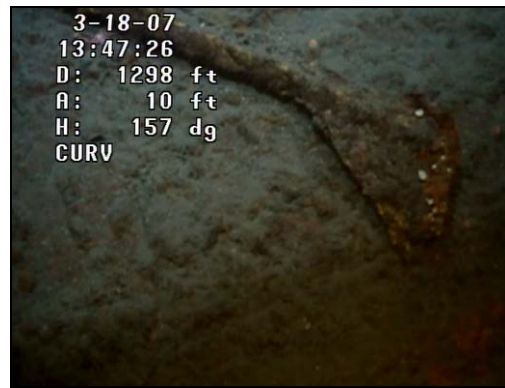
Figure 40: Close-up view of port propeller stay (Photo: DMS 2007)

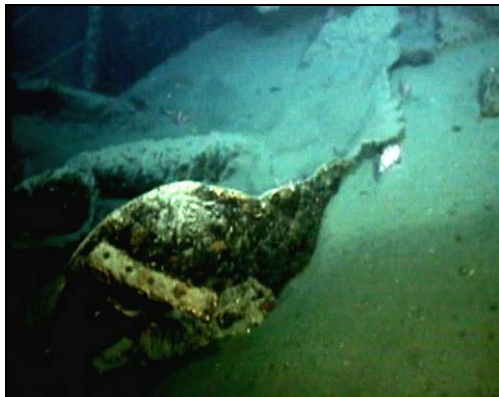
Figure 41: Unidentified piping wreckage alongside starboard hull (Photo: DMS 2007)
