STRANDING OF PS COLLAROY, 1881

Investigation of features Collaroy Beach, Sydney

CONSERVATION MANAGEMENT PLAN

Tim Smith
Heritage Office
August 2002

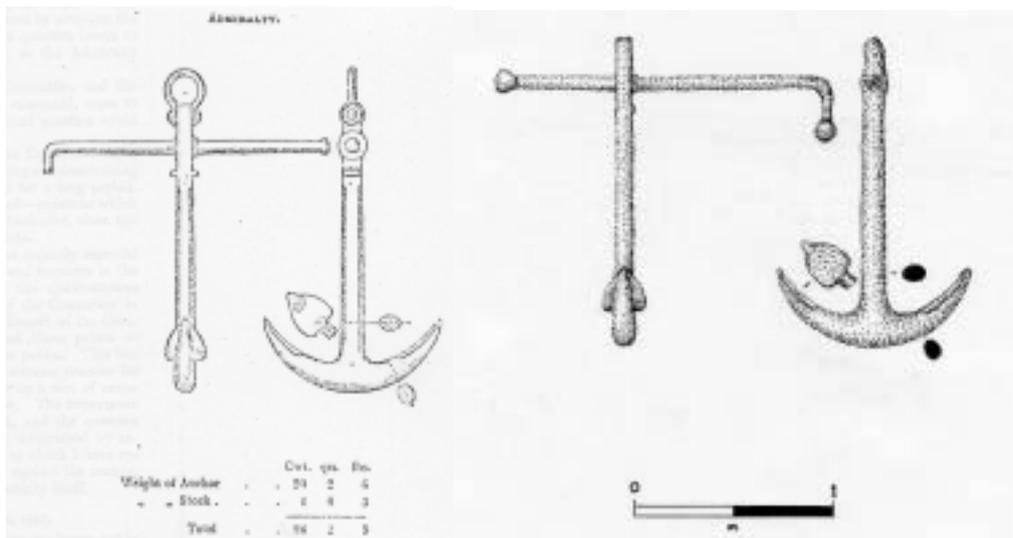
Measuring 1.57 metres (5 feet 2 inches) in overall length, the anchor was immediately recognised as of the standard Admiralty (New Style) pattern, developed from 1841 in the United Kingdom. The anchor was positioned with one of its arms and flukes pointed skyward in the usual resting position, and had an iron stock lying flat against the reef. Heavily encrusted with marine growth and iron corrosion products, the anchor was orientated towards the beach on a bearing of 310 degrees.

Here it is interesting to note that the located Admiralty pattern anchor is missing its shackle – the standard attachment point for chains and cables. Was it wrenched off the anchor when the immense strains were introduced by the *Collaroy's* winch? How the second rope hawser was attached to the anchor is not recorded, but the operation might have utilised the services of the hard-hat diver ordered from Newcastle. The records do not indicate whether this diver arrived on the scene or was ever used in the operations.

Figure 10 The Admiralty “New Style” anchor developed from the 1840’s (after Cotsell, 1856), and the located anchor, right (drawn by Tim Smith).

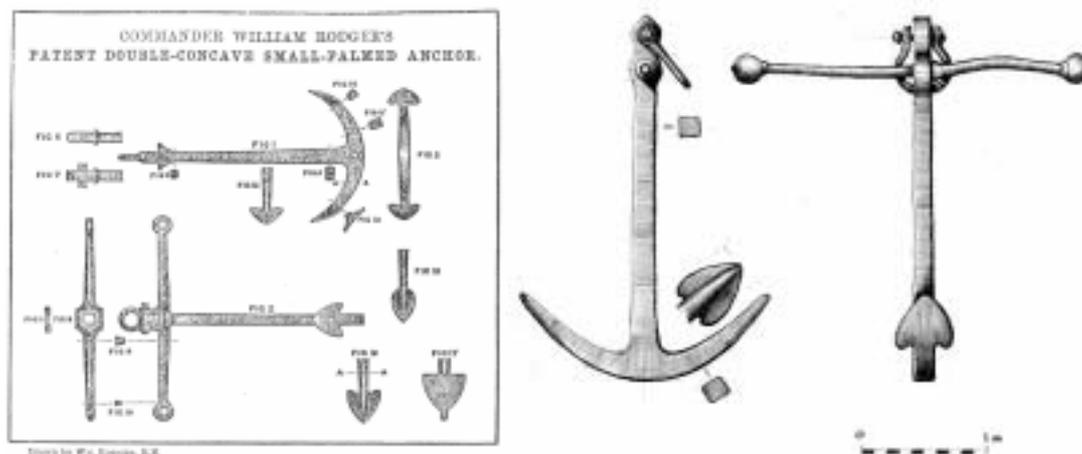
The Collaroy example closely resembles original drawings of the type made by Rodgers. A successful design, this example appears to date from after 1854 when Rodgers patented his “Moveable iron stock” (Curryer, 1999:89). The anchor is noted for its square cross-section and palms in the shape of hearts. Earlier versions of his Small-Palmed Anchor had the palms on the upper (ie inner) surfaces of the arms.

Figure 11: Lt Rodgers Double Concave Small-Palmed Anchor type as depicted in contemporary advertising. Reprinted from Curryer, 1999:90. With a similar example to the anchor located at Collaroy Beach, on display at the Coffs Harbour Yacht Club. Drawn by Tim Smith.
