SOLITARY ISLANDS SHIPWRECKS SURVEY

14-16 February 2000
and
14 August 2000

CONSERVATION MANAGEMENT PLAN

December 2000

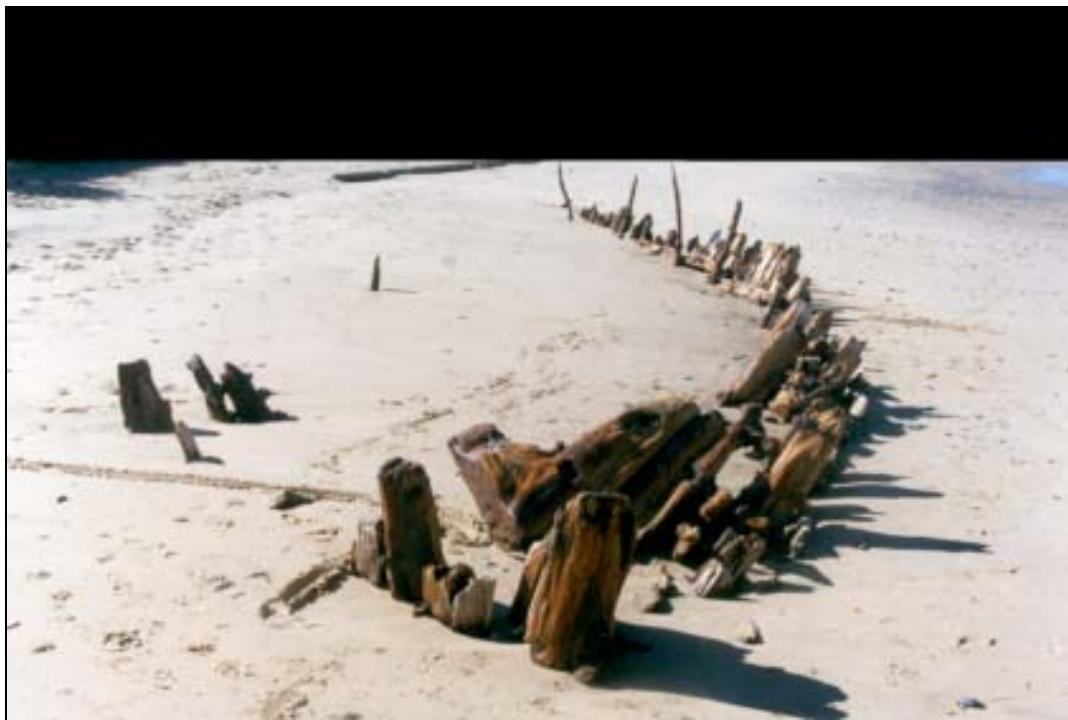
At that time, the bulk of the western side of the hull was exposed to a depth of approximately 70 centimetres. This exposed sections of outer hull planking attached to numerous timber frames, together with the internal “ceiling” planking and a fashion piece comprising part of the “deadwood” from the southern end of the hull. This suggested that only the very lower portion of the hull had survived.

Observed fastenings included timber treenails and iron spikes used to join individual timbers to the frames. Reports by local residents of damage to the shipwreck were investigated. This activity allegedly involved the illegal removal of sections of timber and resulted in the NSW Minister for Urban Affairs & Planning, issuing an immediate media release. The resulting local media coverage and natural reburial of the majority of the wreck reduced this inappropriate activity.

Figure 12: View of the Woolgoolga shipwreck taken in 1999 showing the high level of hull exposure at that time. Courtesy of Paul Rebeck. Solitary Islands Marine Park Authority.

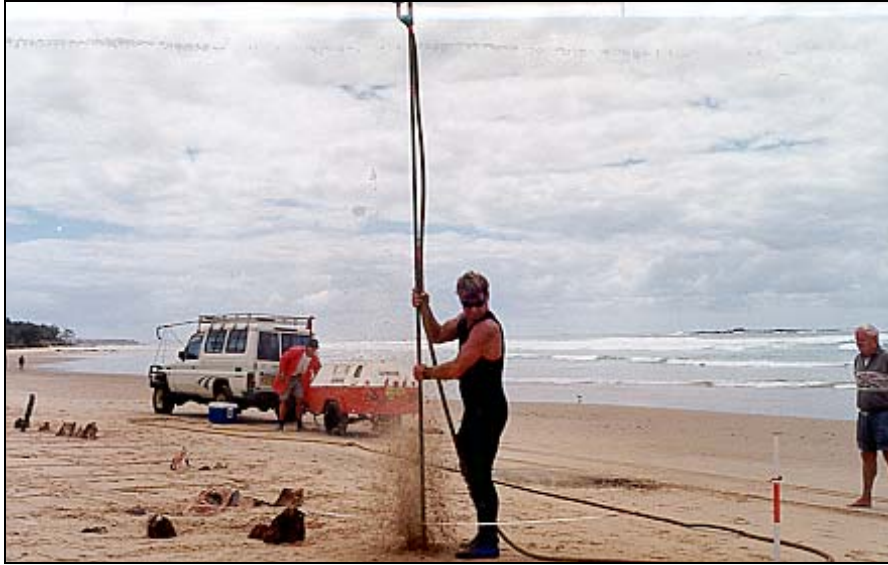
During the February 2000 inspection, sand levels had again increased across the beach, leaving the shipwreck largely covered over. The exposed portion was reduced to approximately seven frames marking the western side of the hull, together with four large iron spikes protruding some 60 centimetres beyond the sand. These were quickly identified as iron “rider knees” positioned in the lower hull, a common fastening or bracket, that ran down the inside surface of a timber hull and bolted to it, and also connected to the underside of a deck above providing additional strength.

Figure 13: *View of the 2000 Heritage Office survey of the site.*
Photo: David Nutley.

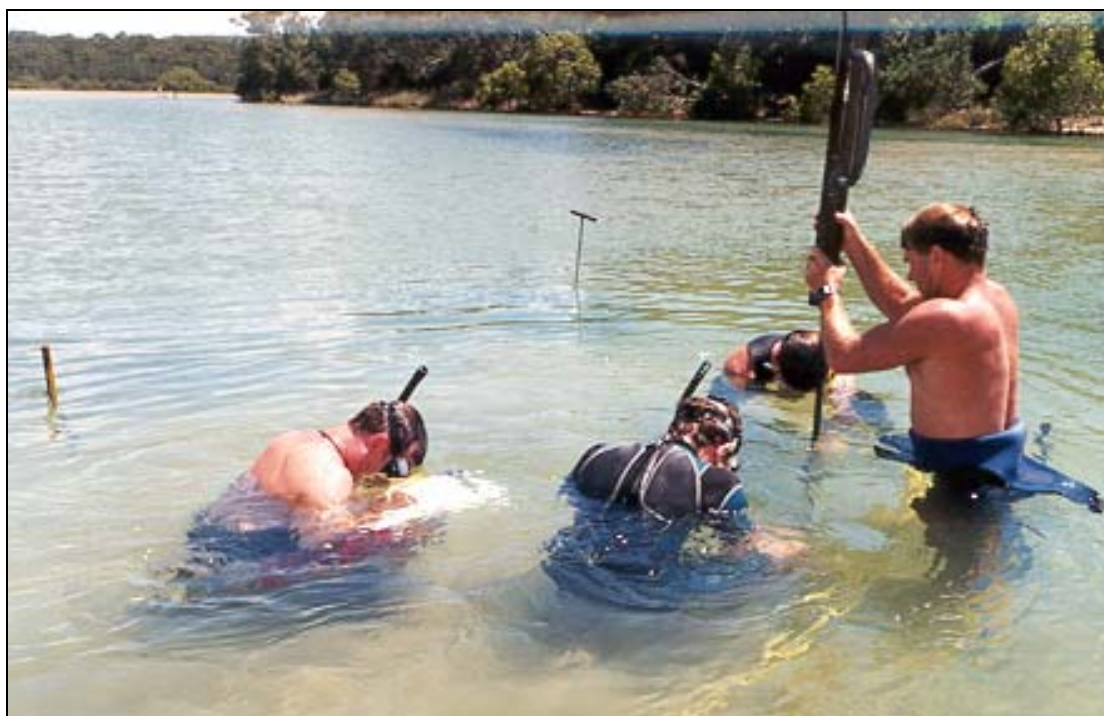
*Figure 15: Recording the buried timber remains identified as part of the ketch, Lady of Lorn.
Photo: David Nutley.*

Divers, by limited hand fanning, could briefly expose the buried timbers until the tidal flow reburied them again. By these means however, several planks could be identified bound to transverse frames attached by wooden treenails. The method of construction was consistent with a comparatively small timber sailing vessel. The timbers were photographed and sketched, although the difficulty in maintaining any level of visibility constrained their recording.

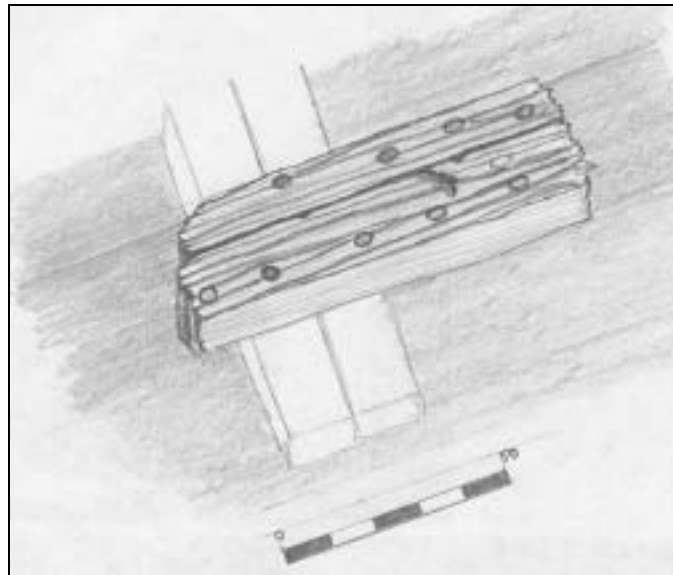
The timber samples were again analysed by the Timber Research Unit of the Queensland Department of Primary Industries. They were found to be an Australian hardwood, probably Spotted Gum (*Corymbia citriodora*). The timber, common to New South Wales and Queensland, is noted for its toughness (Johnson, 1979: 241). This identification lent support to the hull remains being identified as part of the *Lady of Lorn*, built in NSW. While this is the only section of hull reported at Moonee Creek, it is possible that other sections exist under the wide expanse of Moonee Beach.

The site can be confirmed as *Lady of Lorn*, particularly as this was the only vessel wrecked in the immediate vicinity. The historical records indicated that the ketch was thrown onto the beach and quickly broke up. It is likely that this section of hull later washed over the beach and into the creek during periods of extreme storm activity, or that it was perhaps carried to the creek during probable salvage operations by local residents.

Figure 16: Drawing of the buried timber remains located in Moonee Creek. The bottom timber are representative only of buried portions that were not visible due to sand movement. Tim Smith.

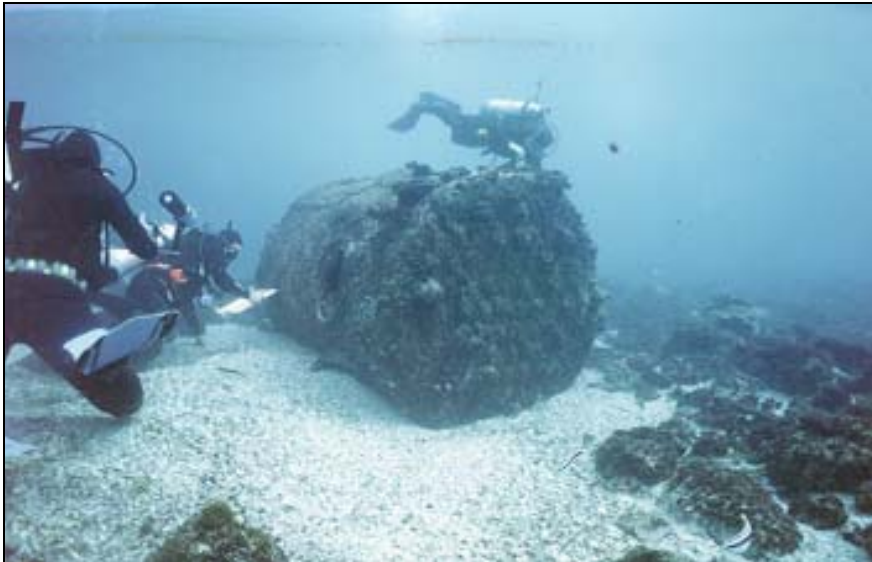
*Figure 17: The boiler located at South Solitary Island.
Photo: David Nutley.*

The boiler was found lying upside down on a sand and shell substrate in 16 metres of water. Identified as a standard scotch boiler, it had a single furnace at one end directed towards the island in which sat a large turtle. The boiler measured 2.24 metres in length and 1.60 metres (~ 5 feet 3 inches) in diameter and was resting on what appeared to be the remains of the uptake of the steam dome. The boiler equates with a five-foot example in the old measurements.

The boiler's shell plating was damaged on its underside (visible as the present "top" surface), exposing the furnace flue inside. This damage was possibly caused by abrasion when the boiler was once sitting upright on the seafloor.

It is possible that the boiler is the original one fitted into the *Wyong* and built in the United Kingdom. Boilers however had a limited life span and were frequently replaced during the life of a working vessel. It is possible that the present boiler is a replacement made a-new during the major engine refit recorded in 1897. Additional detailed recordings of the boiler are required.

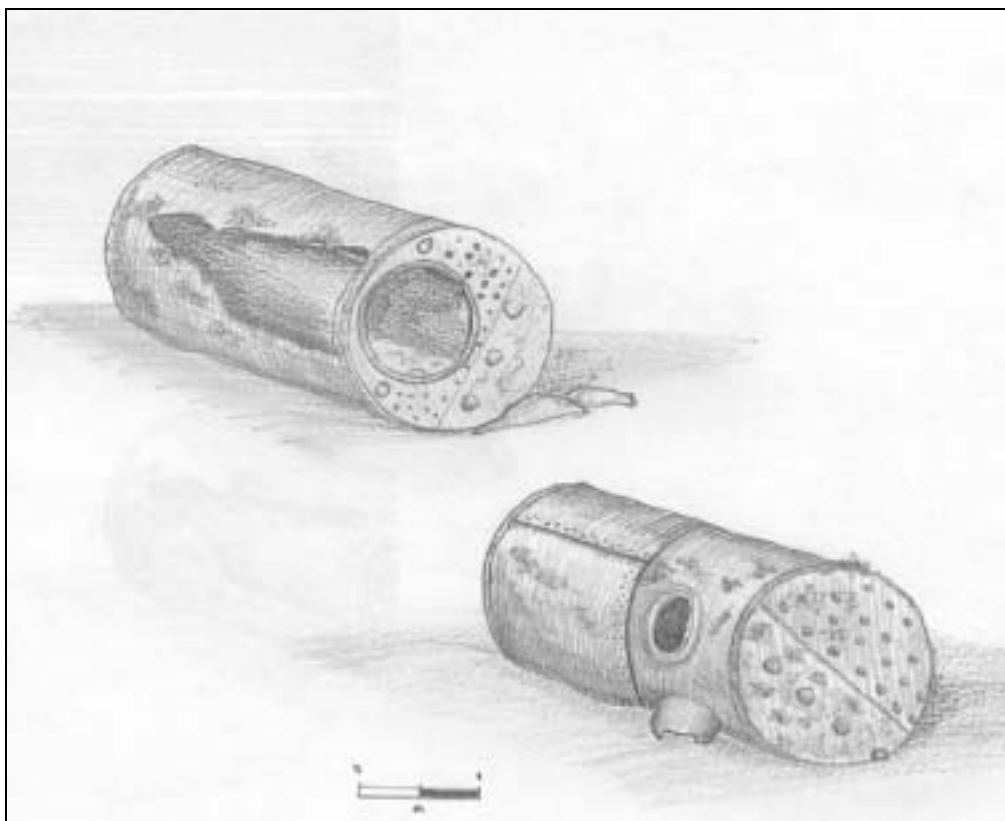
*Figure 18: Drawing of the boiler located in sixteen metres of water.
Tim Smith.*
