Macquarie Watchtower

La Perouse Headland Conservation Management Plan

prepared by Jill Sheppard Heritage Consultants, 2008/2009

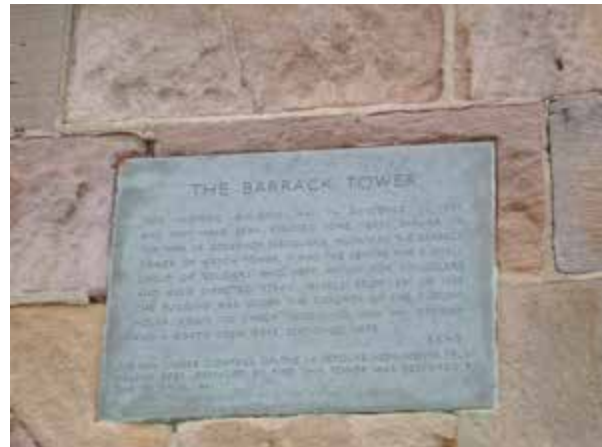
Fig. 3 Left: The tower and the present setting. (Photograph by Sheppard, October 2006)

The tower is essentially sound and has low levels of risk associated with fire and storm damage. There are no obvious visitor safety issues in the vicinity of the tower. Abrasive weathering is impacting the mortar and some stones are showing signs of severe weathering, but are not considered an immediate structural or visitor safety risk.

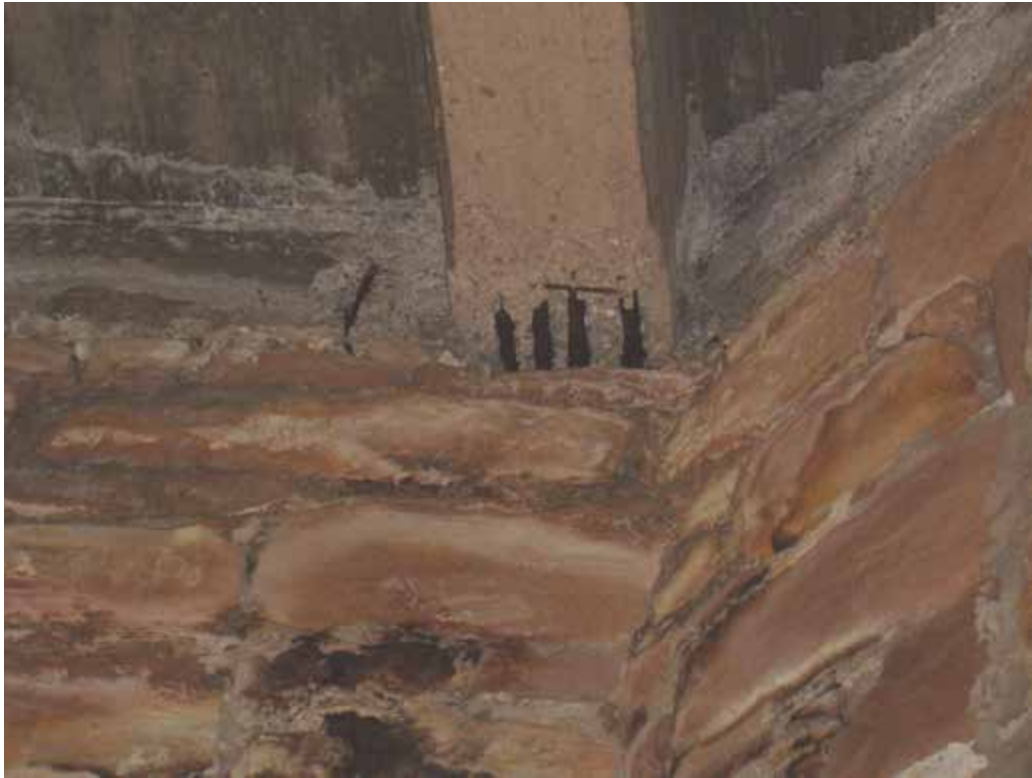
Fig. 4 The west end of the hanging concrete beam under concrete slab roof, showing the exposed and rusting reinforcing rods. (Photograph by Sheppard, October 2006)

- Clean rust off rusting reinforcing rods of the concrete roof structure. Coat with anti-rust and re-render.
- Clear all the grass from the paving around the base of the building and re-mortar gaps where necessary. Ensure that the paving slopes away from the building to carry water away from the walls.
- Infill the well with crushed granite or similar to reduce visitor safety risk and to assist with maintenance

- Check sacrificial plaster condition and continue recommended course of works currently being undertaken.
- Inspect condition of concrete roofing and check reinforcement rods for rust. Treat as required.

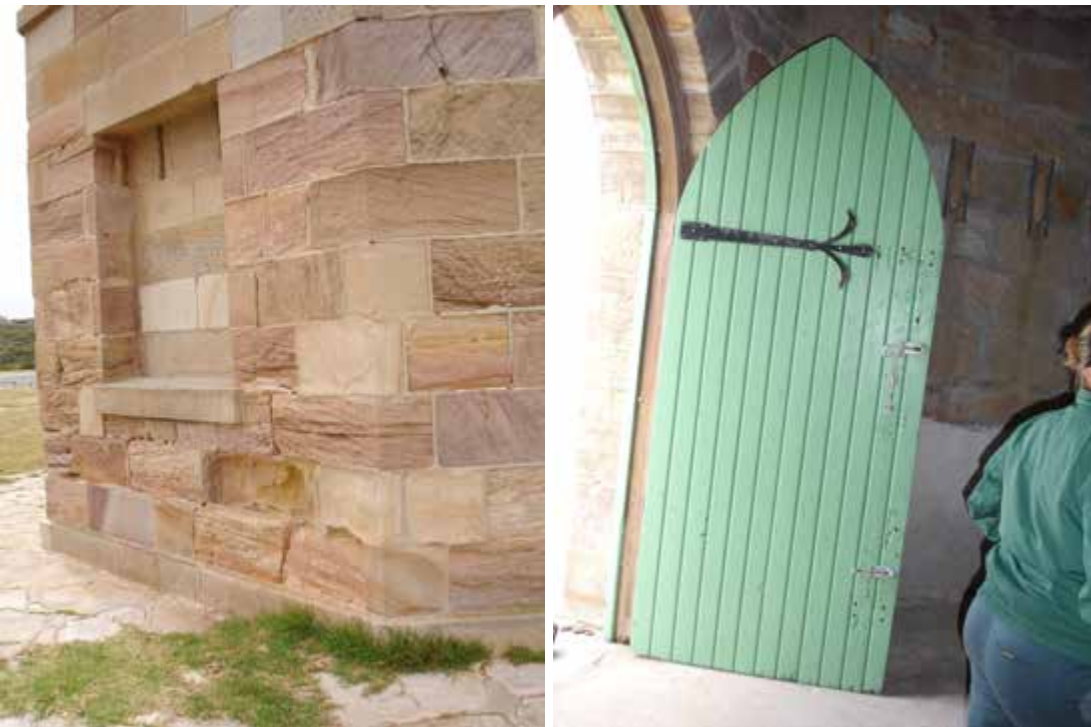
Fig. 5 (left) The degraded surfaces of the west facet of the octagon showing the abraded sandstone and the areas of missing and weathered mortar. Note also the concrete sills and infilled window openings. (Photograph by Sheppard, October 2006)

- Replace badly eroded sandstone blocks.
- Re-mortar areas of failed mortar around the sandstone blocks – with expert advice on the constituents of the mortar. (See Figure 3 p4/11)
- Replace the existing copper roof spouts (spitters) with longer spouts that direct stormwater further from the building.
- Assess the impact of the crazy paving on the stone condition and consider replacing with an alternative such as crushed granite.
