Hazardous Building Materials Report

Revised Exhibition Draft
The Gap, Watsons Bay

Project 85743.01
July 2017

Pre-demolition Hazardous Building Materials Report Various Locations – The Gap National Park

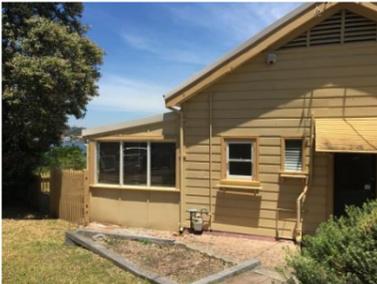
Walls to west extension, internal and external	18	Chrysotile, Amosite, and Crocidolite Asbestos detected	Non Friable	Flat Asbestos Cement Sheet	A1	Remove prior to any demolition or refurbishment works that may disturb the installation. Should the material not be affected by the works, leave <i>in-situ</i> , affix asbestos warning labels, manage and re-inspect.

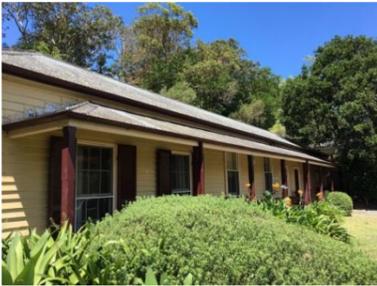
Rear bathroom walls	9	No Asbestos detected Organic Fibres Detected	Non Friable	Flat Asbestos Cement Sheet	-	-	-
Internal walls to original building	11	Chrysotile, Amosite, and Crocidolite Asbestos detected	Non Friable	Flat Asbestos Cement Sheet	A1	Remove prior to any demolition or refurbishment works that may disturb the installation. Should the material not be affected by the works, leave <i>in-situ</i> , affix asbestos warning labels, manage and re-inspect.

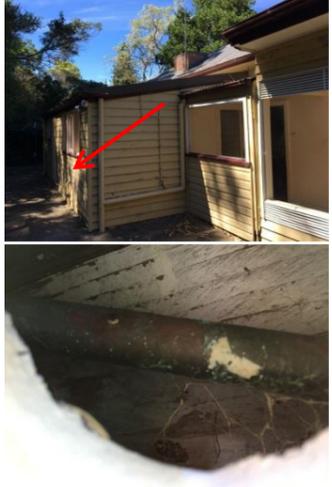
Front verandah	VO	Presume asbestos	Non Friable	Electrical backing board	A1	Remove prior to any demolition or refurbishment works that may disturb the installation. Should the material not be affected by the works, leave <i>in-situ</i> , affix asbestos warning labels, manage and re-inspect.

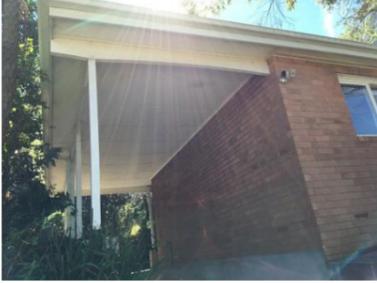
Eaves and soffit of car port	22	Chrysotile, Amosite, and Crocidolite Asbestos detected	Non Friable	Flat Asbestos Cement Sheet	A1	Remove prior to any demolition or refurbishment works that may disturb the installation. Should the material not be affected by the works, leave <i>in-situ</i> , affix asbestos warning labels, manage and re-inspect.

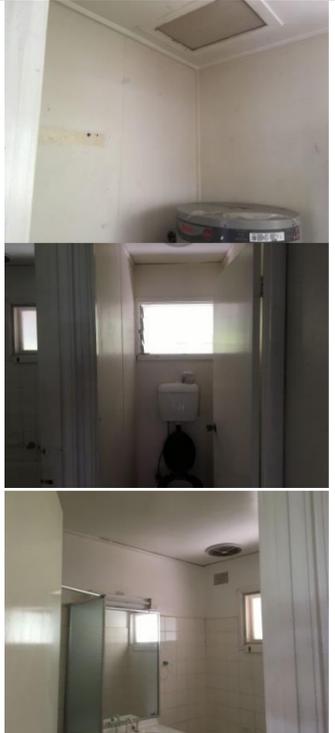
Laundry	23	No Asbestos detected Organic Fibres Detected	Non Friable	Vinyl Floor Tile	-	-	-
Laundry, bathroom, and toilet wall sheeting	24	Chrysotile, Amosite, and Crocidolite Asbestos detected	Non Friable	Flat Asbestos Cement Sheet	-	Remove prior to any demolition or refurbishment works that may disturb the installation. Should the material not be affected by the works, leave <i>in-situ</i> , affix asbestos warning labels, manage and re-inspect.

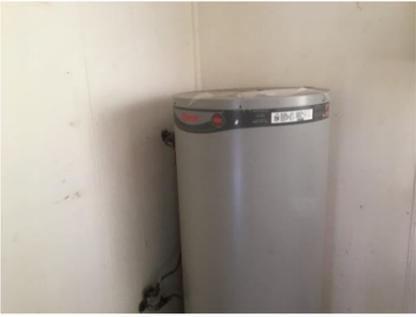
Location and description	Sample ID	Friability	Recommendation	Photo Identification
30 Cliff Street – Laundry Medium Hot water unit	VO	Non-friable	Remove prior to major demolition works

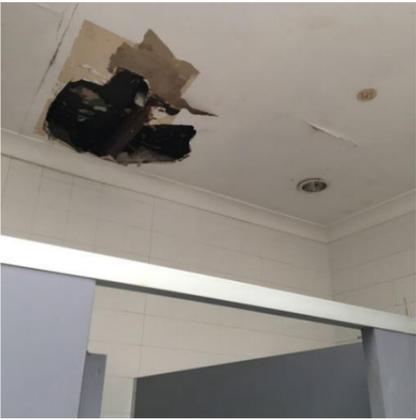
The Armoury – Roof Cavity SMF insulation	VO	Friable	Remove prior to major demolition works

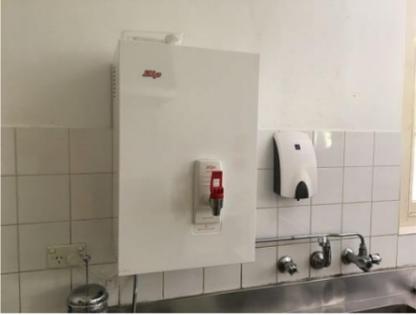
The Armoury – instant hot water unit (Zip Hydroboil)	VO	Non-friable	Remove prior to major demolition works

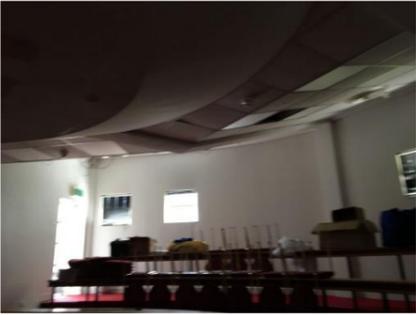
The Officers' Mess – AC ductwork	VO	Non-friable	Remove prior to major demolition works

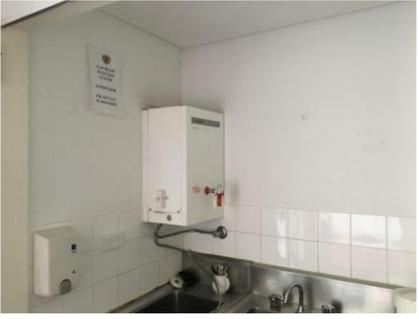
Location and description	Sample ID	Friability	Recommendation	Photo Identification
The Officers' Mess – instant hot water unit (Zip Hydroboil)	VO	Non-friable	Remove prior to major demolition works
