Bare Island Fortress

9

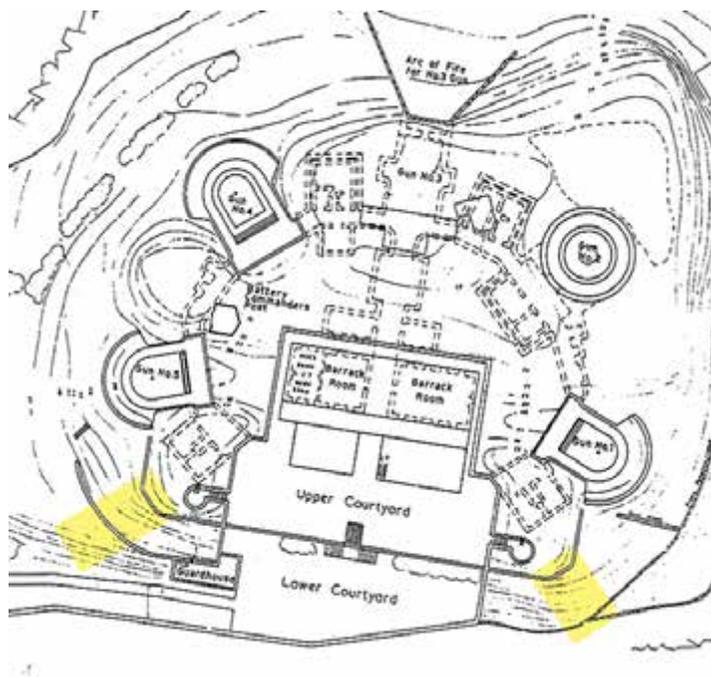
Figure 5. Highlighted areas indicate areas where engineered stabilisation work was undertaken in the early 1990s. (Source: NPWS)

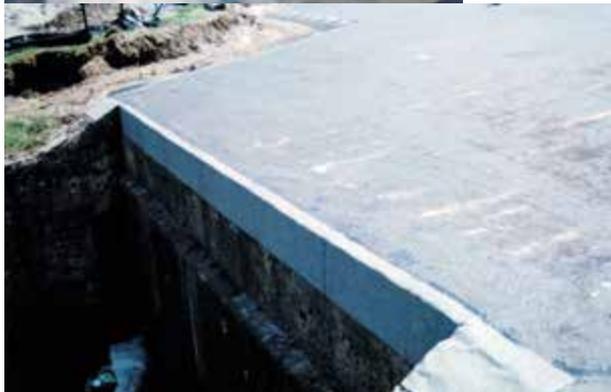
Figure 19. View looking south west indicating capping of waterproof membrane at the embrasure wall at the arc-of-fire. As can be seen no drainage method has been included to reduce water runoff from the waterproofed area onto the face of the iron embrasure wall.

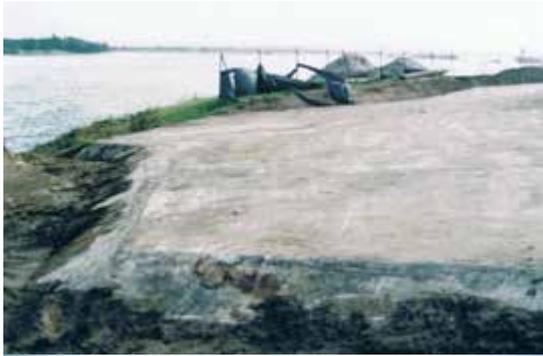
Figure 21. Uncovered concrete catchment area/roof over the casemate as seen before works began.

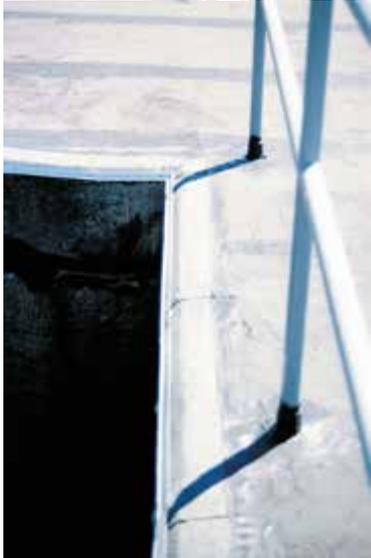
Figure 32. Detail of the new waterproofing membrane at the casemate opening. A metal edging piece was fitted to fix down the edge of the waterproofing. No gutter was installed to collect or address the run-off of water from the catchment area into the casemate below.
