# Darling Baaka River Health Project 2023 to 2025

## Chapter 3 Geomorphic condition

Department of Climate Change,  
Energy, the Environment and Water

EH 2025/0168 September 2025

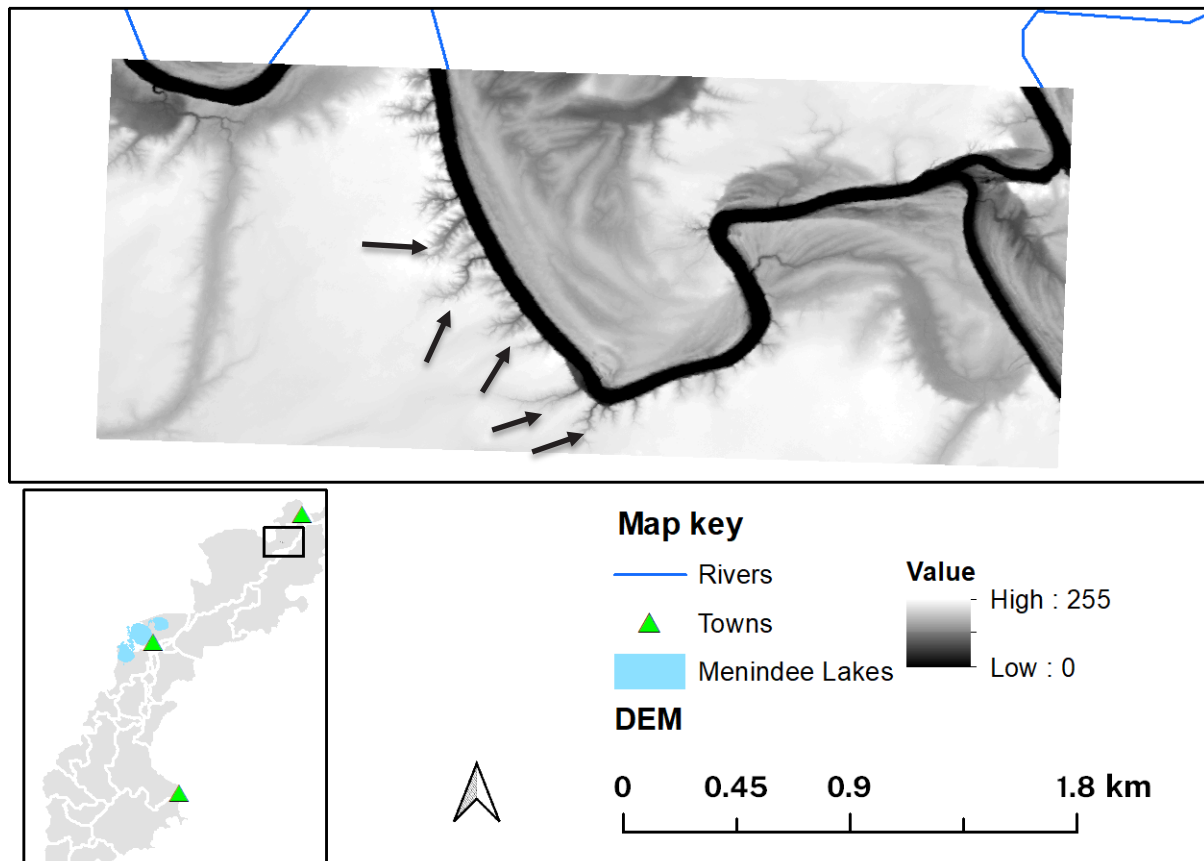
the LiDAR gully mapping for gullies deeper than ~1 m (100% reliably identified in LiDAR). Gullies identified in the field that were smaller than this were not reliably mapped using the 1-m resolution LiDAR DEM (Figure 2). Mapping of alluvial gullies along the mainstem of the lower Darling Baaka River using 1-m LiDAR digital elevation data highlighted that gullies are significantly more prevalent between Wilcannia and Menindee than reaches further downstream.

**Figure 2** Example of alluvial gullies in the 1-m light detection and ranging digital elevation model (DEM) downstream of Wilcannia. Arrows indicate the location of some of the larger gullies, though note that not all gullies have been marked by an arrow

In the RCI subcatchments downstream of Wilcannia on the Darling Baaka River to just downstream of Weir 32, alluvial gully densities range from ~3.2 to 7 gullies/km of river. The downstream reaches of the Darling Baaka River have substantially lower alluvial gully densities ranging from ~0.8 to 1.5 gullies/km river length (Table 5).

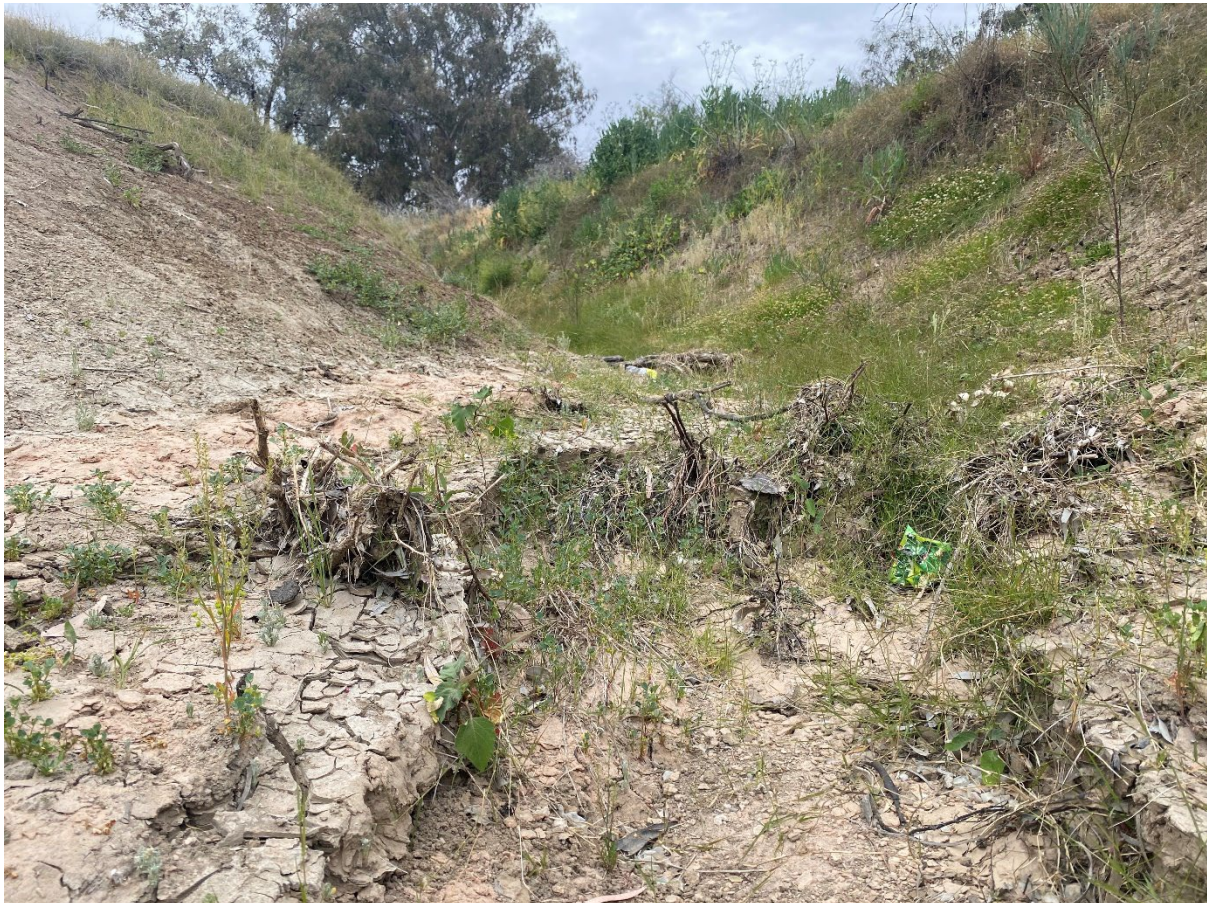
There is significant variation between different types of gullies and their potential impact on river functioning. Gullies formed in the black clay floodplains are generally associated with the waning stages of flooding and return flows to the river. Whereas gullies that extend from higher elevated red, sandy soil are caused by relatively high energy runoff during localised storms (Figure 3).

Field observations on the lower Darling Baaka River highlighted numerous gully formations that extended into coarser grained aeolian red soil, which can result in the localised inputs of fine-medium grained sand into the river. These coarser sediment

inputs tend to be deposited in small fans or on benches. Erosion of gullies during the waning stages of floods may also be associated with the discharge of 'black water' to the main river as overland flows with high organic matter return to the channel. Gullies in red soil tend to transport coarser sediment to the river but will not always be associated with widescale riverine flooding. Further work on the lower Darling Baaka is required to better characterise the drivers of gully formation, their implications for ecological processes and the amount of excess sediment delivered to the river by active gully enlargement in the lower Darling Baaka.

**Figure 3** Knickpoint at the base of an alluvial gully in the bank of the Darling Baaka River near Wilcannia. Photo credit: Zacc Larkin/DCCEEW 2024

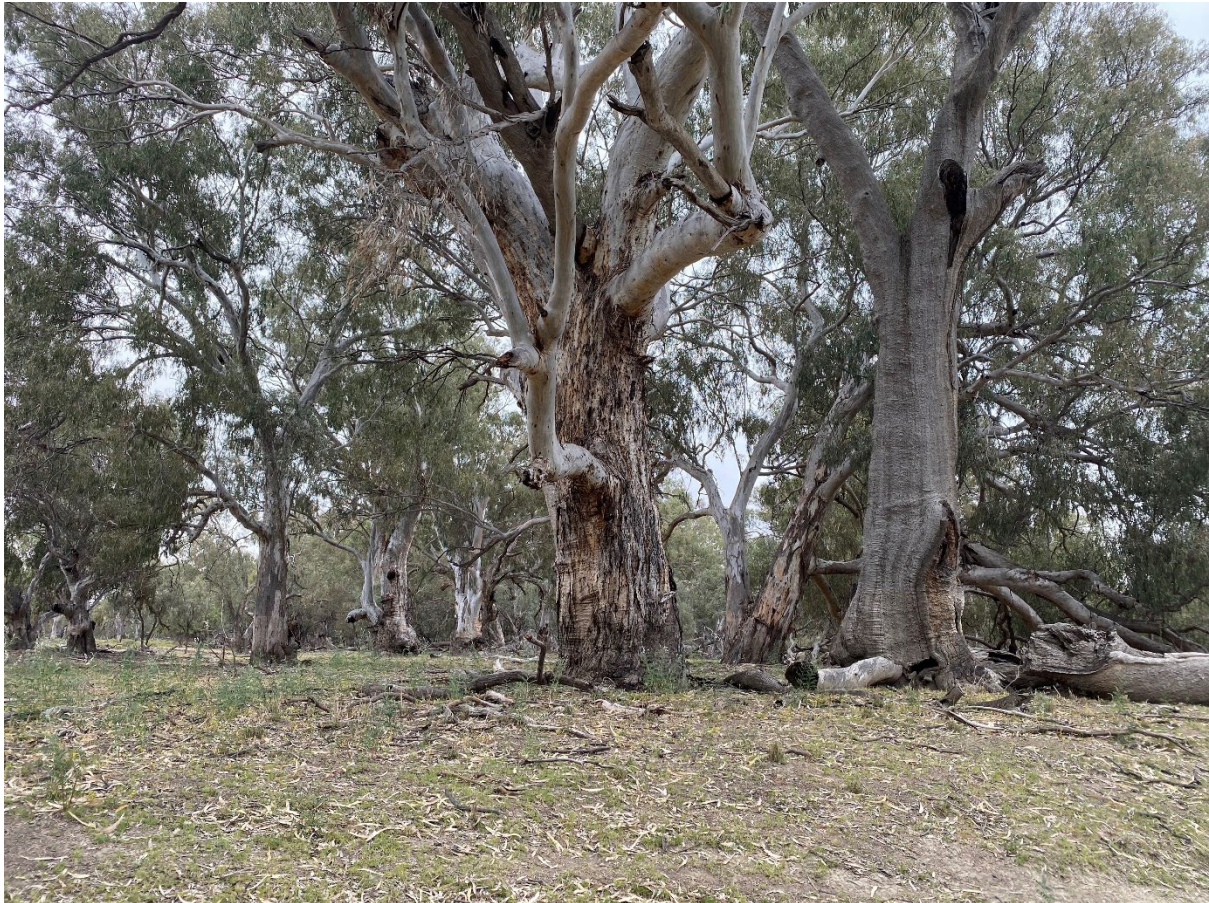
**Figure 4** Well-established riparian river red gums on the lower Darling Baaka River near Pooncarie. At this site there is no evidence of successful recruitment of saplings or juvenile river red gums. Photo credit: Zacc Larkin/DCCEEW 2024

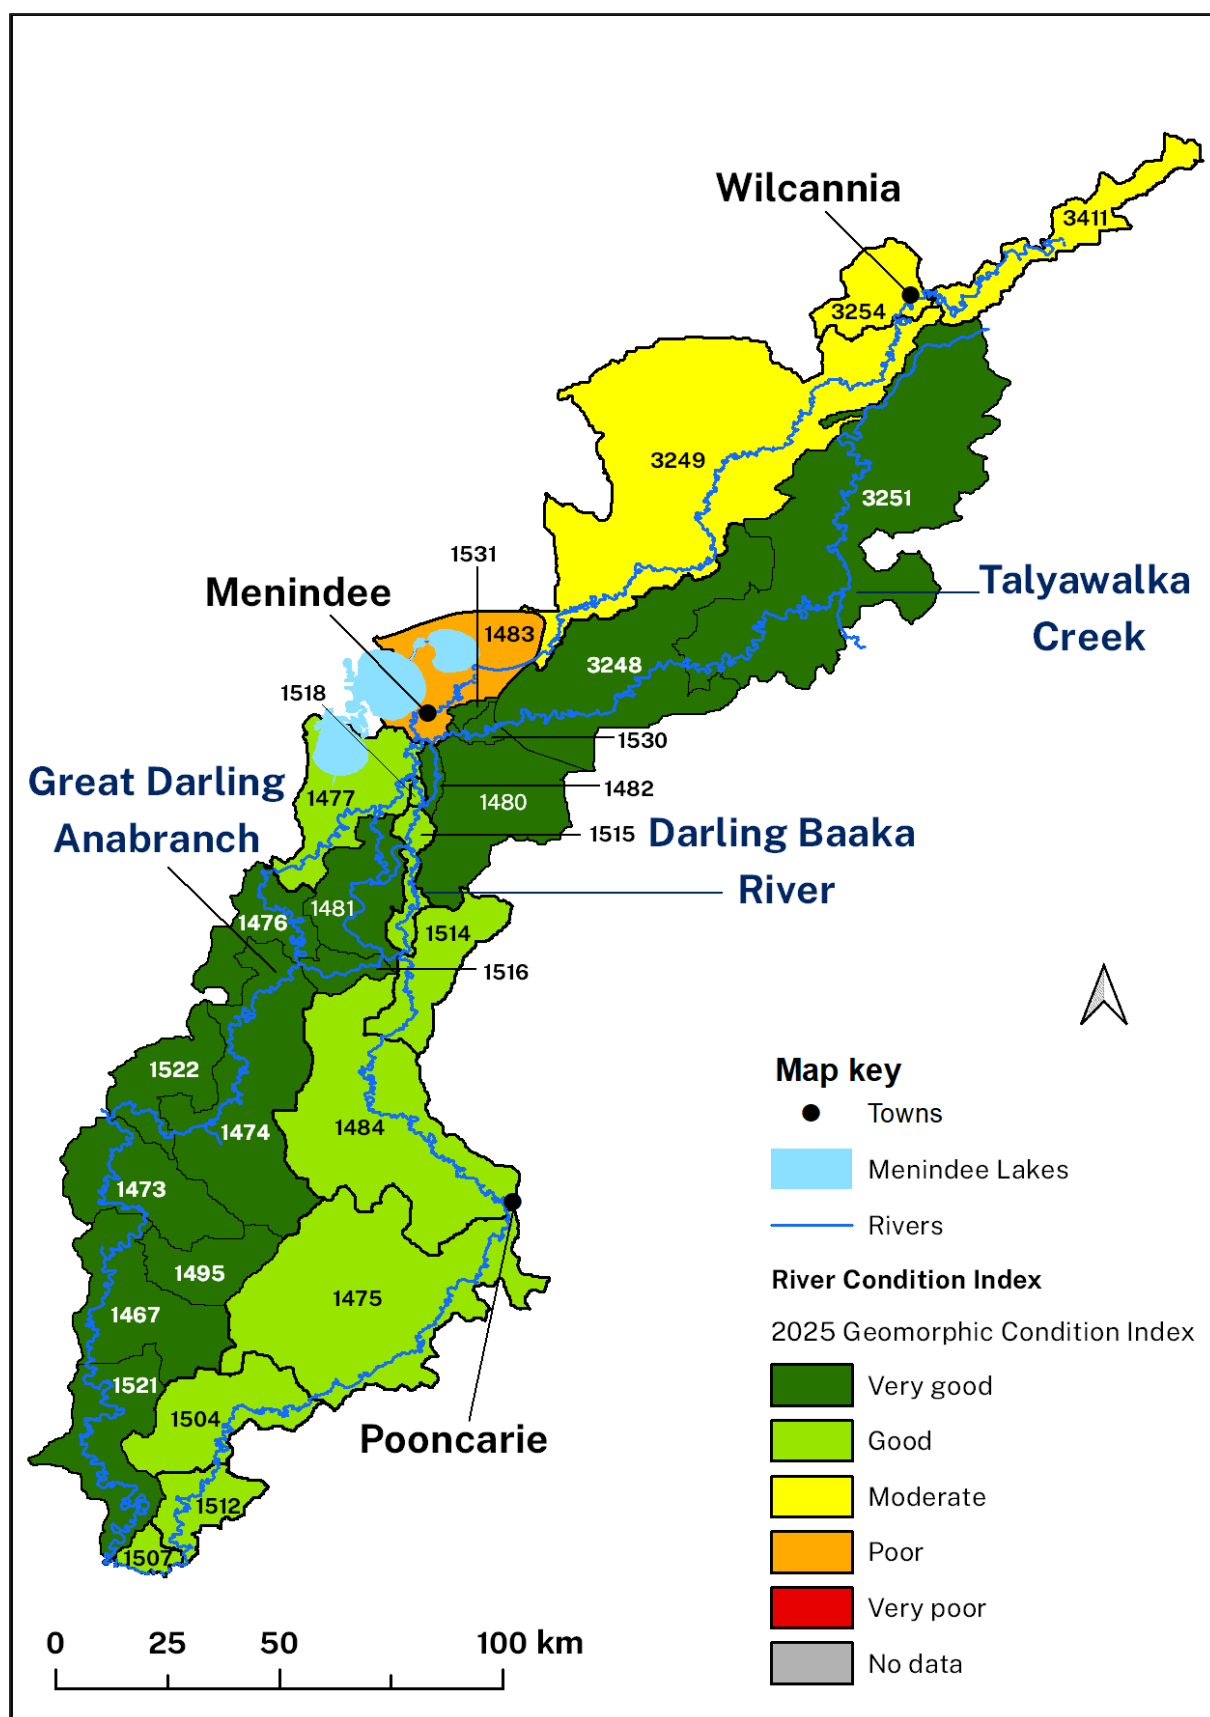
Lake Wetherell (1483) has the lowest overall geomorphic condition grade of poor condition. The Lake Wetherell subcatchment incorporates sections of Lake Wetherell and the Menindee weir pool. This region has experienced significant geomorphic degradation, and many reaches have been classified as having moderate to poor recovery potential. These reaches have a very slow rate of recovery and may not recover without huge financial costs, bank stabilisation and removal of structures such as embankments and weirs. Geomorphic degradation will likely be ongoing in this subcatchment.

**Figure 7** The 2025 Geomorphic Condition Index grades for the lower Darling Baaka. Numbers refer to subcatchments (see Table 9)
