Centurion 1887: Maritime Archaeological Survey

***Centurion* 1869-1887** **Maritime Archaeological Survey**

June 2003 - February 2004

NSW Heritage Office

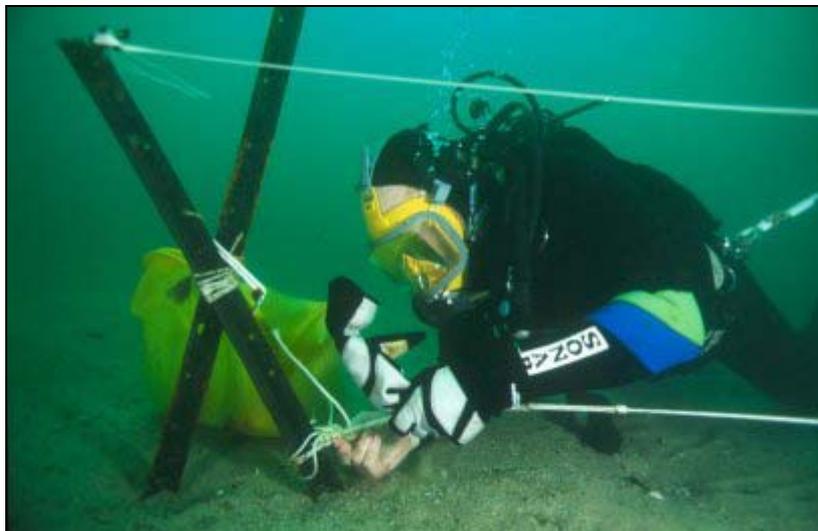
*Figure 1: David Nutley during installation of survey baseline.
Photograph by Mark Spencer.*

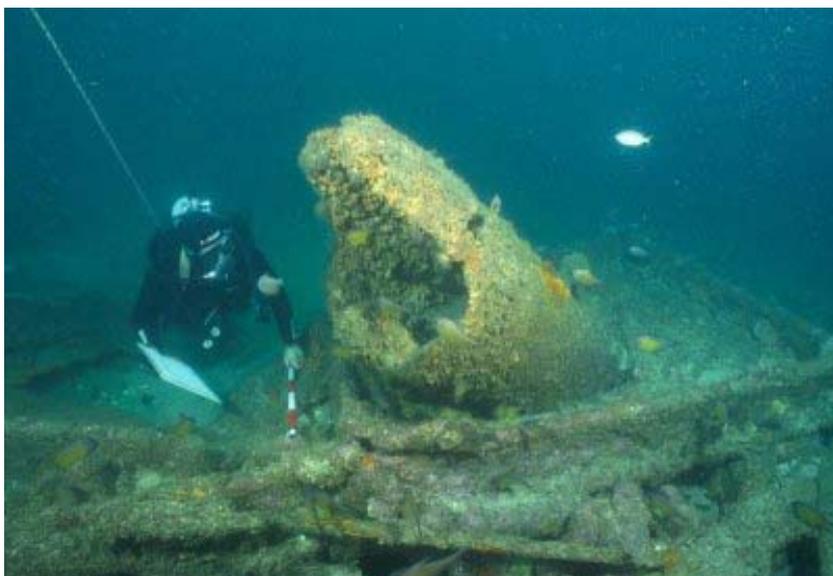
Figure 3: *Centurion*. Main mast section and marine life in 18 metres of water. Photograph by David Nutley.

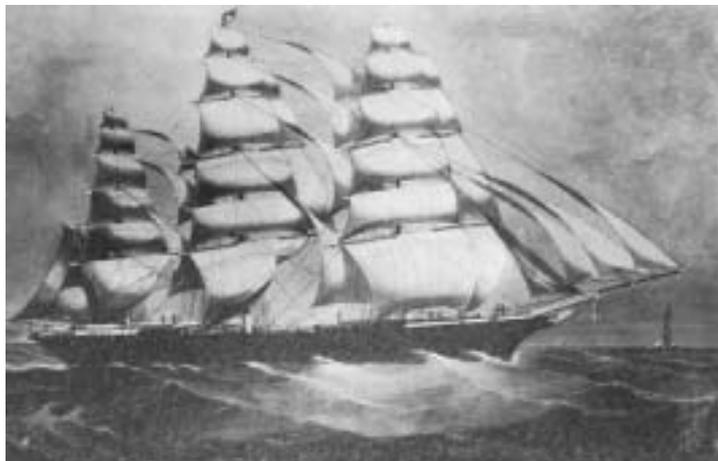
Figure 5: Oil painting of *Centurion*.
This view depicts the vessel in its earlier 'clipper' ship configuration.
Courtesy: Mr Andrew Donald, Aberdeen.

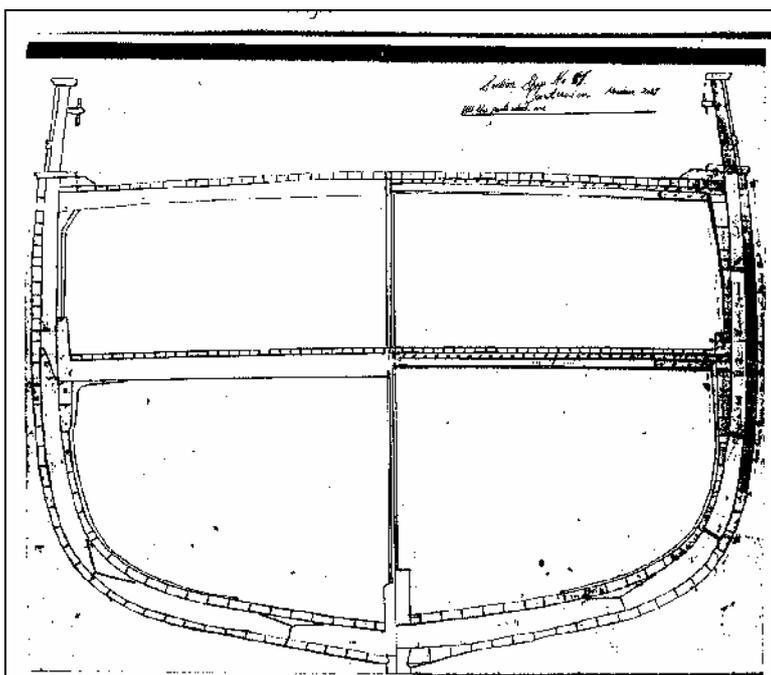
Figure 6: Original cross-sectional drawing of the *Centurion*. This view shows the main elements of hull layout, including two decks, timber hull frame and planking, but with addition of iron deck beams and supports. Original in possession of National Maritime Museum, Greenwich, United Kingdom. Copy obtained from Debbie Hardy.

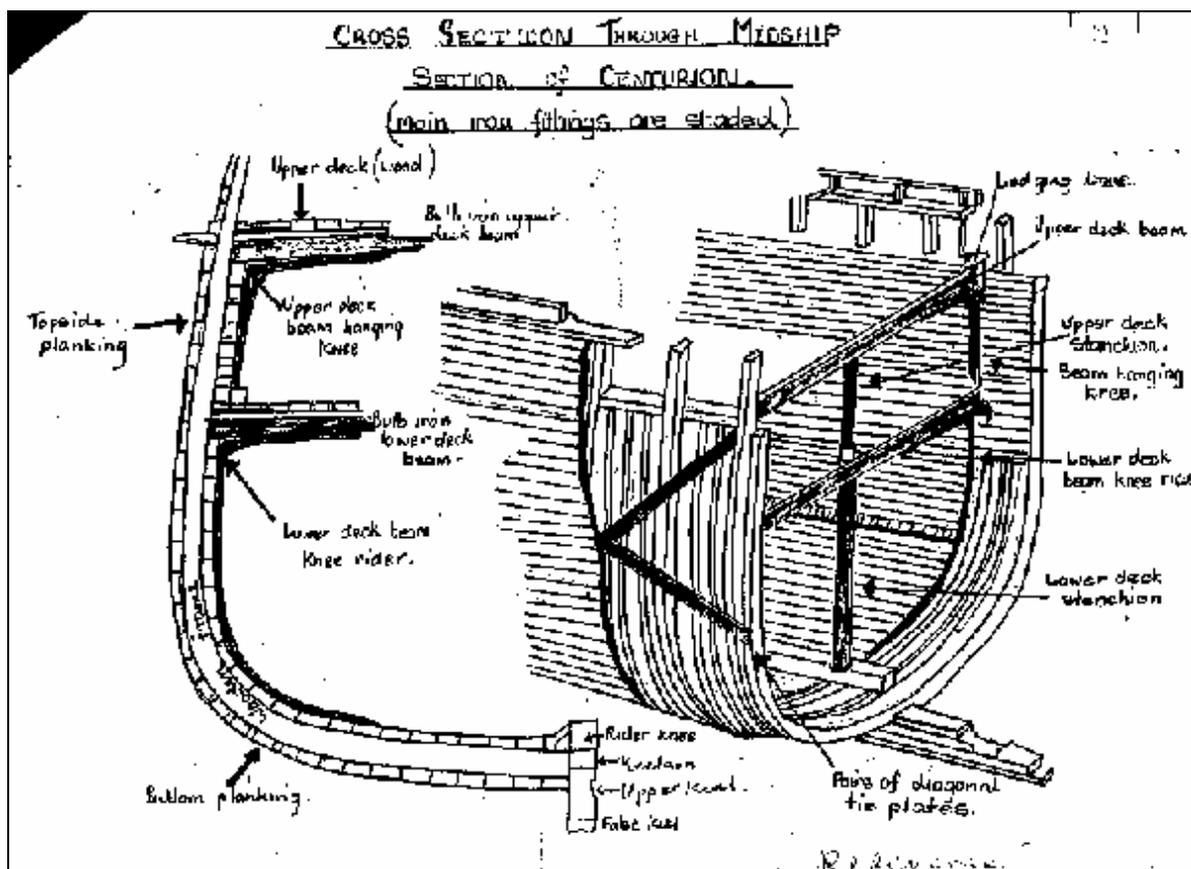
Figure 7: Useful interpretation of the main elements of *Centurion's* hull. This drawing, from the research notes of Debbie Hardy, is adapted from one of several published examples of hull cross-sections.

Centurion, it has been argued, is not a 'composite' vessel in that it did not possess iron frames within its hull (Hardy: 1990; 31; and Haug¹⁰). This is technically correct, while noting MacGregor's and Lubbock's contention that it did fit within this style. There were certainly variations in construction techniques at this time within a single yard, and across the major building centres in England, Scotland, and overseas. A yard could be producing standard timber sailing vessels alongside all iron vessels.

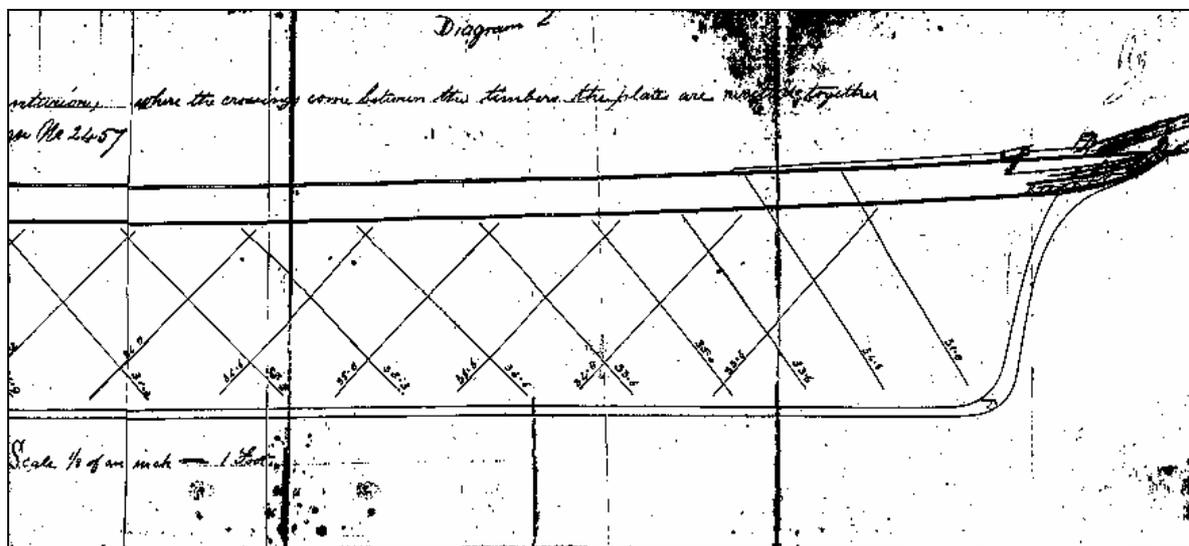
Figure 8: Copy of original survey diagram.

Further, its (still traditional) timber framed and planked hull was strengthened by the fitting of 24 pairs of diagonal iron cross straps along the vessels length – sometimes heralded as a marker of composite construction, as were iron hull frames (Haug argues contrary, noting that this strapping technique was employed in standard vessels as early as the 1840's).

This drawing formed an attachment to the official Lloyds Building Survey Report. This shows the location of the diagonal iron strapping along the hull and details of bowsprit configuration. Original in possession of National Maritime Museum, Greenwich, United Kingdom. Copy obtained from Debbie Hardy.

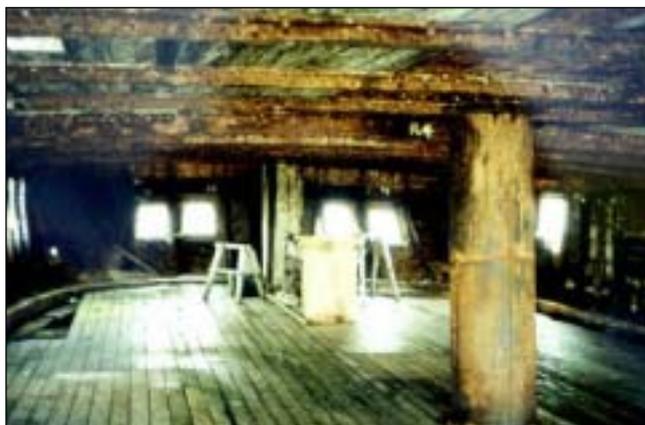
Figure 9: Internal view of the clipper *City of Adelaide*.

This is one of a few composite ships to survive in the world today. The iron deck beams, iron mast between decks and traditional timber decking and sides would have looked very similar to *Centurion*. Image source: http://www.sunderlandmaritimeheritage.com/ad_current.htm

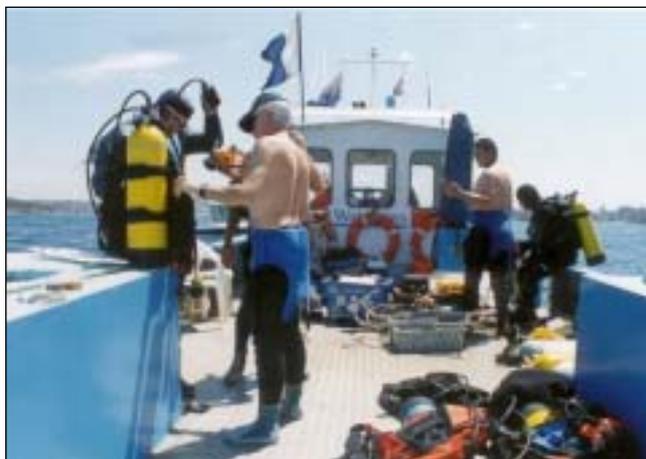
Figure 10: View of the survey team preparing for the archaeological inspection.

The work platform was provided by the NSW Waterways Authority for the duration of the survey operations. Photograph by Tim Smith.

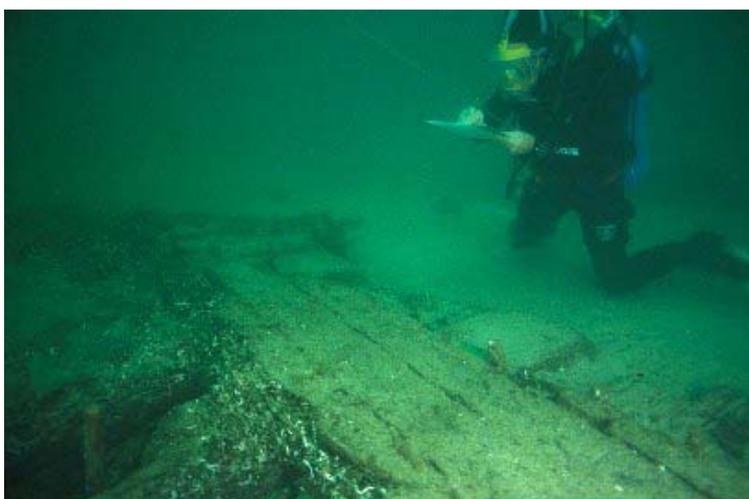
Towards the extreme 'northern' end of the wreck site is an isolated area of ship's timbers. These comprise a section of the hull measuring approximately 7x2 metres which retains portions of 9 strakes of planking. From the orientation of the underlying ~ 17 timber frames, this planking must be external 'outer hull' planking.

Figure 11: Maritime Archaeologist Tim Smith surveying the exposed section of timbers.

Sand movement can alternatively bury or exposed such features where sand cover is light-moderate. Note the degraded nature of timber exposed to marine organism attack and oxygenated water. Photograph by Mark Spencer.

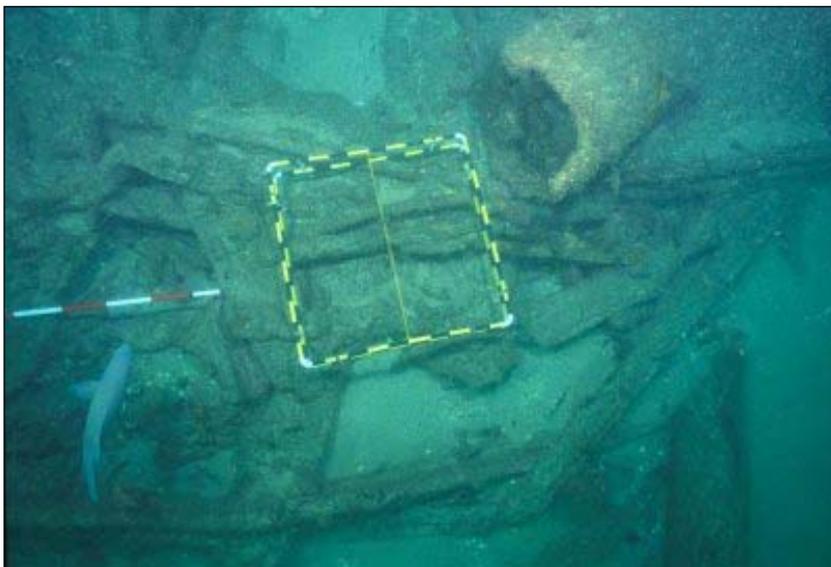
Figure 12: This image shows a portion of the *Centurion* wreck site. It includes the large iron mast section (top right). It shows the complexity of site materials that proved a survey challenge. Photograph by David Nutley.

Scattered through the site are large curved iron beams (probably deck beams). *Centurion* had 36 'hold' deck beams of iron measuring 32 feet in length (9.75 metres), and 38 'main' deck beams (total of 70 iron deck beams). Together with these were a similar number of bulb iron deck beam supports (stanchions) that supported the iron deck beams above the line of the keel (dimensions not recorded). The protruding tops of the iron (vertical) deck stanchions (supports) can be seen across the site (where still largely buried). These potentially mark the central line of the wreck site and are recorded in the site plan.

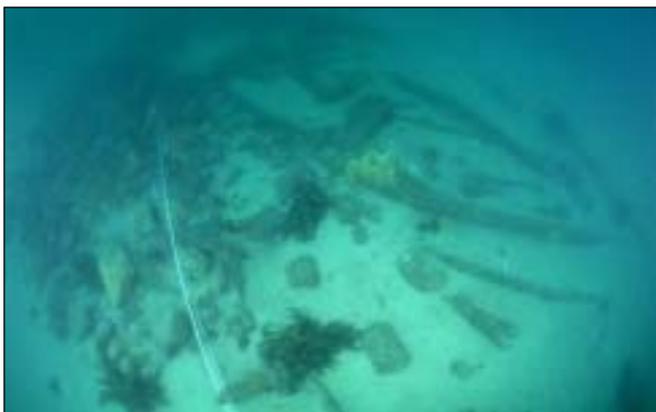
Figure 13: View of debris field. The view shows the concentration of long iron fastenings that comprise deck beam supports (stanchions) and hanging rider knees from the lower hull. Note concentrated grouping of hull ballast stone (top left). Photograph by Mark Spencer.

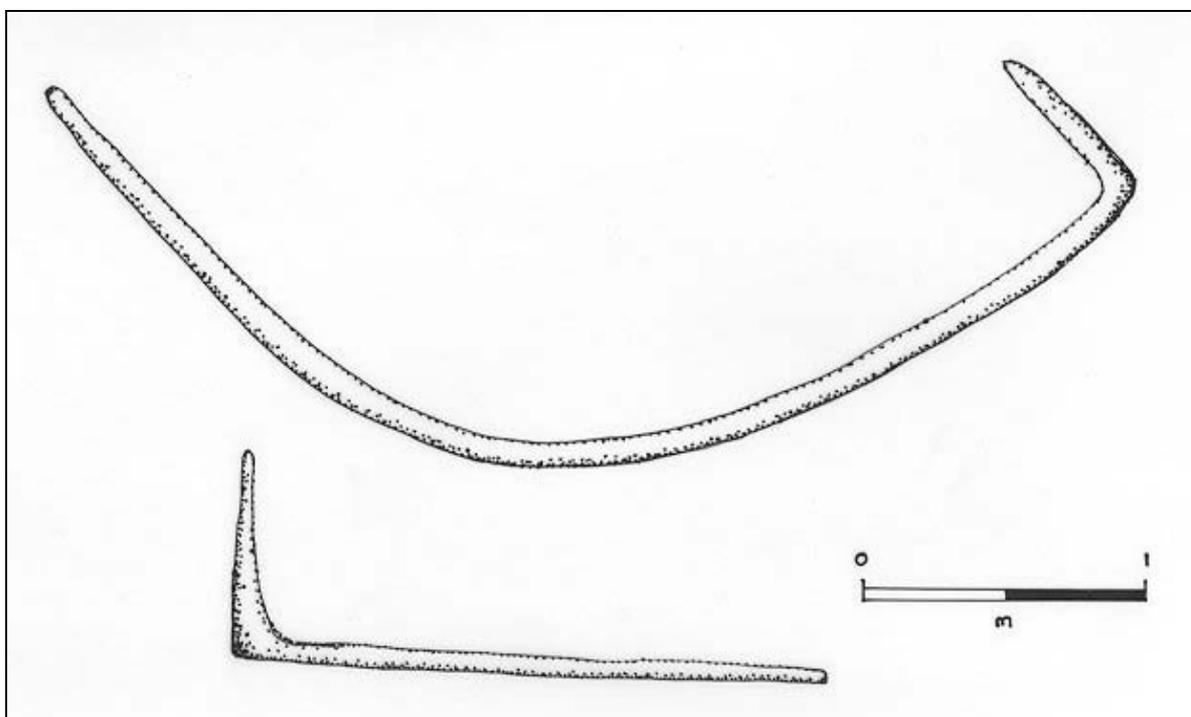
Figure 14: Measured drawings of representative hanging and rider knees. Drawing by Tim Smith.

A feature of the site is the many iron rider knees – solid fastenings used to secure the lower deck to the internal sides of the ship. They are marked by their long curved arms and short angled upper horizontal bar, with one example recorded at five metres in length. The Lloyds Survey Report identified the presence of some 32 pairs of rider knees.

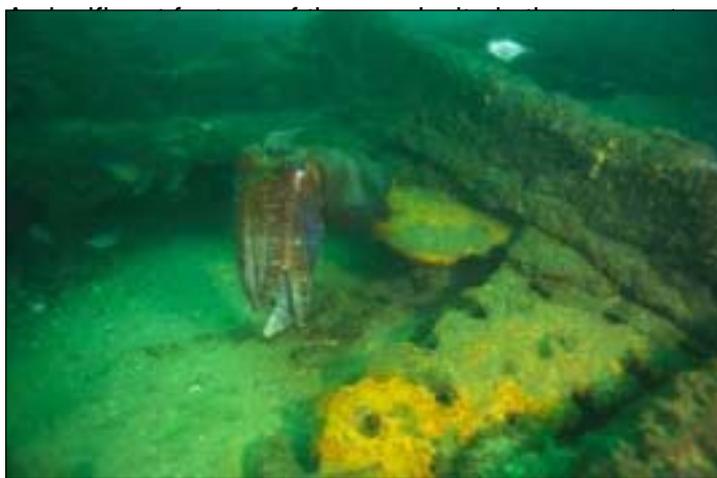
Figure 15: Dramatic image of a cuttlefish 'defending' the *Centurion* site. Note especially the iron deck beam (top right) and fragmentary iron plating (foreground) that shows evidence of recent damage by boat anchors dragging through the site. The tell tale 'rust' colouring is evidence of accelerated corrosion activity. Photograph by Mark Spencer.

Several sections of miscellaneous iron plating are evident across the site which might comprise the sets of diagonal iron tie plates (or 'straps'), fitted along the entire length of the hull at approximately 45°. At present it is not possible to identify these elements with certainty. Iron plating is noted around the section of mast which forms a central feature of the wreck site, but does not appear mentioned specifically in the vessel's Building Survey Report. Hence the other visible sections of iron plating may derive from other areas of the hull.

It was apparent during the survey work that some boat users have been damaging the *Centurion* Historic Shipwreck site by inappropriate mooring activities. This is evidenced by tell tale rust' colouring and wear to sections of the exposed iron plating. The damage could only have occurred by boat handlers dragging small anchors ('picks') through the site, whilst looking to anchor for either diving or fishing activities.

One opportunity to limit vessel damage would be to deploy a permanent mooring at the site. However this is associated with significant constraints that include the cost of permanent moorings and the need for ongoing maintenance, the wreck's location near to a major shipping route (Manly ferry run), and requirements for mooring approvals from appropriate regulatory authorities.

The Heritage Office recommends that boat users adhere to the 'wreck-safe' mooring protocols in its '*Anchoring on Shipwrecks Guideline Note*', available free via the Maritime Heritage Online web site <http://maritime.heritage.nsw.gov.au>. This system suggests that a small float with weight be placed over the wreck site after detection by sounder or GPS position. The mooring vessel then comes upwind and anchors out in barren sand off the wreck, and lies back on its mooring until adjacent to buoy, for diver descent to wreck.

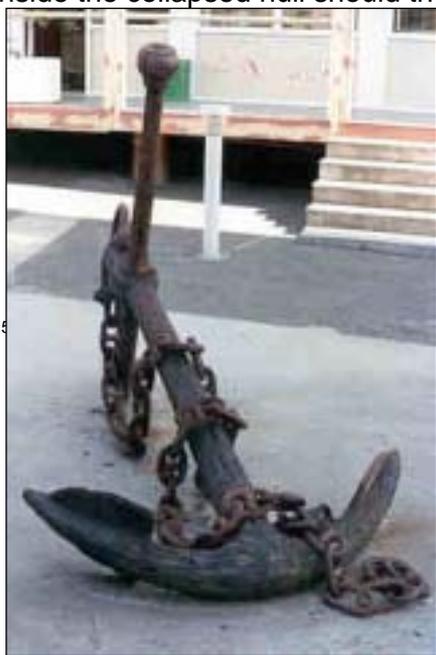
At least one of *Centurion's* main anchors was deployed between the Heads in a desperate attempt to stop the vessel crashing onto North Head. This failed, and it is likely that an anchor could still be located in the area¹⁵, or that further anchors may be found buried inside the collapsed hull should the sand cover naturally shift. However, it is equally likely that all anchors have been salvaged from the site between discovery and later protection under the NSW *Heritage Act* from 1977 (or illegally after that date).

Figure 16: An anchor recovered from the *Centurion* site. The anchor is undergoing conservation by NSW Waterways Authority before being housed at the new NSW Water Police base at Balmain. Photograph by Tim Smith.

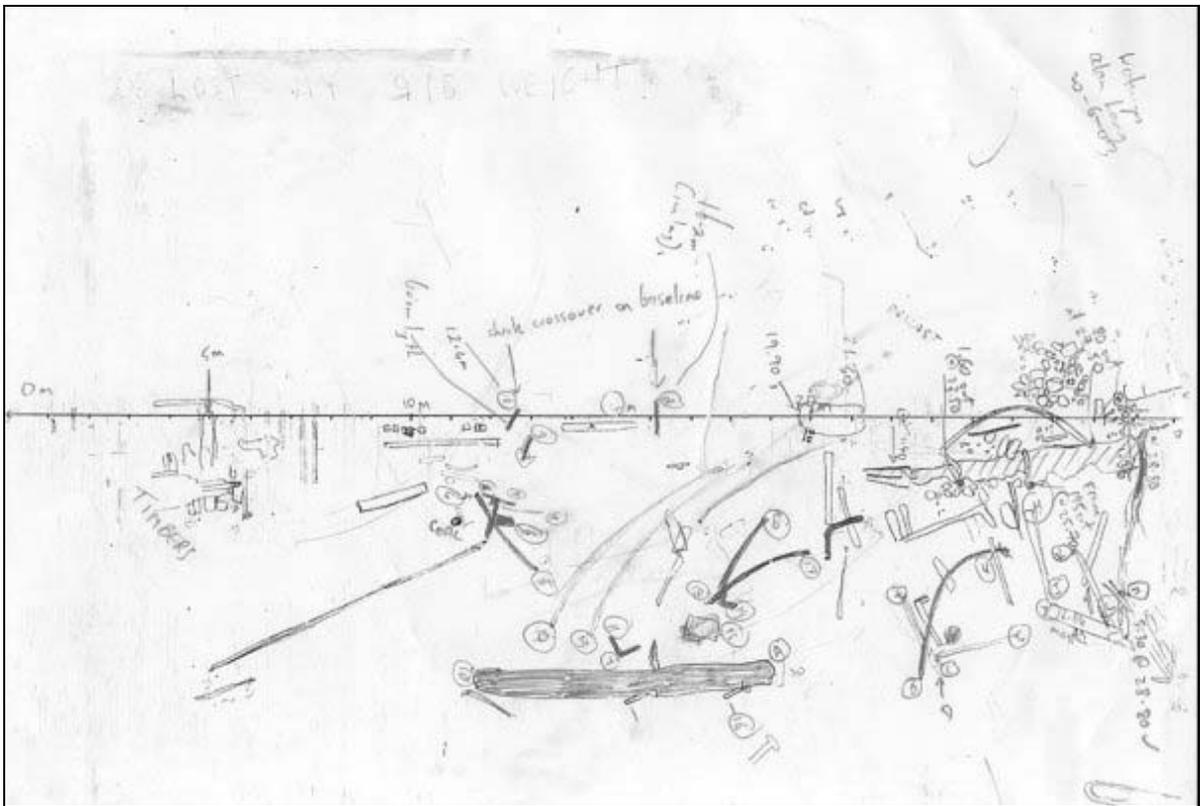
Figure 17: Working drawings compiled during the survey work.
© NSW Heritage Office 2004.

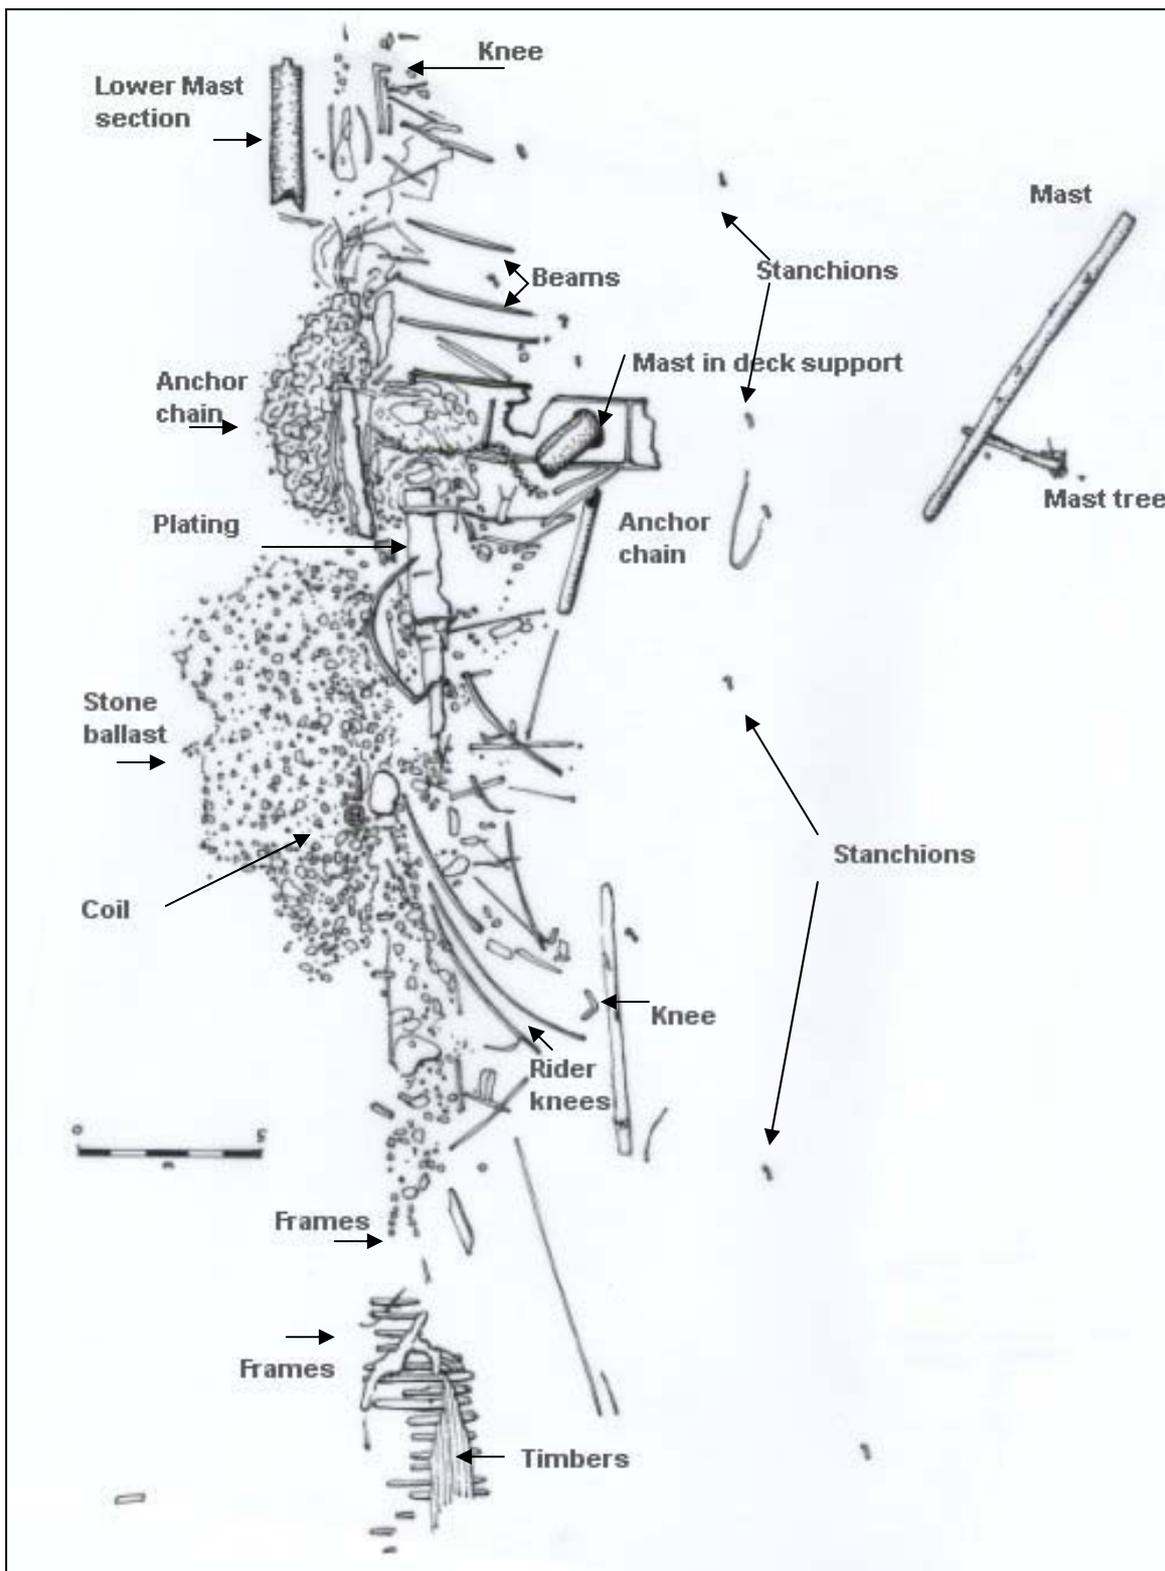
Figure 18: Final wreck site plan of observed features to February 2004.
© NSW Heritage Office 2004. May be reproduced with proper acknowledgement.
