Office of  
Environment  
& Heritage

## State of the Beaches 2014–2015

*Sydney Region New South Wales*

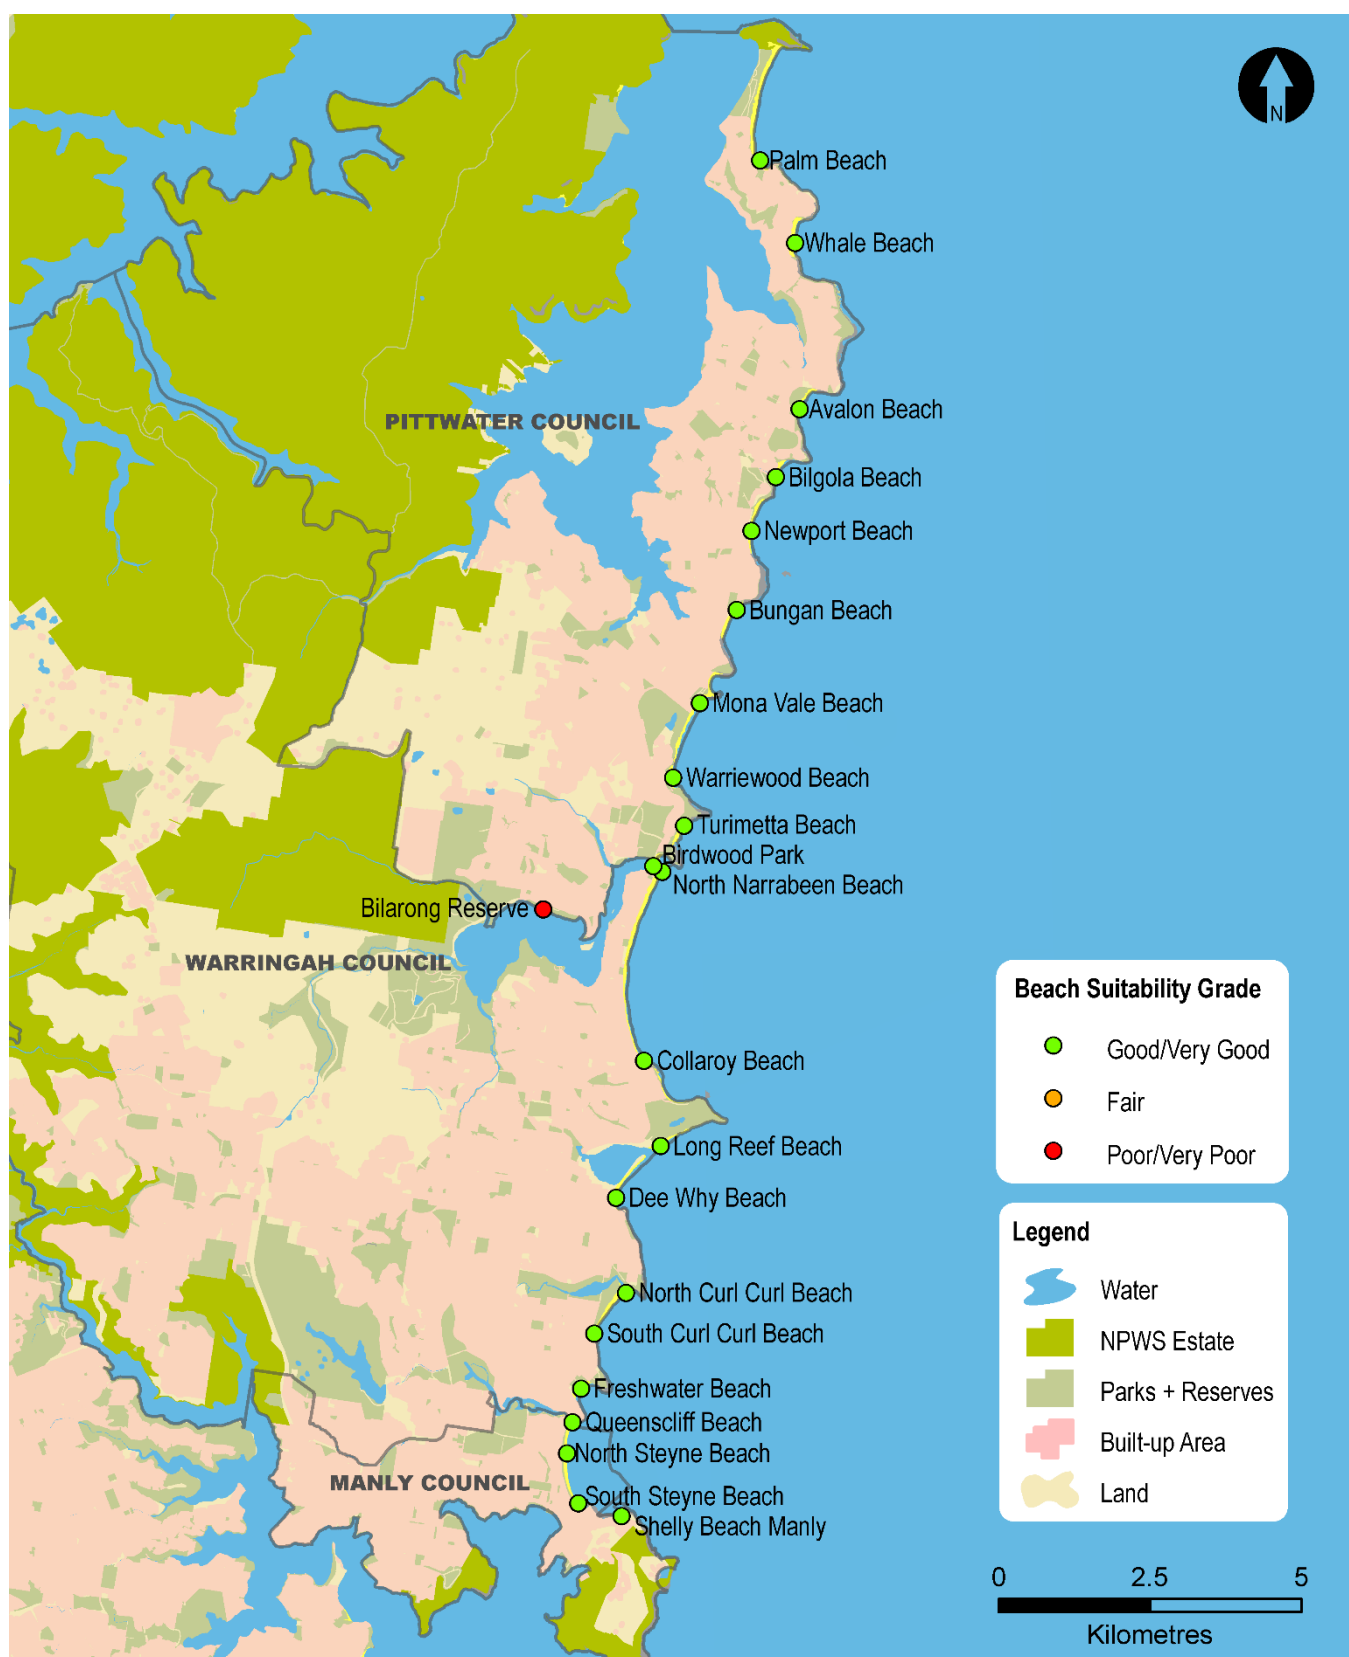
**Sampling sites and Beach Suitability Grades at Sydney's Northern Beaches**

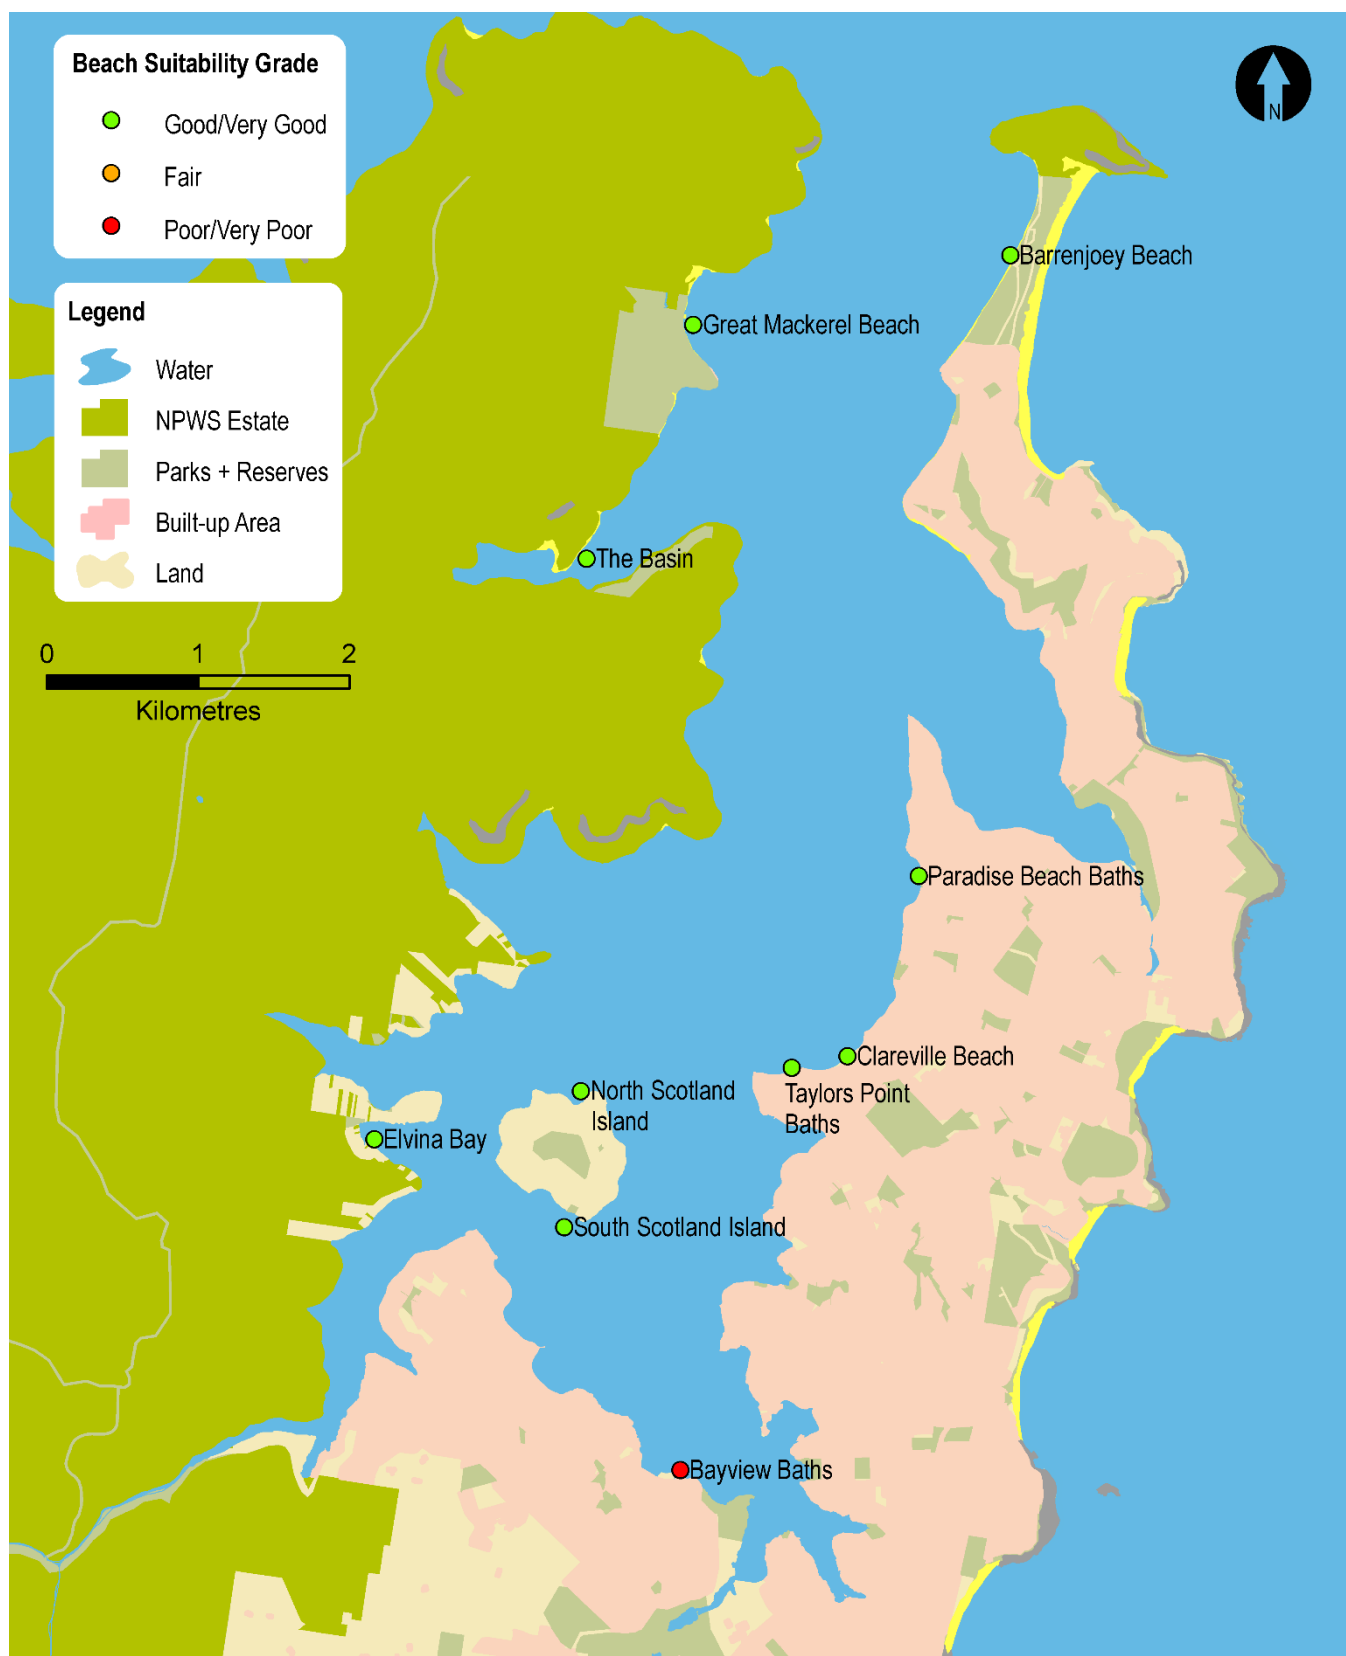
**Sampling sites and Beach Suitability Grades in Pittwater**

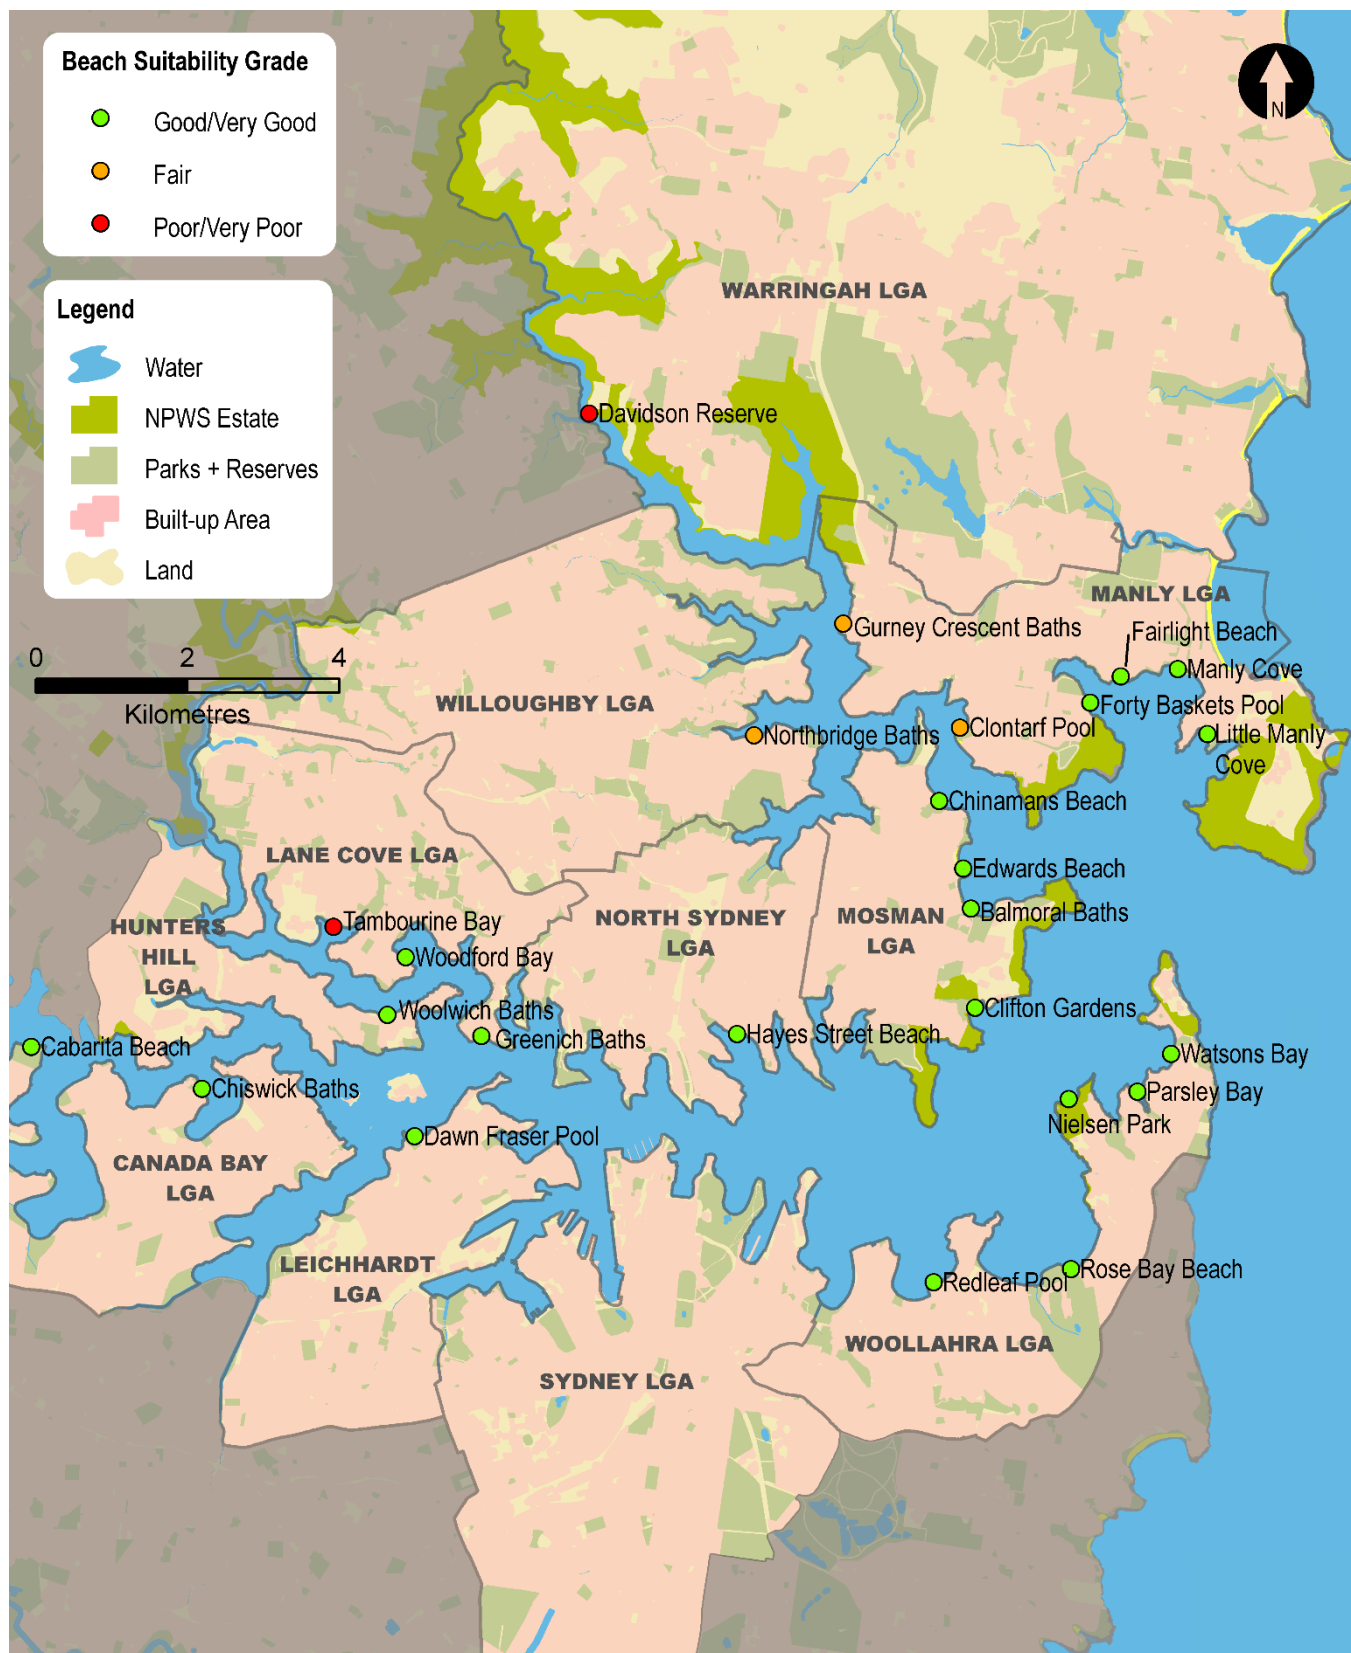
Sampling sites and Beach Suitability Grades in Sydney Harbour

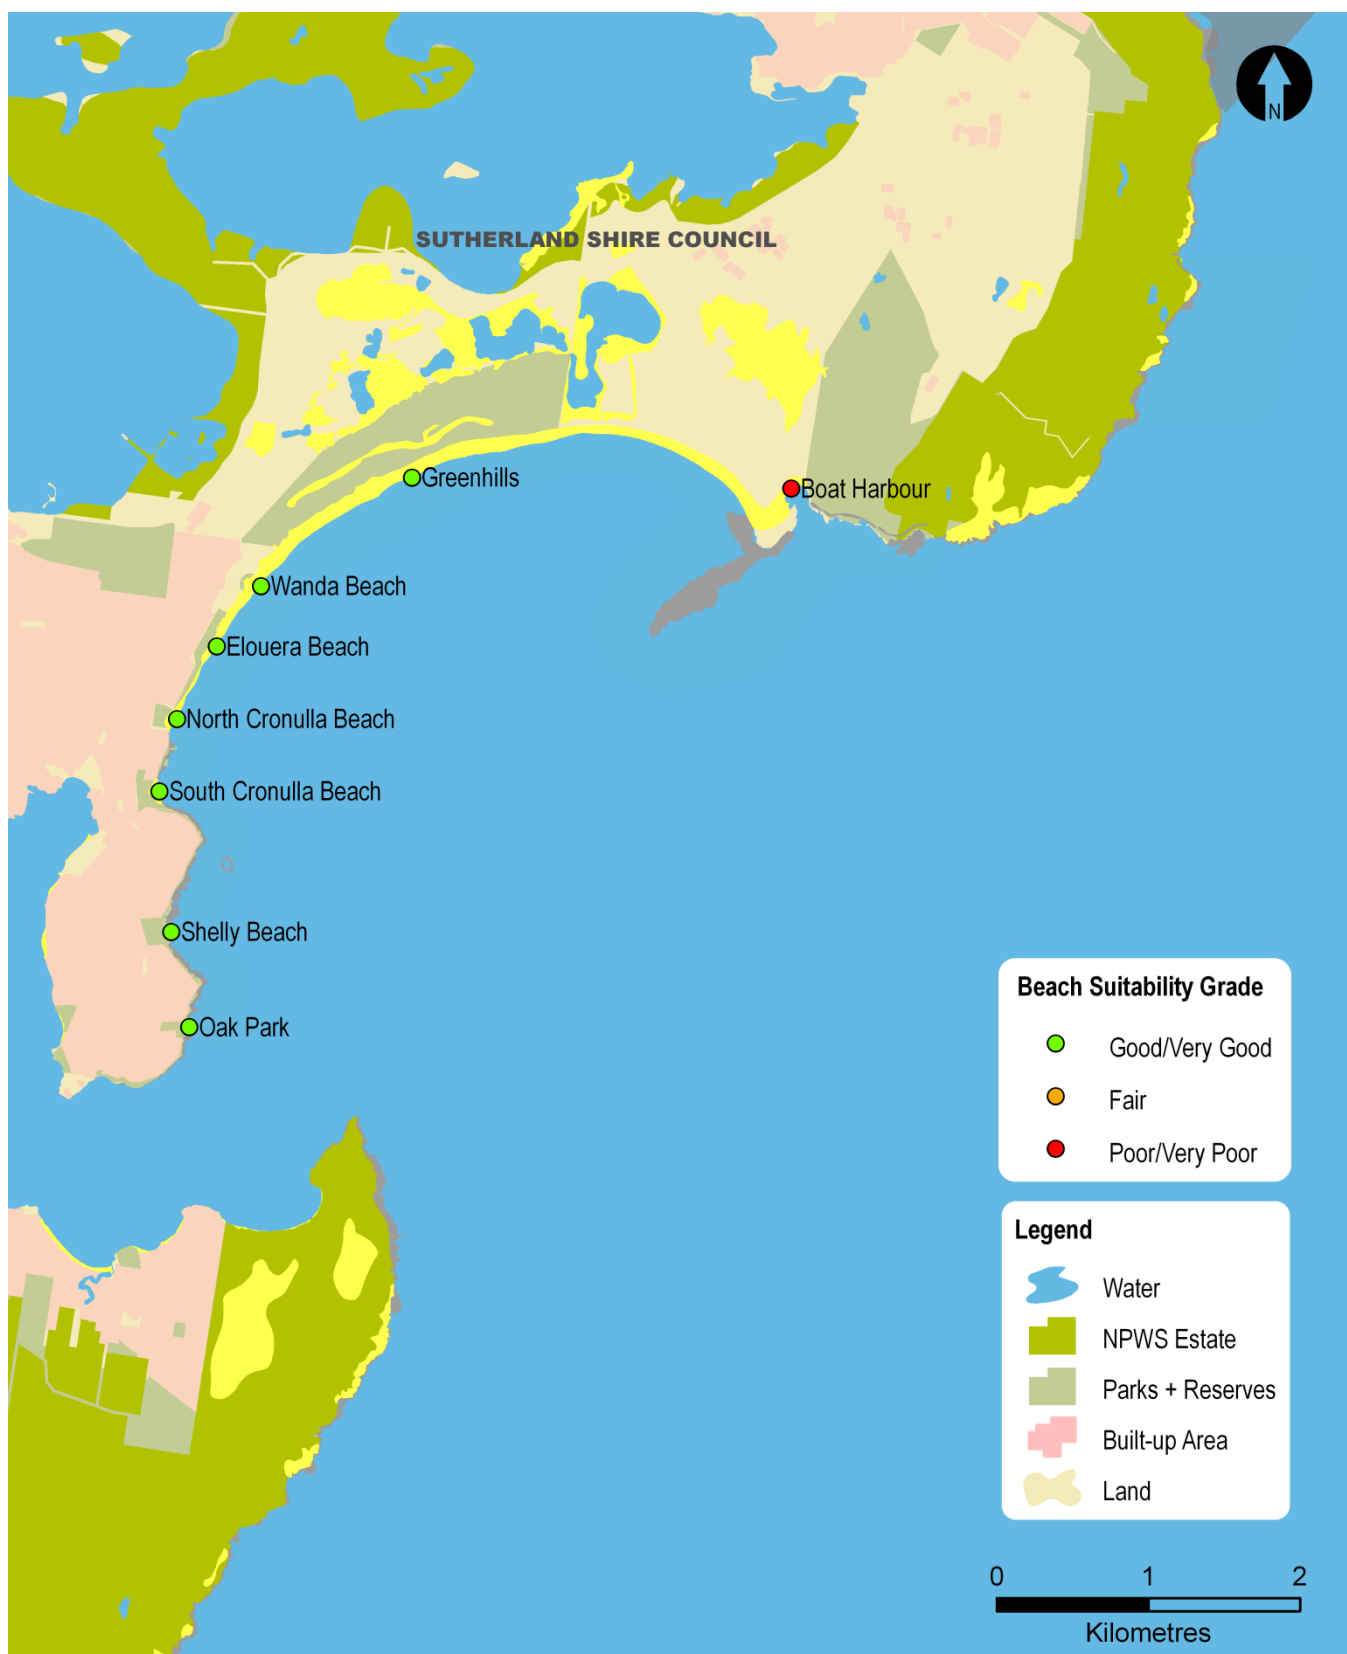
**Sampling sites and Beach Suitability Grades at Sydney's Southern Beaches**
