Department of  
Environment and Conservation (NSW)

# Beachwatch Partnership Pilot Program

## State of the Beaches 2002–03

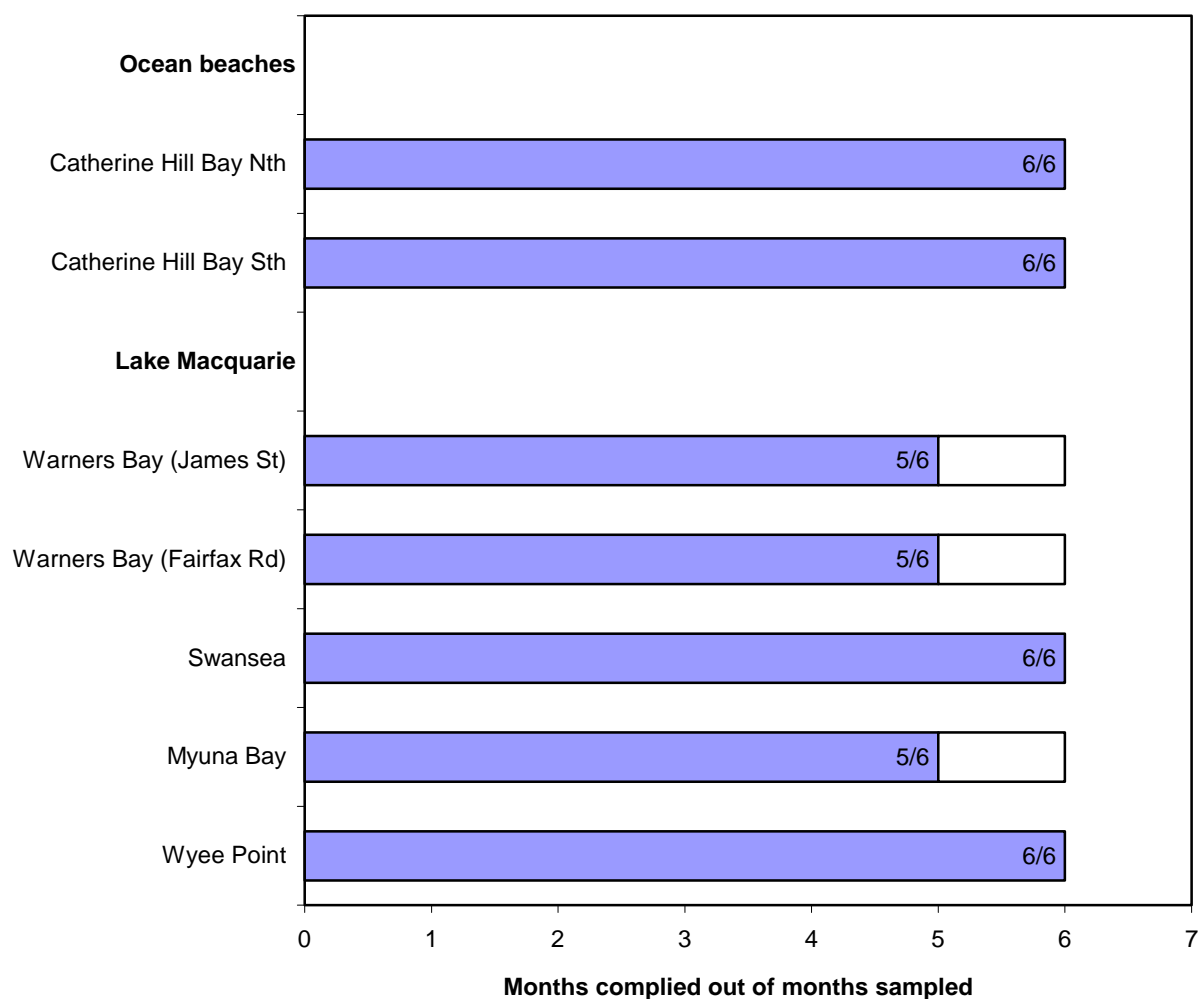
**Figure 7: Summary of compliance with NHMRC (1990) microbiological guidelines for swimming at Lake Macquarie City Council swimming sites from October 2002 to April 2003**

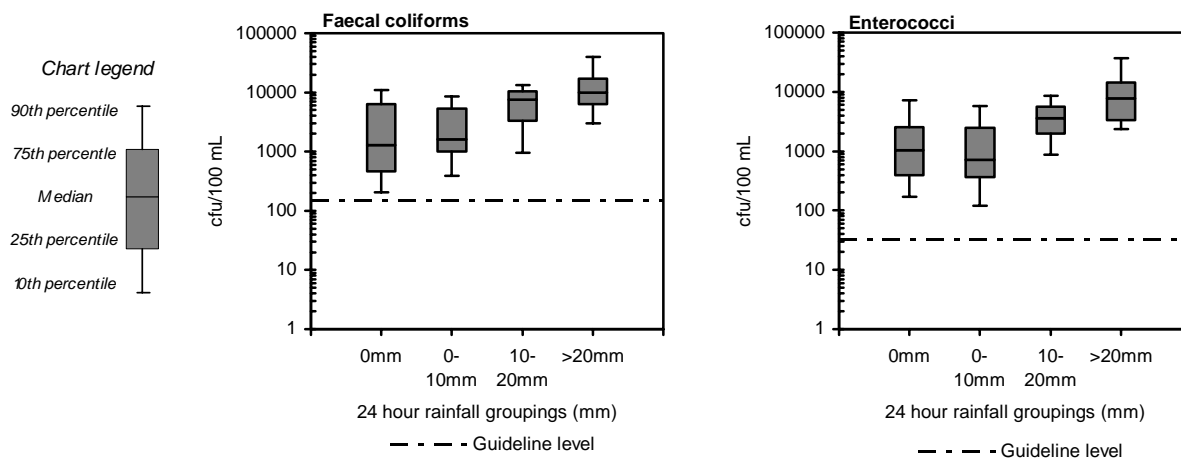
**Figure 13: Response to rainfall at the stormwater drain**

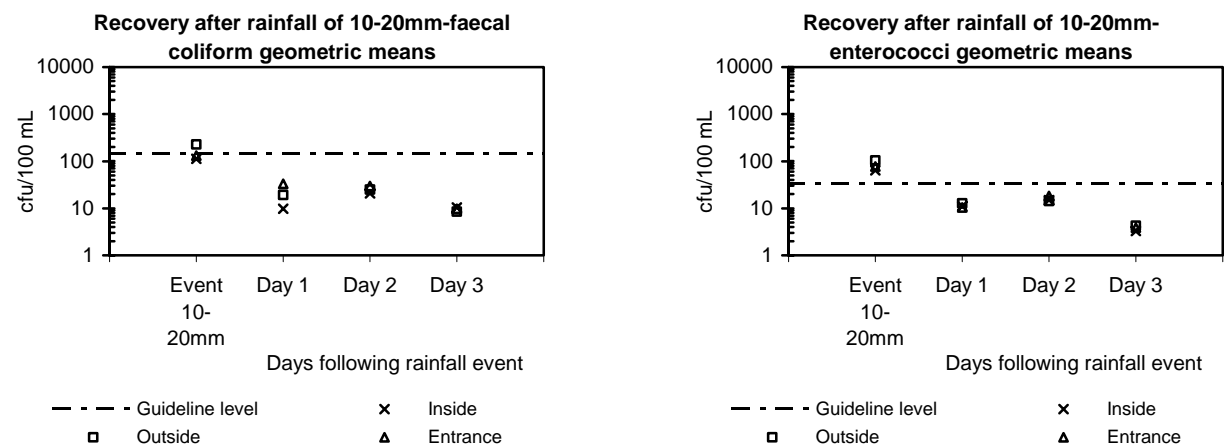
Figure 15: Northbridge Baths recovery after 10–20 mm of rainfall

Based on this data, water quality in Northbridge Baths should be suitable for swimming 24 hours after a rainfall event of 10–20 mm, and 48 hours after a rainfall event of more than 20 mm.
