## Clarence Valley Council

## **Program outline**

Eleven swimming locations were monitored in the Clarence Valley council area during summer 2005–2006. The sites were an ocean beach, a coastal lagoon, four estuarine swimming locations (two at the mouth of the Clarence River and two at the mouth of the Woolli Woolli River) and five locations in the Clarence River.

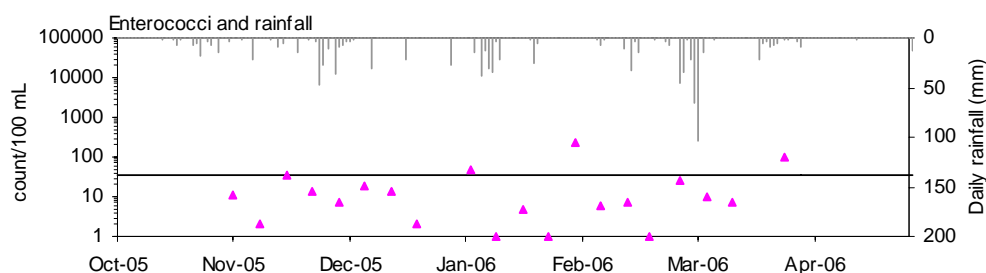
Slightly elevated levels of enterococci were measured on several occasions, but the majority of results were below the geometric mean guideline level.

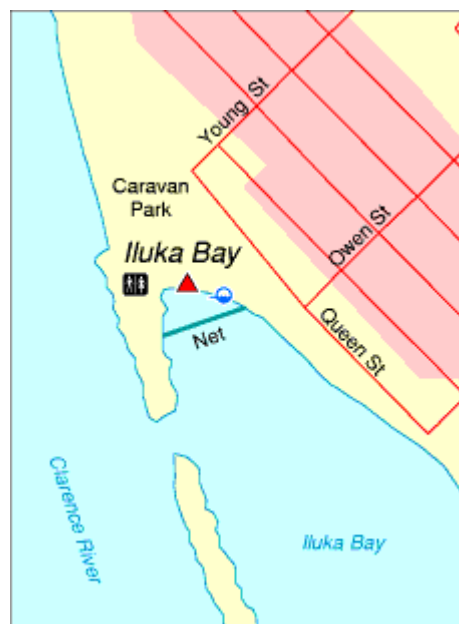
Iluka Bay was monitored between November 2005 and March 2006 and complied with NHMRC (1990) swimming guidelines in three of the four months. The site failed in March 2006 owing to elevated levels of enterococci.

NOV '05	DEC '05**	JAN '06	FEB '06*	MAR '06*
ENT	PASS	-	PASS	PASS	FAIL

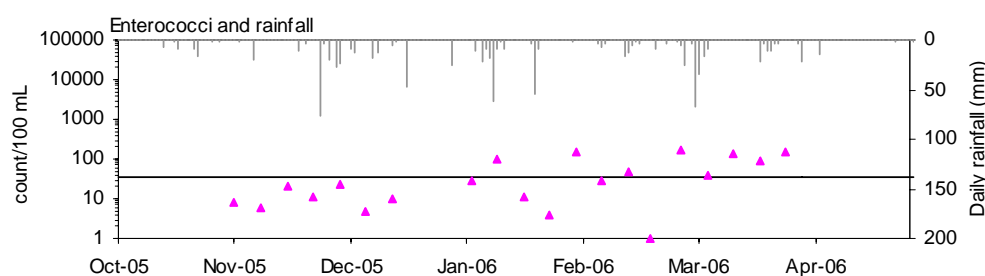
Levels of enterococci that exceeded the geometric mean guideline limit were measured on several occasions during the second half of the monitoring period, in both dry and wet weather conditions.

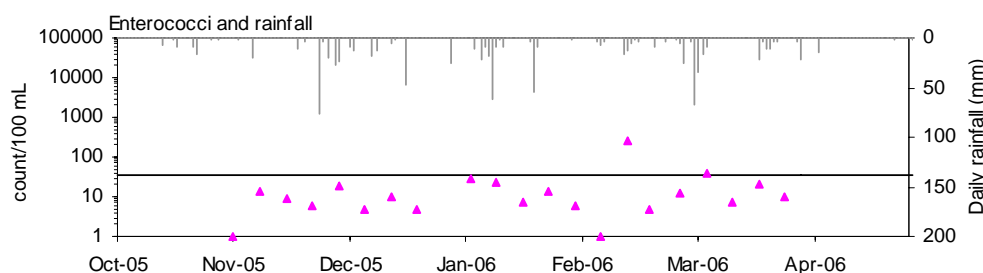
Levels of enterococci remained generally low over the monitoring period, exceeding the geometric mean guideline limit on one occasion in mid February 2006.

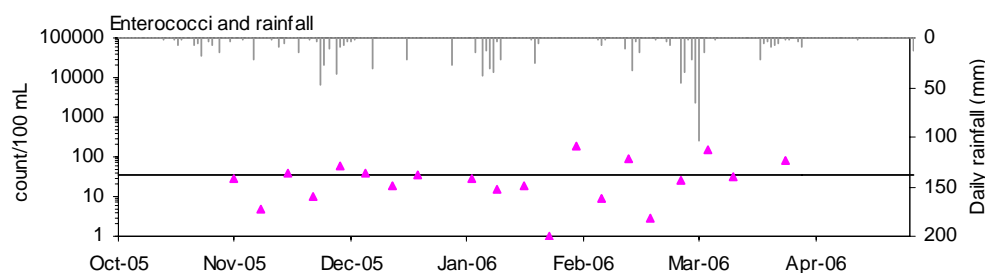
Levels of enterococci generally remained below the geometric mean guideline during the monitoring period, with slightly elevated levels measured on several occasions in February and March 2006.

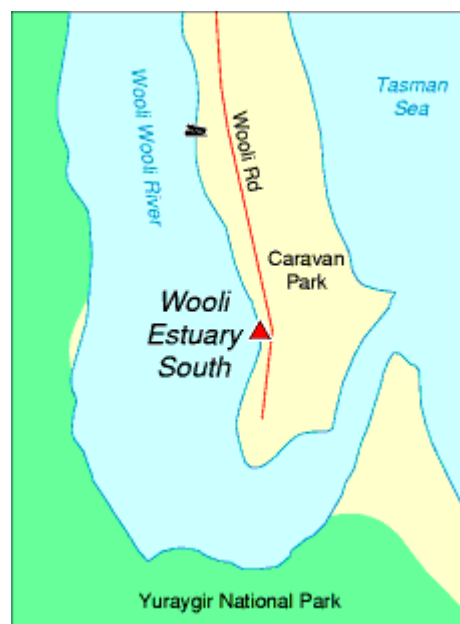
### Compliance with NHMRC (1990) swimming guidelines at Wooli Estuary South

Wooli Estuary South was monitored between November 2005 and March 2006. Levels of enterococci complied with NHMRC (1990) swimming guidelines in two of the three months in which sufficient samples were collected. The site failed the swimming guidelines in November 2005.

NOV '05	DEC '05**	JAN '06	FEB '06*	MAR '06**
ENT	FAIL	-	PASS	PASS	-

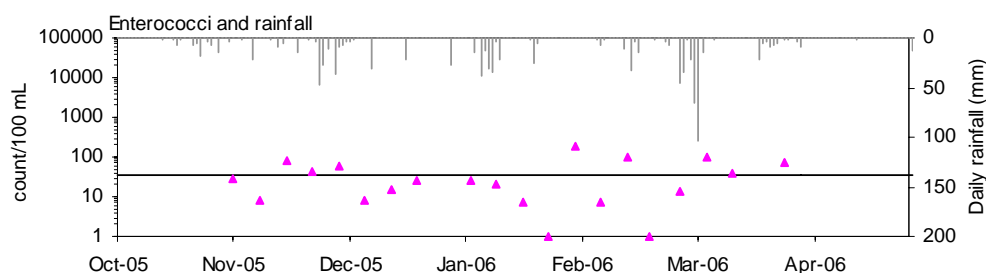
Levels of enterococci exceeded the geometric mean guideline on several occasions during the monitoring period, generally in response to rainfall.

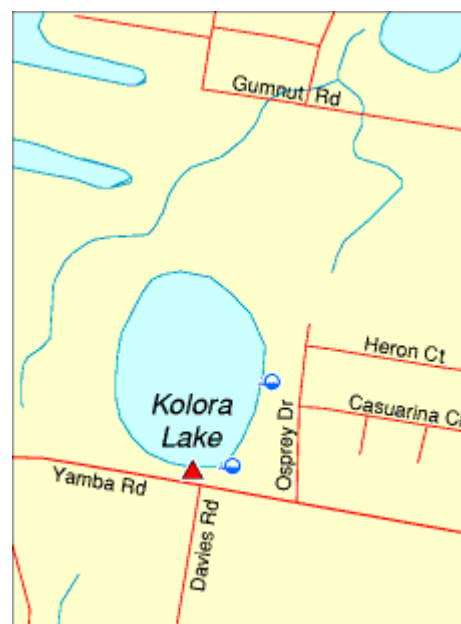
#### Compliance with NHMRC (1990) swimming guidelines at Kolora Lake

Kolora Lake was monitored between November 2005 and March 2006, and levels of enterococci complied with NHMRC (1990) swimming guidelines in all four months in which sufficient samples were collected.

NOV '05	DEC '05**	JAN '06	FEB '06*	MAR '06*
ENT	PASS	-	PASS	PASS	PASS

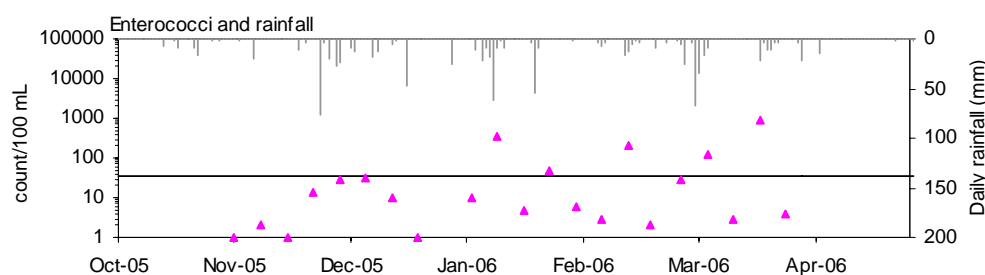
Levels of enterococci exceeded the geometric mean guidelines level on several occasions during the monitoring period, generally in response to rainfall.

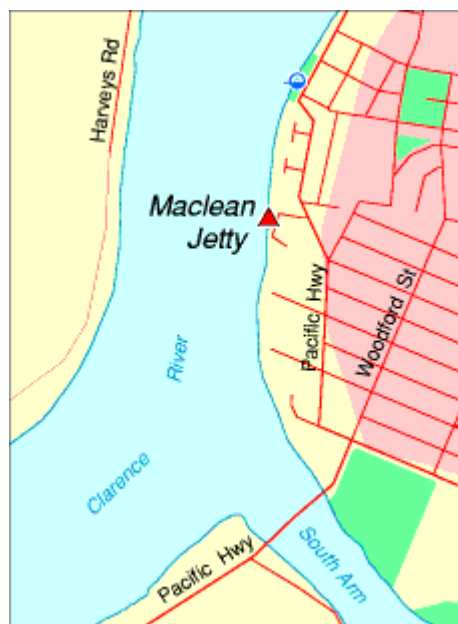
### Compliance with NHMRC (1990) swimming guidelines at Maclean Jetty

**Compliance** Maclean Jetty was monitored between November 2005 and March 2006, and levels of enterococci complied with NHMRC (1990) swimming guidelines in all four months in which sufficient samples were collected.

NOV '05	DEC '05**	JAN '06	FEB '06*	MAR '06*
ENT	PASS	-	PASS	PASS	PASS

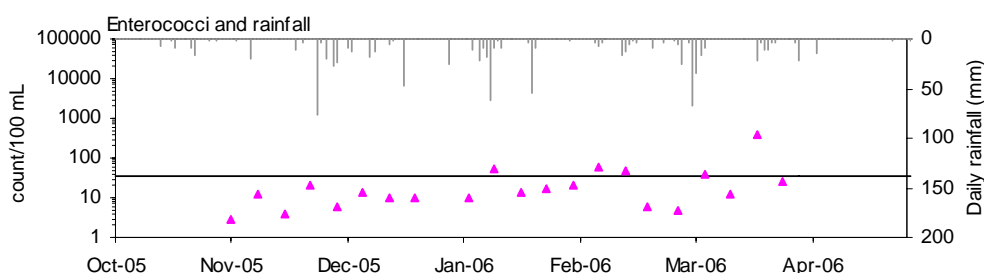
**Timeseries plots** Levels of enterococci were generally below the geometric mean guideline level, with slightly elevated levels recorded on several occasions in the latter half of the monitoring period.

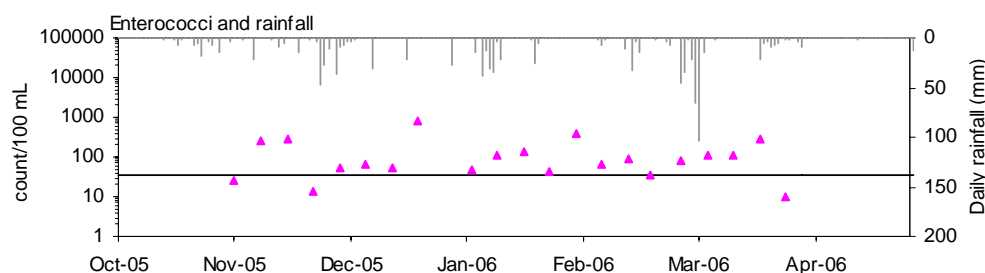
Levels of enterococci exceeded the geometric mean guideline value for most of the monitoring period.

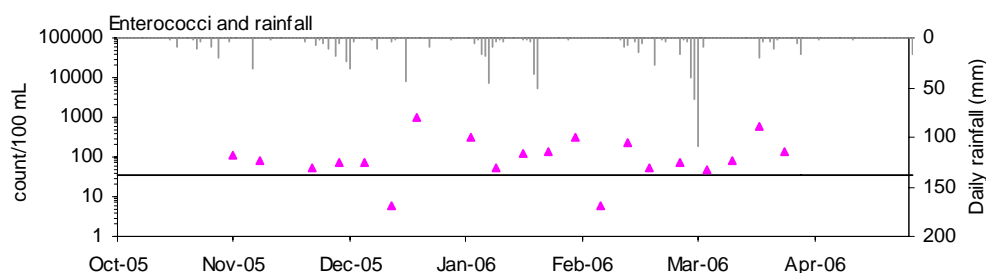
Enterococci levels exceeded the geometric mean guideline level throughout most of the monitoring period.

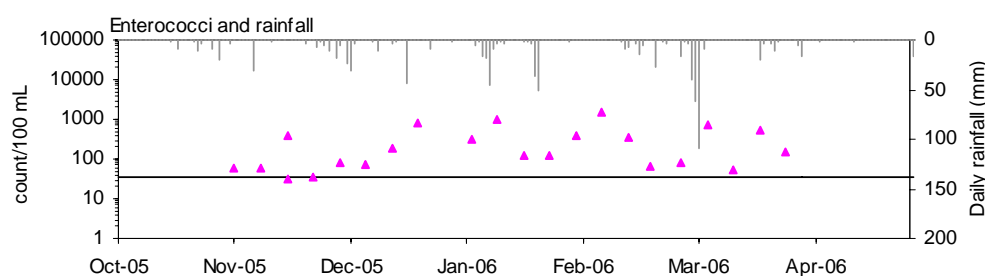
Levels of enterococci exceeded the geometric mean guideline limit throughout most of the monitoring period. Particularly high values were recorded in response to heavy rainfall.

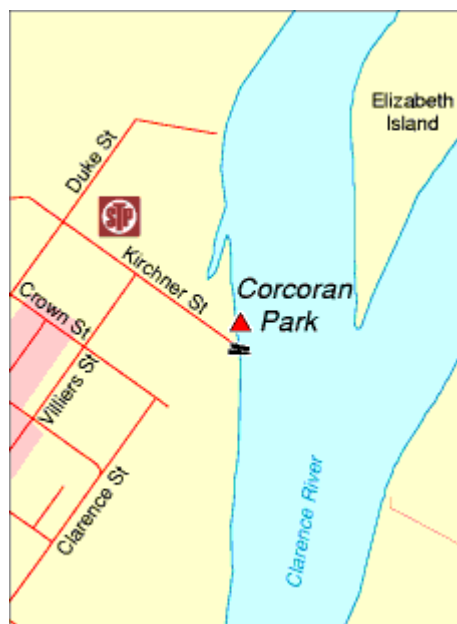
### Compliance with NHMRC (1990) swimming guidelines at Corcoran Park

Corcoran Park was monitored between November 2005 and March 2006. Levels of enterococci failed the NHMRC (1990) swimming guidelines in all four months in which sufficient samples were collected.

NOV '05	DEC '05**	JAN '06	FEB '06*	MAR '06*
ENT	FAIL	-	FAIL	FAIL	FAIL

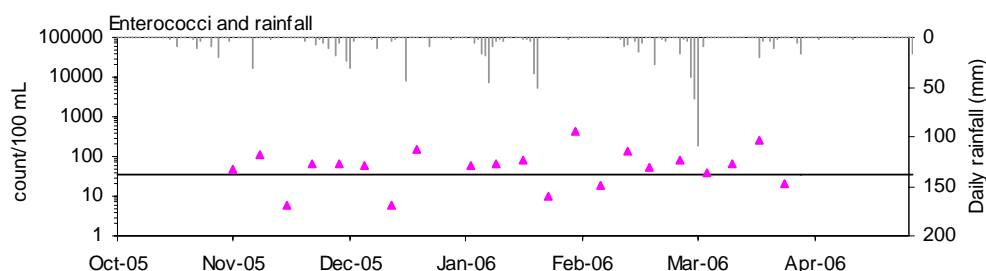
Enterococci levels remained just above the geometric mean guideline level throughout most of the monitoring period.
