Ballina Shire Council

Program outline

Ballina Shire Council monitored nine locations over the 2007–2008 summer swimming season. These were the ocean beaches of Seven Mile and Shelly, three sites in Lake Ainsworth, one site at The Serpentine and three sites in Shaws Bay.

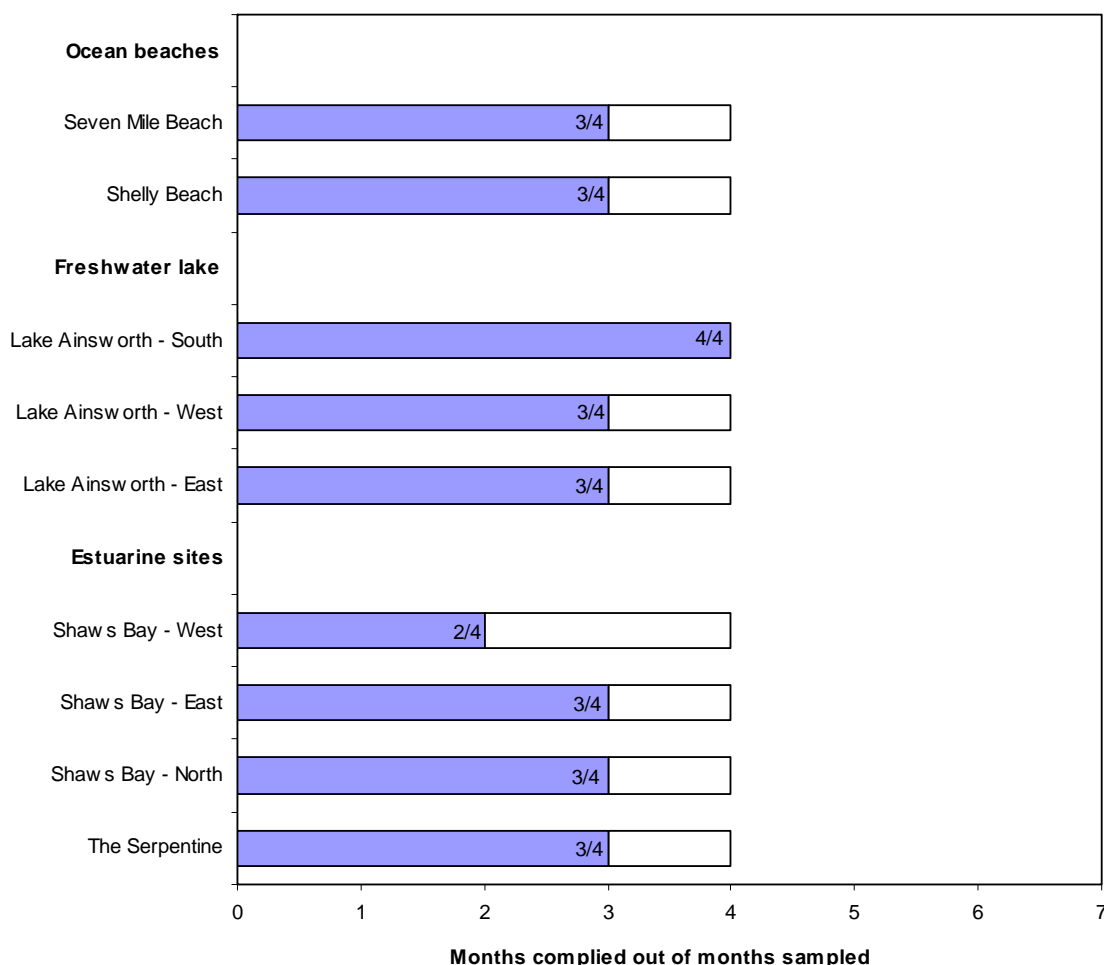
Figure 2: Summary of compliance with NHMRC (1990) microbiological guidelines for swimming at Ballina Shire Council swimming sites during the 2007–2008 summer swimming season

Seven Mile and Shelly beaches complied with the NHMRC (1990) swimming water quality guidelines in three of the four months monitored over the 2007–2008 summer season. Both beaches failed the guidelines in January 2008 owing to elevated levels of enterococci associated with a major flooding event in the region (Figure 2).

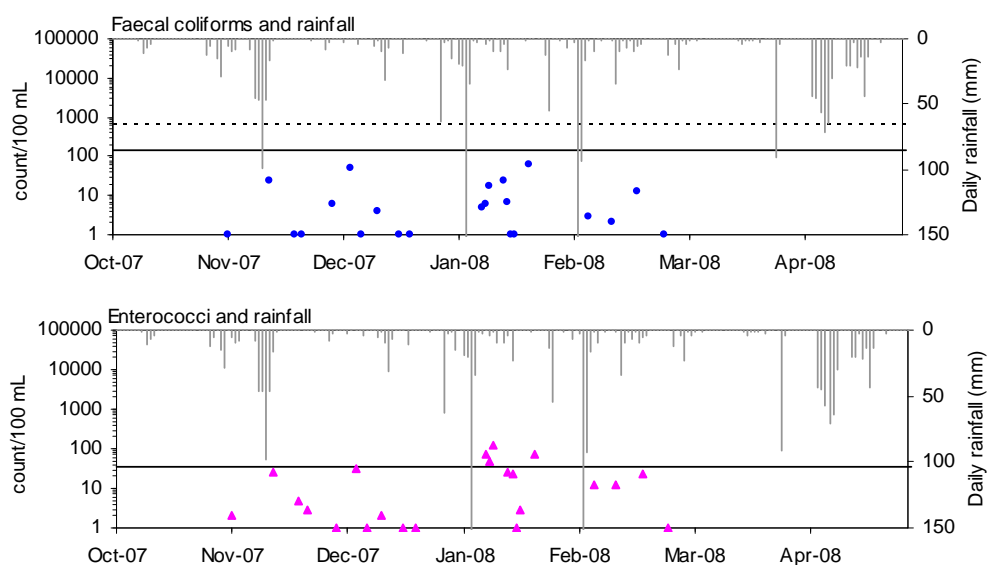
Levels of faecal coliforms were generally low over the monitoring period, remaining below the guideline limits. Levels of enterococci exceeded guideline limits on several occasions in January 2008 following heavy rainfall.

Seven Mile Beach complied with NHMRC (1990) swimming guidelines in three of the four months monitored in the 2007–2008 summer swimming season. The site failed the guidelines in January 2008 owing to elevated levels of enterococci.

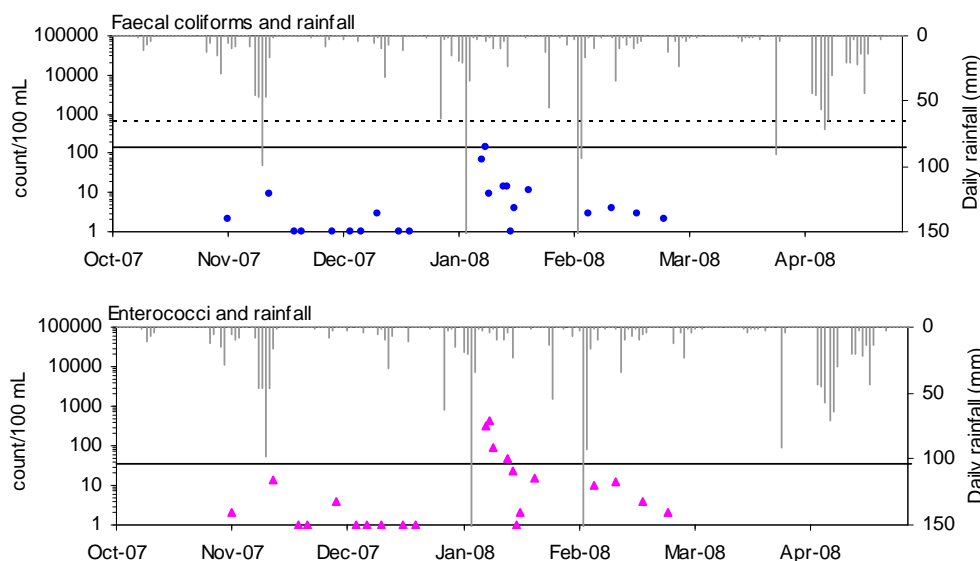
Levels of faecal coliforms were generally low over the monitoring period, with only slightly elevated levels recorded in response to heavy rainfall. Levels of enterococci exceeded guideline limits on several occasions in January 2008 following heavy rainfall.

Shelly Beach complied with NHMRC (1990) swimming guidelines in three of the four months monitored in the 2007–2008 summer swimming season. The site failed the guidelines in January 2008 owing to elevated levels of enterococci.

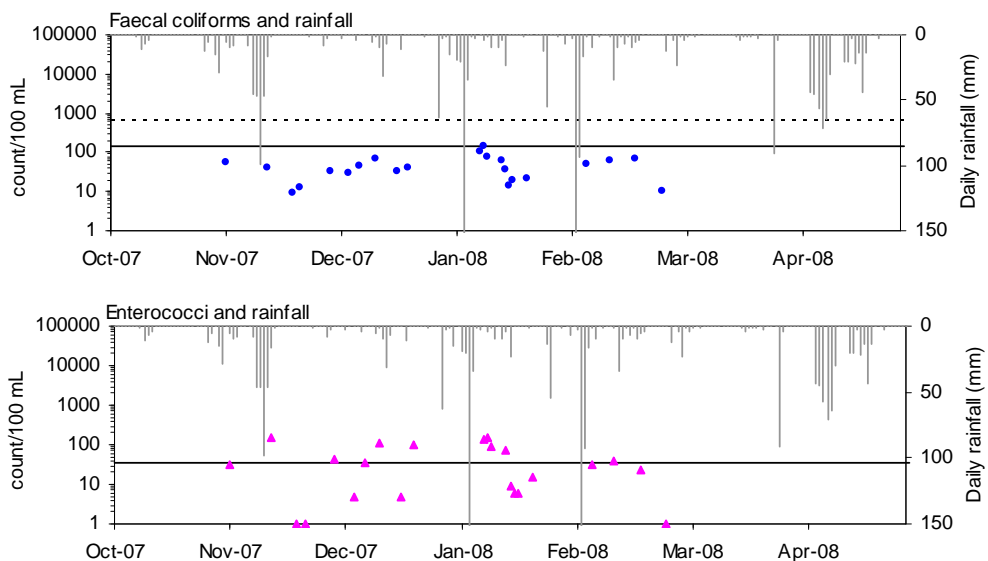
Timeseries plots Levels of faecal coliforms on the eastern side of Lake Ainsworth generally remained below the guideline values during the monitoring period, with slightly elevated levels occasionally recorded in response to heavy rainfall. Elevated levels of enterococci were more frequently recorded throughout the monitoring period.

Compliance Lake Ainsworth East complied with NHMRC (1990) swimming guidelines in three of the four months monitored in the 2007–2008 summer swimming season. The site failed the guidelines in January 2008 owing to elevated levels of enterococci.

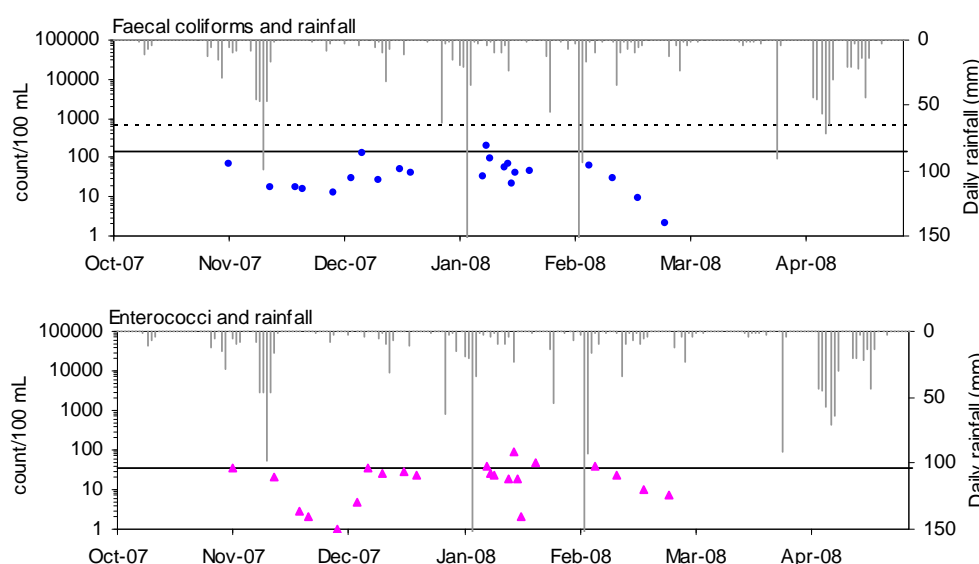
Bacterial levels on the southern side of Lake Ainsworth generally remained below the guideline values during the monitoring period. Slightly elevated results were occasionally recorded in response to heavy rainfall.

Lake Ainsworth South complied with NHMRC (1990) swimming guidelines in all four months monitored in the 2007–2008 summer swimming season.

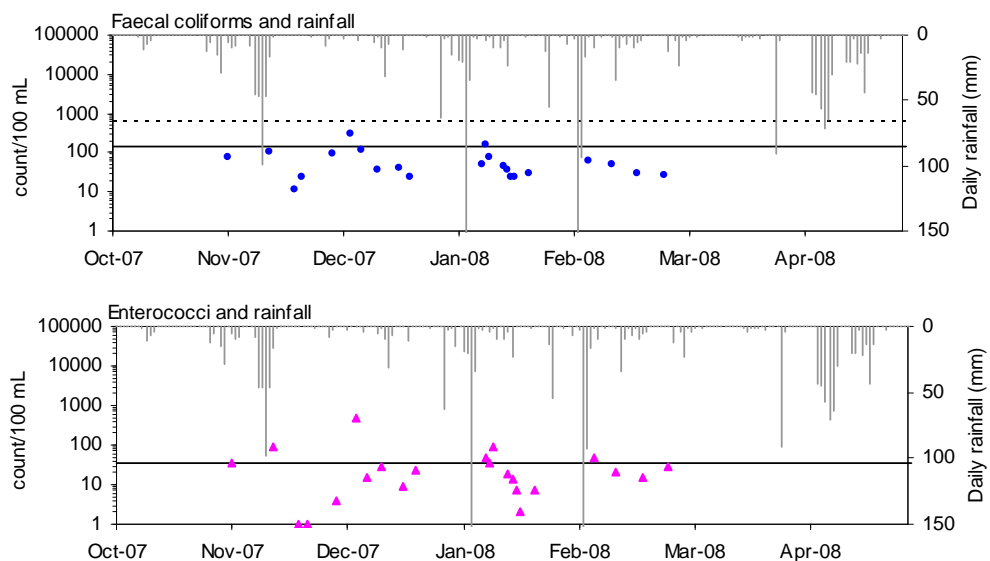
Timeseries plots Faecal coliform levels on the western side of Lake Ainsworth generally remained below the guideline values during the monitoring period. Enterococci levels exceeded the geometric mean guideline more frequently, usually in response to rainfall.

Compliance Lake Ainsworth West complied with NHMRC (1990) swimming guidelines in three of the four months monitored in the 2007–2008 summer swimming season. The site failed the guidelines in December 2007 owing to elevated levels of enterococci.

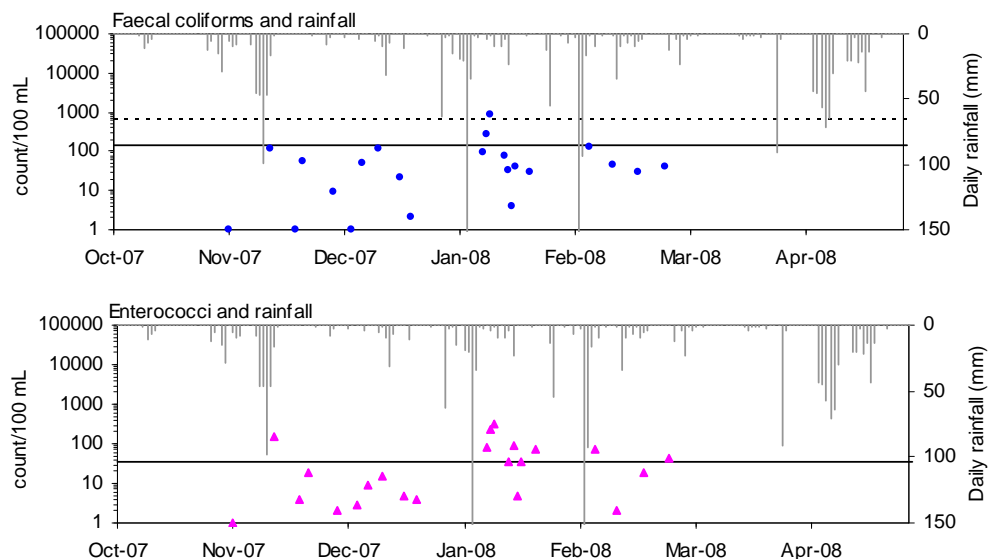
Levels of faecal coliforms at Shaws Bay North generally remained below the guideline limits throughout the monitoring period, with elevated results recorded on two occasions in January 2008. Enterococci levels exceeded the geometric mean guideline more frequently in response to heavy rainfall.

Shaws Bay North complied with NHMRC (1990) swimming guidelines in three of the four months monitored in the 2007–2008 summer swimming season. The site failed the guidelines in January 2008 owing to elevated levels of enterococci.

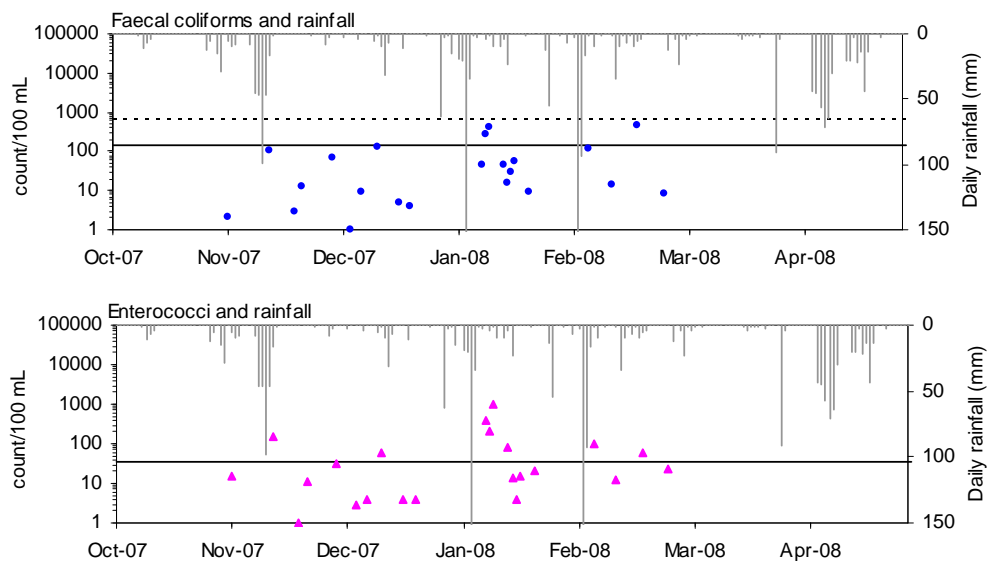
Timeseries plots Levels of faecal coliforms at Shaws Bay East were generally below guideline limits throughout the monitoring period, with three elevated results recorded following rainfall. Enterococci levels more frequently exceeded the geometric mean guideline limit, often in response to heavy rainfall.

Compliance Shaws Bay East complied with NHMRC (1990) swimming guidelines in three of the four months monitored in the 2007–2008 summer swimming season. The site failed the guidelines in January 2008 owing to elevated levels of enterococci.

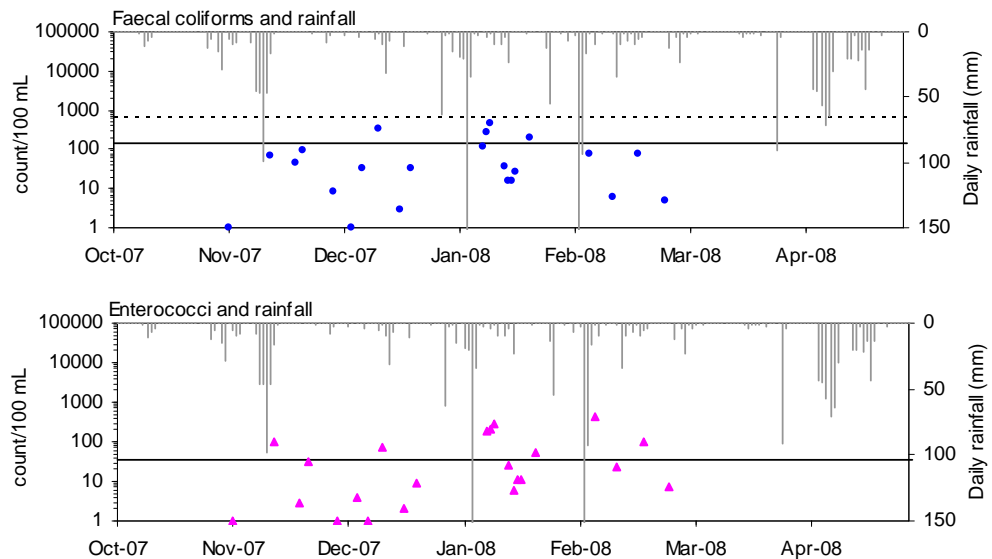
Levels of faecal coliforms at Shaws Bay West generally remained below the median guideline level during the monitoring period, with slightly elevated results recorded on four occasions. Elevated enterococci values were recorded on several occasions, often in response to rainfall.

Shaws Bay West complied with NHMRC (1990) swimming guidelines in two of the four months monitored in the 2007–2008 summer swimming season. The site failed the guidelines in January 2008 and February 2008 owing to elevated levels of enterococci.

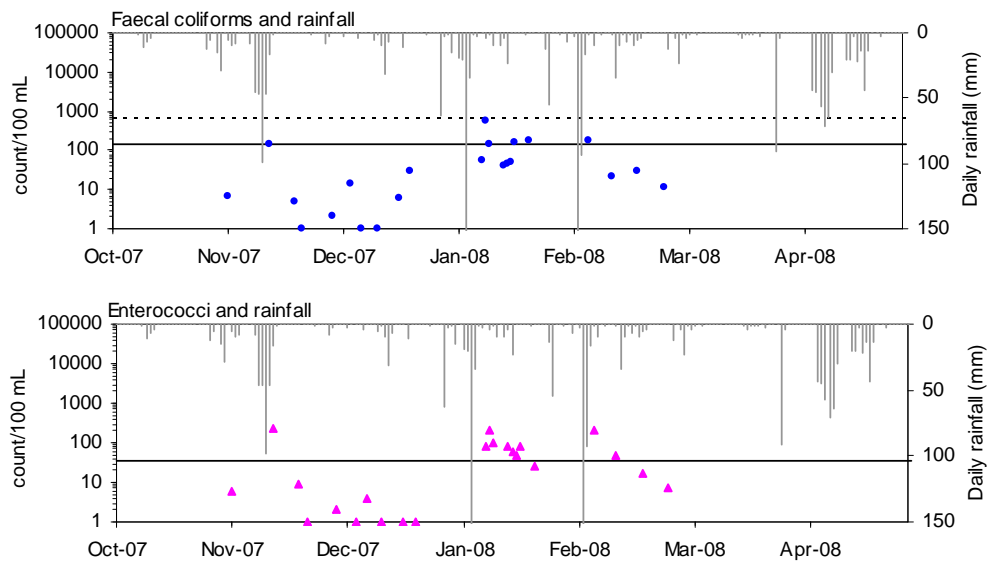
Timeseries plots Levels of faecal coliforms at The Serpentine generally remained below the median guideline level during the monitoring period, with slightly elevated results recorded usually following rainfall. Elevated enterococci values were recorded on several occasions, particularly after heavy rain.

Compliance The Serpentine complied with NHMRC (1990) swimming guidelines in three of the four months monitored in the 2007–2008 summer swimming season. The site failed the guidelines in January 2008 owing to elevated levels of enterococci.
