Bega Valley Shire Council

Program outline

Twenty swimming sites were monitored by Bega Valley Council: nine ocean beaches, nine lagoon or estuarine sites and two pools.

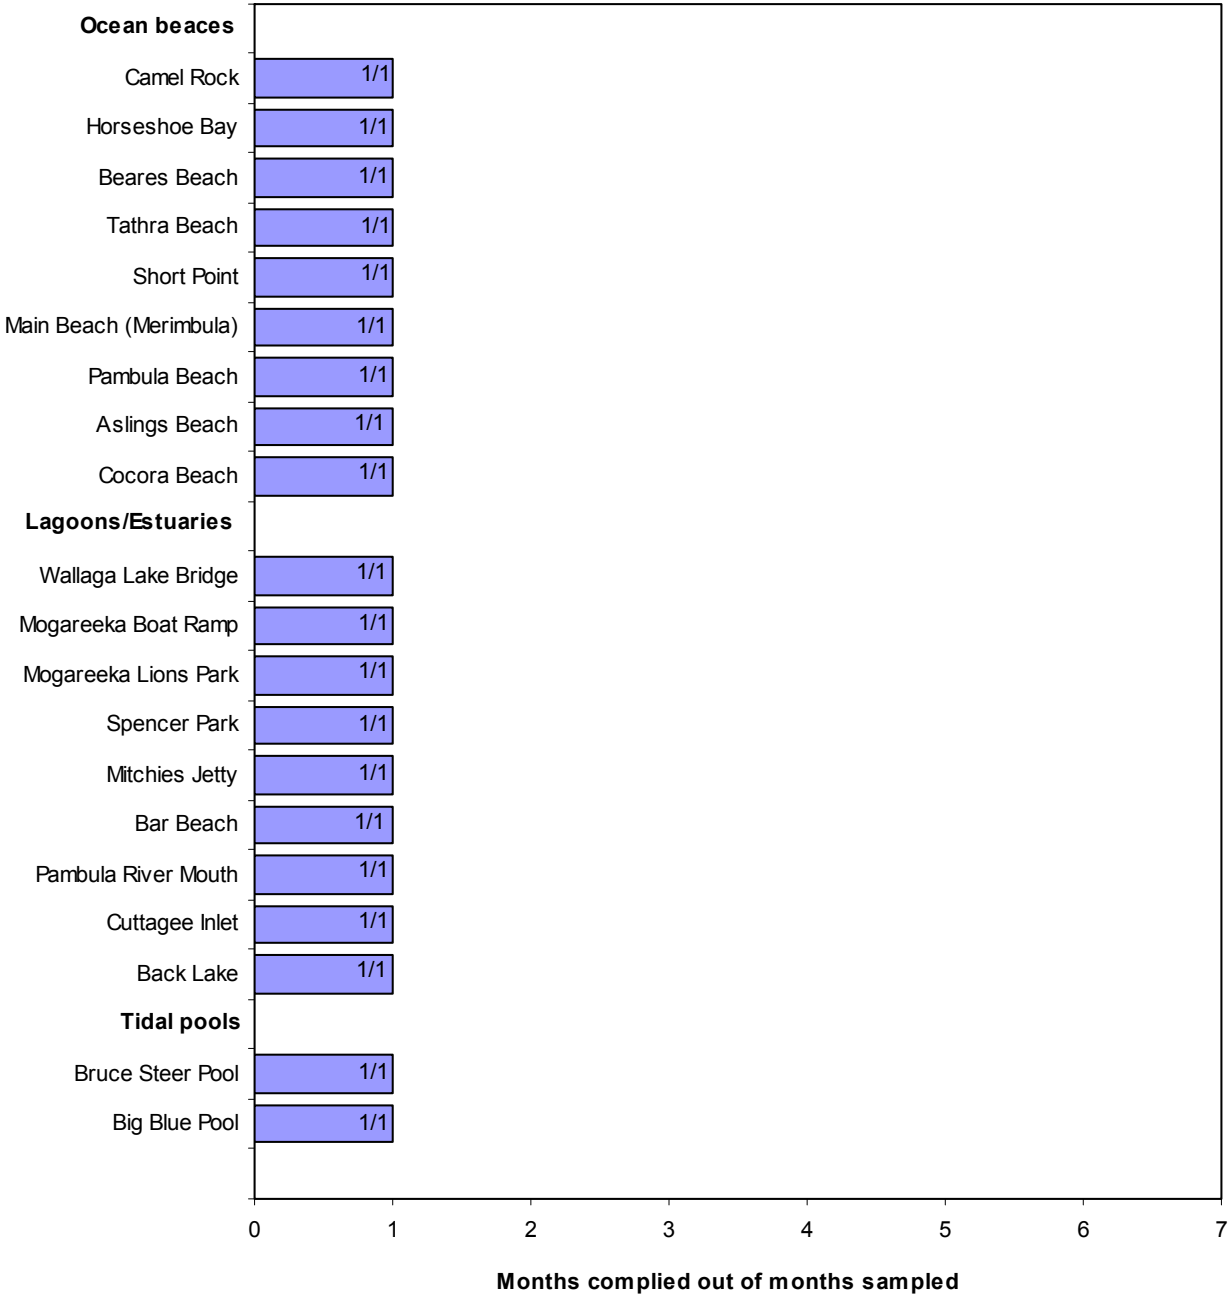
Figure 13: Summary of compliance with NHMRC (1990) microbiological guidelines for swimming at Bega Valley Shire Council swimming sites during January 2008

A high level of compliance was recorded at all nine ocean beaches. Camel Rock, Horseshoe Bay, Beares, Tathra, Short, Merimbula, Pambula, Aslings and Cocora beaches all passed the NHMRC (1990) swimming guidelines in January 2008, the only month in which compliance was assessed (Figure 13).

All nine lagoon and estuarine swimming locations (Wallaga Lake Bridge, Mogareeka Boat Ramp, Mogareeka Lions Club, Spencer Park, Mitchies Jetty, Bar Beach, Pambula River Mouth, Cuttagee Inlet and Back Lake) complied with the NHMRC (1990) swimming water quality guidelines during January 2008 (Figure 13).

Bruce Steer Pool and Big Blue Pool complied with the NHMRC (1990) swimming water quality guidelines in January 2008 (Figure 13). Low levels of bacteria were measured in the pools, providing no evidence of sewage contamination.

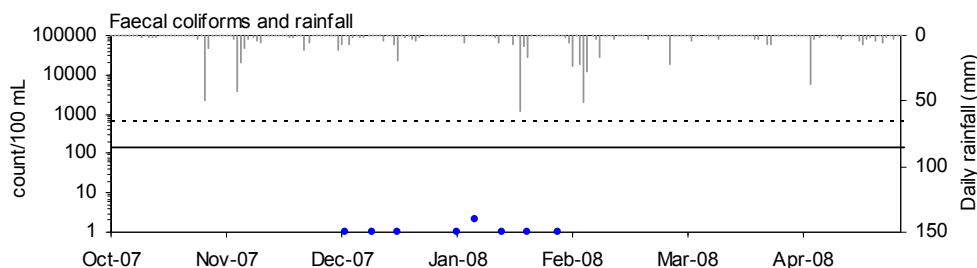
Timeseries plots Levels of faecal coliforms were very low throughout the monitoring period, providing no evidence of sewage contamination.

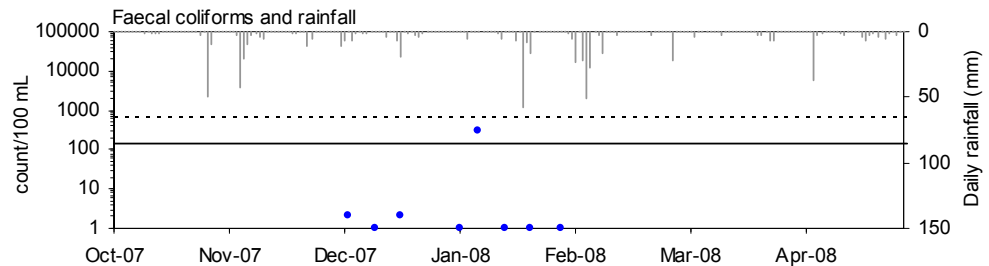
Levels of faecal coliforms remained generally low throughout the monitoring period, with a single elevated result recorded in January 2008.

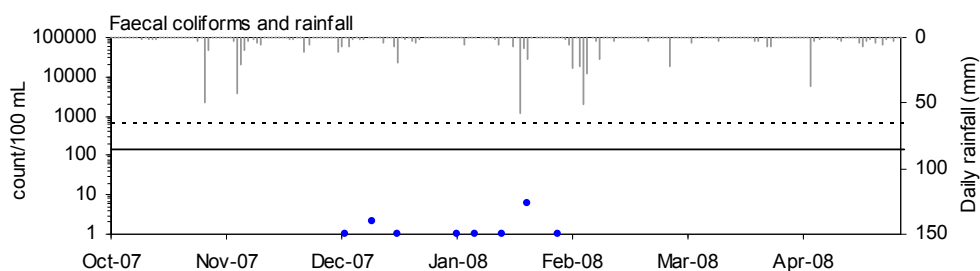
Timeseries plots Levels of faecal coliforms were generally very low throughout the monitoring period, providing no evidence of sewage contamination.

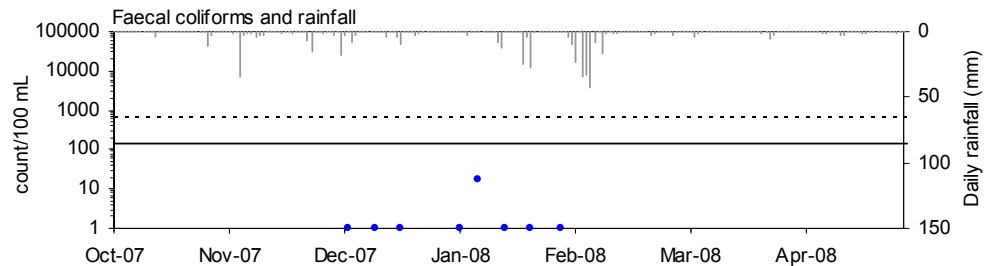
Levels of faecal coliforms were generally low throughout the monitoring period, providing no evidence of sewage contamination.

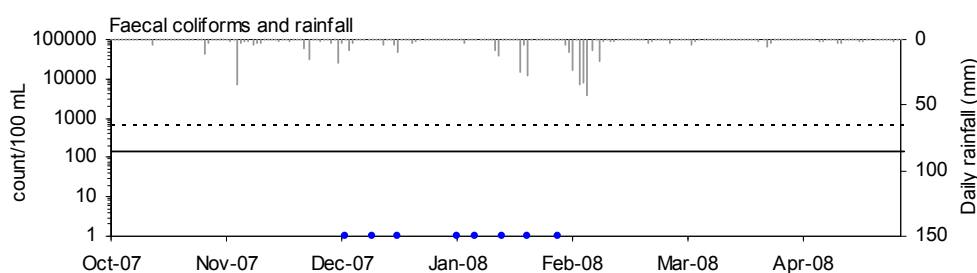
Levels of faecal coliforms remained very low throughout the monitoring period, providing no evidence of sewage contamination.

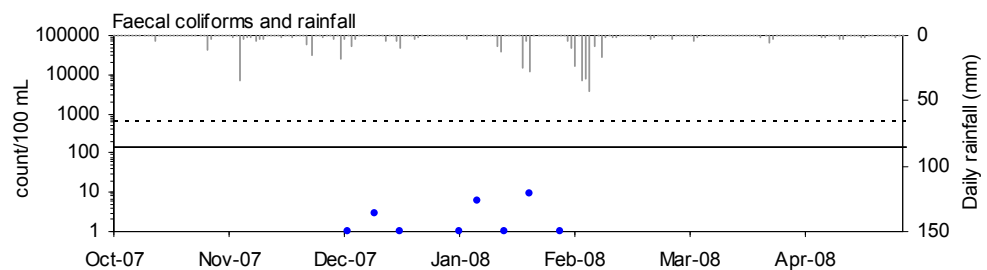
Levels of faecal coliforms remained generally low throughout the monitoring period, providing no evidence of sewage contamination.

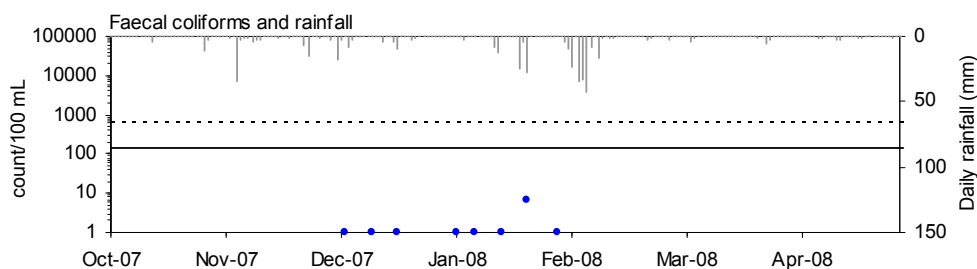
Levels of faecal coliforms were generally very low throughout the monitoring period, providing no evidence of sewage contamination.

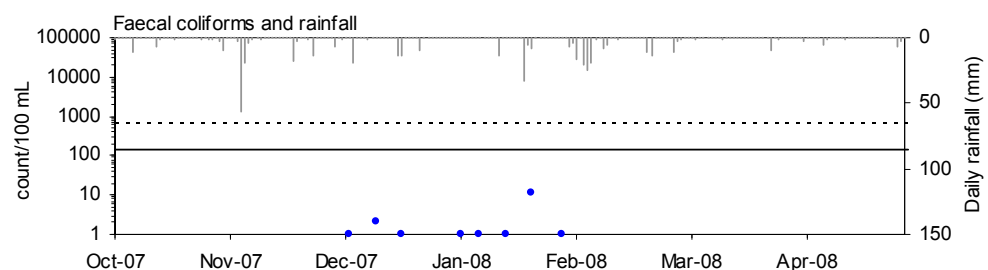
Levels of faecal coliforms were generally very low throughout the monitoring period, providing no evidence of sewage contamination.

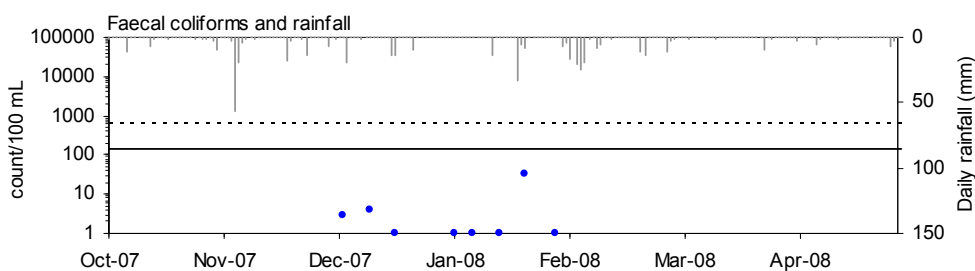
Timeseries plots Levels of faecal coliforms were generally low throughout the monitoring period, remaining below the median guideline limit.

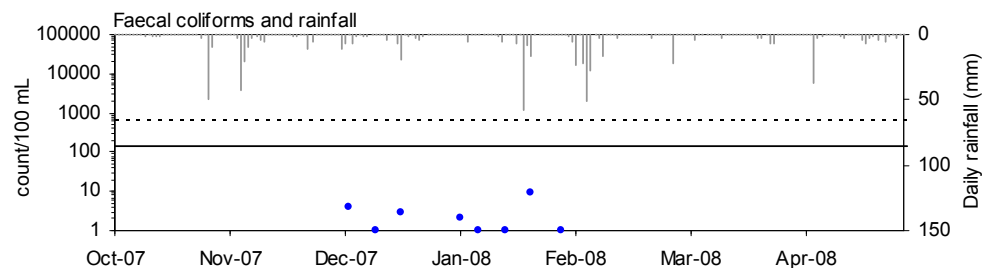
Levels of faecal coliforms were remained low throughout the monitoring period, providing no evidence of sewage contamination.

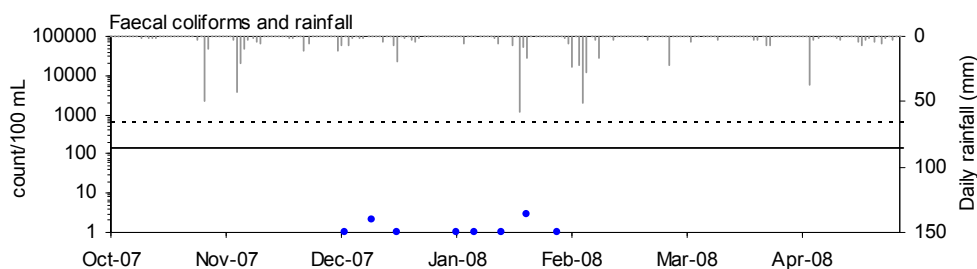
Levels of faecal coliforms were generally very low throughout the monitoring period, providing no evidence of sewage contamination.

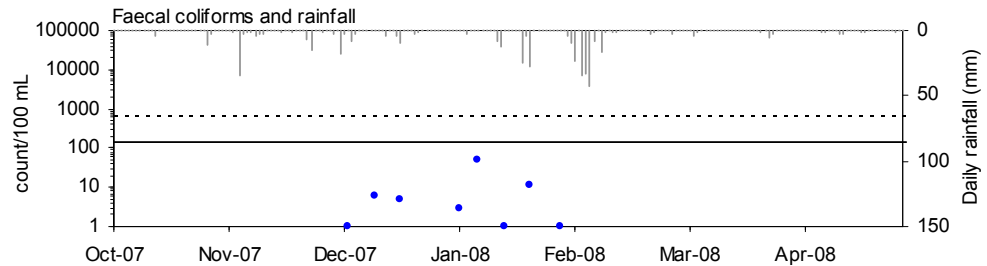
Levels of faecal coliforms were generally low throughout the monitoring period, with all values below the median guideline limit.

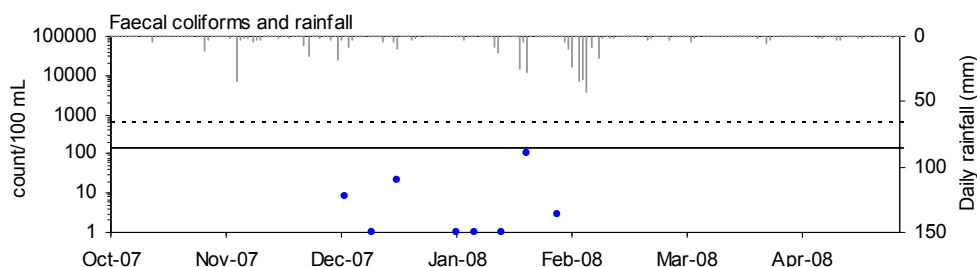
Levels of faecal coliforms were generally low throughout the monitoring period, with all values below the median guideline limit.

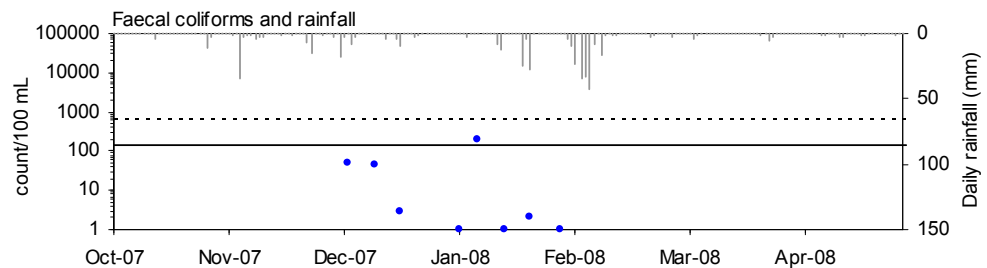
Levels of faecal coliforms were generally low throughout the monitoring period, with a single value above the median guideline limit recorded in early January 2008 during dry weather conditions.

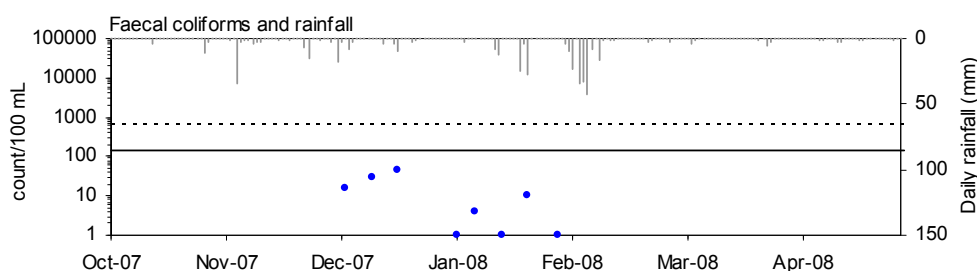
Levels of faecal coliforms were generally low throughout the monitoring period, remaining below the median guideline limit.

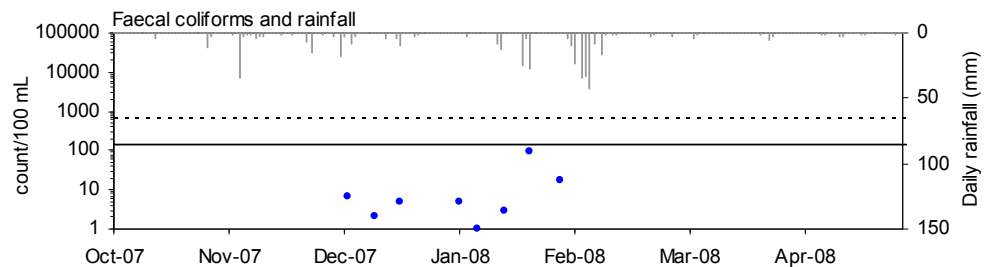
Levels of faecal coliforms were generally low throughout the monitoring period, with all values below the median guideline limit.

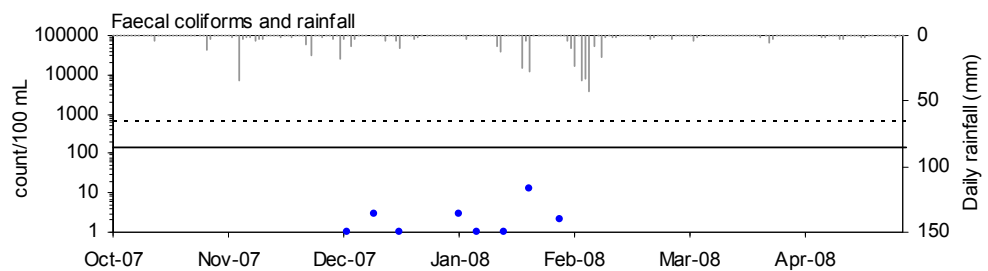
Levels of faecal coliforms were generally low throughout the monitoring period, with all values below the median guideline limit.

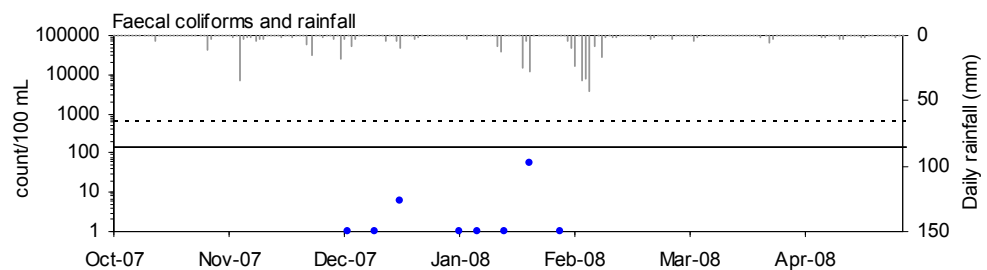
Levels of faecal coliforms remained generally low throughout the monitoring period with all values below the median guideline limit.

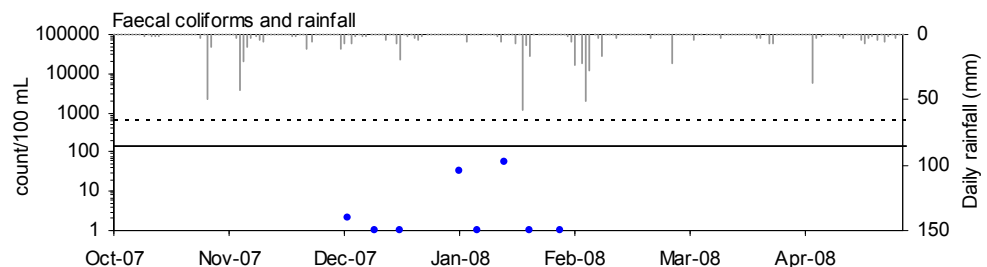
Levels of faecal coliforms remained generally low throughout the monitoring period, providing no evidence of sewage contamination.
