Clarence Valley Council

Estuarine beaches: Iluka Bay, Wooli Estuary North, Wooli Estuary South. **Lagoons:** Kolora Lake. **Riverine swimming sites:** Maclean Jetty, Lawrence, Ulmarra Jetty, Corcoran Park, Grafton Sailing Club, South Mariner, Prince Street (Grafton).

Local government area description

Program outline

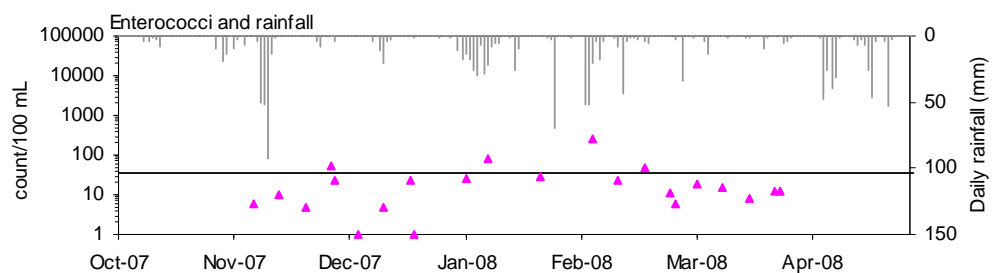
See page 5 for key to graph

Timeseries plots Levels of enterococci generally remained below the geometric mean guideline throughout the monitoring period. Slightly elevated results were recorded occasionally, generally following rainfall.

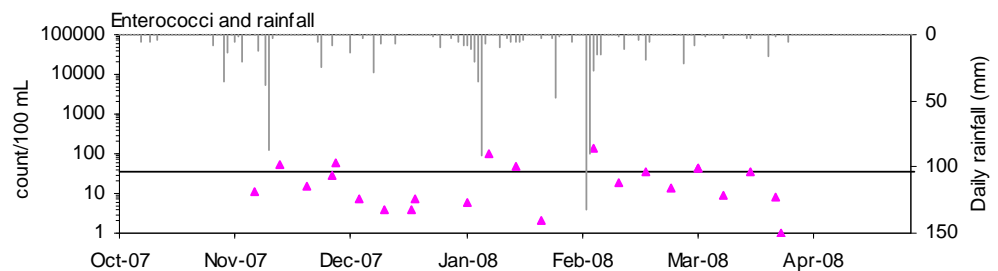
See page 5 for key to graph

Levels of enterococci generally remained below the geometric mean guideline throughout the monitoring period. Slightly elevated results were recorded on a number of occasions, usually in response to heavy rainfall.

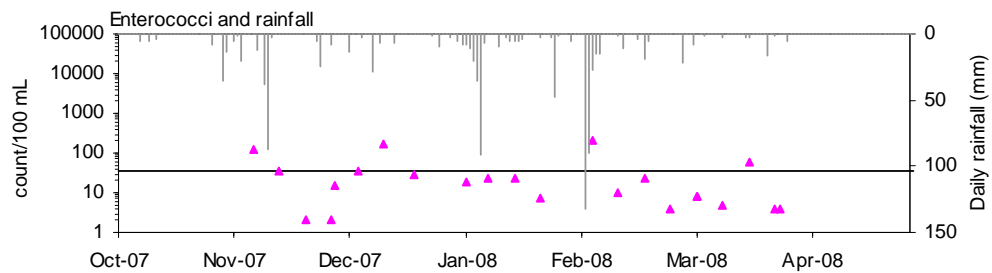
See page 5 for key to graph

Timeseries plots Levels of enterococci generally remained below the geometric mean guideline throughout the monitoring period. Elevated results were recorded on a several occasions, generally in response to rainfall.

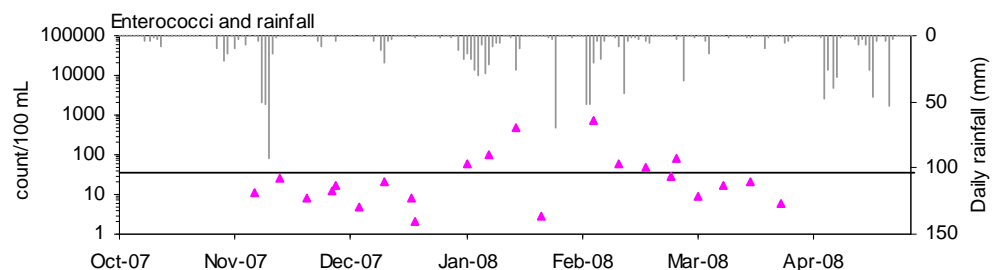
See page 5 for key to graph

Levels of enterococci exceeded the geometric mean guidelines level on several occasions during January and February in response to rainfall.

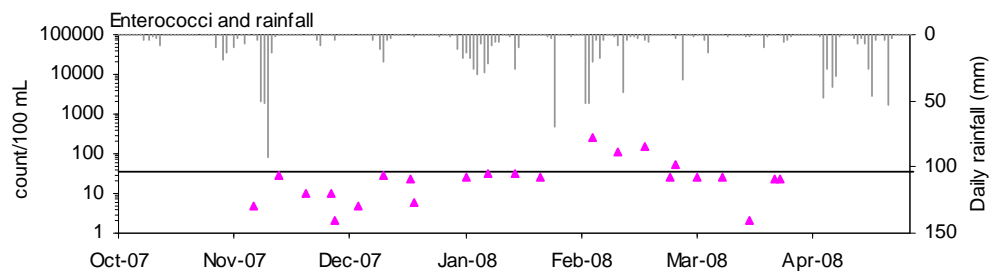
See page 5 for key to graph

Timeseries plots Levels of enterococci were generally below the geometric mean guideline level with most elevated results occurring in response to rainfall during February 2008.

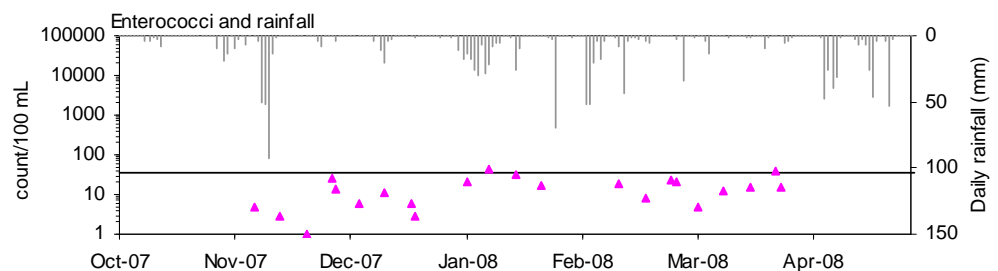
See page 5 for key to graph

Levels of enterococci generally remained below the geometric mean guideline level throughout the monitoring period, with only two slightly elevated results in January and March 2008.

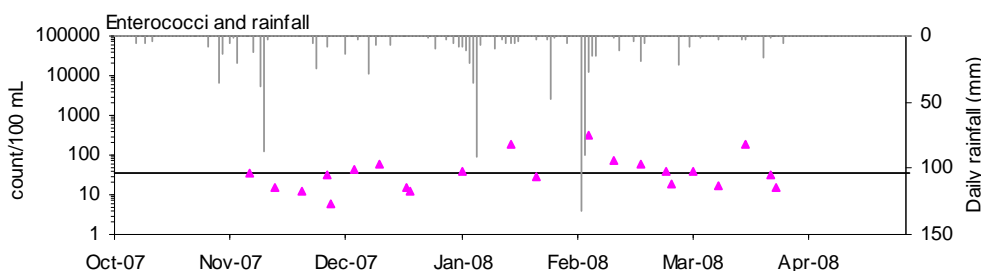
See page 5 for key to graph

Timeseries plots Levels of enterococci often exceeded the geometric mean guideline, with elevated results recorded on throughout the monitoring period.

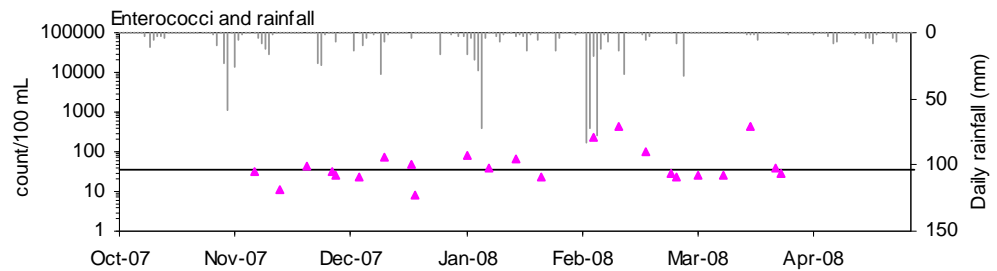
See page 5 for key to graph

Enterococci levels exceeded the geometric mean guideline level on several occasions throughout the monitoring period, not always in response to rainfall.

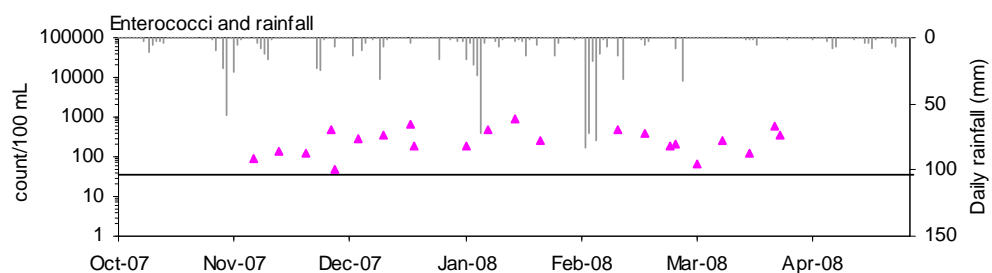
See page 5 for key to graph

Levels of enterococci consistently exceeded the geometric mean guideline limit throughout the monitoring period. Elevated results were recorded in both dry and wet weather conditions.

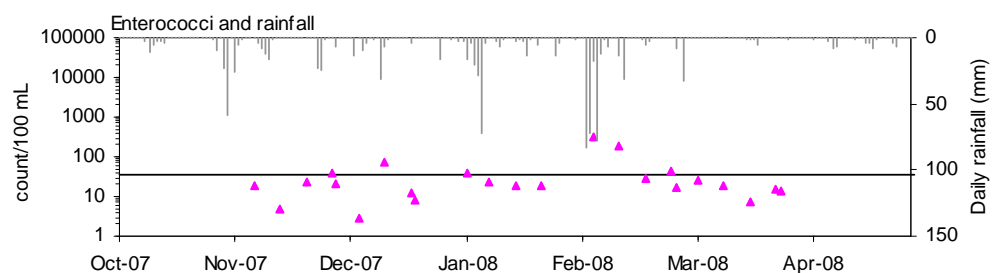
See page 5 for key to graph

Levels of enterococci generally remained below the geometric mean guideline limit throughout the monitoring period. Elevated results were recorded on several occasions generally in response to rainfall.

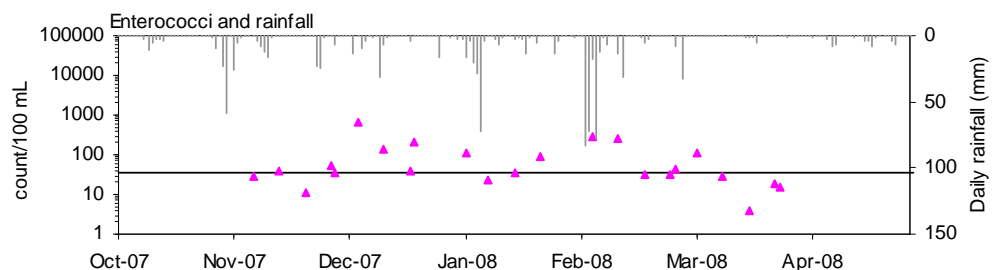
See page 5 for key to graph

Timeseries plots Enterococci levels frequently exceeded the geometric mean guideline level during the monitoring period, usually in response to rainfall.
