Coffs Harbour City Council

Local government area description

Program outline

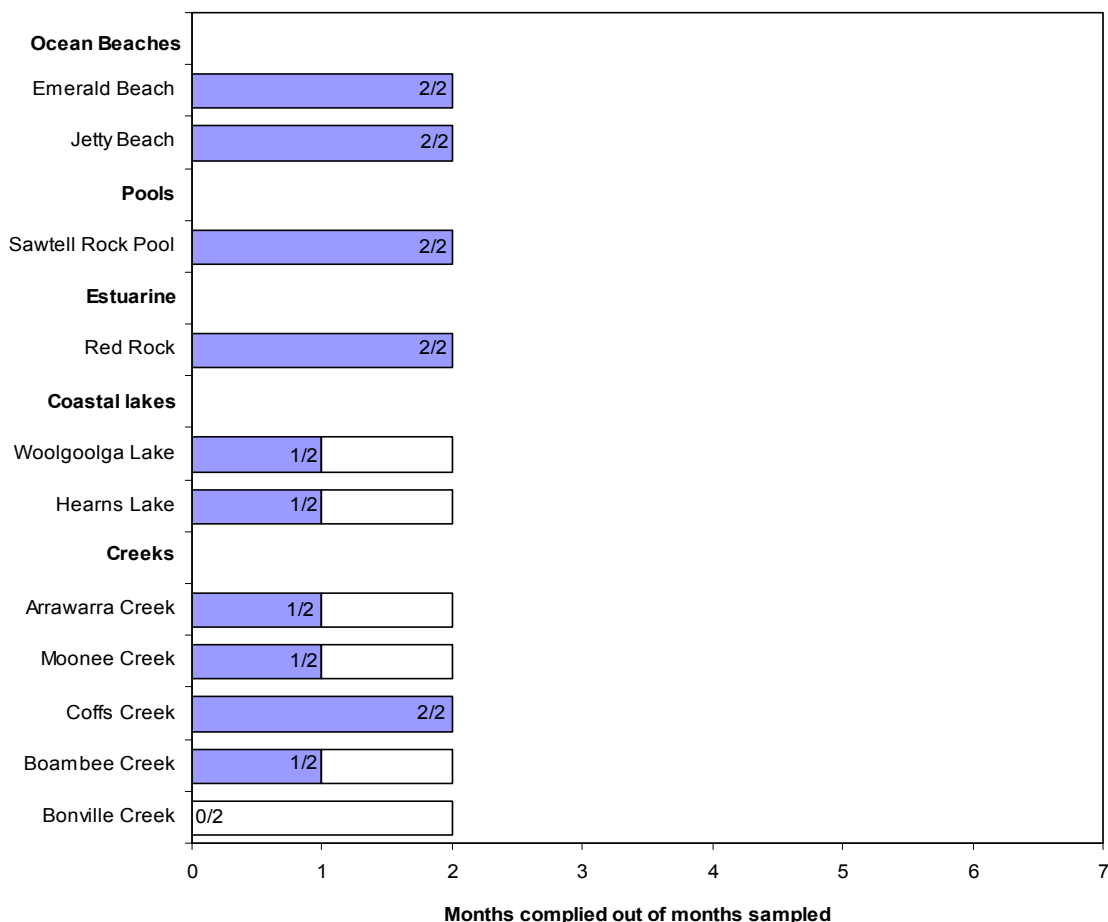
Figure 5: Summary of compliance with NHMRC (1990) microbiological guidelines for swimming at Coffs Harbour City Council swimming sites during the 2007–2008 summer swimming season

A high level of compliance with NHMRC (1990) swimming water guidelines was recorded at both ocean beaches. Emerald and Jetty beaches were suitable for swimming in the two months between November 2007 and February 2008 in which sufficient samples were collected to calculate compliance (Figure 5).

A high level of compliance with NHMRC (1990) swimming water guidelines was recorded at Sawtell Rockpool (Figure 5). The site was suitable for swimming in both months of the summer season in which sufficient samples were collected to calculate compliance (Figure 5).

Woolgoolga Lake and Hearn's Lake both passed the NHMRC (1990) swimming water guidelines in only one of two months between November 2007 and February 2008 in which sufficient samples were collected to calculate compliance (Figure 5).

A high level of compliance was recorded at Red Rock and Coffs Creek which passed NHMRC (1990) swimming water guidelines in both months in which sufficient samples were collected to calculate compliance (Figure 5). This result was similar to the previous season's when both sites complied with guidelines in all four months between November 2006 and February 2007 (DECC 2007).

Arrawarra Creek, Moonee Creek and Boambee Creek complied in only one of the two months. All sites failed in February 2008 owing to elevated levels of enterococci.

comply with swimming guidelines in both months in which sufficient samples were collected to calculate compliance (Figure 5).

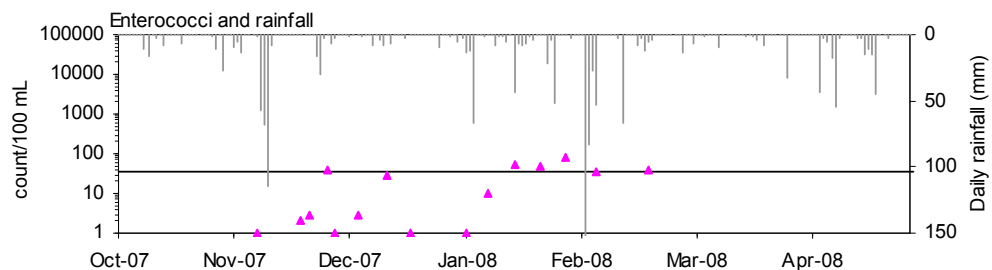
Timeseries plots Enterococci levels were generally low, with an occasional slightly elevated results recorded in January and February 2008 in response to heavy rainfall.

Enterococci levels were generally low throughout the monitoring period. Slightly elevated results were recorded at Emerald Beach in response to rainfall.

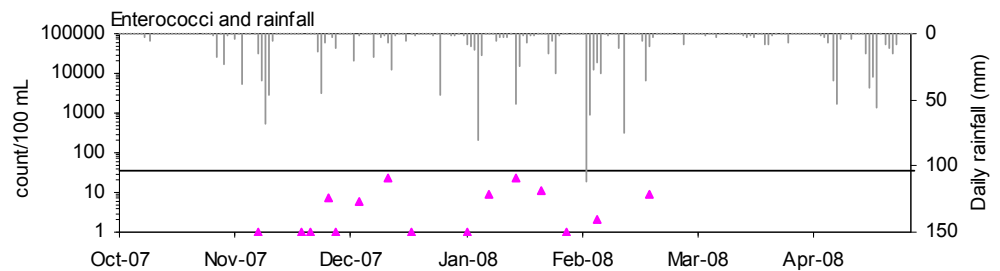
Levels of enterococci were generally low over the monitoring period, remaining below the median guideline values.

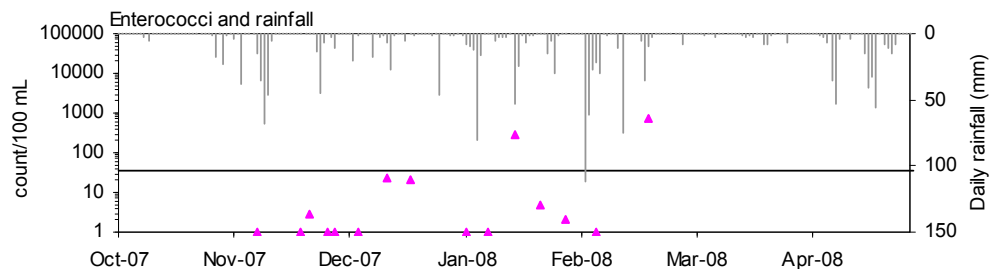
Levels of enterococci remained generally low over the monitoring period. Two elevated results were recorded in response to heavy rainfall.

Enterococci levels were generally low throughout the monitoring period, with only two elevated results recorded in response to heavy rainfall.

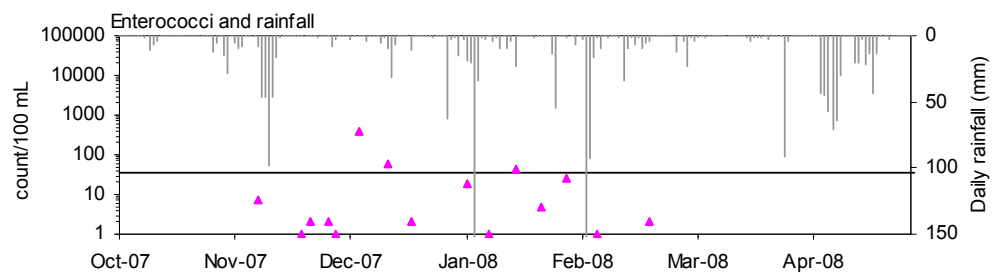
Levels of enterococci remained generally low over the monitoring period with only three elevated results recorded throughout the monitoring period, in both wet and dry weather conditions.

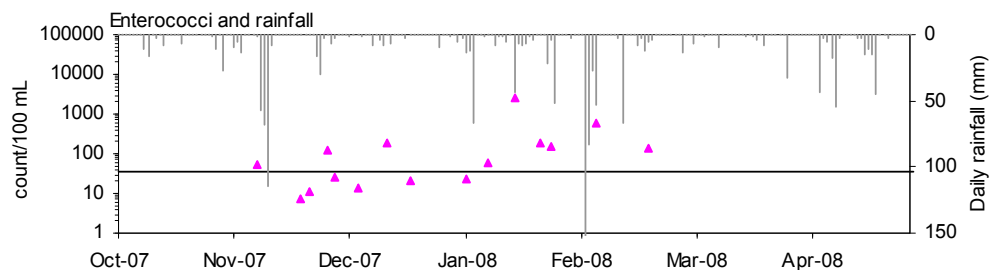
Timeseries plots Levels of enterococci frequently exceeded the geometric mean guideline limit, with very high values recorded on a number of occasions in response to rainfall.

Levels of enterococci frequently exceeded the geometric mean guideline limit at Woolgoolga Lake and Hearn's Lake, with very high values recorded on a number of occasions in response to rainfall.

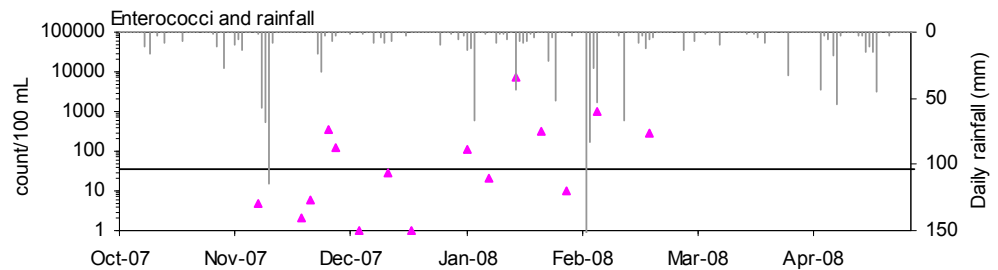
Timeseries plots Levels of enterococci frequently exceeded the geometric mean guideline limit, with very high values recorded on a number of occasions in response to rainfall.

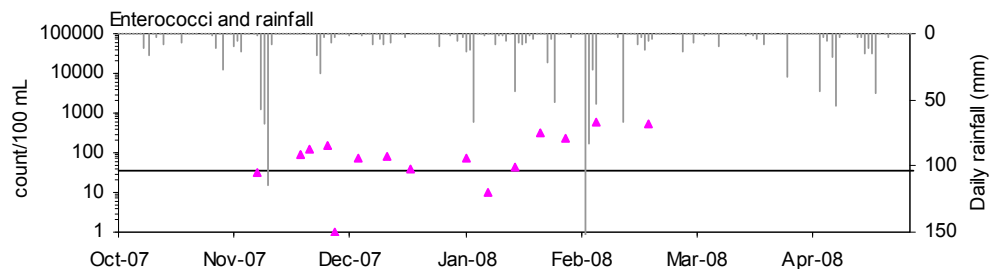
Timeseries plots Levels of enterococci usually exceeded the geometric mean guideline limit, with elevated levels recorded in both wet and dry weather conditions.

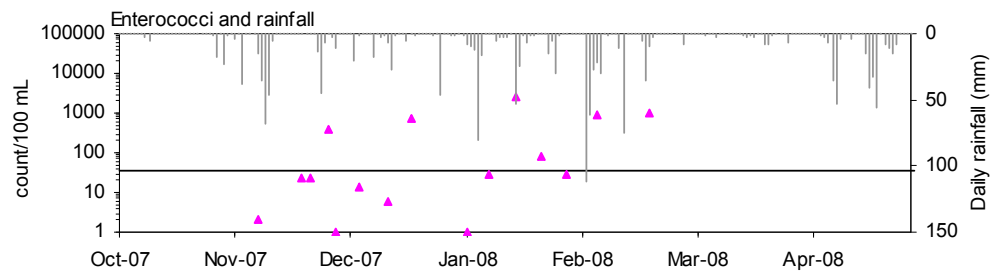
Levels of enterococci often exceeded the geometric mean guideline limit throughout the monitoring period, usually in response to rainfall. Very high results were recorded in January in response to heavy rainfall.

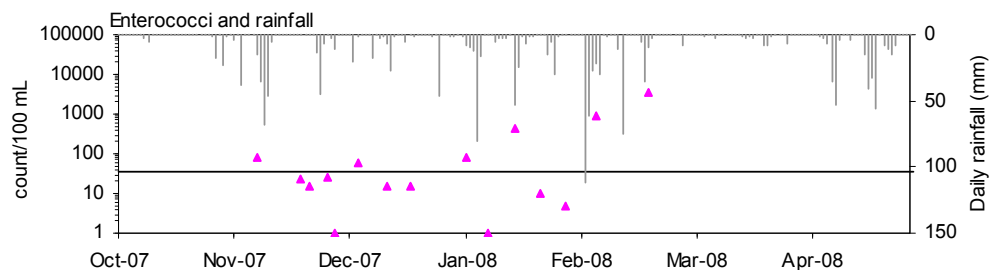
Levels of enterococci exceeded the geometric mean guideline limit on several occasions throughout the monitoring period. High levels were recorded in January and mid-February 2008 in response to heavy rainfall.

Although low levels of enterococci were often recorded at Coffs Creek throughout the monitoring period, some high results were recorded in January and mid-February 2008 in response to heavy rainfall.

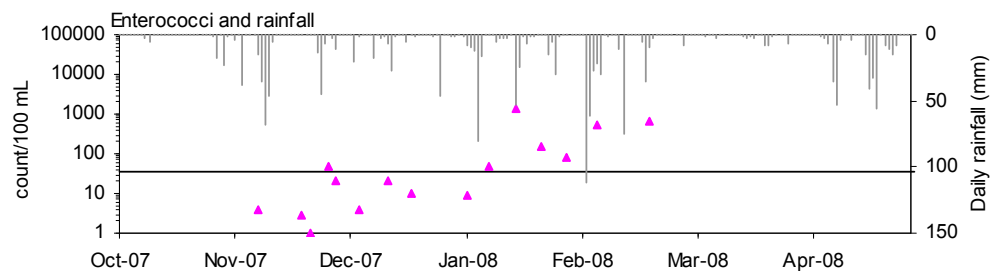
Levels of enterococci generally remained below the geometric mean guideline limits during November and December 2007. High levels of bacteria were measured from mid-January to February 2008 in response to heavy rainfall.

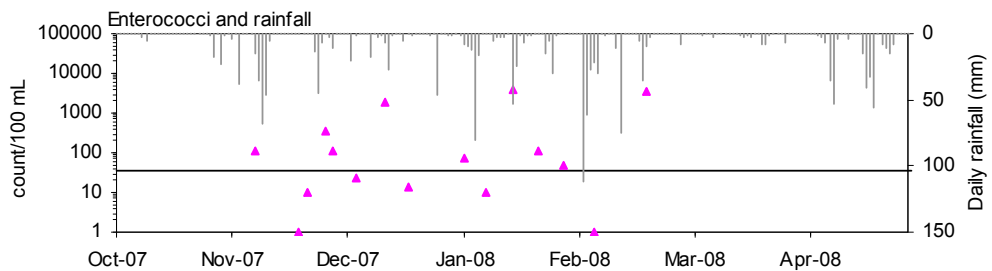
Timeseries plots Levels of enterococci were frequently above the geometric mean guideline limits. Very high levels of both bacteria were measured in December 2007 and January and February 2008 in response to heavy rainfall.
