Eurobodalla Shire Council

Ocean beaches: Cookies, Casey, Surf, Malua Bay, Broulee, Bengello, Shelley, Tuross Main, Brou, Narooma Main. **Netted beach:** Wagonga Inlet.

Program outline

Eleven swimming sites were monitored by Eurobodalla Shire Council between October 2007 and April 2008. The sites were 10 ocean beaches and a netted beach just within the breakwalls of Wagonga Inlet.

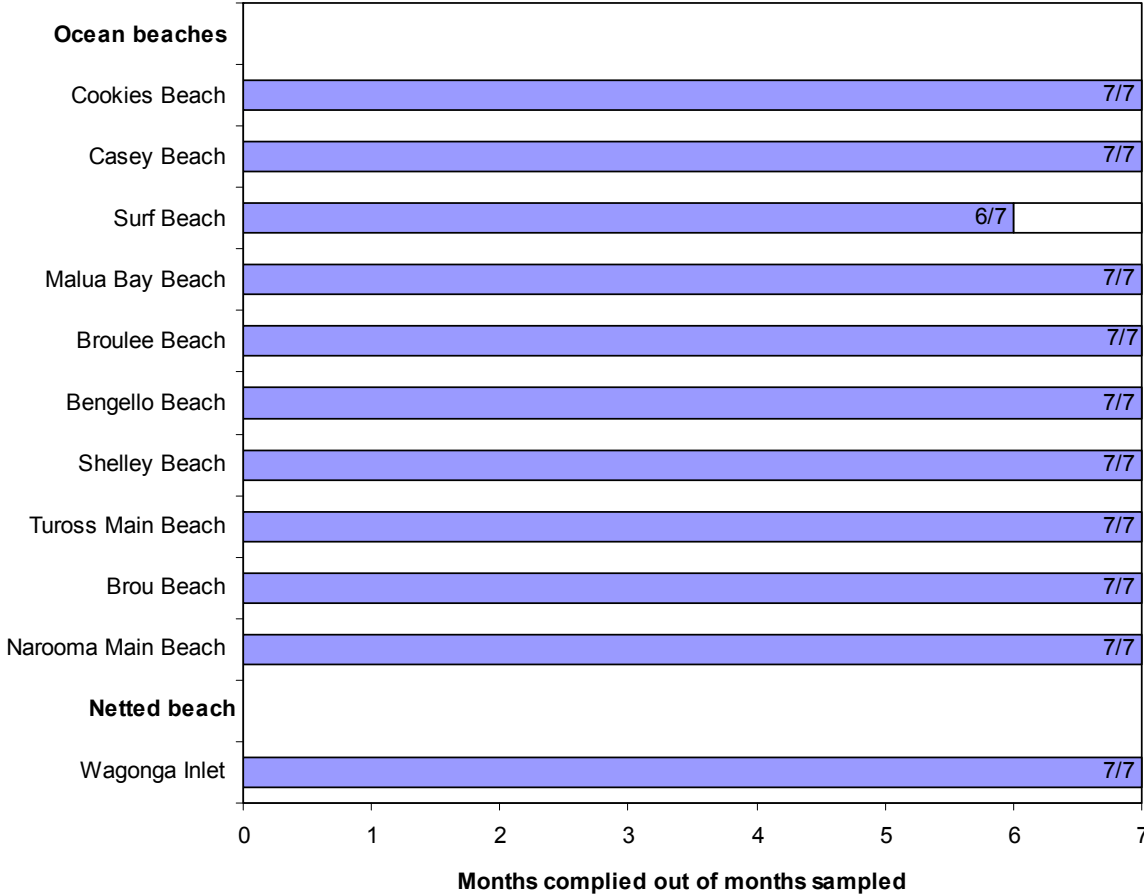
Figure 12: Summary of compliance with NHMRC (1990) microbiological guidelines for swimming at Eurobodalla Shire Council swimming sites over the 2007–2008 summer season

Nine of the 10 ocean beaches consistently complied with the NHMRC (1990) swimming water quality guidelines in all seven months of the 2007–2008 summer swimming season (Figure 12).

A relatively high level of compliance was also recorded at Surf Beach. This site complied in six of the seven months, failing the guidelines in November 2007 owing to elevated levels of enterococci.

The netted beach at Wagonga Inlet consistently complied with the NHMRC (1990) swimming water quality guidelines in all seven months of the 2007–2008 summer swimming season (Figure 12).

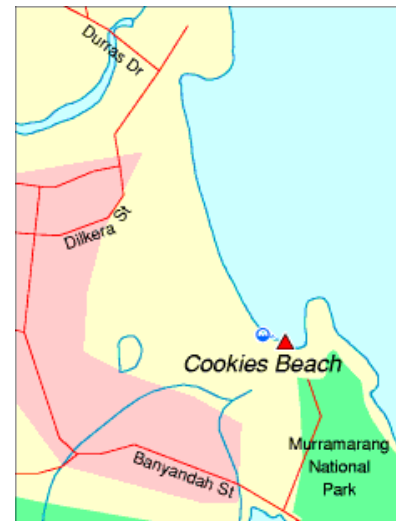
Description Cookies Beach is situated east of the South Durras township. The sampling site is located at the southern end of the beach, adjacent to a caravan park and boat ramp, and north of the Murrumurang Resort National Park. The beach is popular with tourists and the local community.

Pollution sources Urban stormwater is discharged at the southern end of the beach. Water quality may also be affected by onsite wastewater management systems within the catchment.

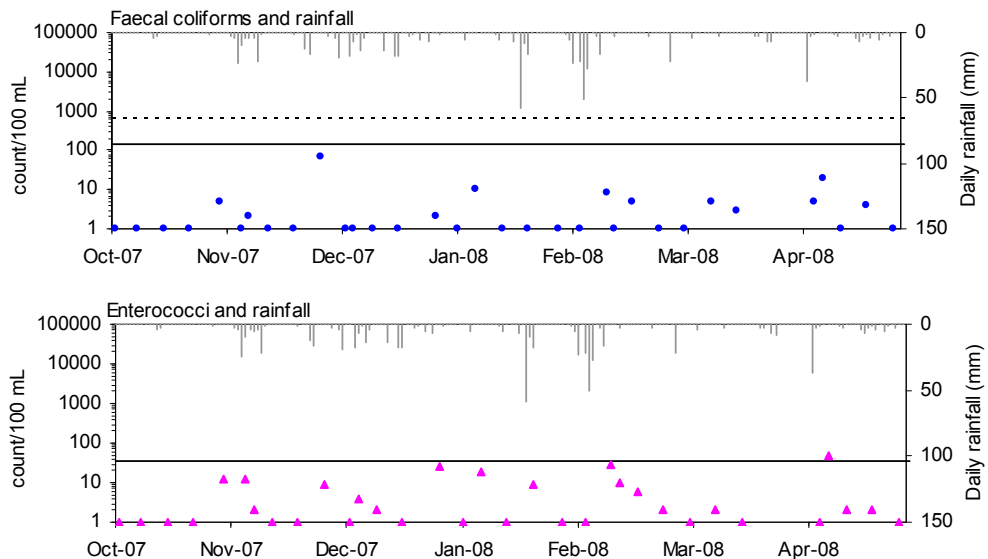
Timeseries plots

Levels of faecal coliforms and enterococci were generally low throughout the monitoring period. A single elevated enterococci result was recorded in early April 2008.

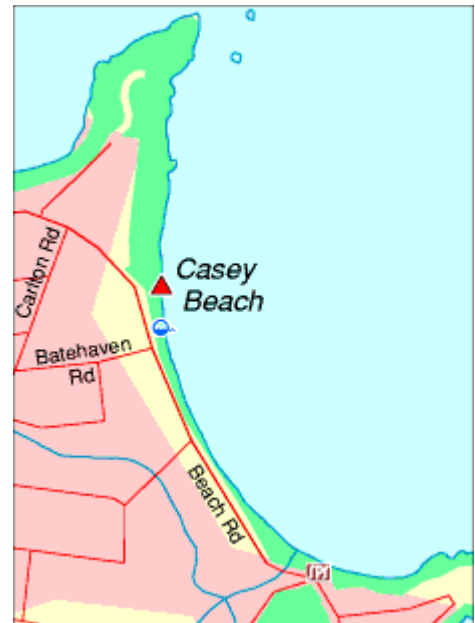
Casey Beach is approximately one kilometre long and is located to the south of Observation Point. The beach is not patrolled. It is backed by the village of Batehaven and is a popular swimming location for local residents and tourists. Fishing from the rocks of Observation Point is also popular.

Urban stormwater runoff is discharged via an outlet adjacent to the sampling site. Beach water quality may also be affected by overflows from a sewage pumping station at the southern end of the beach and leachate from onsite wastewater systems within the catchment.

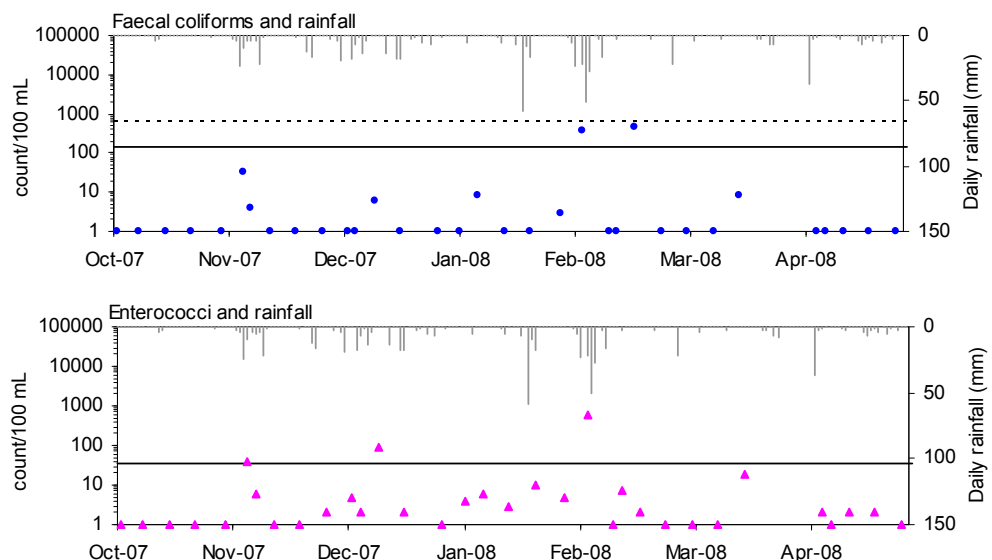
Timeseries plots

Levels of faecal coliforms and enterococci were generally low throughout the monitoring period, with slightly elevated values measured on two occasions for both bacterial indicators, but not always in response to rainfall.

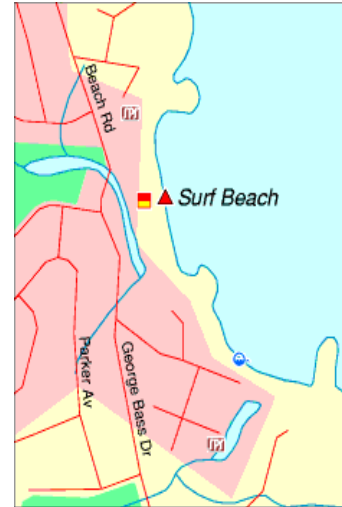
Description Surf Beach is approximately 300 metres long and backed by a parking area and shops. The beach is patrolled during summer and considered to be a safe swimming beach. It is popular with local residents and tourists.

Pollution sources Wimbie Creek discharges across Wimbie Beach at the southern end of the beach. Wimbie Creek carries urban stormwater, may be affected by leachate from a local landfill, and also carries wet weather overflows from the sewage treatment plant. A sewage pumping station at the northern end of the beach and public toilets in the beach reserve are also potential sources of faecal contamination via an unnamed creek behind the beach.

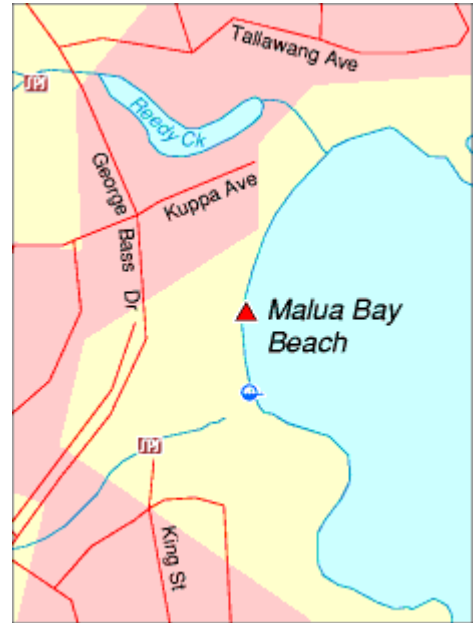
Malua Bay Beach is approximately 400 metres long and backed by a surf club, picnic facilities and a parking area. The beach is popular with both the local community and tourists.

Beach water quality may be affected by discharges from Reedy Creek at the northern end of the beach, the stormwater outlet to the south of the sampling area, and leachate from onsite wastewater management systems within the catchment. Overflows from a sewage pumping station behind the beach may also affect water quality at the beach.

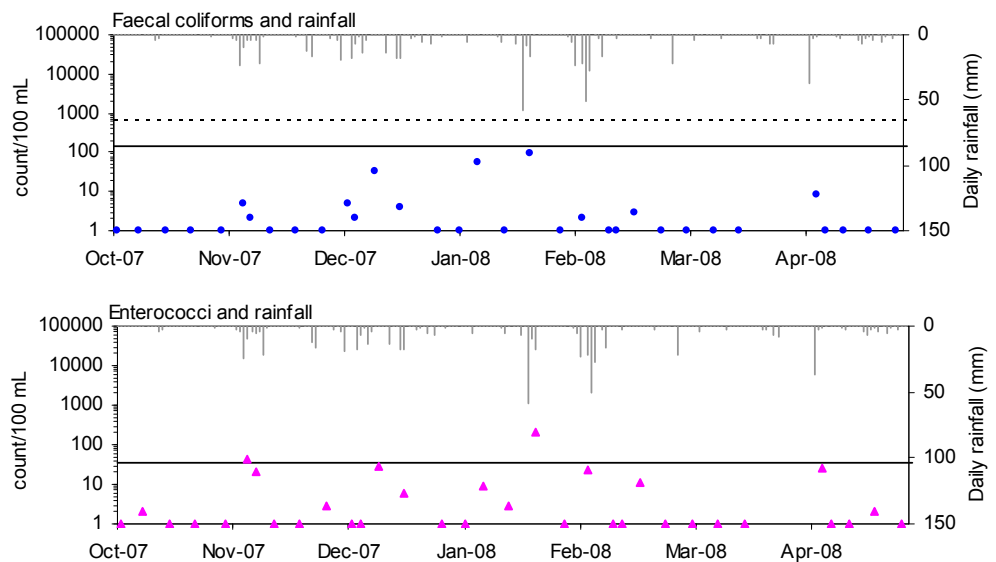
Timeseries plots

Levels of indicator bacteria were generally low throughout the monitoring period. A single elevated enterococci result was recorded in late January 2008, in response to heavy rainfall.

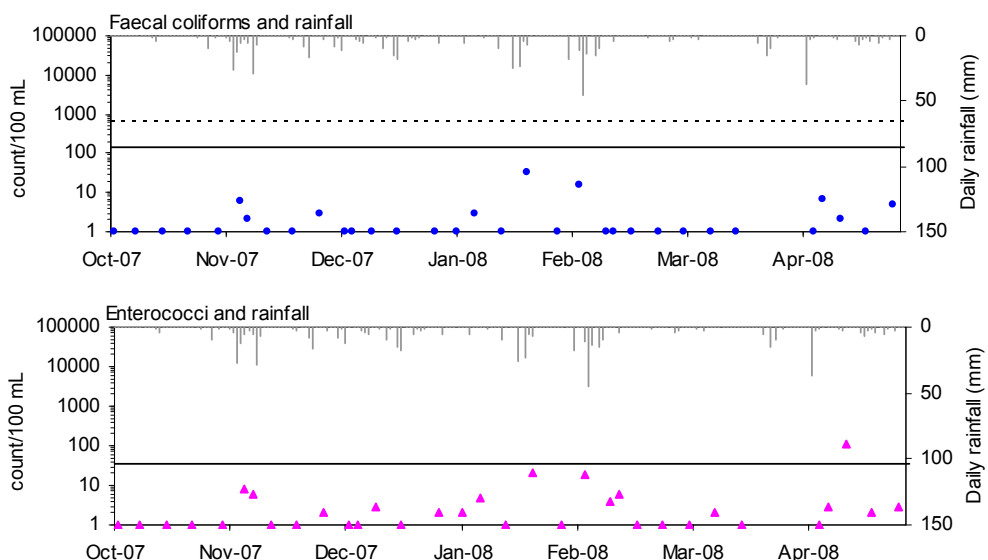
Timeseries plots

Levels of indicator bacteria were generally low throughout the monitoring period, remaining below the median and geometric mean guideline levels. A single elevated enterococci result was recorded in April 2008 in dry weather conditions.

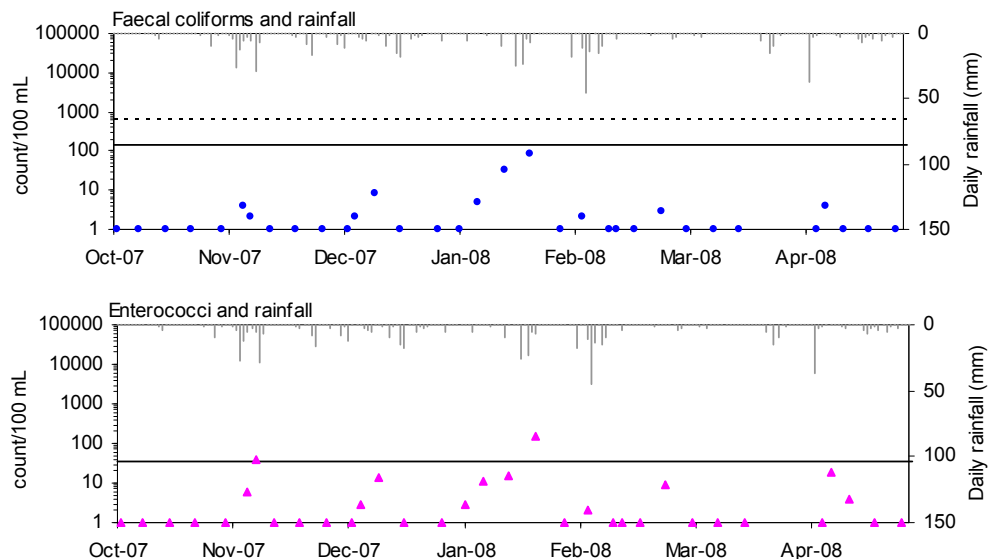
Timeseries plots

Levels of faecal coliforms were generally low throughout the monitoring period. A single elevated level of enterococci was recorded on only one occasion, following rainfall.

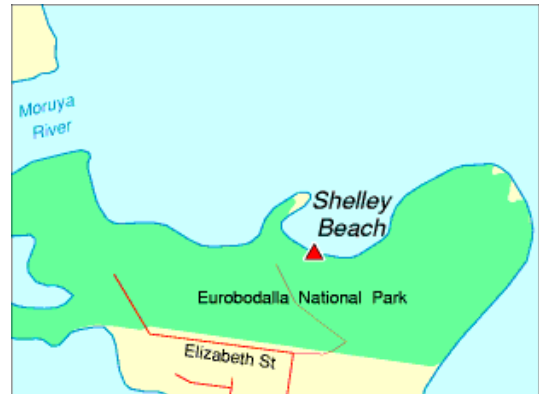
Shelley Beach is situated east of the mouth of the Moruya River. It is backed by a well vegetated council reserve and accessed by a walkway. It is protected from the east and the south by the headland that is part of the Eurobodalla National Park. The location is popular with the local community and tourists.

Beach water quality may be affected by urban stormwater runoff and overflows from a nearby sewage pumping station. A sewage treatment plant discharging to the Moruya River may also contribute to faecal contamination at this site.

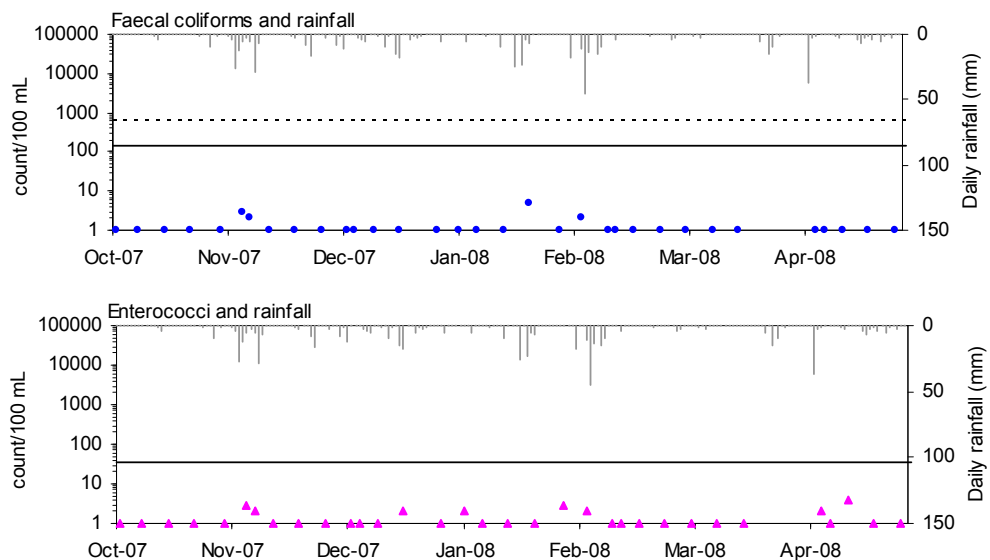
Timeseries plots

Levels of faecal coliforms and enterococci remained very low throughout the monitoring period, providing no evidence of sewage contamination.

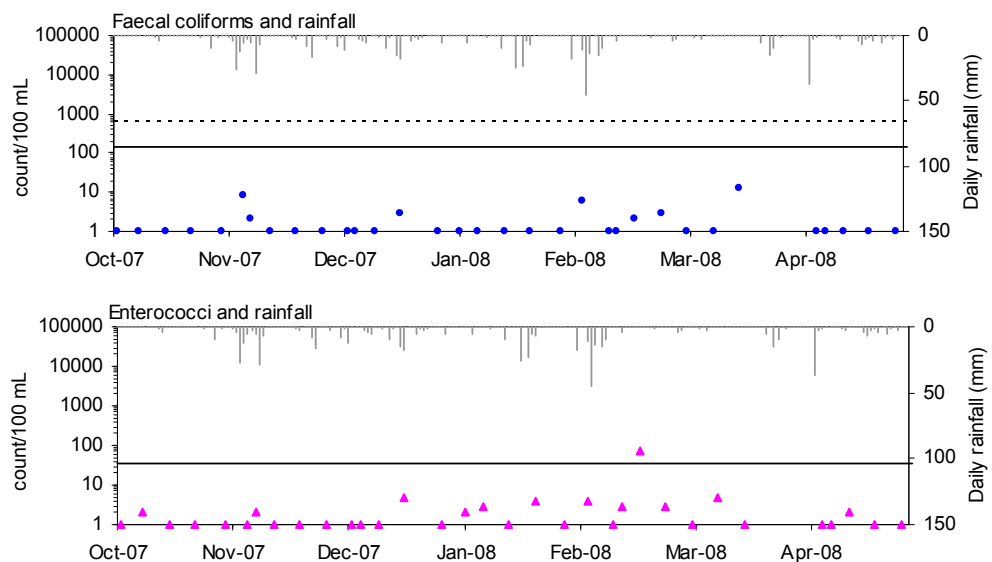
Timeseries plots Levels of faecal coliforms and enterococci were generally very low throughout the monitoring period. A slightly elevated enterococci level was recorded on one occasion in February 2008 in dry weather conditions.

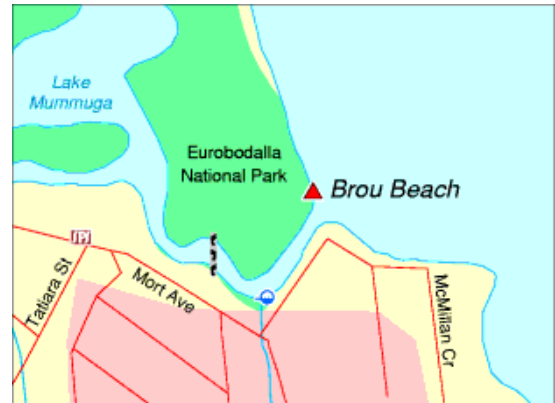
Description Brou Beach is approximately 6.5 kilometres long and located to the north of the township of Dalmeny. The sampling site is near the entrance of Lake Mummuga. Access to the beach is via the southern end, which is also popular for surfing and fishing.

Pollution sources Urban stormwater from the town of Dalmeny potentially affects water quality at the beach. Outflow from Lake Mummuga may contain faecal contamination from rural runoff and overflows from sewerage pumping stations.

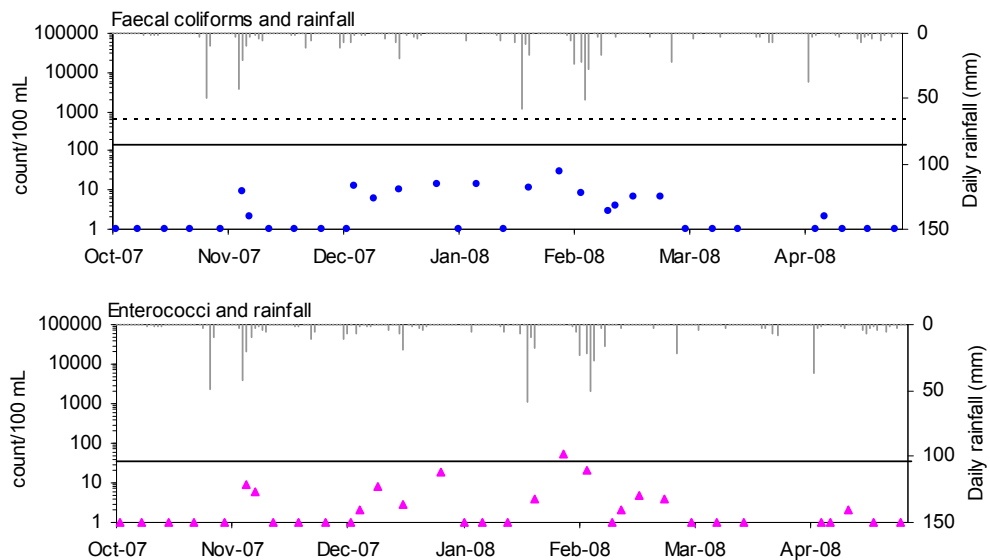
Timeseries plots Levels of faecal coliforms and enterococci were generally low throughout the monitoring period, with a slightly elevated enterococci level recorded during dry weather on one occasion in January 2008.

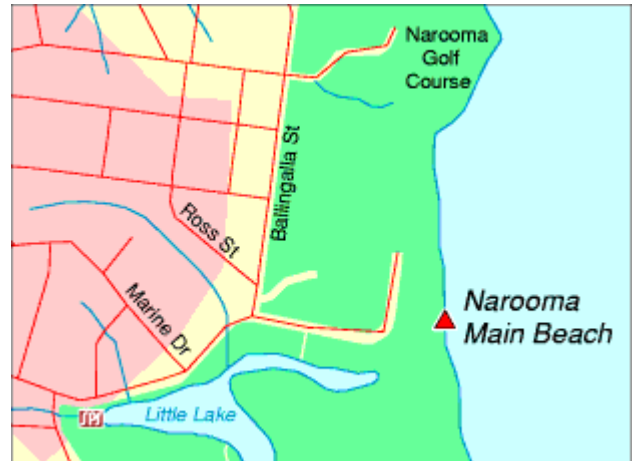
Narooma Beach is approximately 750 metres long and is a popular for surfing and fishing. The sampling site is located at the northern end of the beach, adjacent to the surf club.

Urban stormwater from the residential area behind the beach and a nearby industrial estate potentially affect water quality at Narooma Main Beach. Runoff from Narooma golf course and overflows from the sewage pumping station in the Little Lake catchment may also contribute to faecal contamination at the site.

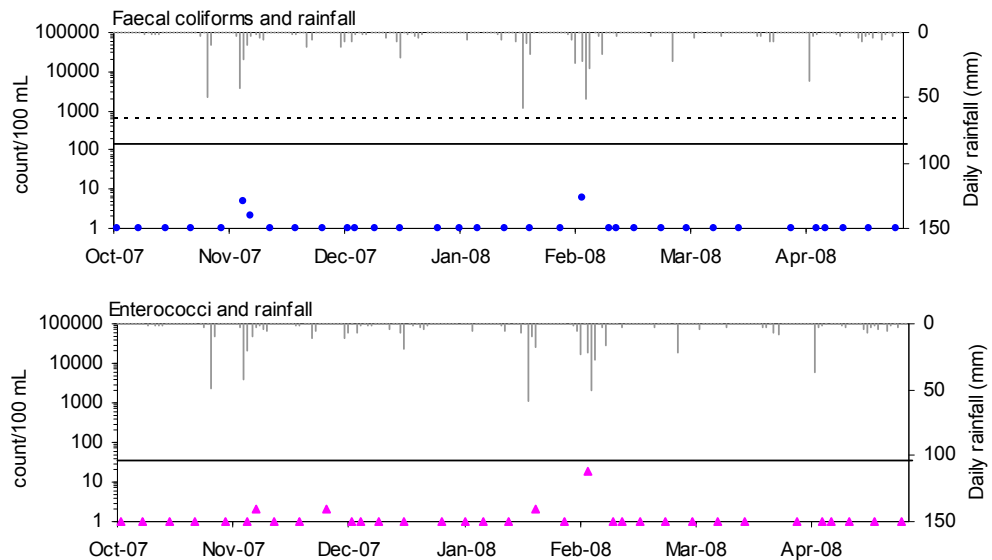
Timeseries plots

Levels of faecal coliforms and enterococci remained low throughout the monitoring period, providing no evidence of sewage contamination.

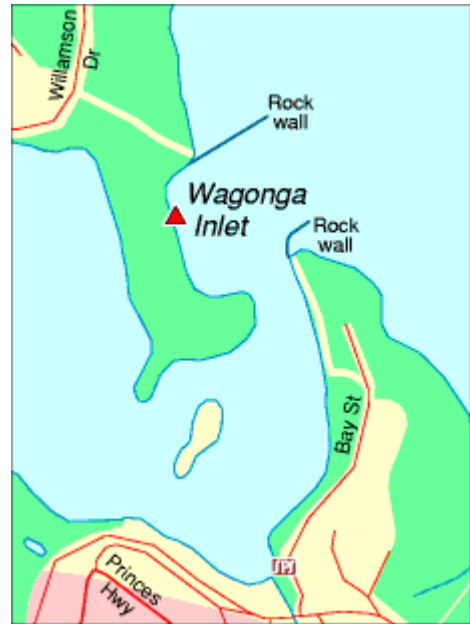
Pollution sources Outflow from the Wagonga Inlet may be affected by urban stormwater runoff and rural runoff from the upper catchment. Recreational and commercial boating traffic, together with onsite wastewater management systems, may also contribute to faecal contamination at the swimming area.

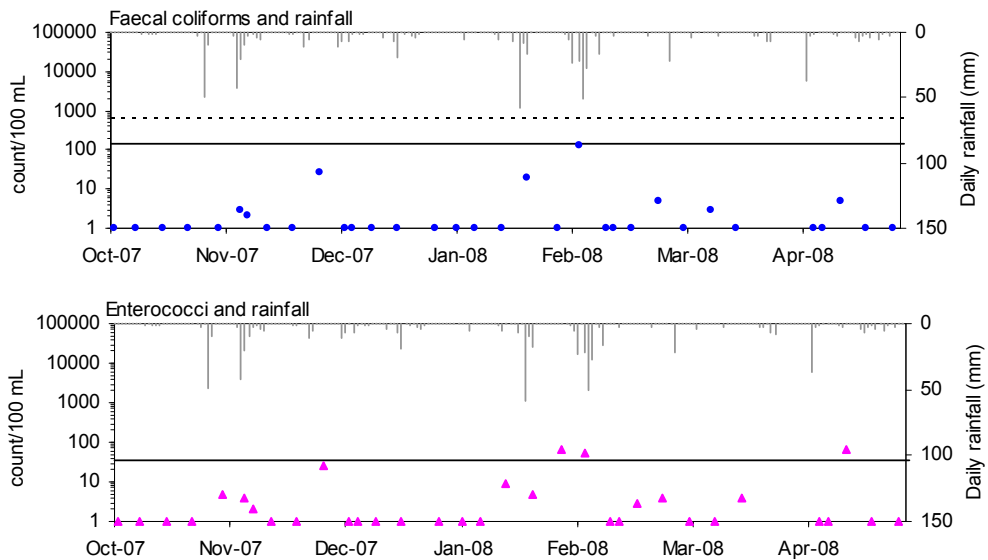
Timeseries plots Levels of faecal coliforms were generally low throughout the monitoring period. Slightly elevated enterococci levels were recorded on several occasions in both wet and dry conditions.
