Kempsey Council

Program outline

Figure 6: Summary of compliance with NHMRC (1990) microbiological guidelines for swimming at Kempsey Council swimming sites during the 2007–2008 summer swimming season

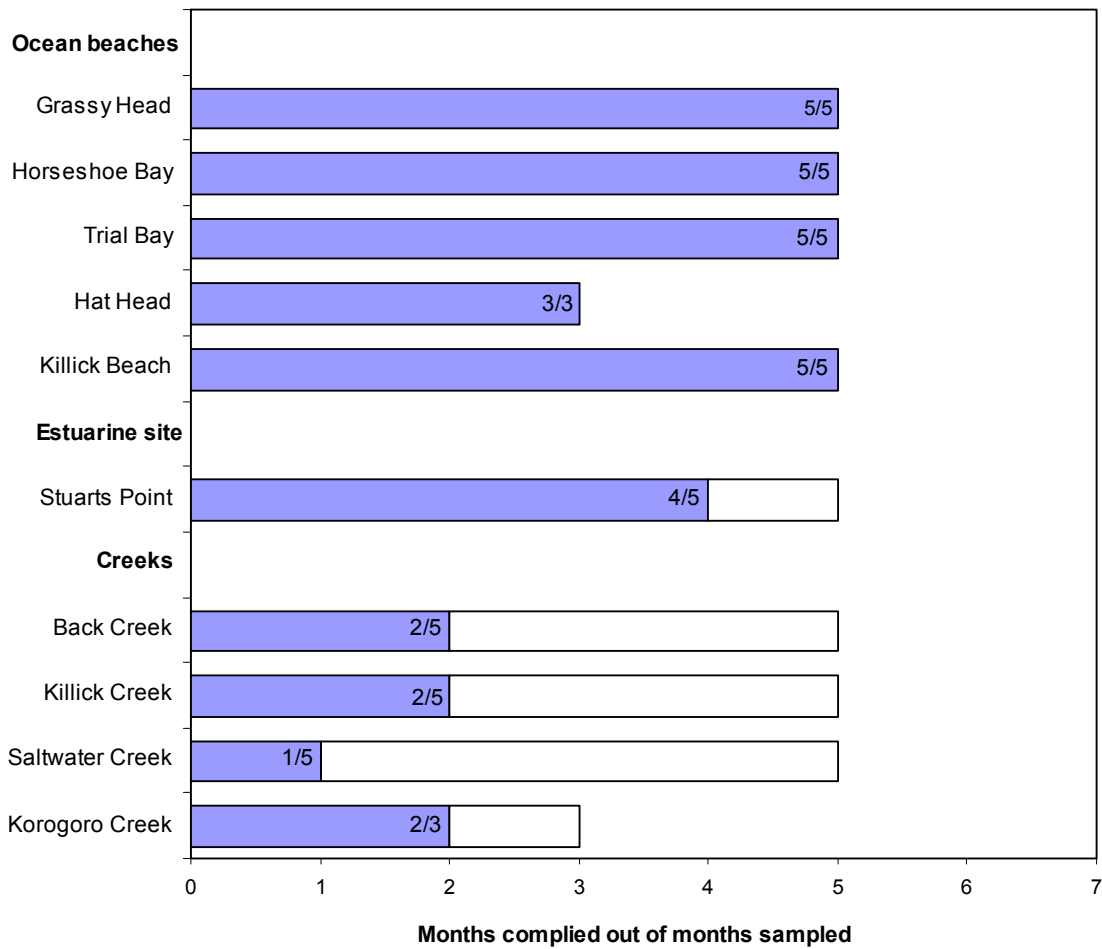
A high level of compliance with NHMRC (1990) swimming guidelines was recorded

at the ocean beaches during the 2007–2008 summer swimming season (Figure 6).

Grassy Head, Horseshoe Bay, Trial Bay, Hat Head and Killick beaches all complied with the swimming guidelines in all months in which sufficient samples were collected.

A high level of compliance was recorded at Stuarts Point, which complied with the NHMRC (1990) swimming water quality guidelines in four of the five months in which sufficient samples were collected (Figure 6).

A low level of compliance was recorded at Killick Creek and Back Creek, which passed the NHMRC (1990) swimming water quality guidelines in only two of five months during the summer swimming season (Figure 6). Korogoro Creek complied with swimming guidelines in October 2007 and January 2008, only two of the three months in which sufficient samples were collected to calculate compliance.

Compliance in Saltwater Creek was the lowest, complying with swimming guidelines in only one of the five months in which sufficient samples were collected (Figure 6).

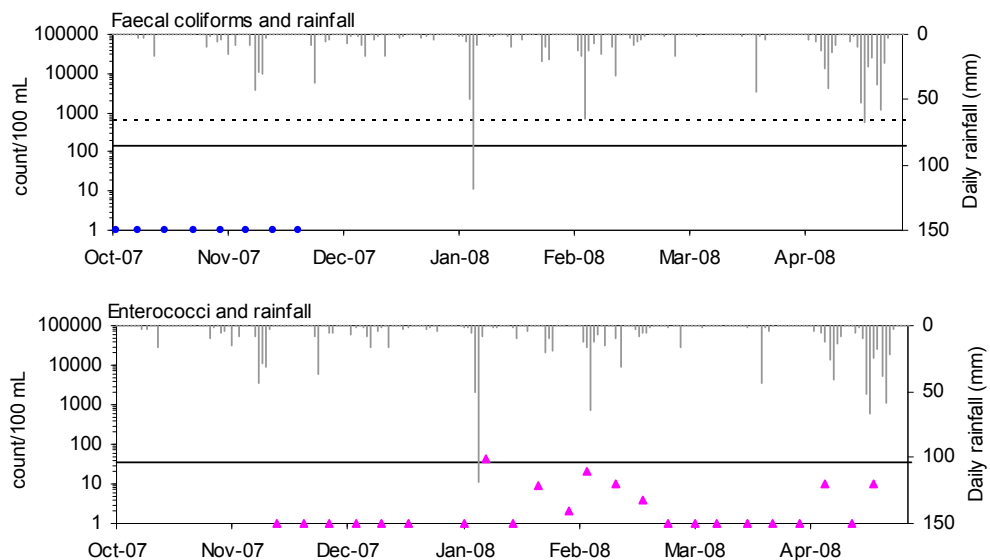
Bacterial levels generally remained low and below the median and geometric mean guideline values throughout the monitoring period. A single elevated enterococci result was recorded in January 2008 following heavy rainfall.

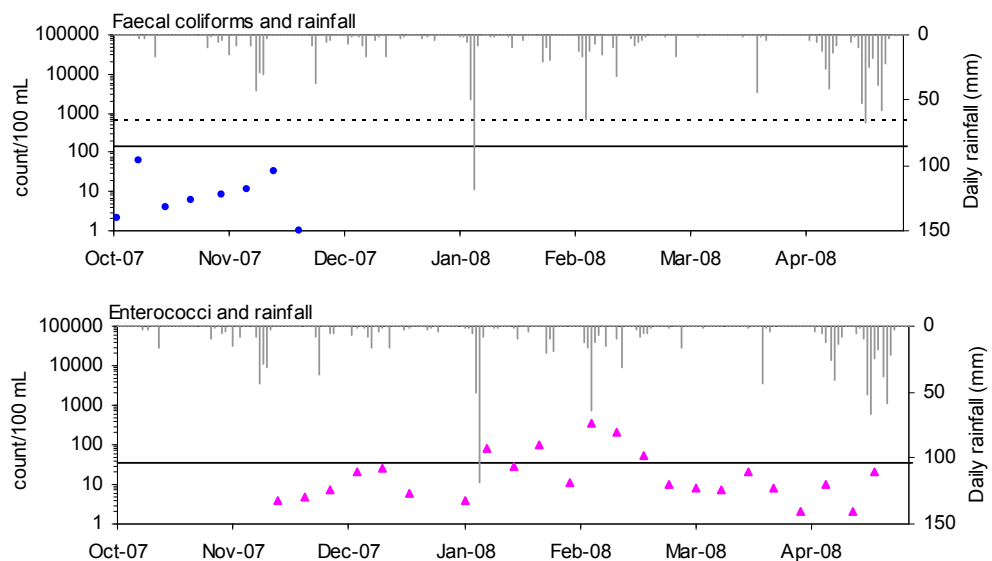
Levels of bacteria mostly remained below the median and geometric mean guideline limits over the monitoring period, with some elevated enterococci levels recorded in January 2008 and February 2008 in response to rainfall.

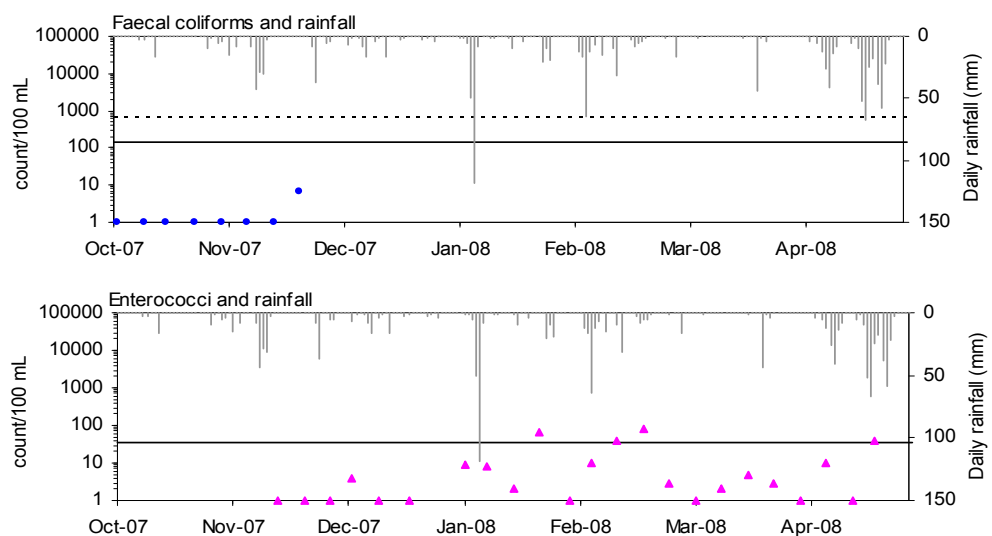
Levels of bacteria remained generally low over the monitoring period, with enterococci levels exceeding the geometric mean guideline value on only two occasions.

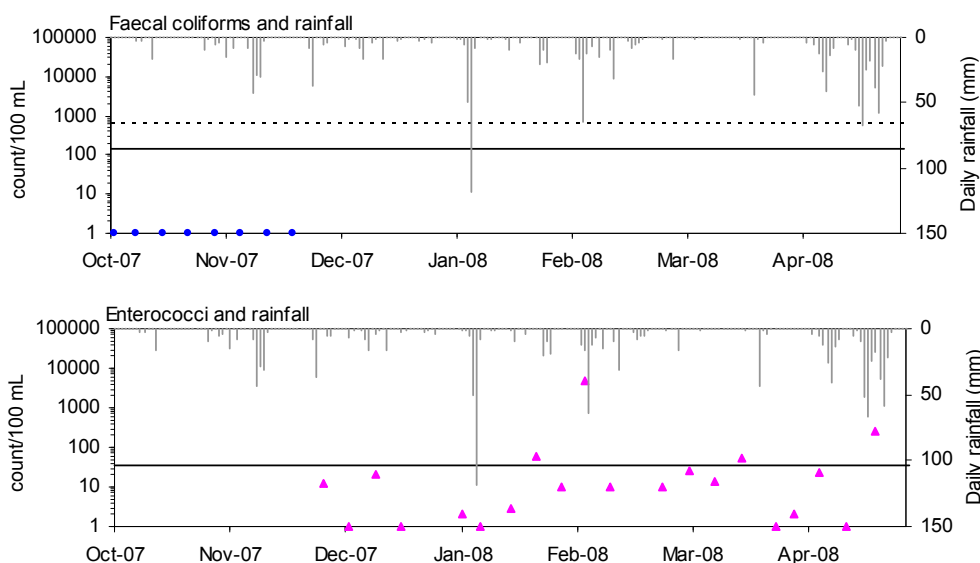
Bacterial levels remained generally low over the monitoring period, with elevated levels recorded on four occasions. A very high value was recorded in February 2008 during heavy rainfall.

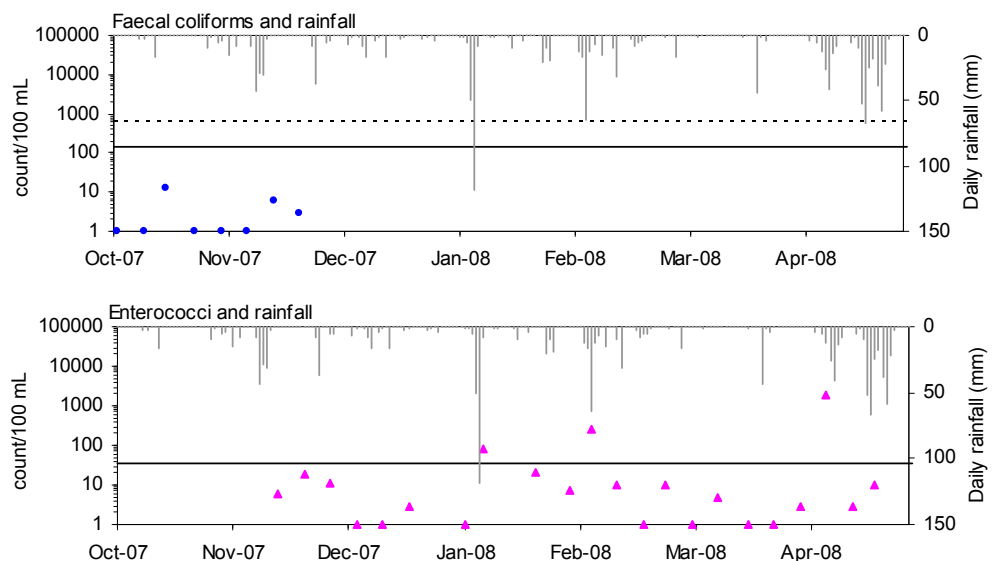
Bacterial levels generally remained below the median and geometric mean guideline levels throughout the monitoring period. Elevated values were recorded on three occasions mostly in response to heavy rainfall.

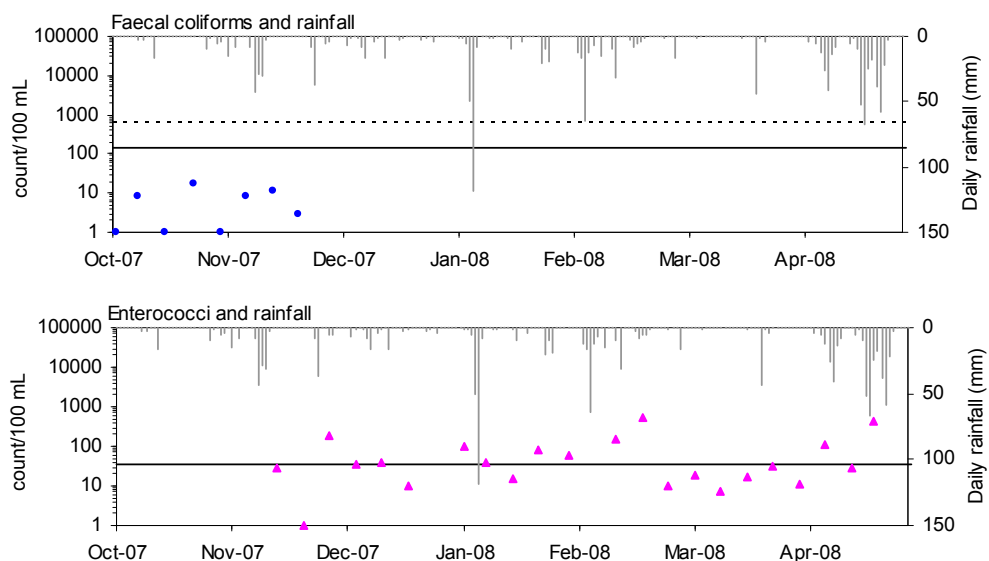
Timeseries plots Slightly elevated levels were recorded throughout the monitoring period, with values exceeding the guidelines limits on several occasions, often in response to rainfall.

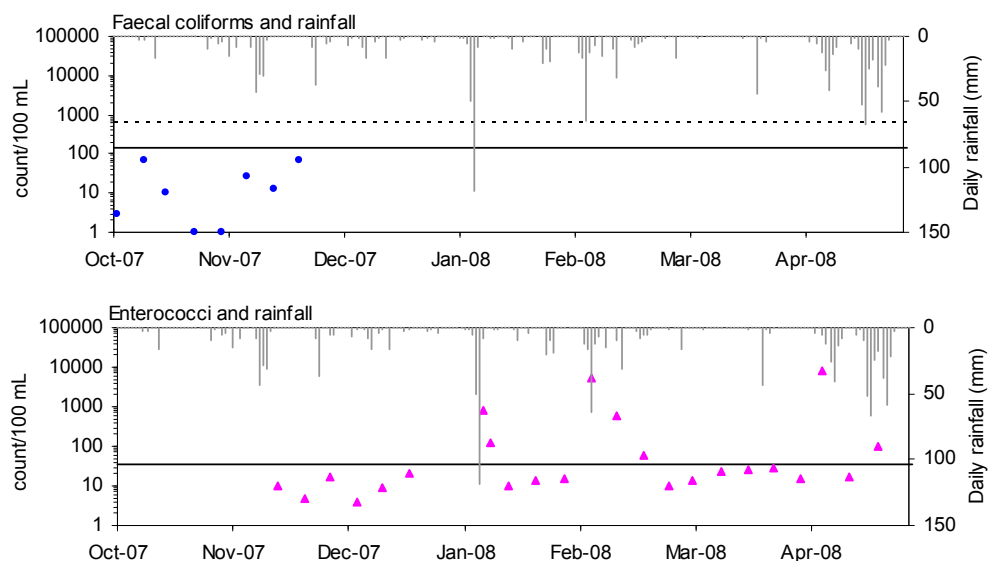
Elevated bacterial levels were recorded on several occasions throughout the monitoring period. Very high values were recorded in February and April 2008 in response to rainfall.

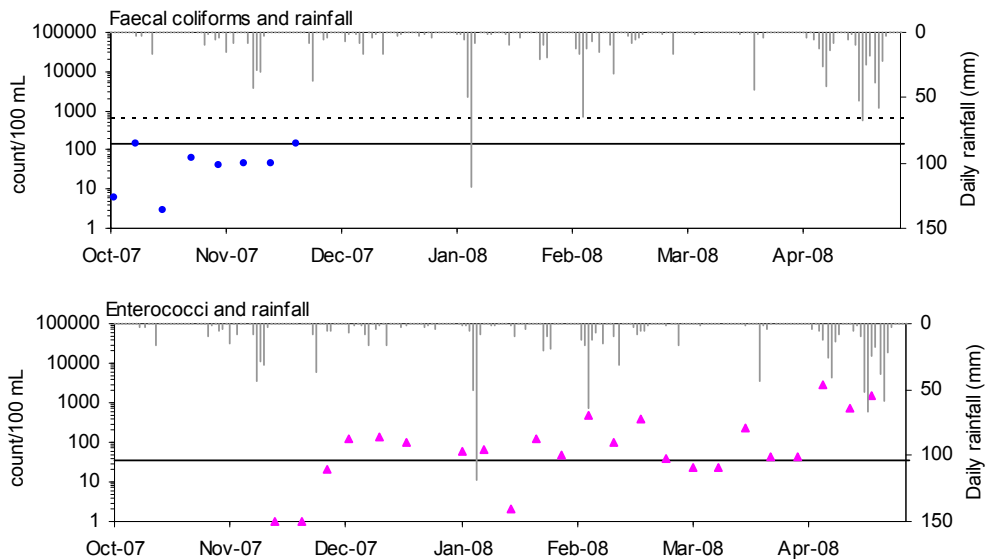
Timeseries plots Elevated levels of bacteria were measured throughout the monitoring period, in both wet and dry weather conditions.

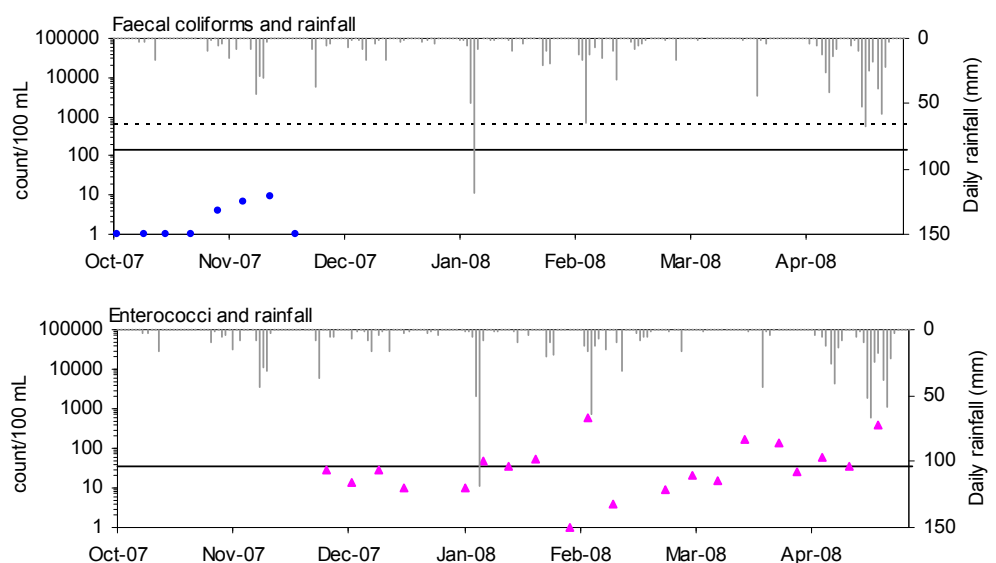
Slightly elevated levels of bacteria were recorded during the last four months of the monitoring period in both wet and dry weather conditions.
