Shoalhaven City Council

Ocean beaches: Shoalhaven Heads, Tilbury Cove, Warrain, Collingwood, Cudmirrah, Mollymook, Rennies, Racecourse, Bawley Point, Merry.

Program outline

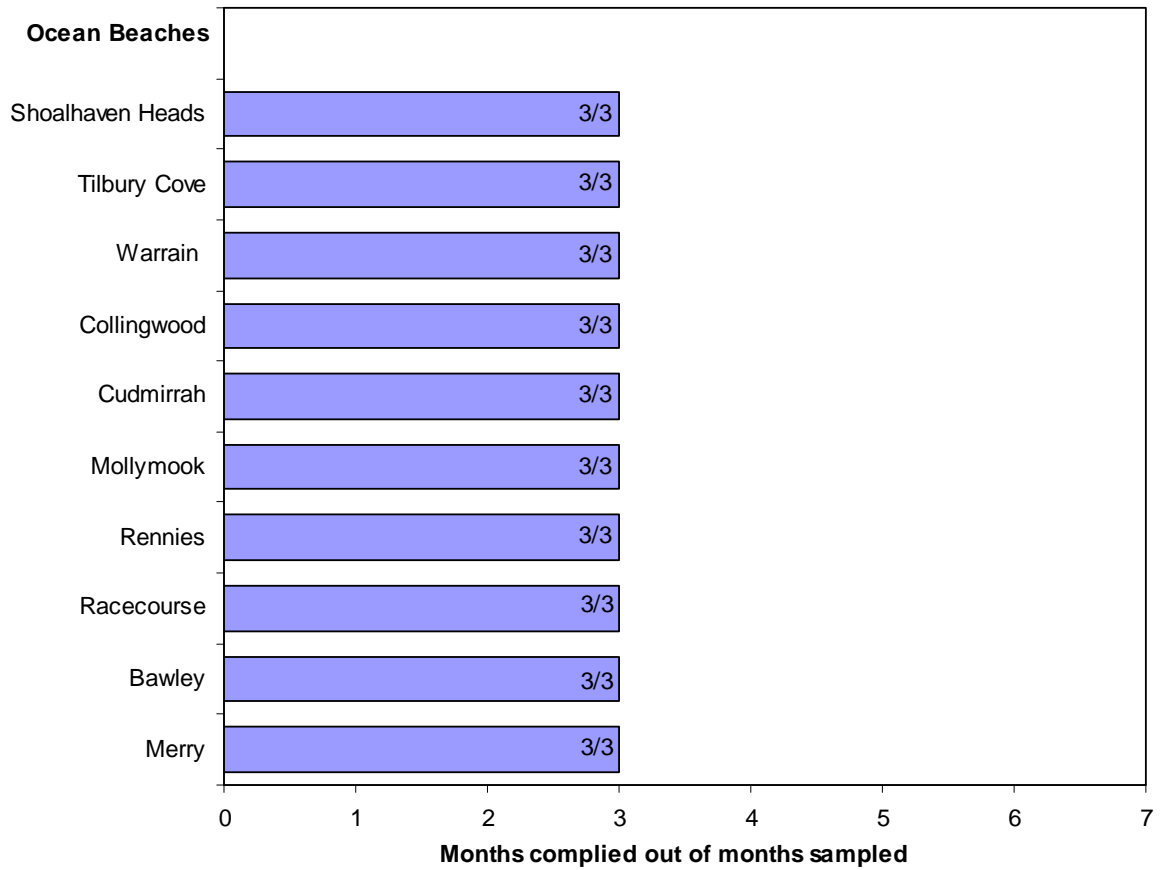
Figure 11: Summary of compliance with NHMRC (1990) microbiological guidelines for swimming at Shoalhaven City Council swimming sites over the 2007–2008 summer season

A high level of compliance was recorded at ocean beaches in the Shoalhaven. All ten beaches complied with the NHMRC (1990) swimming water quality guidelines in the three months between December 2007 and February 2008 (Figure 11).
