# Ballina Shire Council

## State of the Beaches 2012–2013

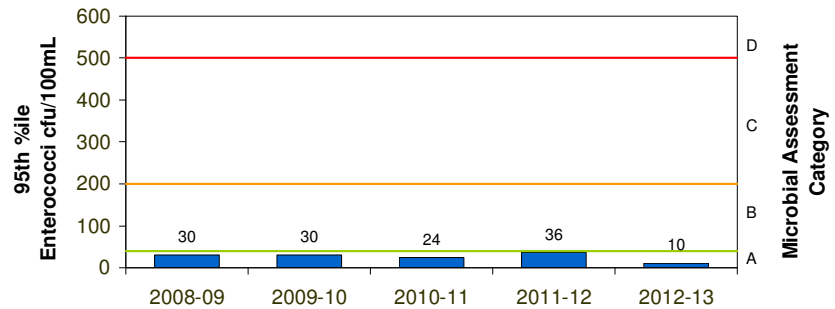
## Microbial Assessment: **A**

Monitoring period for 2012–13 result is November 2008 to February 2013.

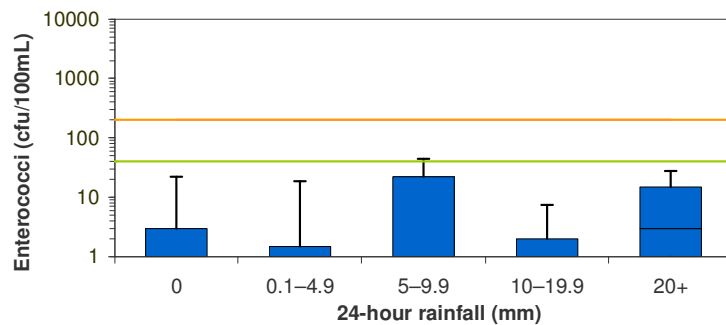
## Response to rainfall

The response to rainfall graph indicates that levels of enterococci generally remain below the safe swimming limit across all rainfall categories, showing little response to rainfall.

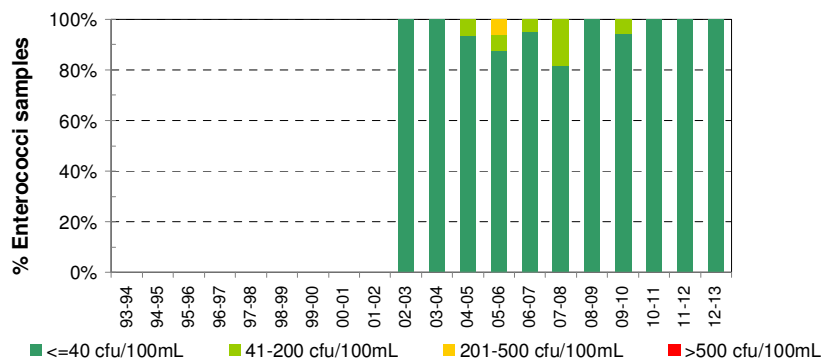
## Trends in enterococci data through time

The site has been monitored since 2002 and microbial water quality has been of a generally high standard.

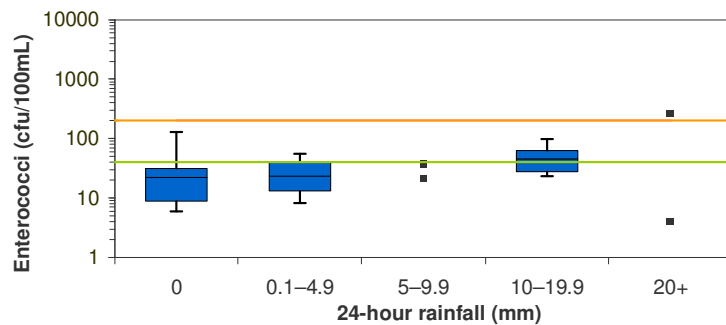
## Response to rainfall

The response to rainfall graph indicates that enterococci levels increased slightly with increasing rainfall, occasionally exceeding the safe swimming limit after only low levels of rain.

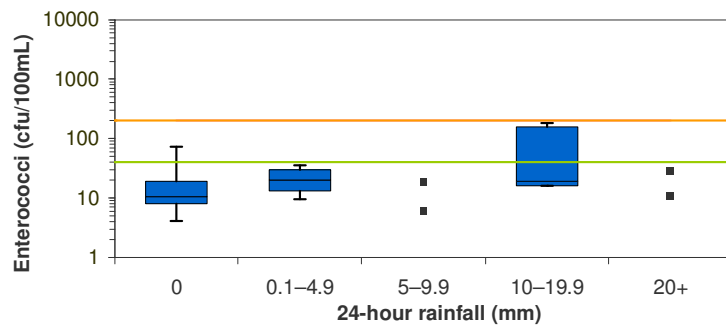
## Response to rainfall

The response to rainfall graph indicates that enterococci levels increased slightly with increasing rainfall, often exceeding the safe swimming limit after 10 mm or more of rain.

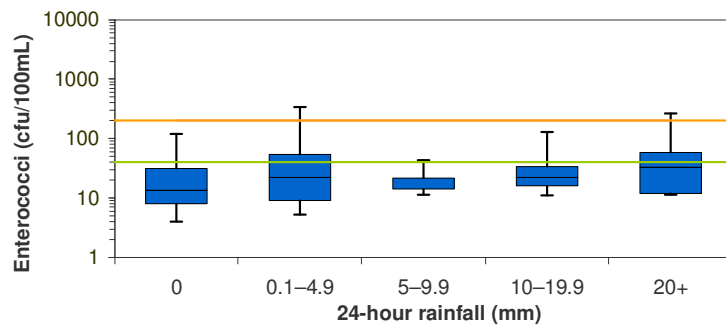
## Response to rainfall

The response to rainfall graph indicates that enterococci levels increased slightly with increasing rainfall, often exceeding the safe swimming limit after only low levels of rain.

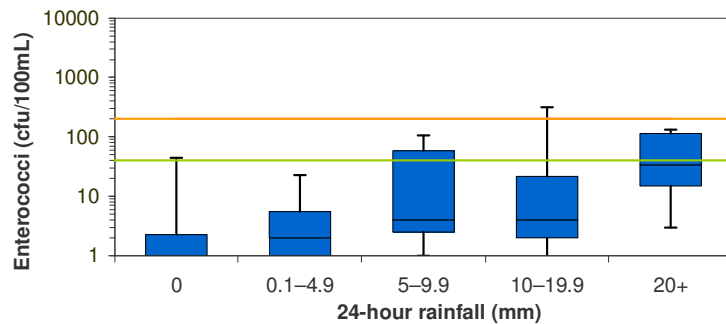
## Response to rainfall

The response to rainfall graph indicates that enterococci levels increased with increasing rainfall often exceeding the safe swimming limit in response to 5 mm of rainfall.

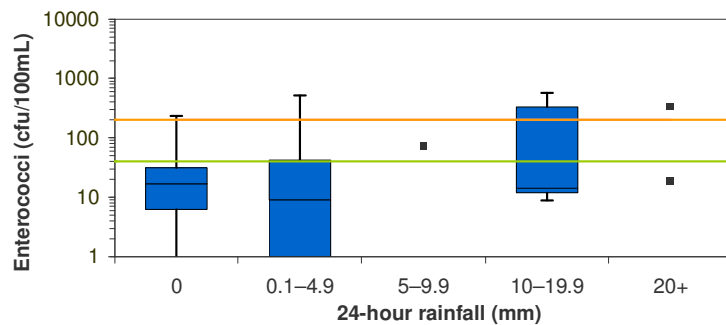
## Response to rainfall

The response to rainfall graph indicates that enterococci levels increased with increasing rainfall, often exceeding the safe swimming limit in response to 10 mm or more of rain.

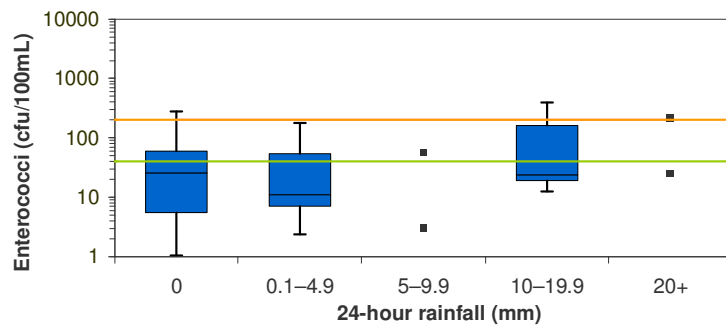
## Response to rainfall

Enterococci levels generally increased with increasing rainfall and often exceeded the safe swimming limit in response to little or no rain.

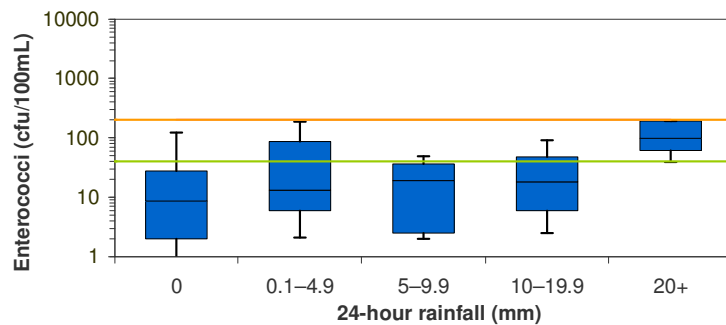
## Response to rainfall

The response to rainfall graph indicates that enterococci levels increased slightly with increasing rainfall, usually exceeding the safe swimming limit in response to 20 mm or more of rainfall.

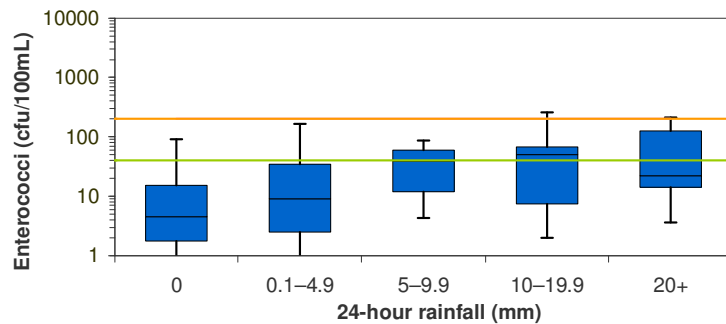
## Response to rainfall

The response to rainfall graph indicates that enterococci levels increased slightly with increasing rainfall, often exceeding the safe swimming limit in response 5 mm of rainfall or more.

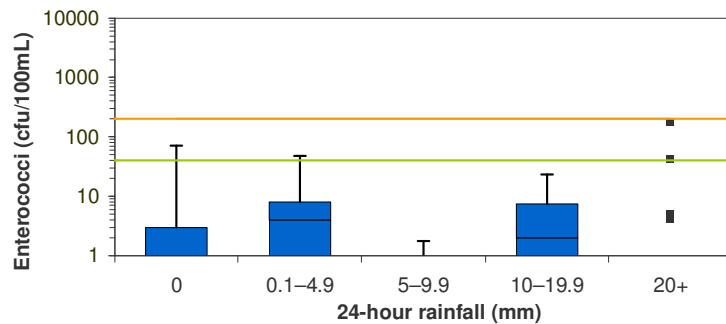
## Response to rainfall

The response to rainfall graph indicates that levels of enterococci increased slightly in response to rainfall, but generally remain below the safe swimming limit across all rainfall categories.
