# Central Sydney (Bondi to Little Bay & Sydney Harbour)

## State of the Beaches 2012–2013

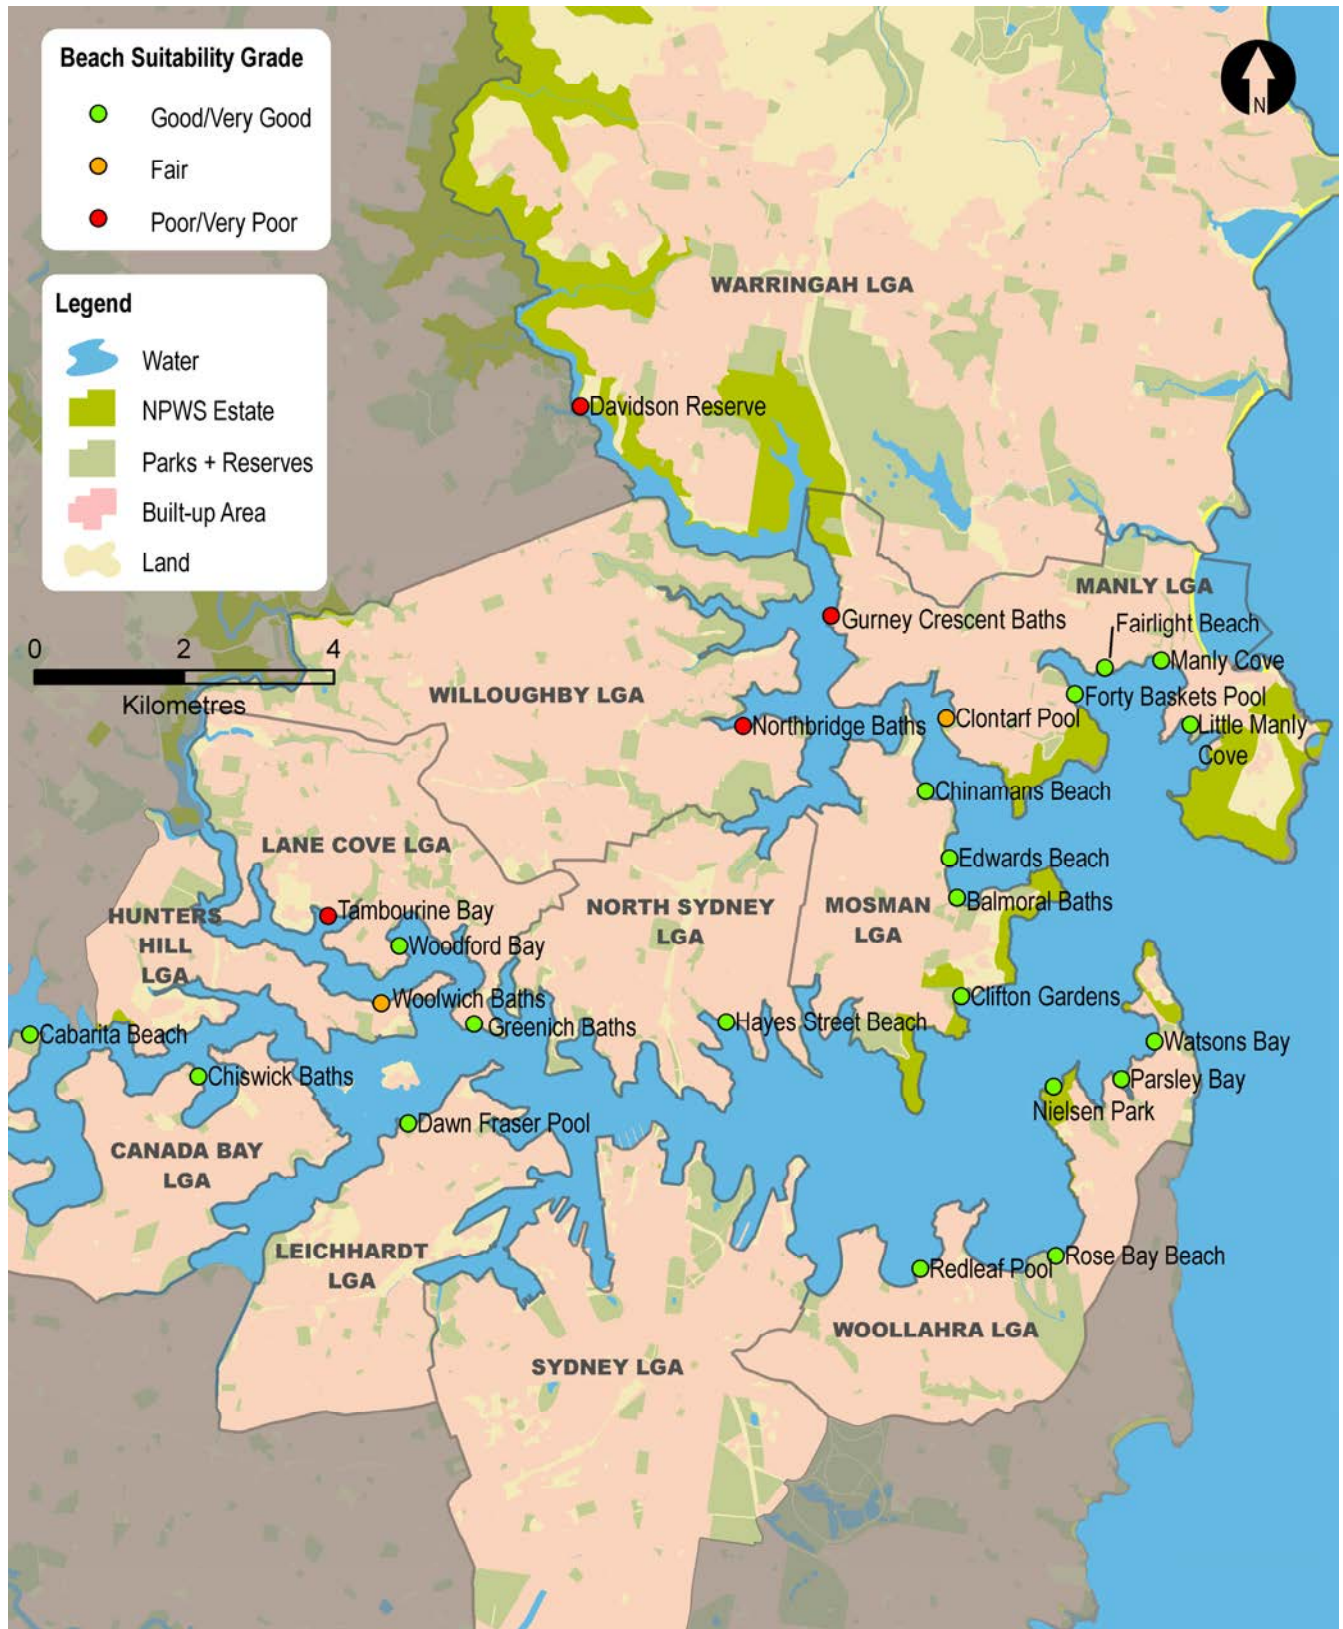
Sampling sites and Beach Suitability Grades in Sydney Harbour

Nielsen Park in Sydney Harbour was graded as Very Good. This site had excellent water quality and was suitable for swimming almost all of the time. Elevated enterococci levels were occasionally recorded following heavy rainfall and swimming should be avoided at these times.

A further 18 of the 25 swimming locations in Sydney Harbour were graded as Good: Watsons Bay, Parsley Bay, Rose Bay Beach, Murray Rose Pool, Dawn Fraser Pool, Chiswick Baths, Cabarita Beach, Woodford Bay, Greenwich Baths, Hayes Street Beach, Clifton Gardens, Balmoral Baths, Edwards Beach, Chinamans Beach, Forty Baskets Pool, Fairlight Beach, Manly Cove and Little Manly Cove. These sites had mostly good water quality, although elevated enterococci levels were recorded following rainfall.

Two swimming locations were graded Fair: Woolwich Baths and Clontarf Pool. These sites had generally good water quality, but had more significant potential sources of microbial contamination.

Four swimming locations were graded as Poor: Tambourine Bay in the lower Lane Cove River; and Northbridge Baths, Davidson Reserve and Gurney Crescent Baths in the upper reaches of Middle Harbour. Although microbial water quality at these sites is generally suitable for swimming during dry weather conditions, elevated enterococci levels were frequently measured following light rainfall. These sites also have relatively low levels of tidal flushing.
