Hunter Region Beaches

Figure 12: Compliance of Hunter Region Beaches during Summer 2007–2008

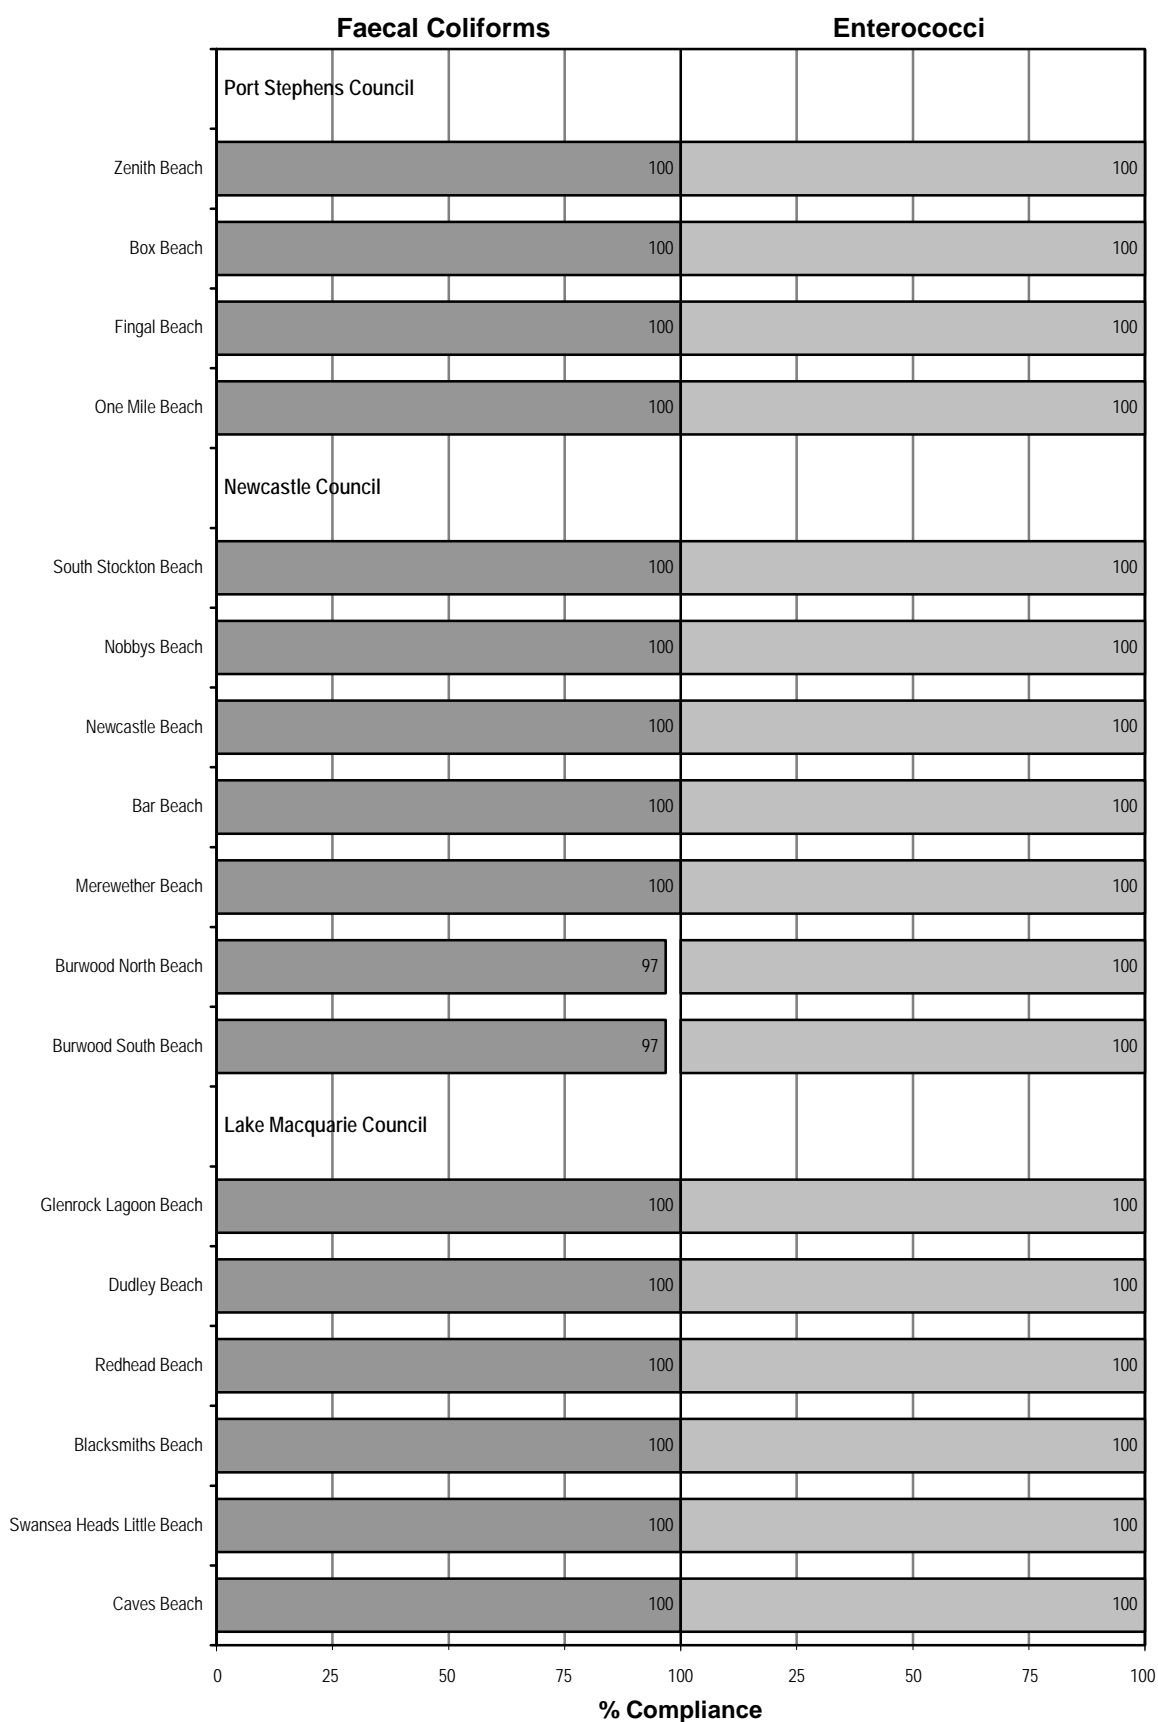
Despite the above average rainfall in the region, 15 of the 17 Hunter beaches complied 100% with Beachwatch water quality criteria for both faecal coliforms and enterococci for the entire 2007–2008 summer season (Figure 12). Only Burwood North and Burwood South beaches did not comply 100% with the faecal coliform criteria, although compliance was still very high at 97%.

All four Port Stephens ocean beaches recorded 100% compliance with recreational water quality criteria for faecal coliforms and enterococci (Figure 12). These results were identical to the previous summer season.

Five of the seven Newcastle ocean beaches recorded 100% compliance with Beachwatch water quality criteria for faecal coliforms and enterococci (Figure 12). Burwood North and Burwood South beaches performed very well, complying with faecal coliform criteria 97% of the time, and 100% compliance for enterococci criteria.

All of the six Lake Macquarie City Council beaches recorded 100% compliance with Beachwatch water quality criteria for faecal coliforms and enterococci (Figure 12). Swansea Heads Little Beach improved by six percentage points for the enterococci criteria from the previous summer season.

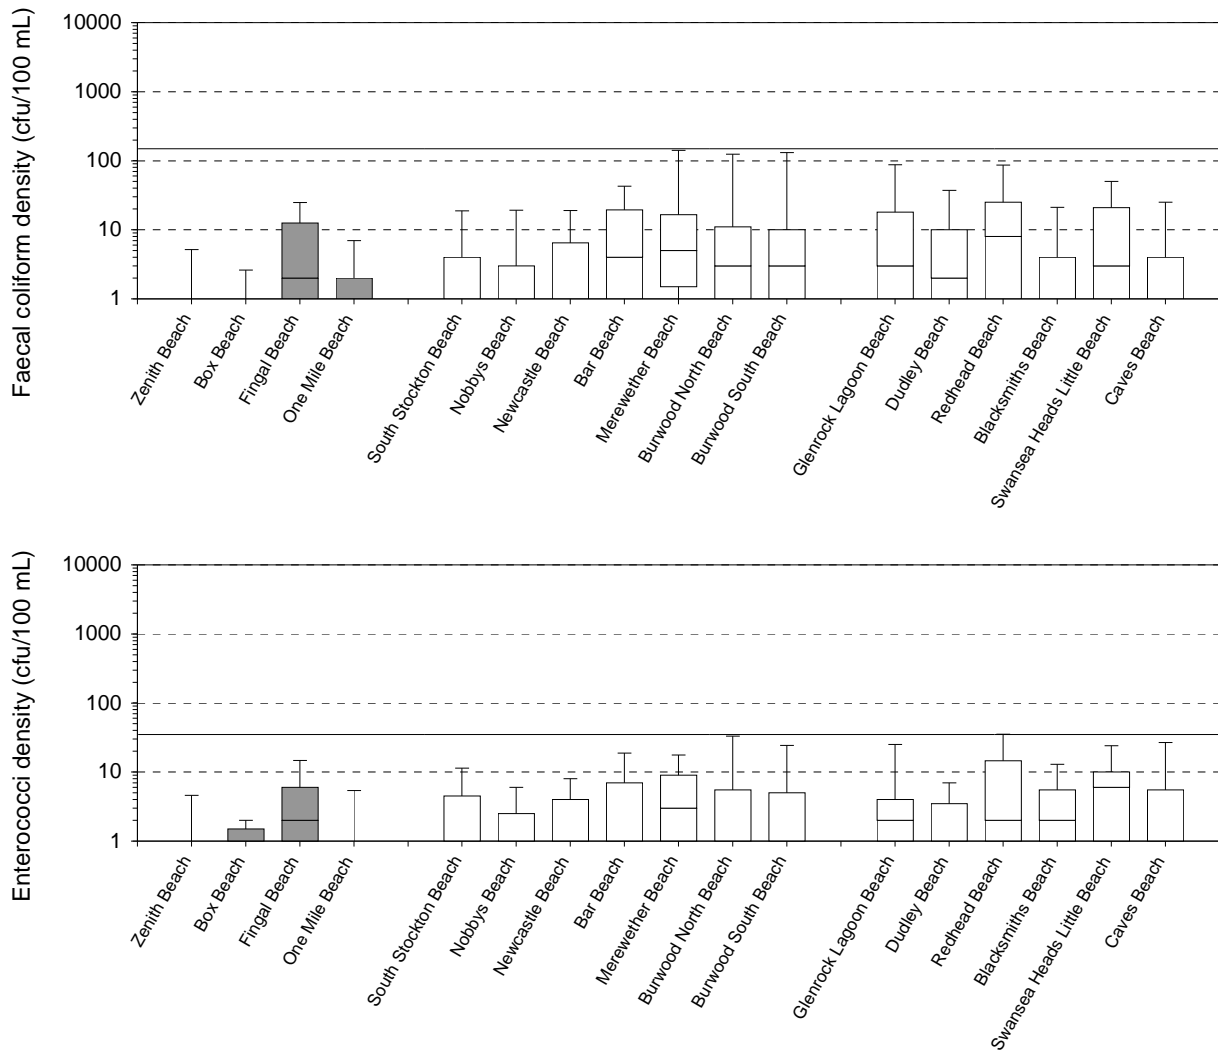
Figure 13: Range of Bacterial Levels at Hunter Beaches during Summer 2007–2008

The range of bacterial levels measured at Hunter Region beaches during summer 2007–2008 is shown in Figure 13, with Port Stephens beaches highlighted in grey. Levels of faecal coliforms and enterococci were consistently low.

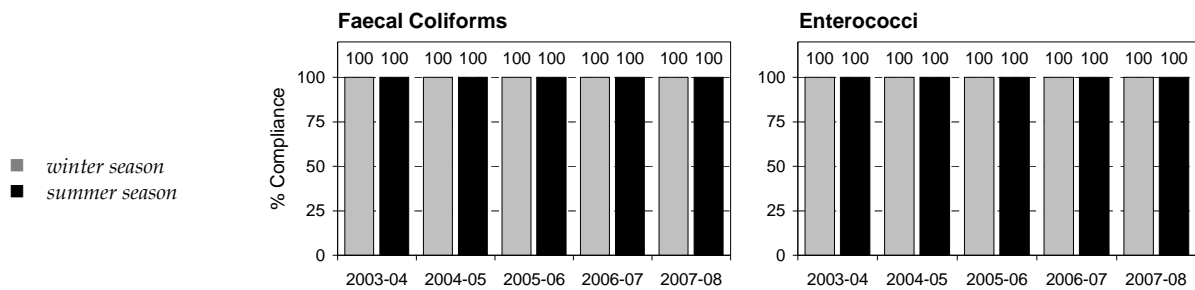
Faecal coliform and enterococci levels complied with swimming guidelines 100% of the time over the last five years.

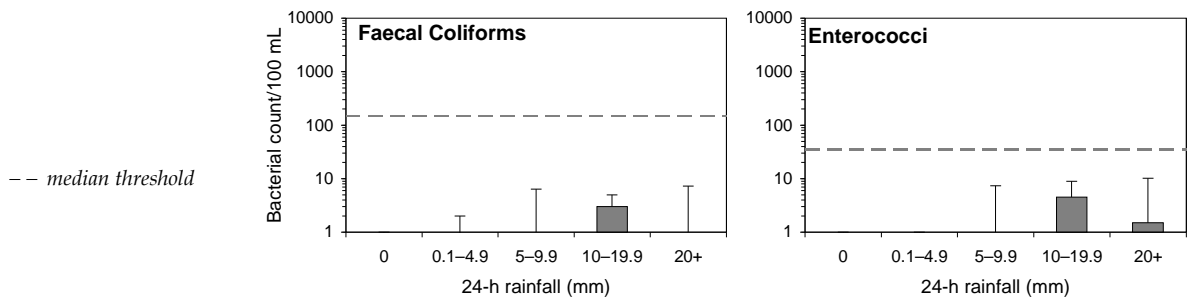
Response to rainfall

Faecal coliform and enterococci densities displayed little response to rainfall and generally remained well below the median guideline limits across all rainfall categories.

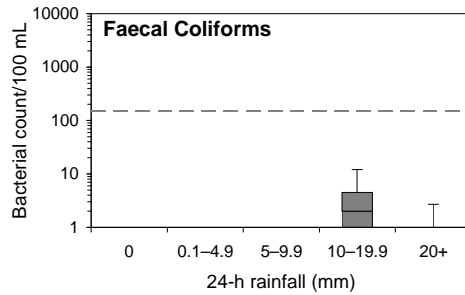
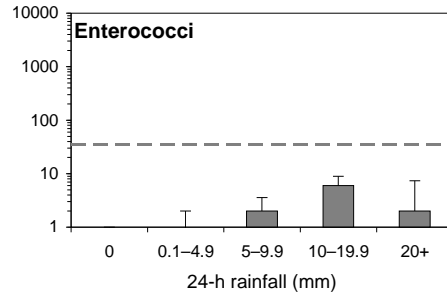
Response to rainfall

Faecal coliform and enterococci densities displayed little response to rainfall and generally remained well below the median guideline limits across all rainfall categories.

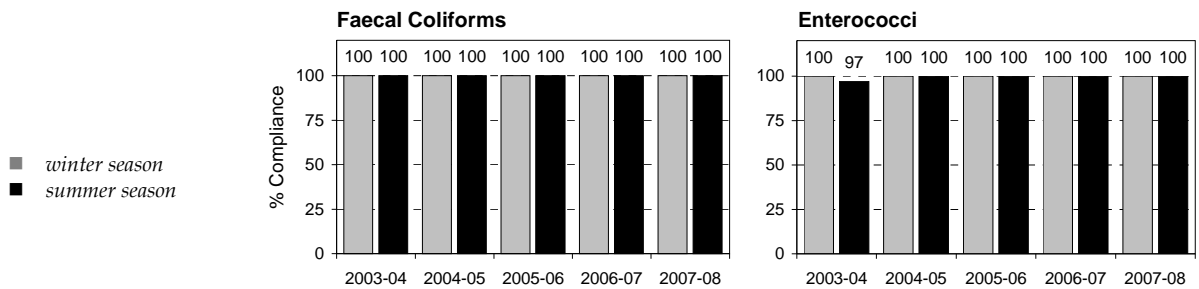
Faecal coliform levels complied with swimming guidelines 100% of the time over the last five years. With the exception of summer 2003–2004, enterococci levels complied 100% of the time over the last five years.

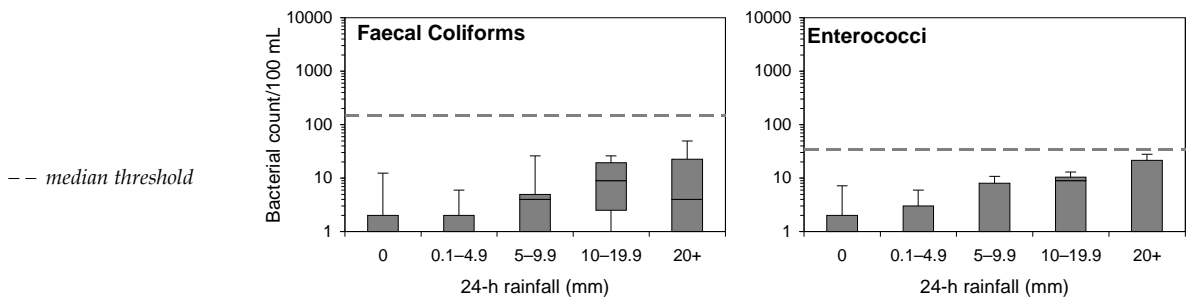
Response to rainfall

Faecal coliform and enterococci densities displayed little response to rainfall and generally remained below the median guideline limits across all rainfall categories.

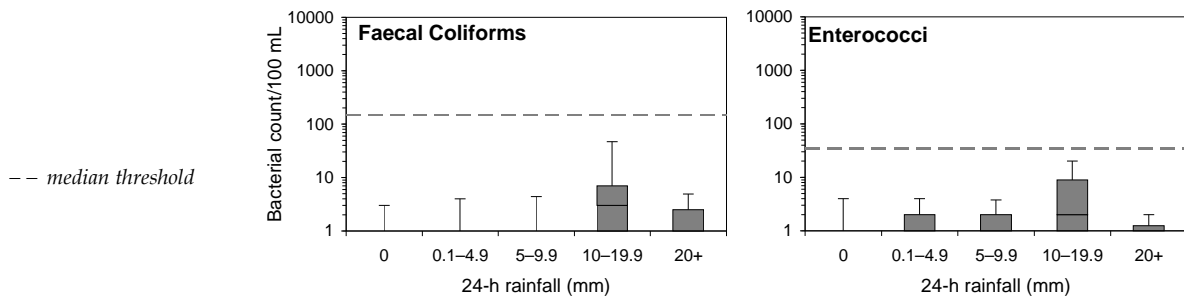
Response to rainfall Faecal coliform and enterococci densities displayed no clear response to rainfall and generally remained below the median guideline limits across all rainfall categories.

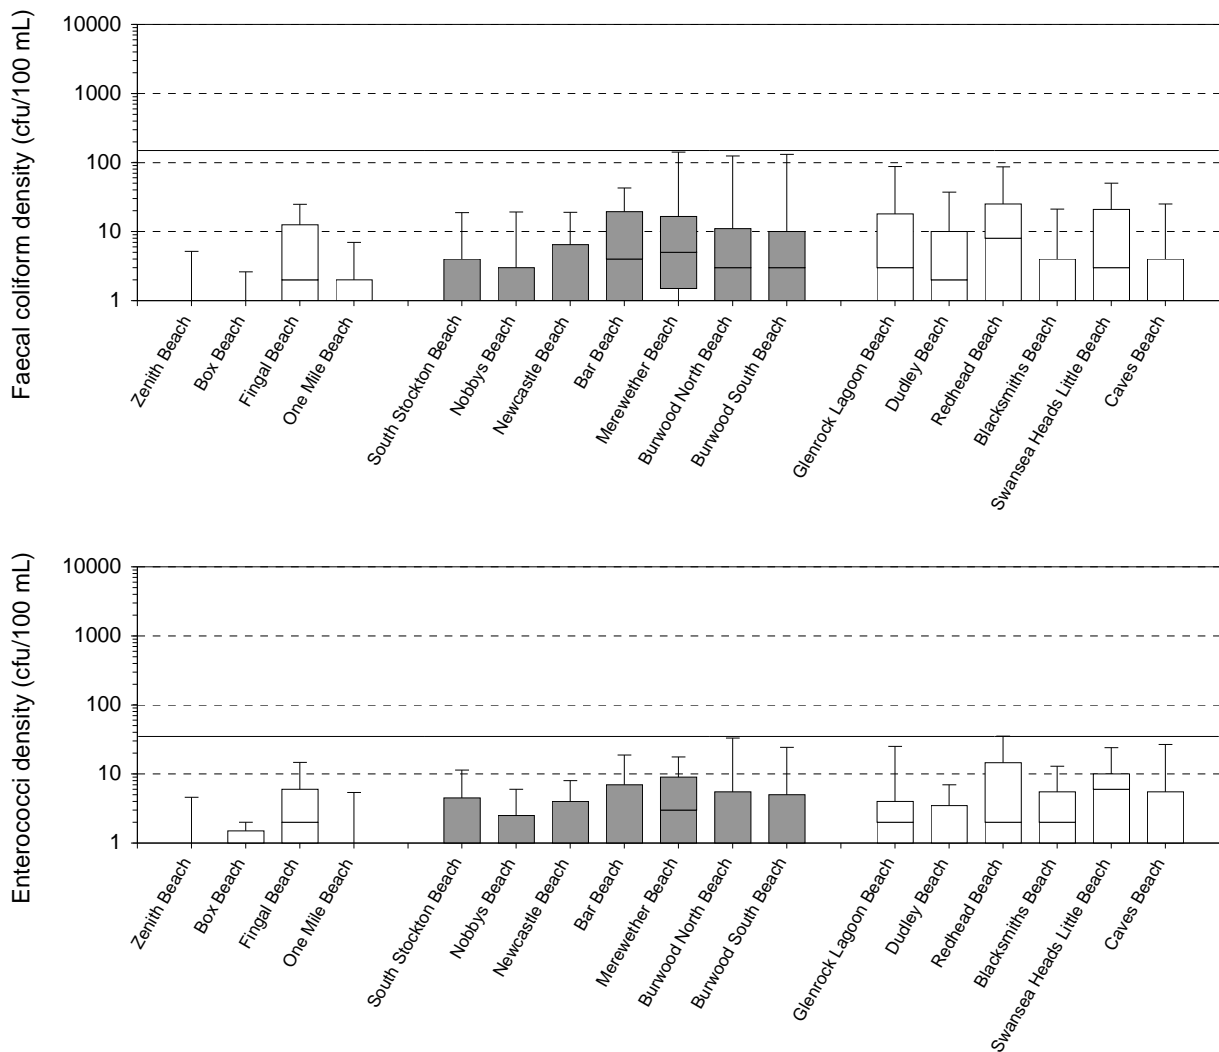
Figure 14: Range of Bacterial Levels at Hunter Beaches during Summer 2007–2008

The range of indicator bacteria levels measured at Hunter Region beaches during summer 2007–2008 is shown in Figure 14, with Newcastle City beaches highlighted in grey. Levels of faecal coliforms and enterococci were consistently low and similar to those at other Hunter region beaches.

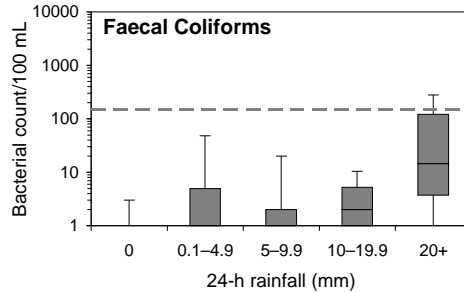
Faecal coliform and enterococci densities increased slightly with increasing rainfall, occasionally exceeding the median guideline limits after 20 millimetres of rain or more in the previous 24 hours.

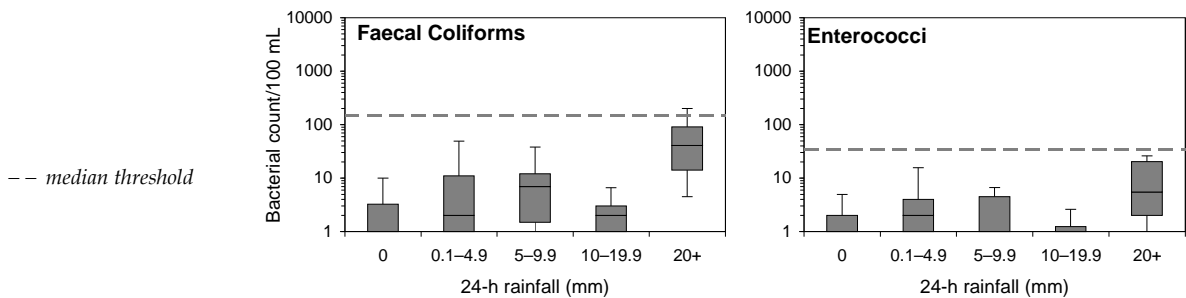
Response to rainfall

Faecal coliform and enterococci densities displayed no clear response to rainfall. Faecal coliform densities occasionally exceeded the median guideline limit in response to 20 millimetres of rain or more in the previous 24 hours. Enterococci densities generally remained below the median guideline limit across all rainfall categories.

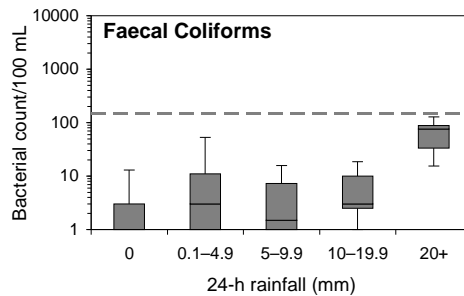
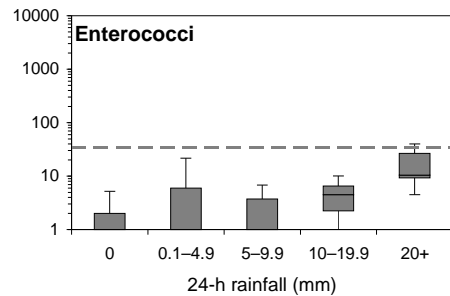
Faecal coliform and enterococci densities tended to increase slightly with increasing rainfall. Faecal coliform densities generally remained below the median guideline limit across all rainfall categories. Enterococci levels occasionally exceeded the median guideline limit in response to 20 millimetres of rain or more in the previous 24 hours.

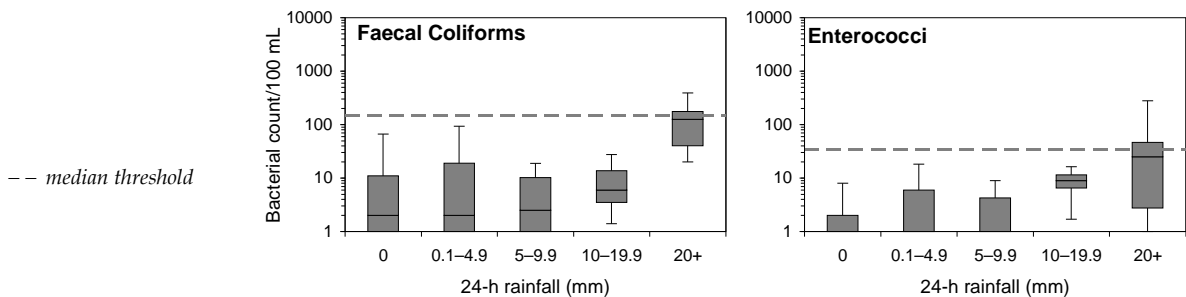
Response to rainfall Faecal coliform and enterococci densities tended to increase slightly with increasing rainfall, often exceeding the median guideline limits after 20 millimetres of rain or more in the previous 24 hours.

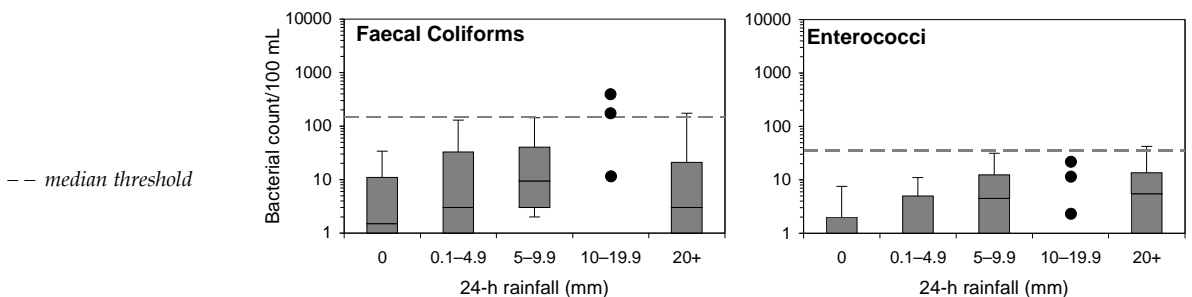
Response to rainfall

Bacterial densities tended to increase slightly with increasing rainfall. Faecal coliform densities occasionally exceeded the median guideline limit after five millimetres of rain or more in the previous 24 hours. Enterococci densities occasionally exceeded the median guideline limit in response to 20 millimetres of rain or more in the previous 24 hours.

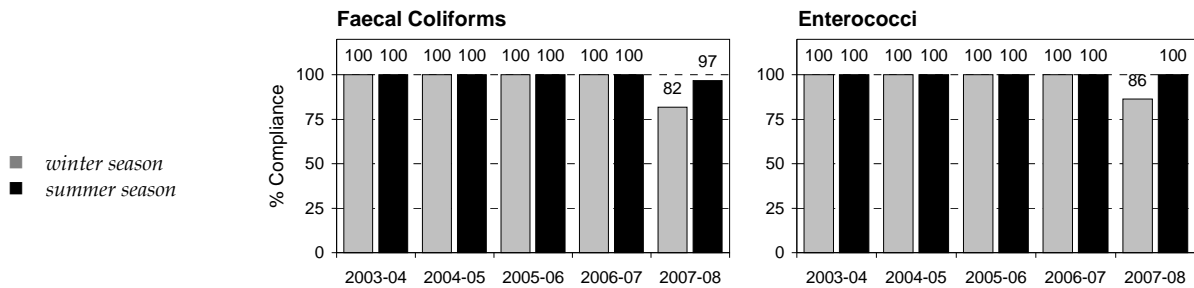
Faecal coliform compliance with swimming guidelines has varied recently, ranging from 82% to 100% over the last five years. With the exception of winter 2007–2008, enterococci levels complied with swimming guidelines 100% of the time over the last five years.

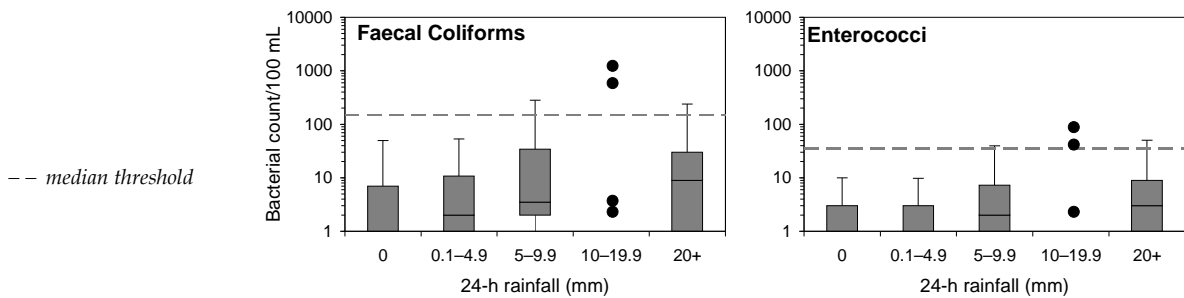
Response to rainfall

Faecal coliform and enterococci densities tended to increase with increasing rainfall, occasionally exceeding the median guideline limits in response to five millimetres of rain or more in the previous 24 hours.

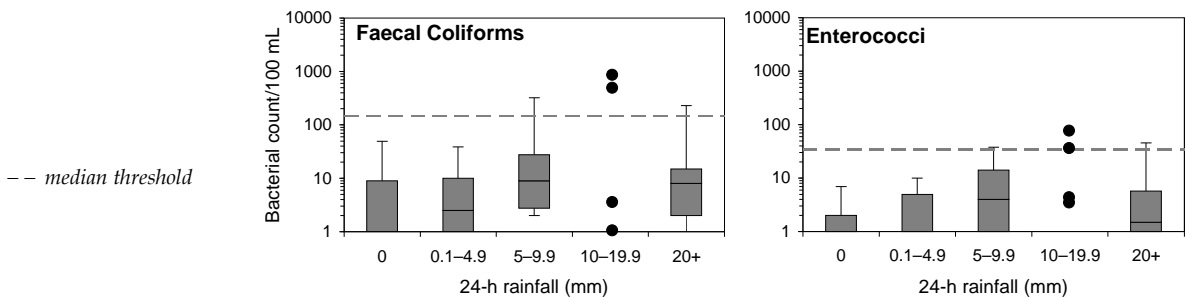
Response to rainfall

Faecal coliform and enterococci densities generally increased with increasing rainfall and occasionally exceeded the median guideline limits in response to five millimetres of rain or more in the previous 24 hours.

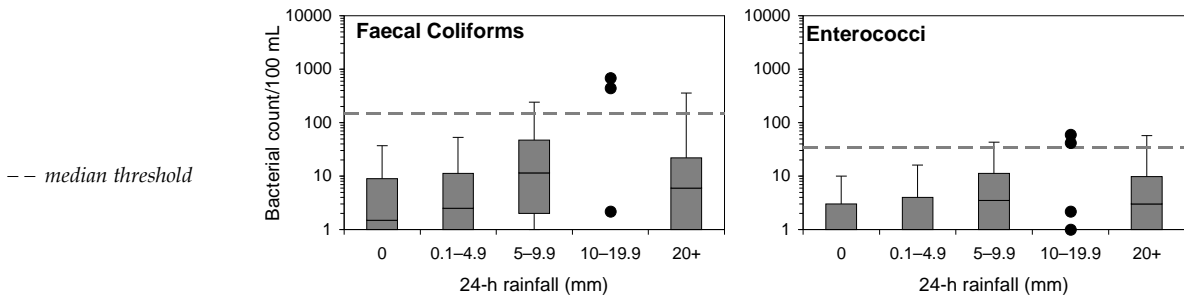
Response to rainfall Faecal coliform and enterococci densities generally increased with increasing rainfall, with bacterial densities occasionally exceeding the median guideline limits in response to five millimetres of rain or more in the previous 24 hours.

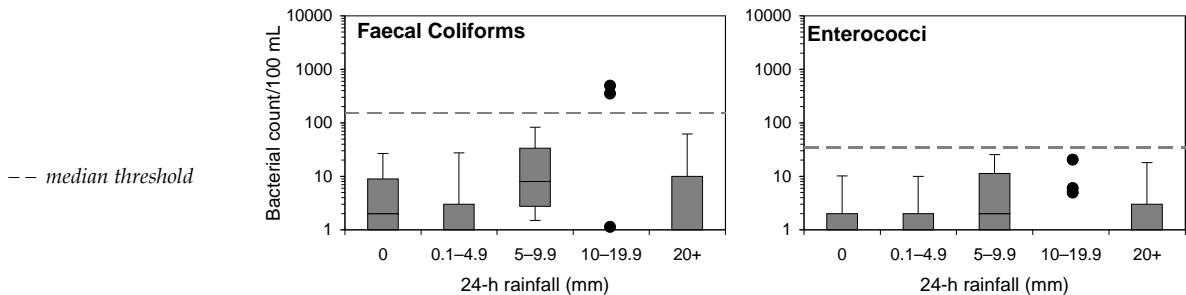
Response to rainfall

Faecal coliform and enterococci densities tended to increase slightly with increasing rainfall and generally remained below the median guideline limits across all rainfall categories.

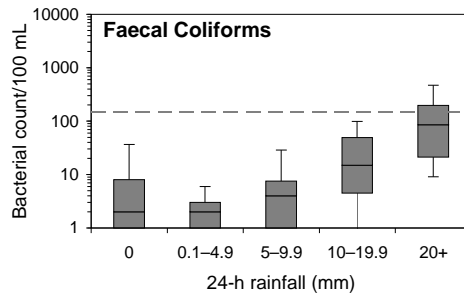
Response to rainfall Faecal coliform and enterococci densities generally increased with increasing rainfall and often exceeded the median guideline limit in response to 20 millimetres of rain or more in the previous 24 hours.

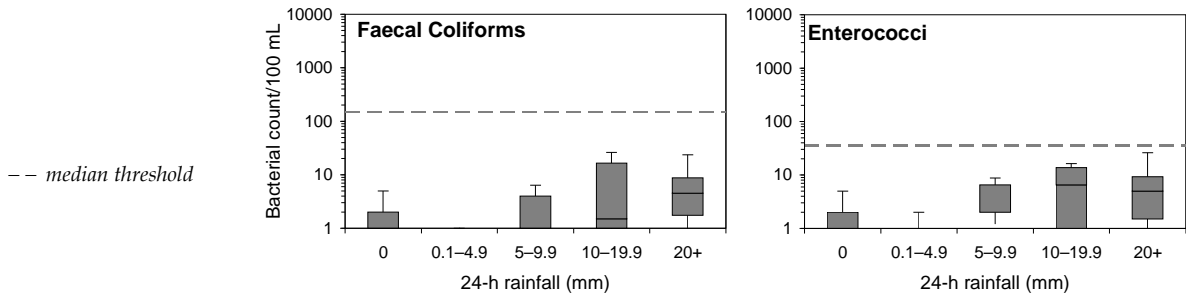
Response to rainfall

Faecal coliform and enterococci densities tended to increase slightly with increasing rainfall and generally remained below the median guideline limits across all rainfall categories.

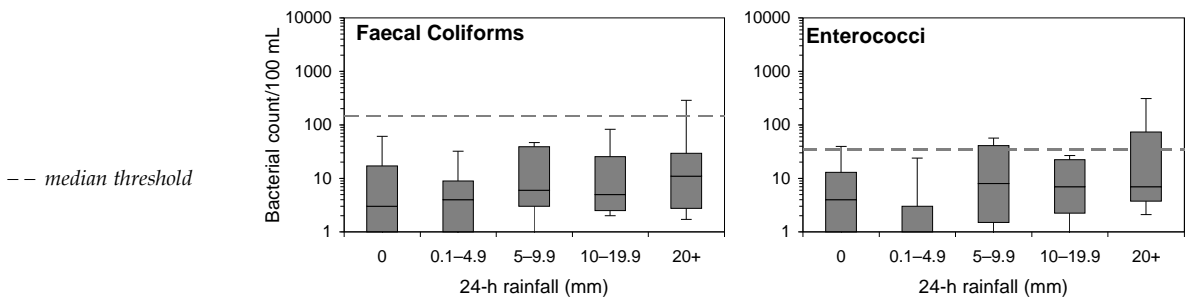
Response to rainfall

Bacterial densities tended to increase slightly with increasing rainfall. Faecal coliform densities occasionally exceeded the median guideline limit in response to 20 millimetres of rain or more in the previous 24 hours. Enterococci densities occasionally exceeded the median guideline limit in response to no rain, indicating a possible dry-weather contamination problem. Enterococci densities often exceeded the median guideline limit in response five millimetres of rain or more in the previous 24 hours.

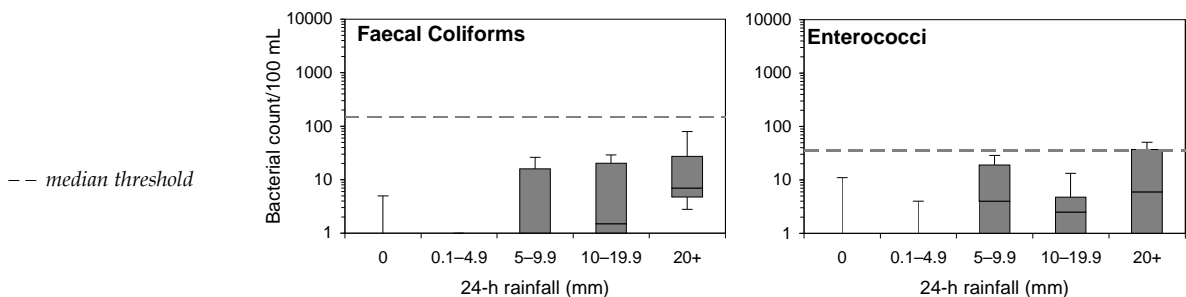
Response to rainfall Faecal coliform and enterococci densities tended to increase with increasing rainfall. Faecal coliform levels generally remained below the median guideline limit across all rainfall categories. Enterococci levels often exceeded the median guideline limit in response to 20 millimetres of rain or more in the previous 24 hours.
