Sydney Metropolitan Area Harbour Swimming Sites

Sydney Harbour – Port Jackson

Sites: Hayes Street Beach, Little Sirius Cove, Clifton Gardens, Redleaf Pool, Watsons Bay, Parsley Bay, Nielsen Park and Rose Bay Beach

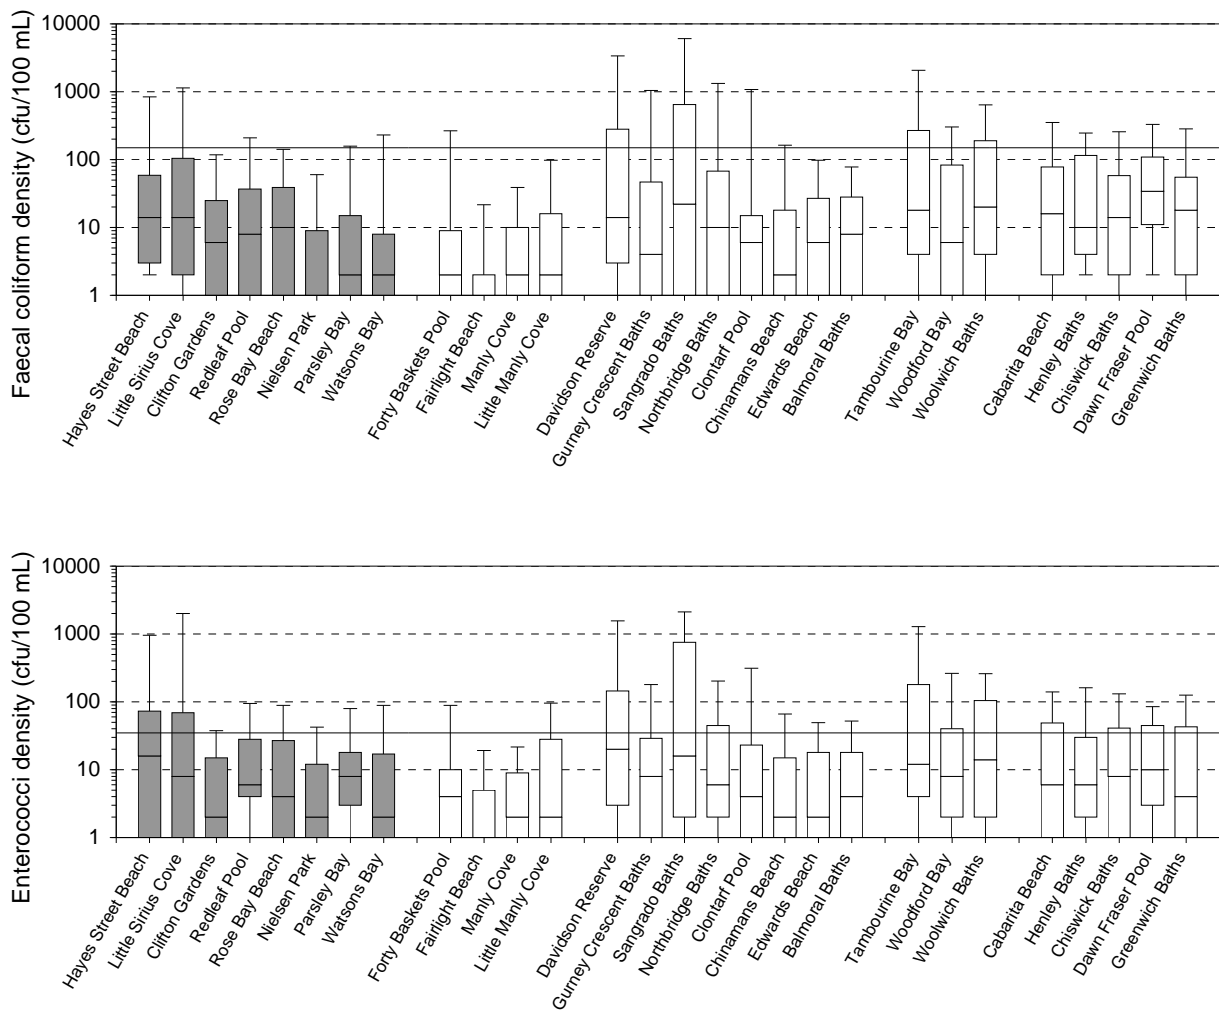
Figure 23: Bacterial Levels at Sydney Harbour Sites during Summer 2007–2008

The range of indicator bacteria levels measured at Sydney Harbour swimming areas during summer 2007–2008 is shown in Figure 23, with Port Jackson sites highlighted in grey. Levels of faecal coliforms and enterococci were within the ranges measured in other swimming sites in Sydney Harbour.

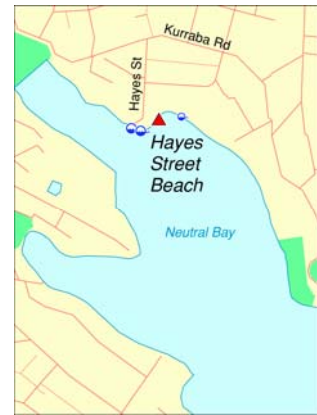
Compliance Faecal coliform compliance with swimming guidelines ranged from 59% to 100% over the last five years. Enterococci compliance ranged from 55% to 100% over the last five years.

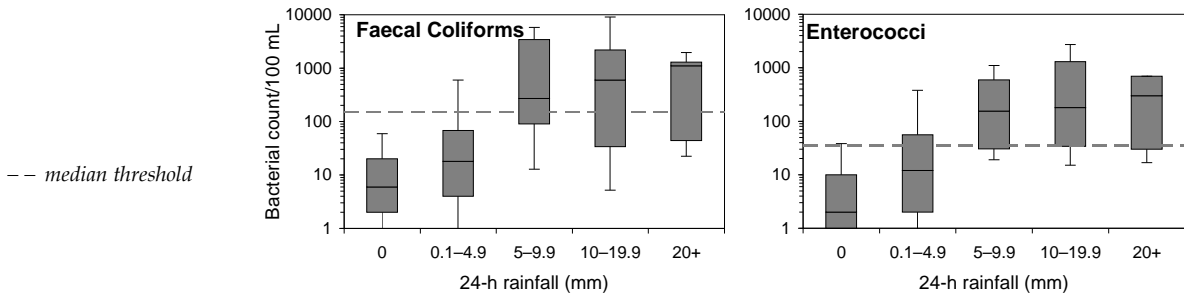
Response to rainfall Faecal coliform and enterococci densities tended to increase with increasing rainfall. Both bacterial levels regularly exceeded the median guideline limits in response to five millimetres of rain or more in the previous 24 hours. Enterococci densities occasionally exceeded the median guideline limit after no rainfall indicating a possible dry-weather contamination problem.

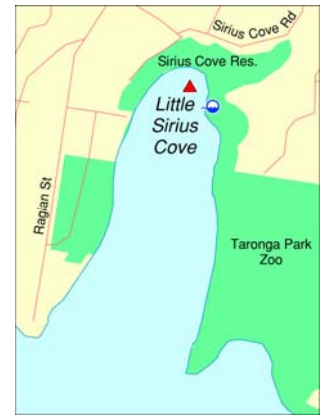
Compliance Faecal coliform compliance with swimming guidelines ranged from 72% to 100% over the last five years. Enterococci compliance has been more variable, ranging from 23% to 100% over the last five years.

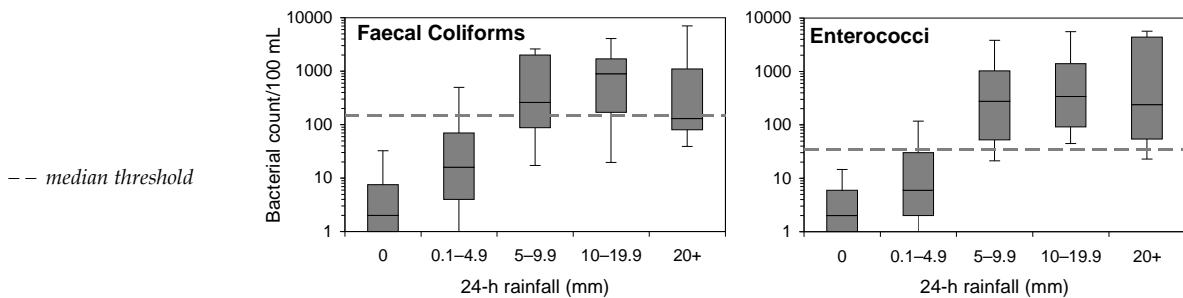
Response to rainfall Faecal coliform and enterococci densities generally increased with increasing rainfall. Both bacterial indicators occasionally exceeded the median guideline limits in response to light rain. Faecal coliform levels regularly exceeded the median guideline limit in response to five millimetres of rain or more in the previous 24 hours. Enterococci levels frequently exceeded the median guideline limit in response to five millimetres of rain or more in the previous 24 hours.

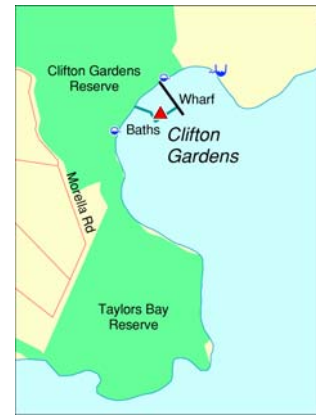
Compliance With the exception of winter 2007–2008, faecal coliform levels complied 100% of the time over the last five years. Enterococci compliance has ranged from 91% to 100% over the last five years.

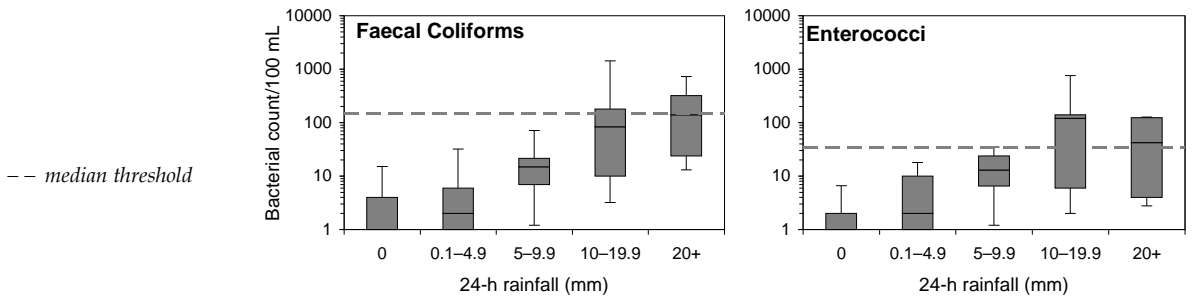
Response to rainfall Bacterial densities tended to increase with increasing rainfall. Faecal coliform levels often exceeded the median guideline limit in response to ten millimetres of rain or more in the previous 24 hours. Enterococci levels regularly exceeded the median guideline limit in response to ten millimetres of rain or more in the previous 24 hours.

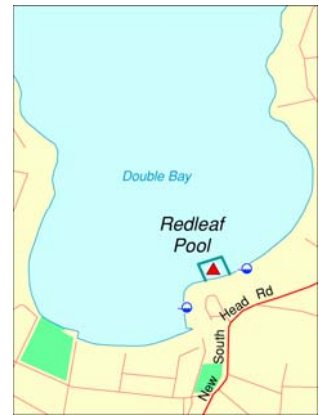
Faecal coliform compliance with swimming guidelines ranged from 77% to 100% over the last five years. Enterococci compliance has been more variable, ranging from 61% to 100% over the last five years.

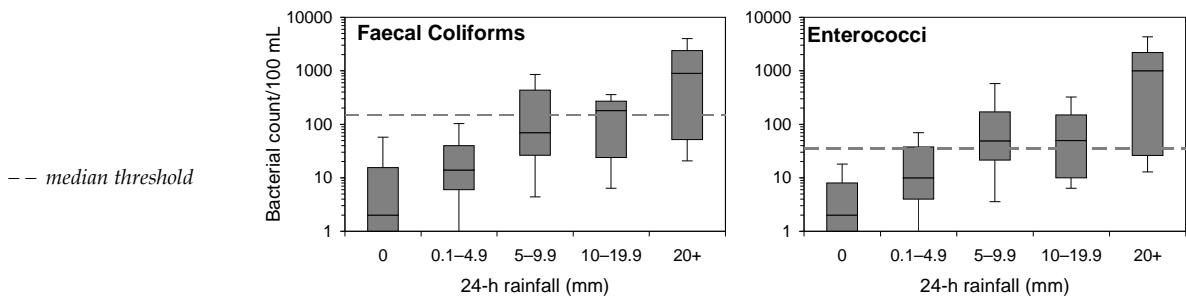
Faecal coliform densities increased with increasing rainfall, often exceeding the median guideline limit after five millimetres of rain or more in the previous 24 hours. Enterococci densities increased with increasing rainfall and regularly exceeded the median guideline limit in response to five millimetres of rain or more in the previous 24 hours.

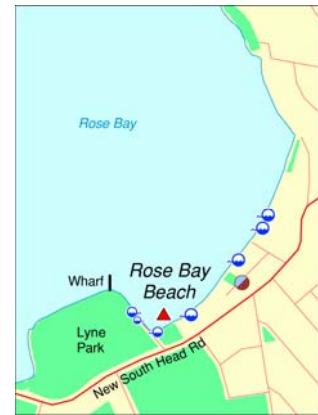
With the exception of winter 2006–2007, faecal coliform levels complied with swimming guidelines 100% of the time over the last five years. Compliance with enterococci swimming guidelines has been more variable, ranging from 40% to 100% over the last five years.

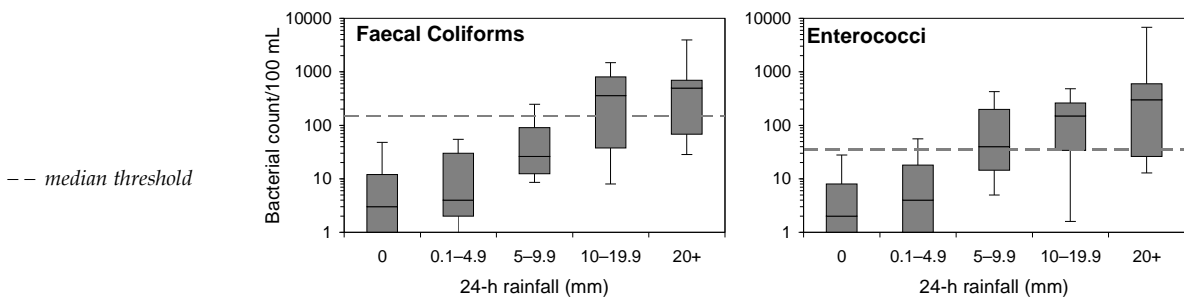
Faecal coliform and enterococci densities generally increased with increasing rainfall. Faecal coliform densities occasionally exceeded the median guideline limit in response to five millimetres of rain or more and regularly exceeded the median guideline limit in response to ten millimetres of rain or more in the previous 24 hours. Enterococci densities regularly exceeded the median guideline limit in response to five millimetres of rain or more in the previous 24 hours.

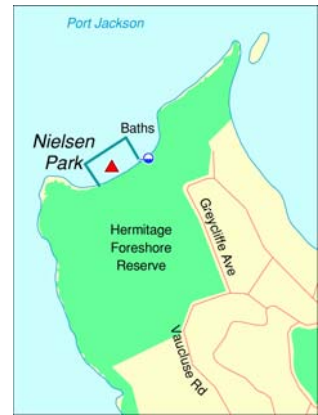
Faecal coliform and enterococci levels complied with swimming guidelines 100% of the time over the last five years.

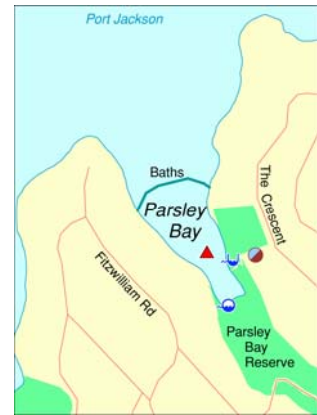
Faecal coliform levels complied with swimming guidelines 100% of the time over the last five years. Compliance with the enterococci criteria has generally been high, ranging from 85% to 100% over the last five years.

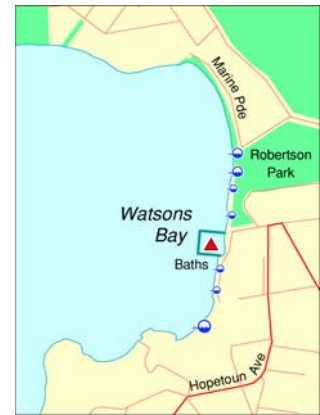
| Compliance | Faecal coliform levels complied with swimming guidelines 100% of the time over the last five years. Enterococci compliance has generally been high, ranging from 84% to 100% over the last five years. |

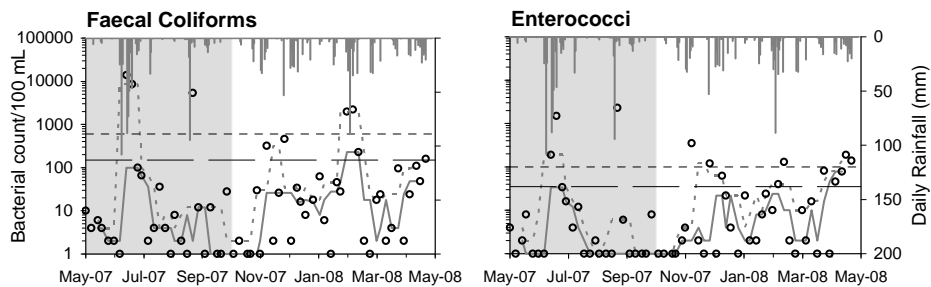
Season data

- | rainfall
 - o individual result
 - rolling median
 - - - rolling 80th percentile
- Guidelines
(see page 7 for details)
- median threshold
 - - - 80th percentile threshold
