Sydney Metropolitan Area Harbour Swimming Sites

Lower Georges River

Sites: Jew Fish Bay Baths, Como Baths, Oatley Bay Baths, Carss Point Baths, Sandringham Baths and Dolls Point Baths

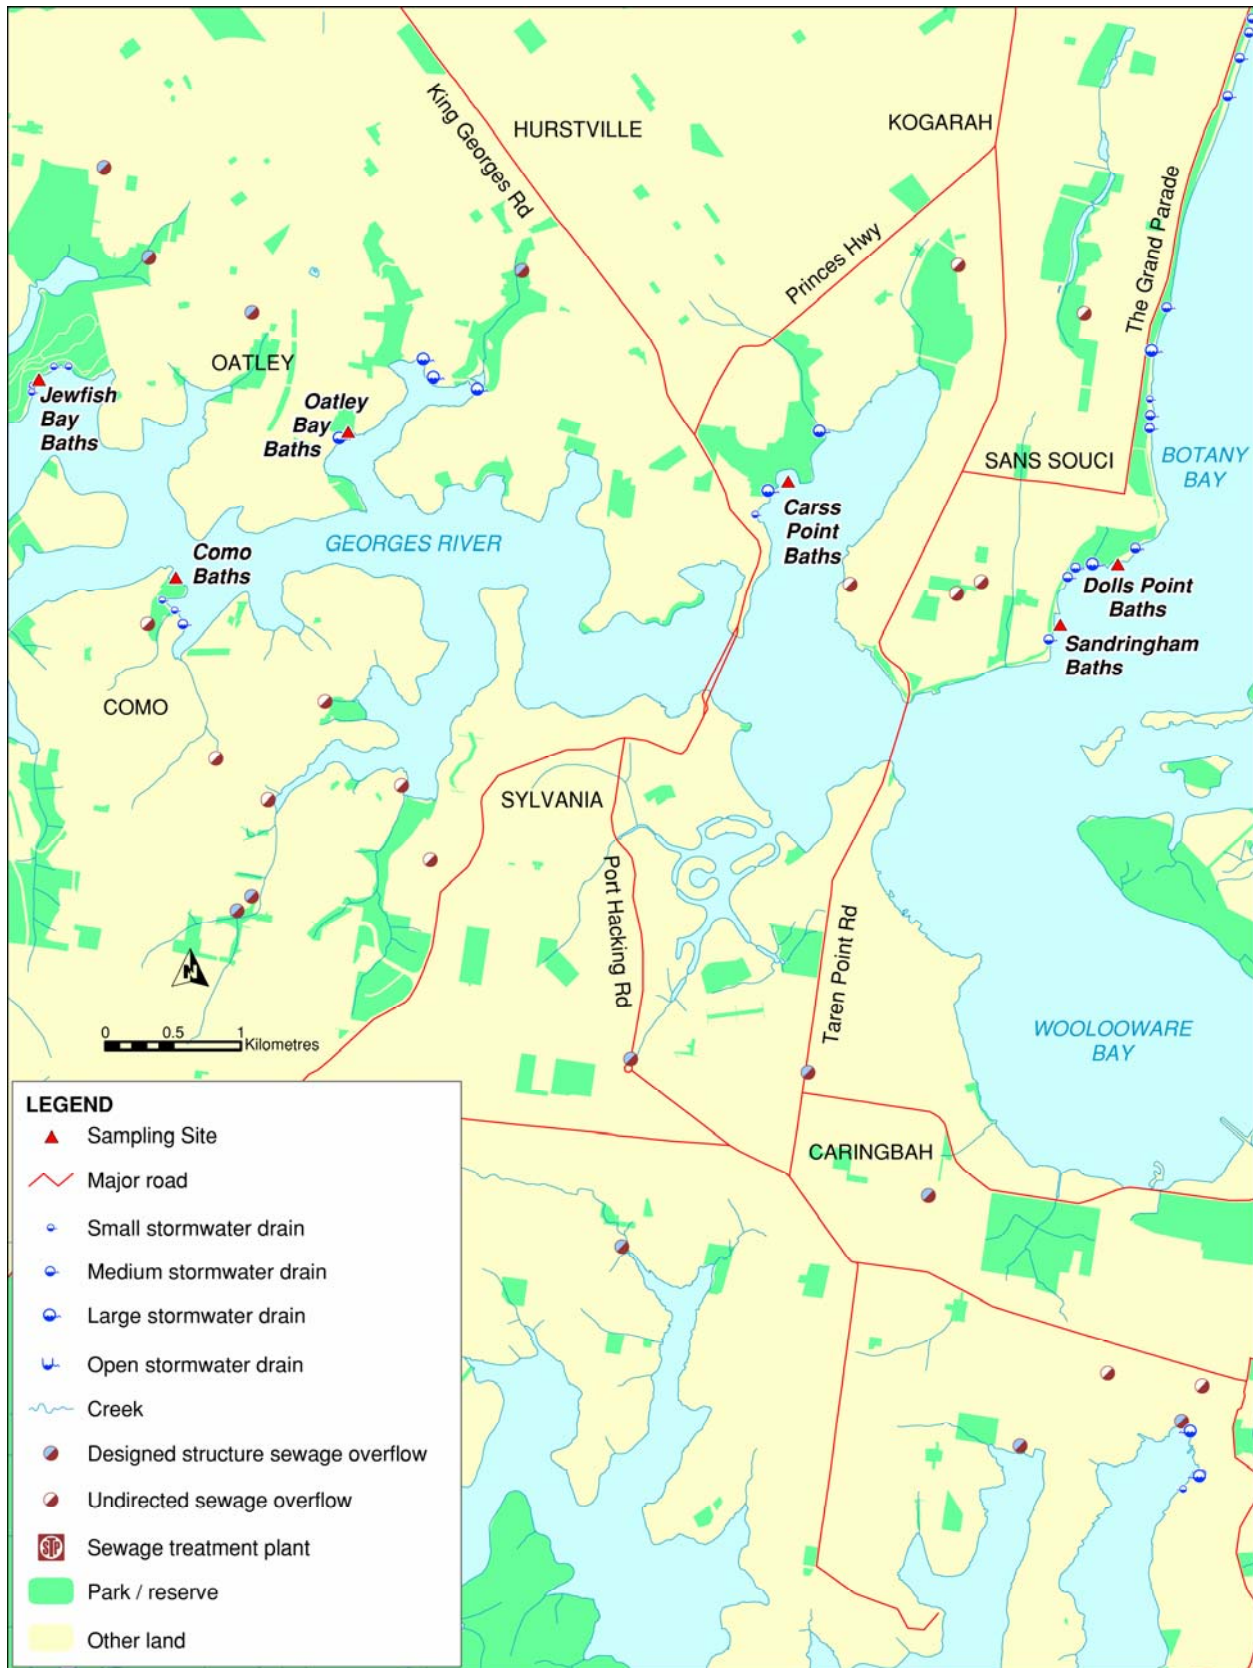
The lower Georges River is the ten kilometre downstream reach of the 96 kilometre long Georges River. Land use in the lower Georges River catchment is mostly residential, with some industrial, commercial, recreational and bushland.

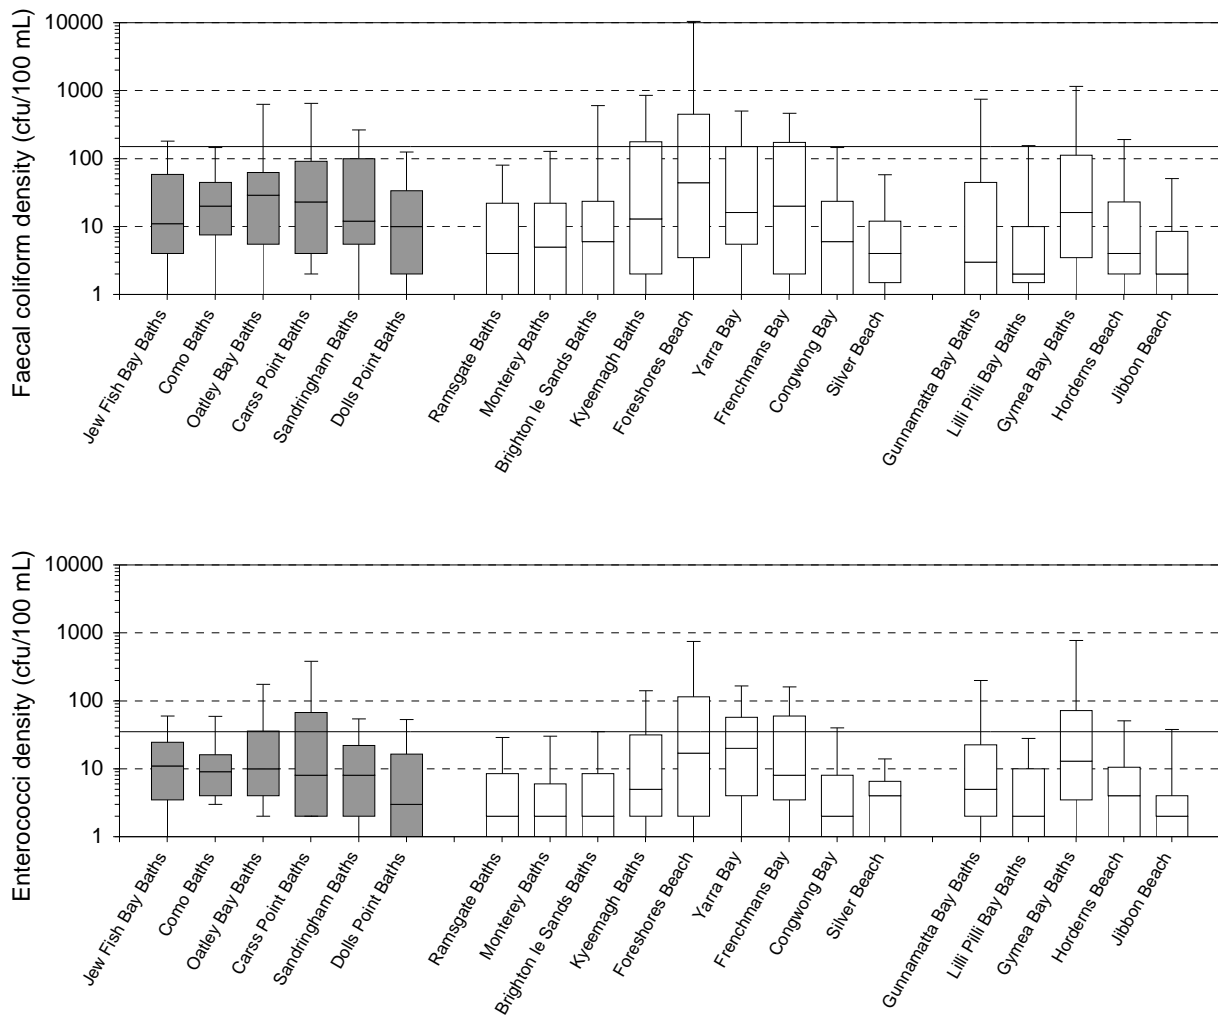
Figure 28: Bacterial Levels at Lower Georges River, Botany Bay and Port Hacking Sites during Summer 2007–2008

The range of indicator bacteria levels measured at Botany Bay, lower Georges River and Port Hacking swimming areas during summer 2007–2008 is shown in Figure 28. Lower Georges River sites are highlighted in grey. The levels of faecal coliforms and enterococci tended to be similar to the range of values measured across the local estuaries.

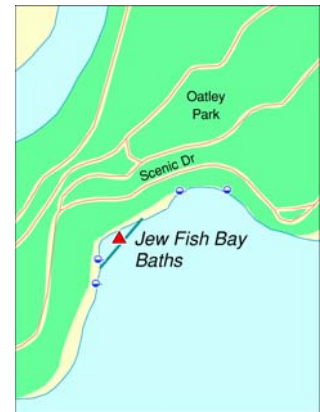
Jew Fish Bay Baths

This is a 200 metre long netted swimming enclosure with a narrow, sandy beach. The baths are situated within the 45 hectare Oatley Park.

Stormwater drains discharge directly to the beach area. This site may also be affected by poor quality water from the upper Georges River.

Faecal coliform and enterococci compliance with swimming guidelines has varied over the last five years, both ranging from 67% to 100%.

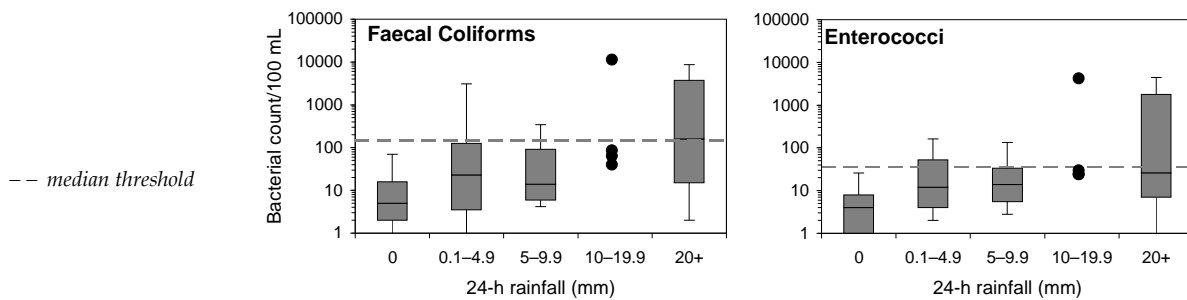
Bacterial densities increased with increasing rainfall. Faecal coliform levels occasionally exceeded the median guideline limit after light rain and regularly exceeded the median guideline limit in response to 20 millimetres of rain or more in the previous 24 hours. Enterococci levels often exceeded the median guideline limit in response to light rain in the previous 24 hours.

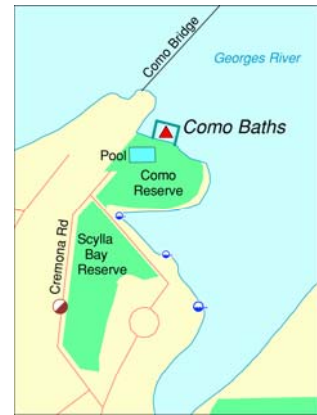
See page 258 for key to map

The enclosed tidal baths are approximately 25 metres wide and include a narrow, sandy beach. The baths are situated adjacent to Como marina and back on to the Como Pleasure Gardens.

Several stormwater drains discharge in the vicinity of the baths. Waters from the Woronora River may also affect water quality. Septic tank seepage from several unsewered properties in Como may also be a source of pollution.

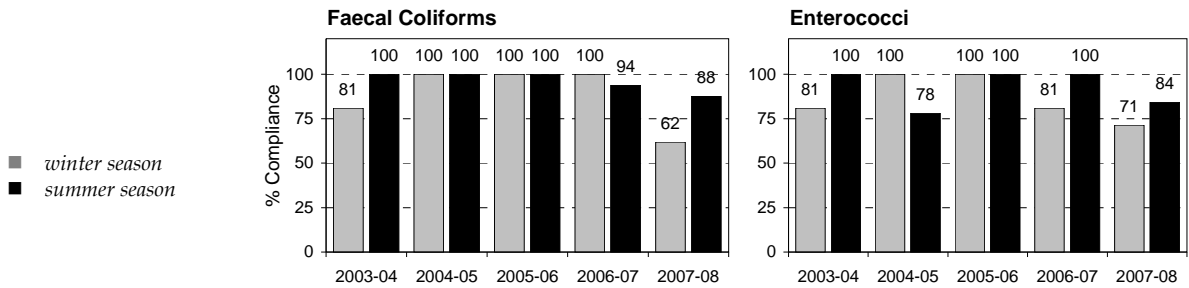
Faecal coliform compliance with swimming guidelines has varied, ranging from 62% to 100% over the last five years. Enterococci compliance with swimming guidelines also varied, ranging from 71% to 100% over the last five years.

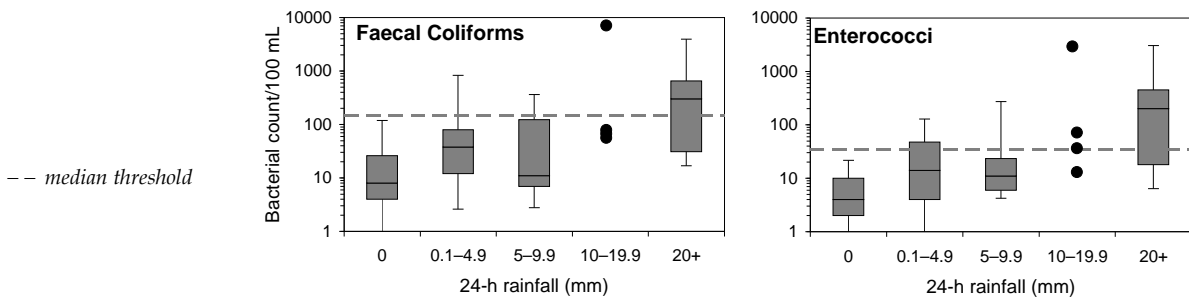
Bacterial densities increased with increasing rainfall. Faecal coliform levels occasionally exceeded the median guideline limit in response to light rain and regularly exceeded the median guideline limit in response to 20 millimetres of rain or more in the previous 24 hours. Enterococci levels often exceeded the median guideline limit after light rain and regularly exceeded the median guideline limit in response to 20 millimetres of rain or more in the previous 24 hours.

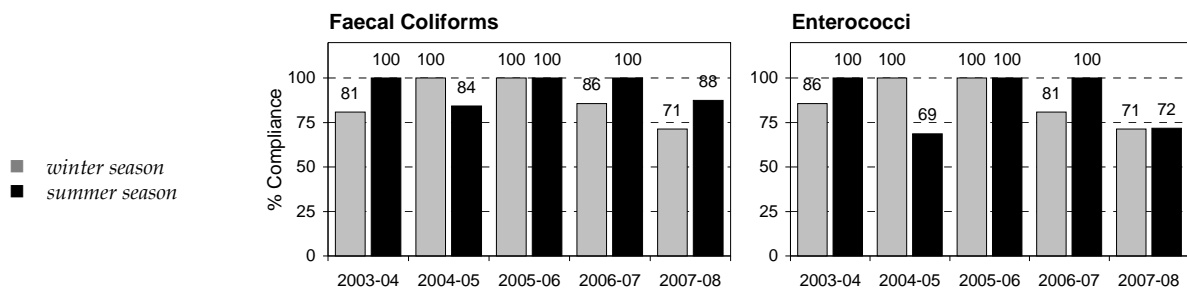
Faecal coliform compliance with swimming guidelines has been variable, ranging from 71% to 100% over the last five years. Enterococci compliance has also varied, ranging from 69% to 100% over the last five years.

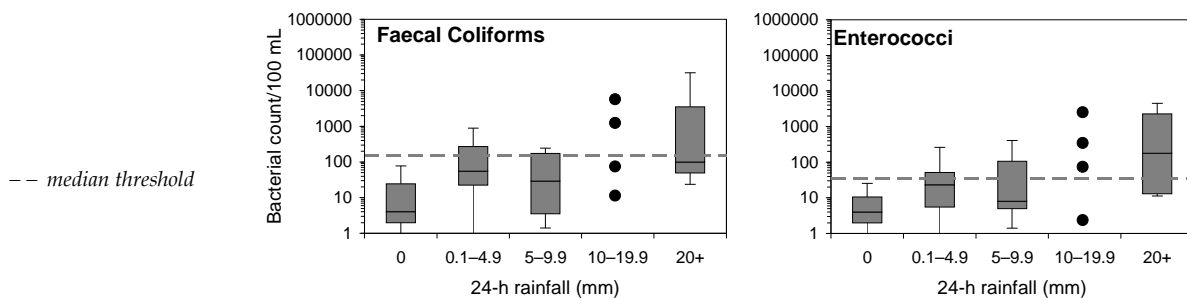
Faecal coliform and enterococci densities generally increased with increasing rainfall, often exceeding the median guideline limits after light rain in the previous 24 hours. Enterococci densities regularly exceeded the median guideline limit in response to 20 millimetres of rain or more in the previous 24 hours.

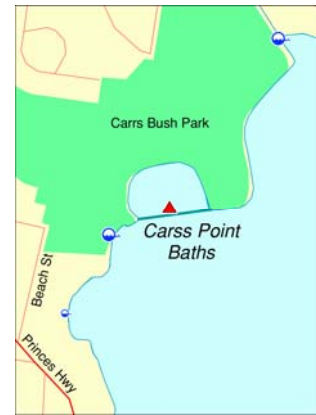
Description This is a 100 by 60 metre netted swimming enclosure that backs on to a narrow beach.

Pollution sources Stormwater drains discharge in the vicinity of the swimming enclosure, bringing litter from two major roadways: the Princes Highway and King Georges Road. Sewer overflows can discharge into Kogarah Bay during wet weather.

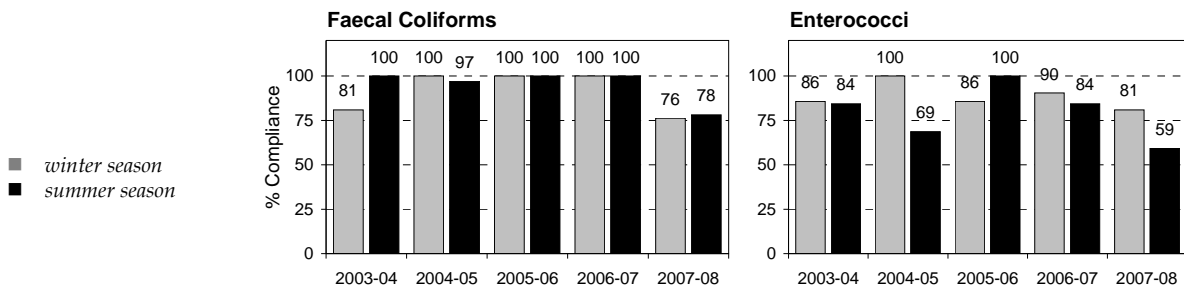
Compliance Faecal coliform compliance with swimming guidelines has ranged from 76% to 100% over the last five years. Enterococci compliance with swimming guidelines has varied considerably, ranging from 59% to 100% over the last five years.

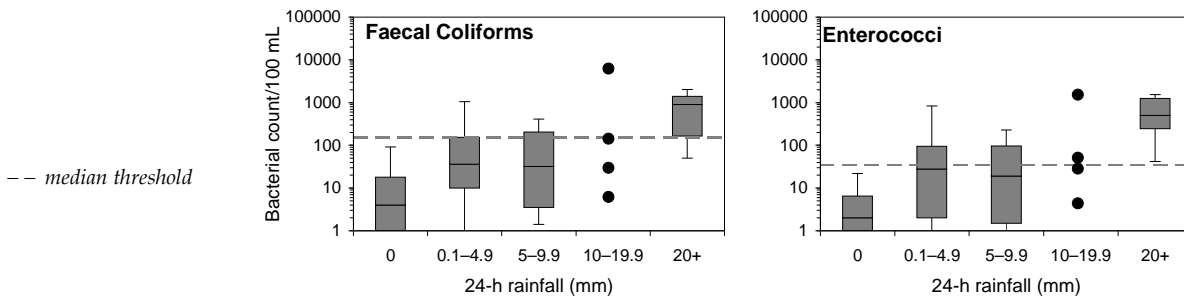
Response to rainfall Faecal coliform and enterococci densities generally increased with increasing rainfall. Faecal coliform densities often exceeded the median guideline limit in response to light rain and frequently exceeded the median guideline limit in response to 20 millimetres of rain or more in the previous 24 hours. Enterococci densities often exceeded the median guideline limit after light rain and usually exceeded the median guideline limit in response to 20 millimetres of rain or more in the previous 24 hours.

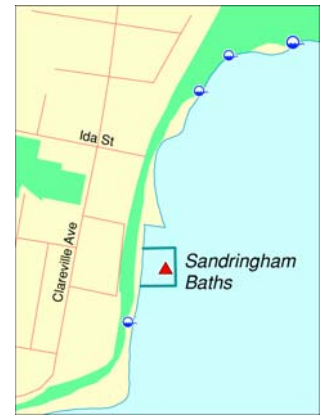
Rockdale City Council has constructed the Scotts Park Wetland, which treats stormwater that discharges close to the baths. Ten gully pit traps have been installed in the Sans Souci area to control silt and some dissolved pollutants in stormwater flows. Council has continued to install small absorption pits in Meriel Street, Lawson Street and Sybil Lane to prevent direct gutter flows discharging into the Georges River.

Faecal coliform and enterococci compliance with swimming guidelines has generally been high, both ranging from 81% to 100% over the last five years.

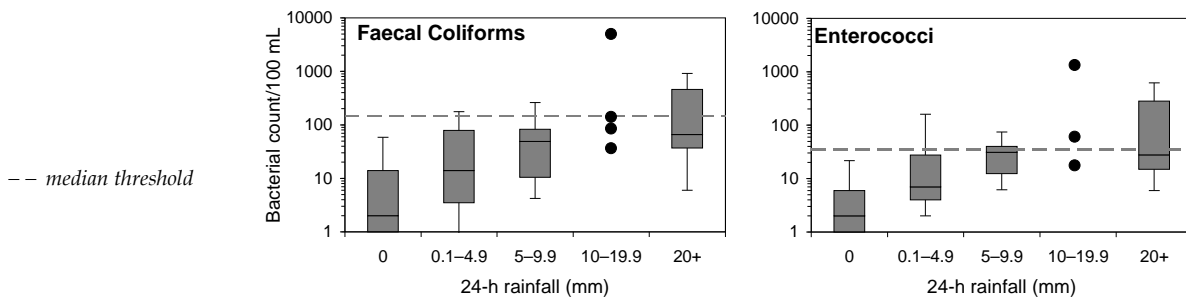
Faecal coliform and enterococci densities occasionally exceeded the median guideline limits in response to light rain in the previous 24 hours. Faecal coliform levels often exceeded the median guideline limit in response to 20 millimetres of rain or more in the previous 24 hours. Enterococci levels often exceeded the median guideline limit after five millimetres of rain or more in the previous 24 hours.

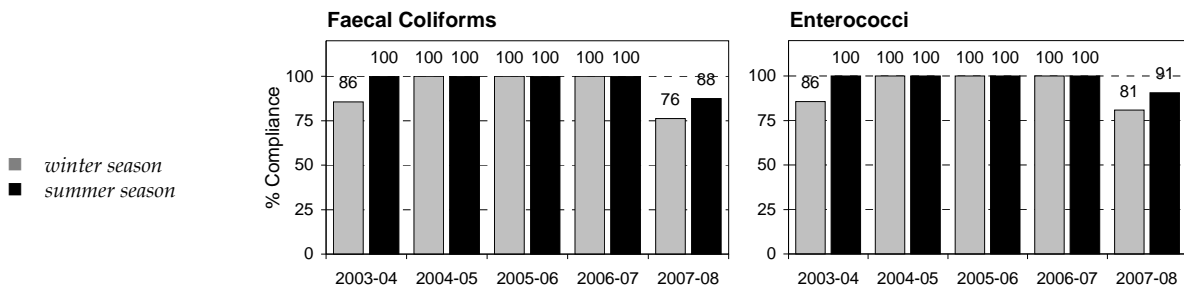
Compliance Faecal coliform compliance with swimming guidelines has ranged from 76% to 100% over the last five years. Enterococci compliance with swimming guidelines has generally been high, ranging from 81% to 100% over the last five years.

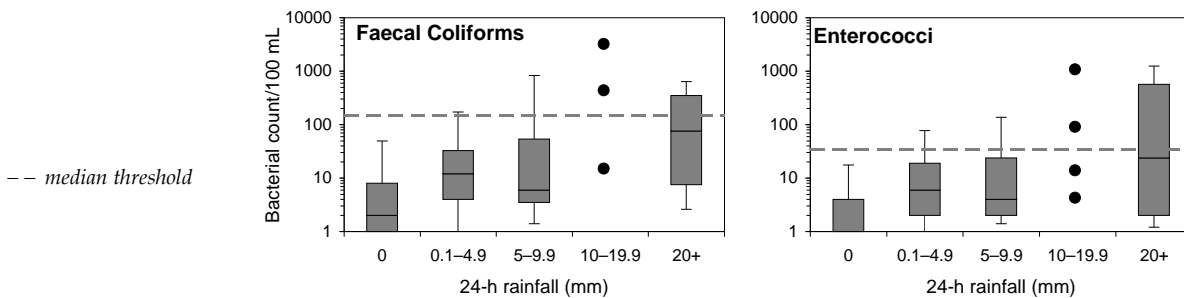
Response to rainfall Faecal coliform and enterococci densities occasionally exceeded the median guideline limits in response to light rain and often exceeded the median guideline limits in response to 20 millimetres of rain or more in the previous 24 hours.

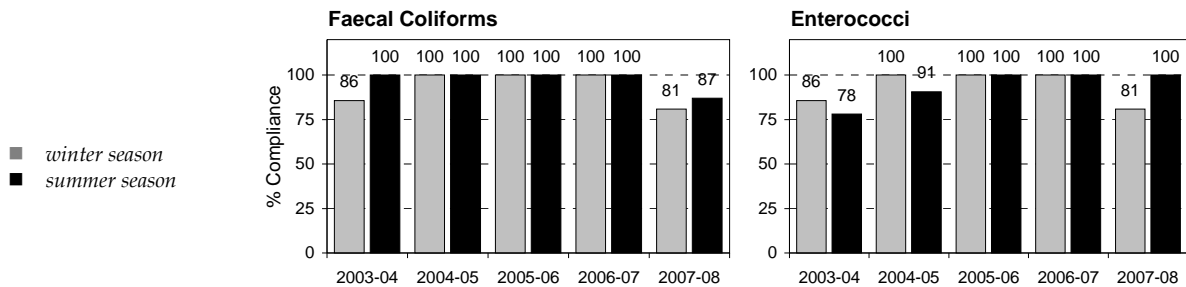
Faecal coliform compliance with swimming guidelines has generally been high ranging from 81% to 100% over the last five years. Enterococci compliance with swimming guidelines has ranged from 78% to 100% over the last five years.

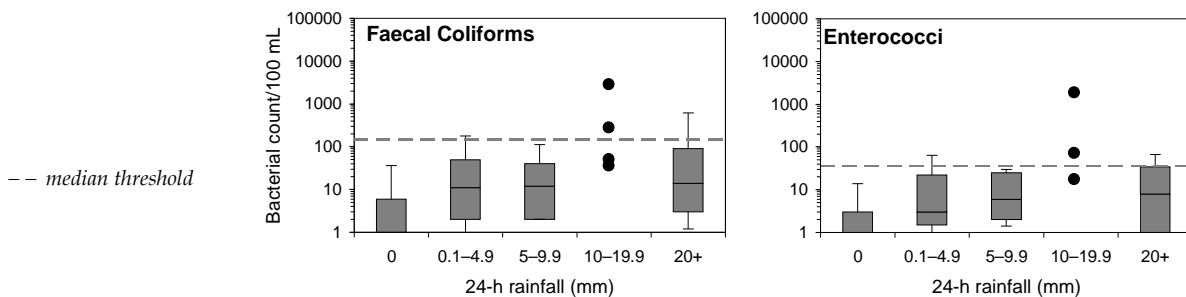
Faecal coliform and enterococci densities generally increased with increasing rainfall. Faecal coliform densities occasionally exceeded the median guideline limit in response to light rain in the previous 24 hours. Enterococci densities occasionally exceeded the median guideline limit after light rain and often exceeded the median guideline limit in response to 20 millimetres of rain or more in the previous 24 hours.

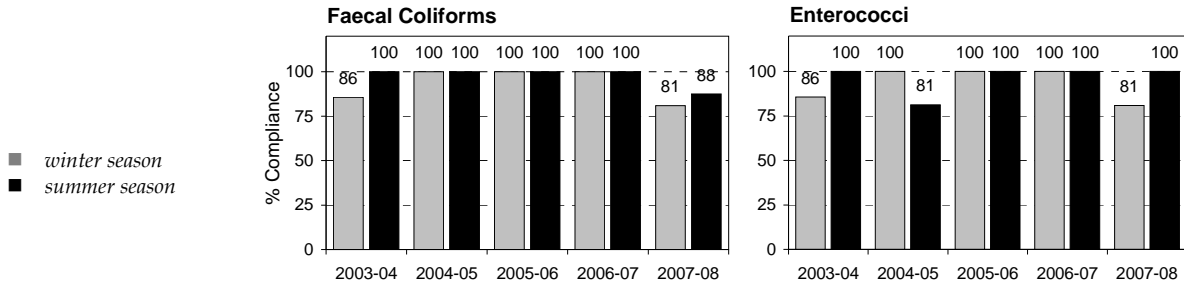
Compliance Faecal coliform and enterococci compliance with swimming guidelines has ranged from 81% to 100% over the last five years.

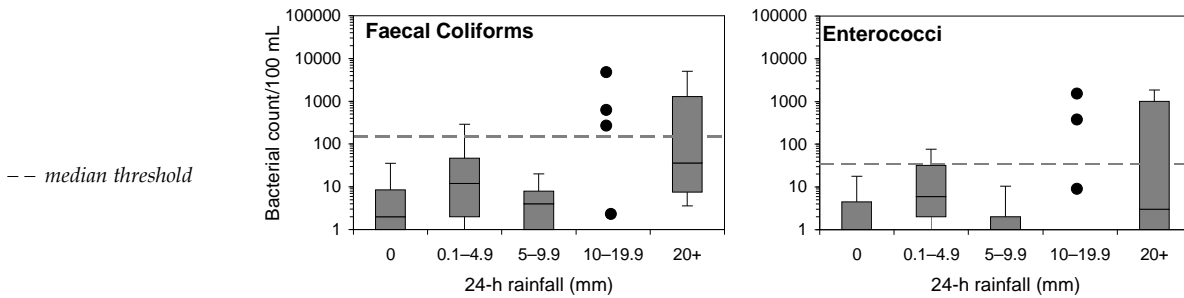
Response to rainfall Faecal coliform and enterococci densities generally increased with increasing rainfall. Faecal coliform and enterococci densities occasionally exceeded the median guideline limit after light rain and often exceeded the median guideline limit in response to 20 millimetres of rain or more in the previous 24 hours.

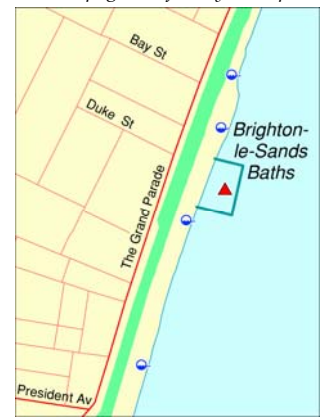
This 60 by 50 metre netted swimming enclosure is situated towards the centre of Lady Robinsons Beach. The southern edge of the swimming enclosure is a pier.

Stormwater drains discharge to the beach in the vicinity of the swimming enclosure. Outflow from the Cooks River can also affect the water quality of the swimming area.

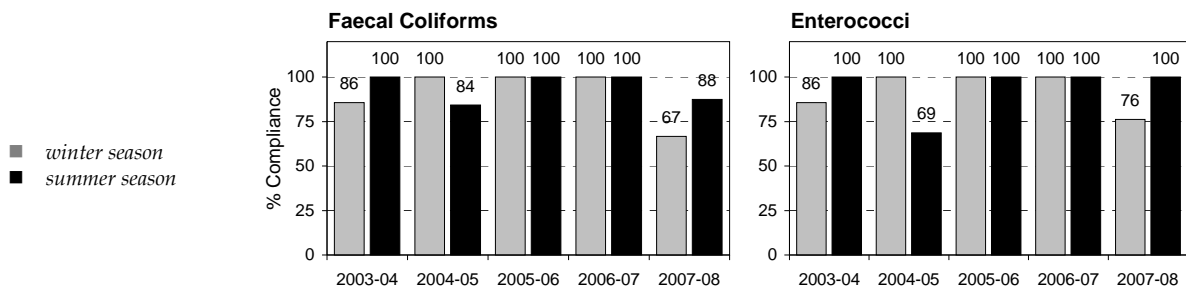
Faecal coliform and enterococci compliance with swimming guidelines has varied, ranging from 67% to 100% for faecal coliforms, and 69% to 100% for enterococci over the last five years.

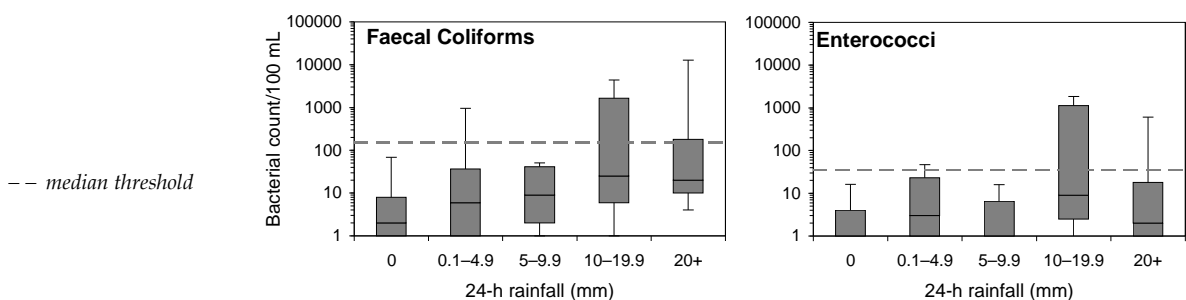
Faecal coliform and enterococci densities generally increased with increasing rainfall. Faecal coliform and enterococci levels occasionally exceeded the median guideline limits after light rain and often exceeded the median guideline limits after ten millimetres of rain or more in the previous 24 hours.

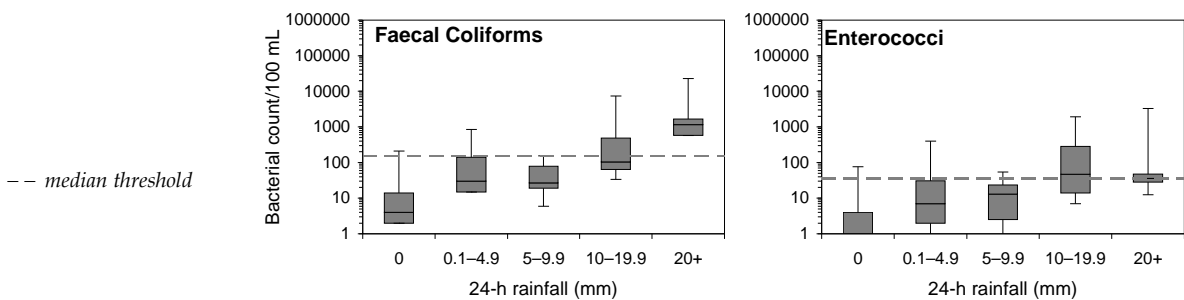
Bacterial densities tended to increase with increasing rainfall, occasionally exceeding the median guideline limits during dry weather, indicating a possible dry-weather contamination problem. Faecal coliforms often exceeded the median guideline limit in response to ten millimetres of rain or more in the previous 24 hours. Enterococci densities regularly exceeded the median guideline limit in response to ten millimetres of rain or more in the previous 24 hours.

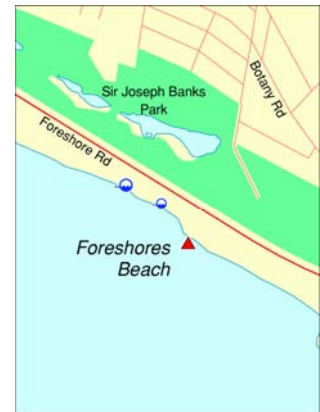
Stormwater drains discharge along the length of the beach. Sewage overflows discharge into Mill Pond Diversion Channel at the western end of the beach, and industrial and urban runoff discharge into Penrhyn Estuary at the eastern end of the beach.

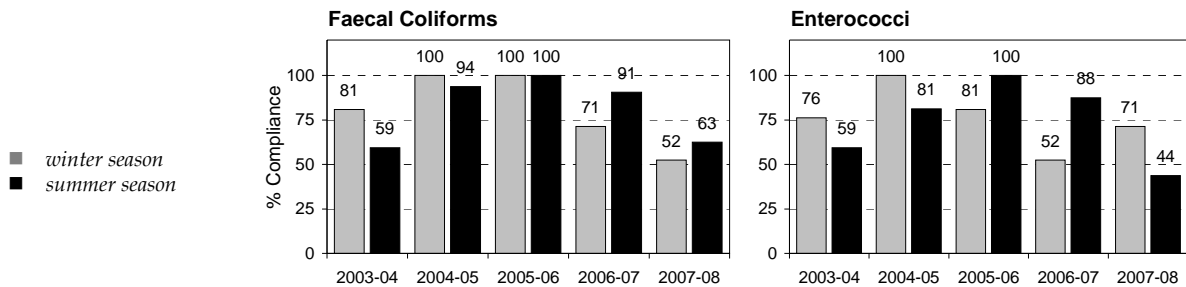
Faecal coliform and enterococci compliance with swimming guidelines have varied considerably, ranging from 52% to 100% for faecal coliforms, and from 44% to 100% for enterococci over the last five years.

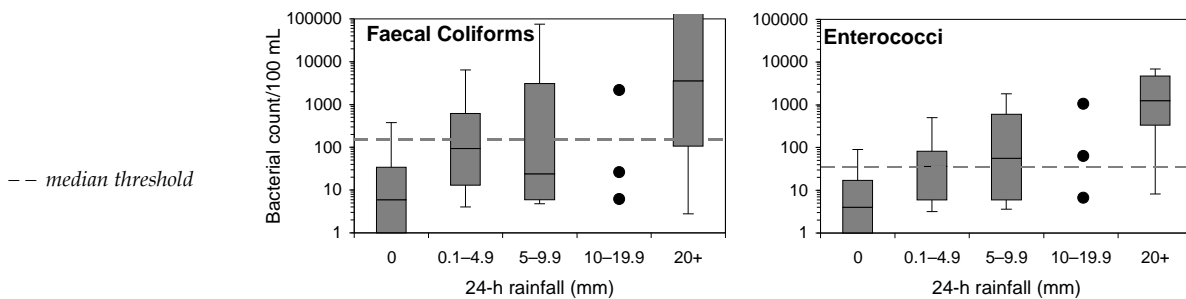
Bacterial densities tended to increase with increasing rainfall, occasionally exceeding the median guideline limits during dry weather, indicating a possible dry-weather contamination problem. Faecal coliform levels often exceeded the median guideline limit in response to light rain and regularly exceeded the median guideline limit after 20 millimetres of rain or more in the previous 24 hours. Enterococci levels regularly exceeded the median guideline limit after light rain and frequently exceeded the median guideline limit in response to 20 millimetres of rain or more in the previous 24 hours.

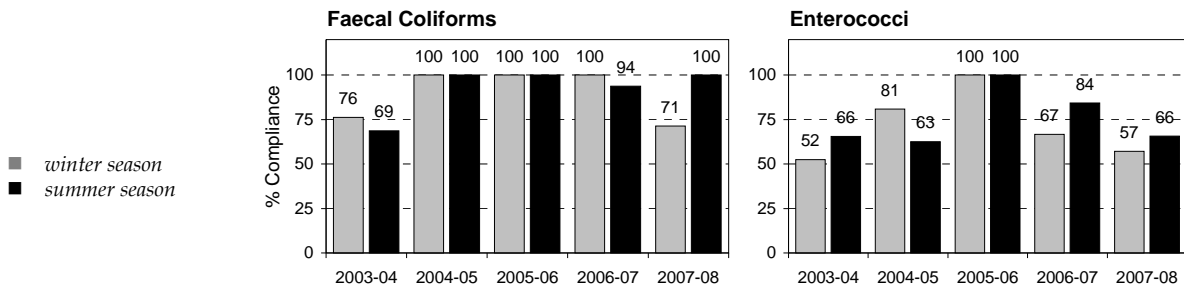
Faecal coliform compliance with swimming guidelines has ranged from 69% to 100% over the last five years. Enterococci compliance with swimming guidelines has been more variable, ranging from 52% to 100% over the last five years.

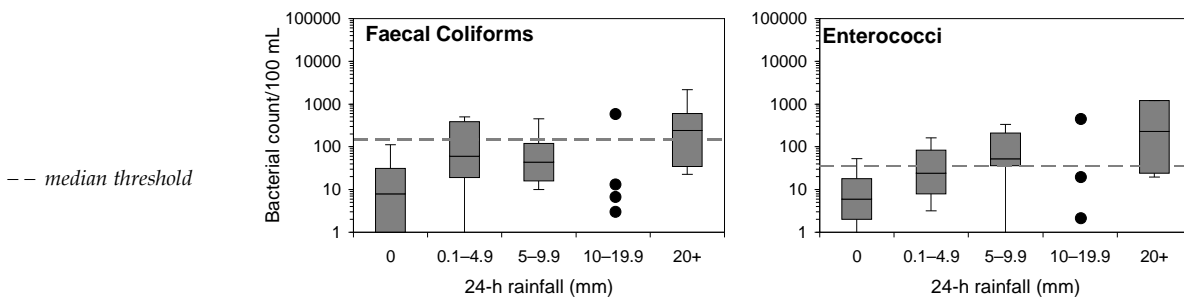
Faecal coliform and enterococci densities tended to increase with increasing rainfall. Faecal coliform levels often exceeded the median guideline limit after little rain and regularly exceeded the median guideline limit after 20 millimetres of rain or more in the previous 24 hours. Enterococci levels occasionally exceeded the median guideline limit after no rain, indicating a possible dry-weather contamination problem. Enterococci levels frequently exceeded the median guideline limit after five millimetres of rain or more in the previous 24 hours.

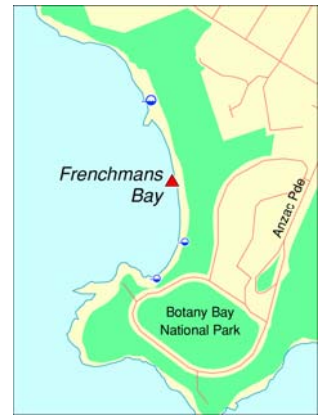
This narrow beach is approximately 500 metres long, with a rock wall towards the northern end. The swimming area is not netted. A small recreational reserve is situated behind the beach at the southern end.

Stormwater drains discharge to the beach.

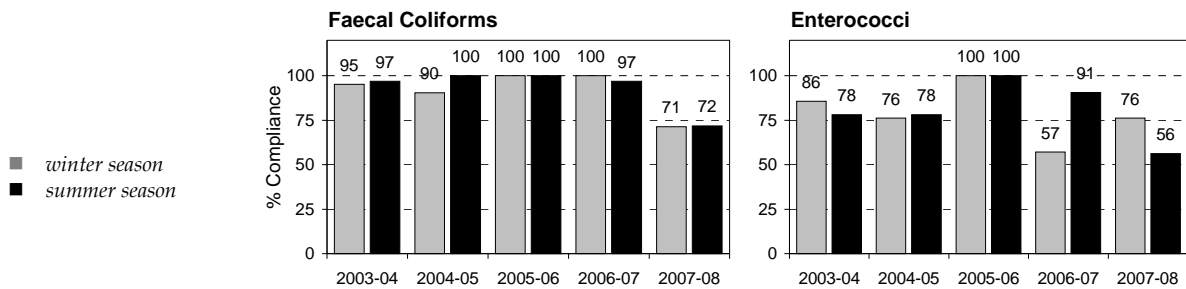
Faecal coliform compliance with swimming guidelines has ranged from 71% to 100% over the last five years. Enterococci compliance with swimming guidelines has been more variable, ranging from 56% to 100% in the last five years.

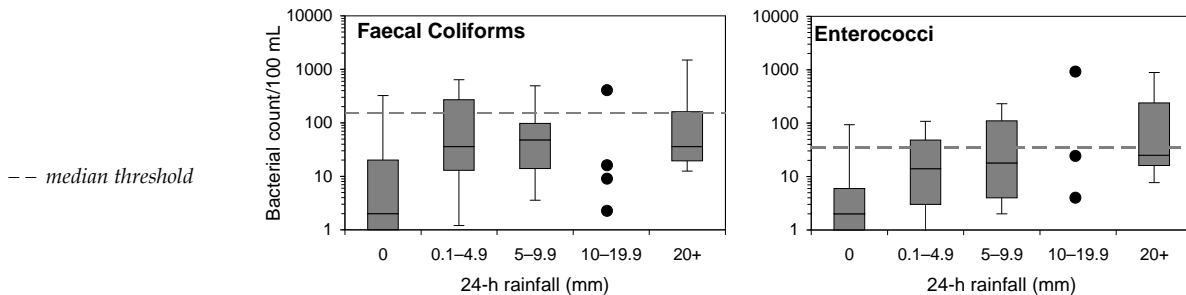
Faecal coliform and enterococci densities did not display a clear response to increasing rainfall and occasionally exceeded the median guideline limit in response to no rainfall in the previous 24 hours. Results indicate a possible dry-weather contamination problem.

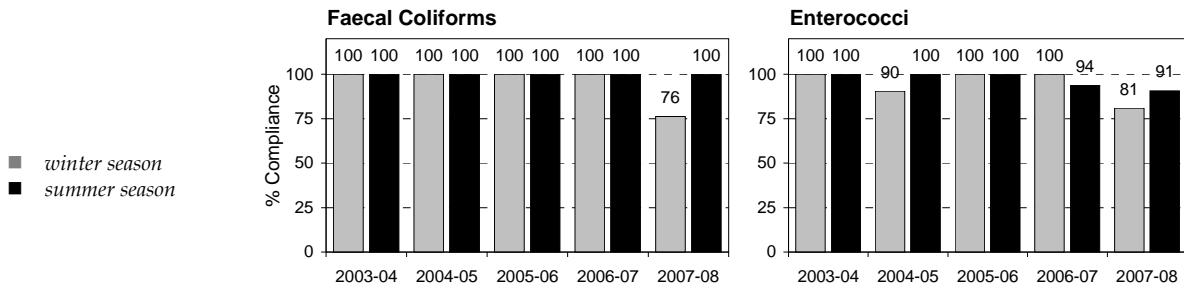
With the exception of winter 2007, faecal coliform levels have complied 100% of the time with swimming guidelines over the last five years. Enterococci compliance with swimming guidelines has been more variable, ranging from 81% to 100% over the last five years.

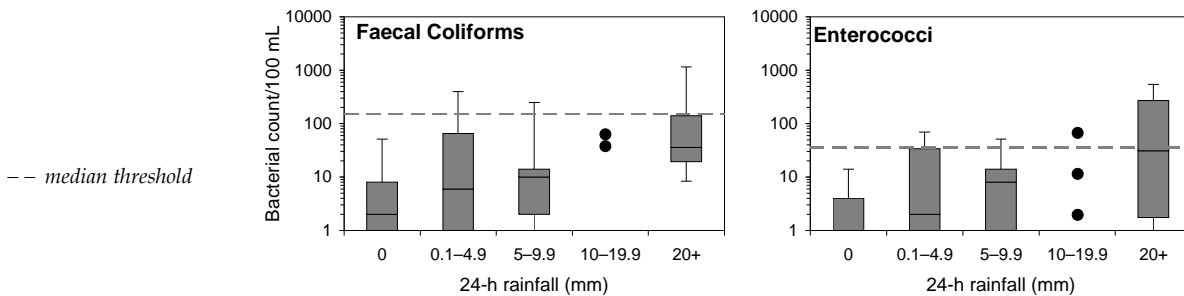
Faecal coliform and enterococci densities tended to increase with increasing rainfall. Faecal coliform and enterococci levels occasionally exceeded the median guideline limits in response to light rain in the previous 24 hours. Enterococci levels often exceeded the median guideline limit in response to 20 millimetres of rain or more in the previous 24 hours.

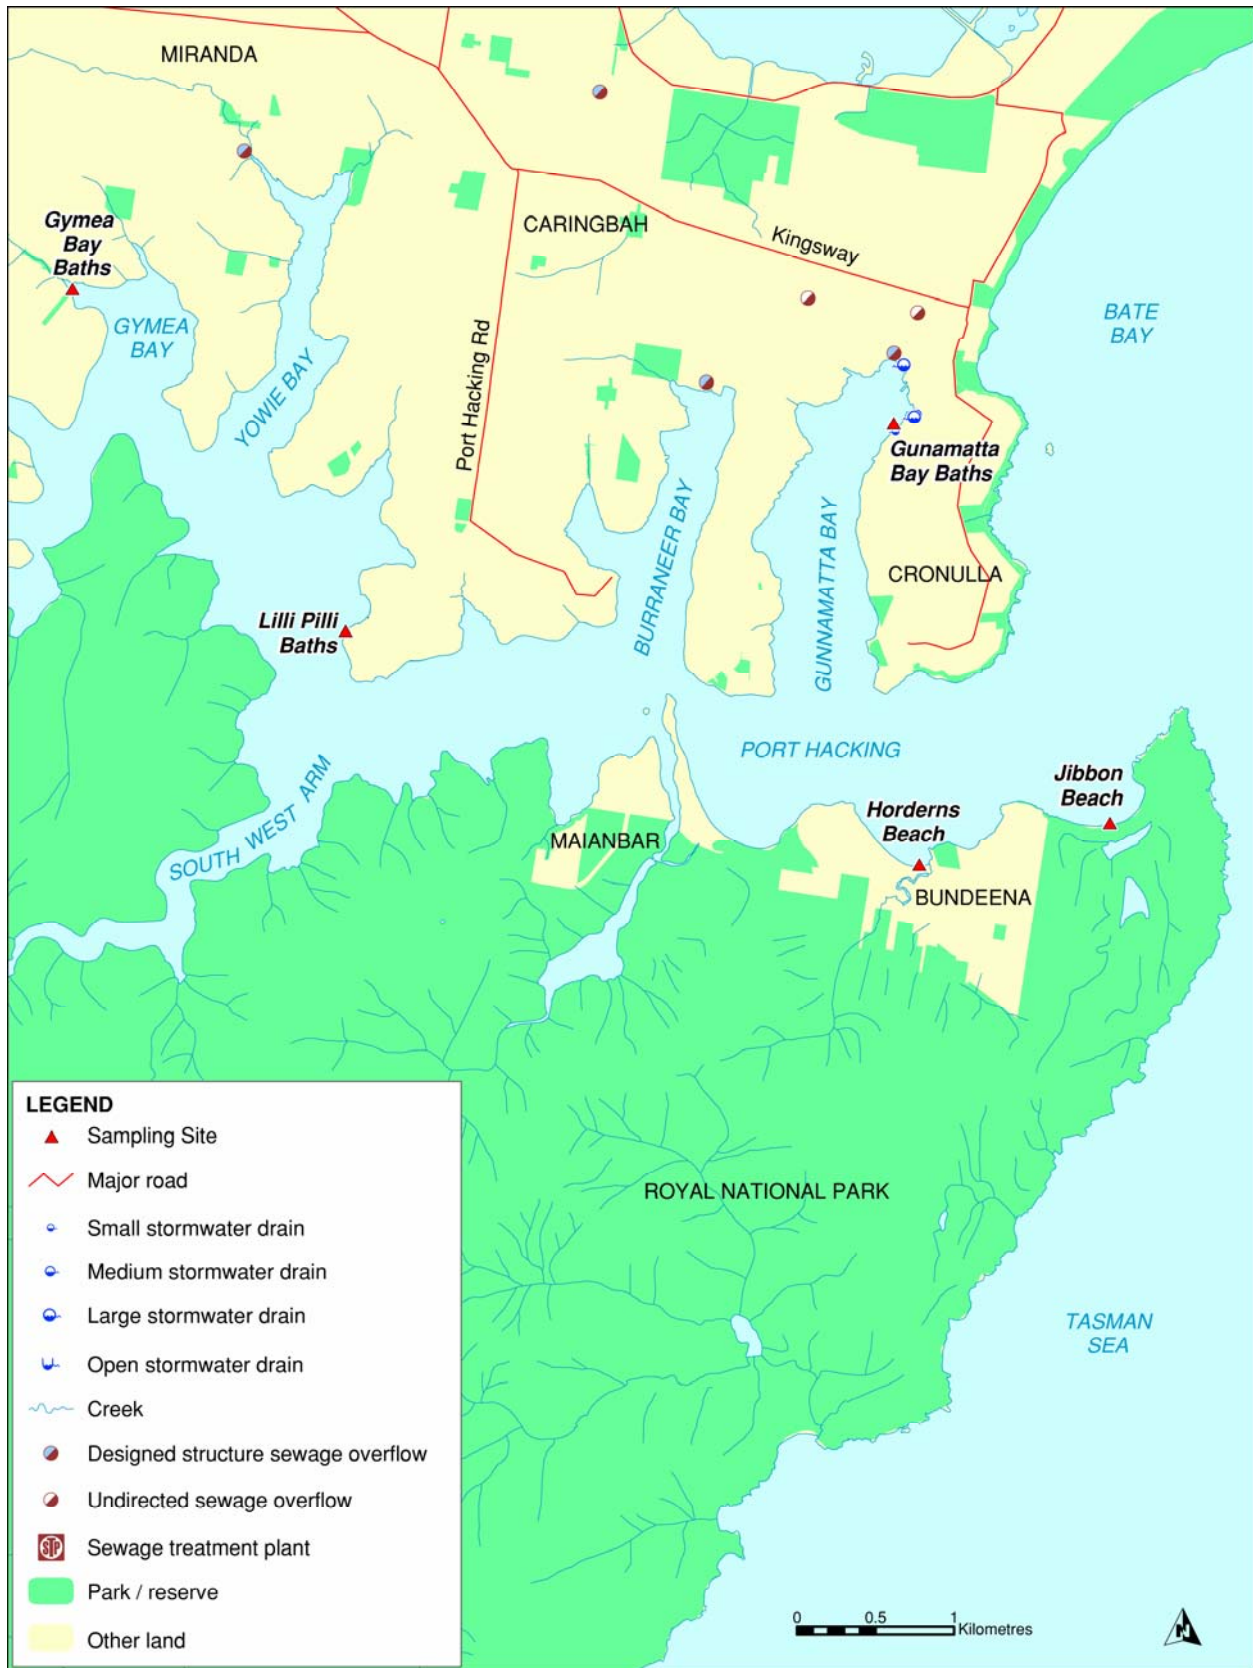
Sites: Gunnamatta Bay Baths, Gymea Bay Baths, Lilli Pilli Bay Baths, Horderns Beach and Jibbon Beach

Port Hacking is the downstream reach of the Hacking River, which flows into Bate Bay. Land use in the Port Hacking catchment is mainly residential on the northern shore, with The Royal National Park on the southern shore.

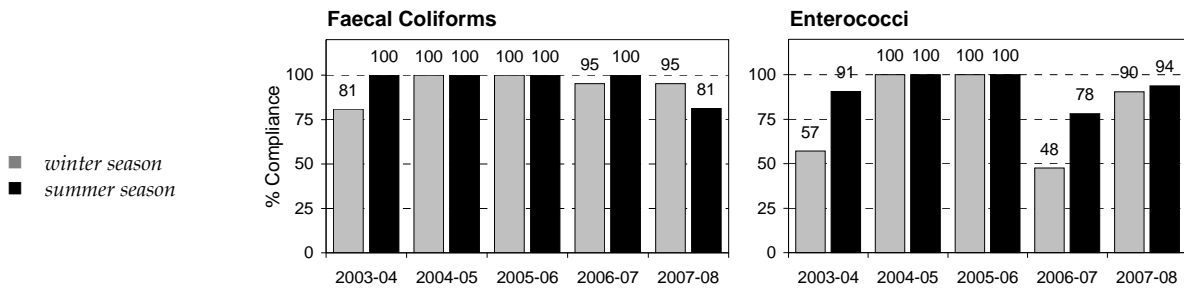
Compliance Faecal coliform compliance has generally been high ranging from 81% to 100% over the last five years. Enterococci compliance has been more variable, ranging from 48% to 100% over the last five years.

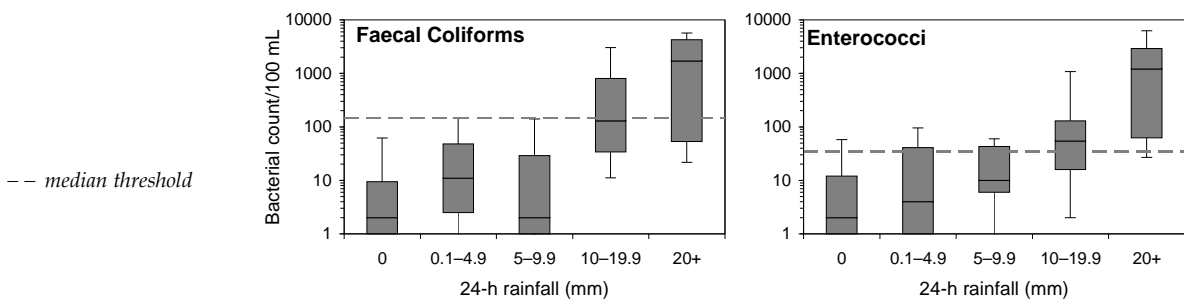
Response to rainfall Faecal coliform and enterococci densities generally increased with increasing rainfall. Faecal coliforms often exceeded the median guideline limit in response to ten millimetres of rain or more and regularly exceeded the median guideline limit in response to 20 millimetres of rain or more in the previous 24 hours. Enterococci levels occasionally exceeded the median guideline limit after no rain and frequently after 20 millimetres of rain or more in the previous 24 hours. Enterococci densities exceeding the median guideline limit after no rainfall indicate a possible dry-weather contamination problem.

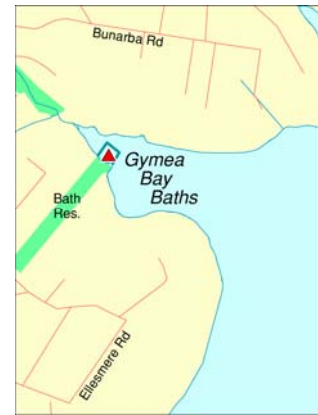
See page 286 for key to map

Description This is a 50 by 30 metre enclosed tidal swimming area with a narrow, sandy beach. Two small recreation reserves lead to the beach. Coonong Creek flows to Gymea Bay behind the beach.

Pollution sources Stormwater discharges from the surrounding residential area, and sewers may overflow from blocked sewer mains.

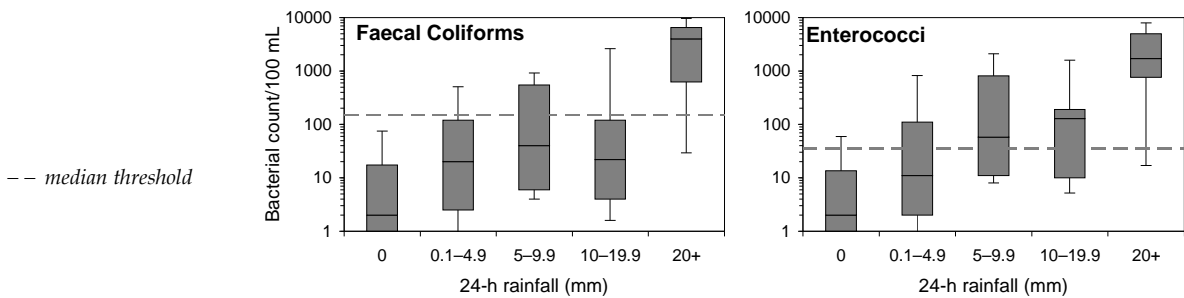
Response to rainfall Faecal coliform and enterococci densities generally increased with increasing rainfall. Faecal coliform levels occasionally exceeded the median guideline limit after light rain and frequently exceeded the median guideline limit in response to 20 millimetres of rain or more in the previous 24 hours. Enterococci densities occasionally exceeded the median guideline limit after no rain, indicating a possible dry-weather contamination problem. Enterococci densities regularly exceeded the median guideline limit in response to five millimetres of rain or more and frequently exceeded the median guideline limit in response to 20 millimetres of rain or more in the previous 24 hours.

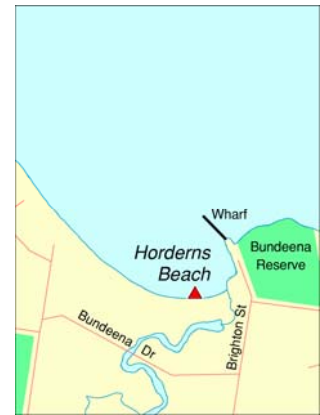
This is a 700 metre long, narrow, sandy beach in Bundeena Bay on the southern side of Port Hacking. The Cronulla–Bundeena wharf and a recreation reserve border the beach on the eastern end. The beach is backed by the township of Bundeena.

There is potential septic tank seepage from an unknown number of properties in Bundeena and Maianbar not yet connected to Sydney Water's sewerage system. Stormwater discharge and a small creek at the eastern end of the beach may also be a potential source of pollution.

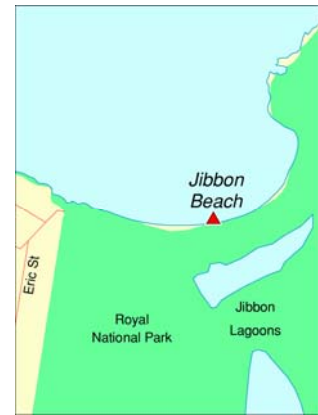
This is a 700 metre long sandy beach located inside the southern entrance to Port Hacking. The beach is backed by the Royal National Park and can be accessed via Bundeena. The water is deep inshore and a popular boating destination. Beach conditions are safest in the eastern corner.

Stormwater discharge from the nearby residential area of Bundeena is a potential source of pollution, along with illegal discharge of untreated sewage from visiting vessels without holding facilities.

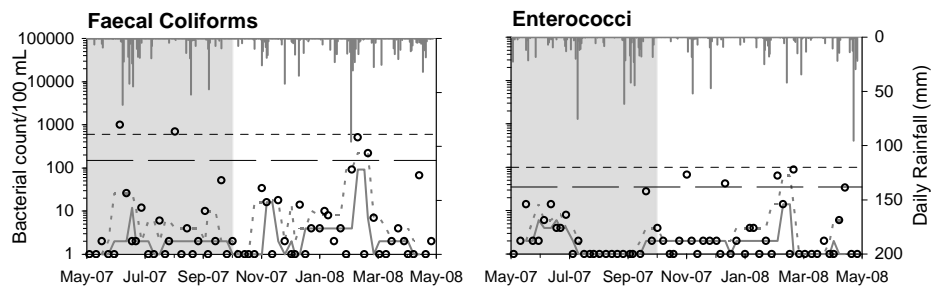
Season data

- | rainfall
 - o individual result
 - rolling median
 - rolling 80th percentile
- Guidelines
(see page 7 for details)
- median threshold
 - 80th percentile threshold
