Sydney Metropolitan Beaches

Waverley Council

Beaches: Bondi, Tamarama and Bronte

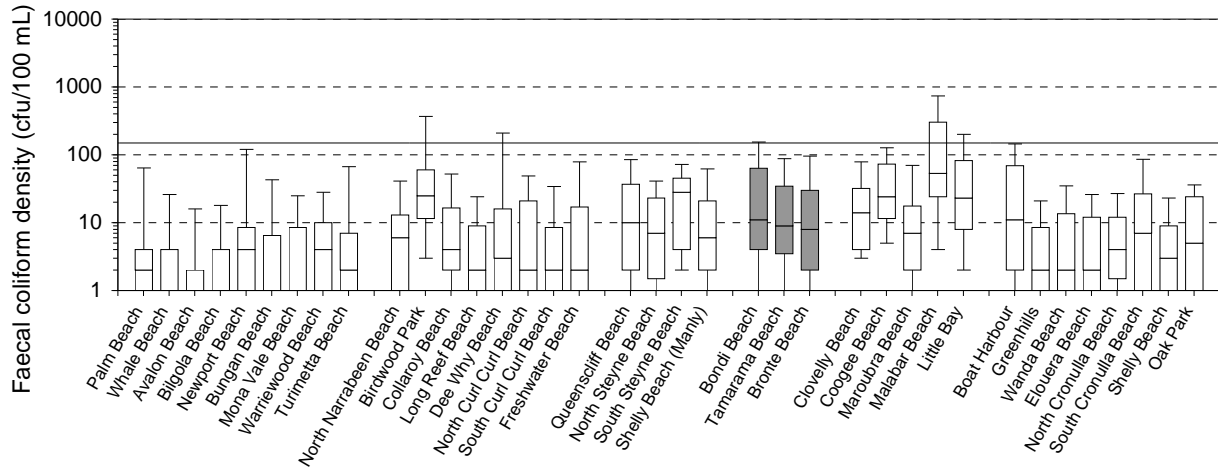
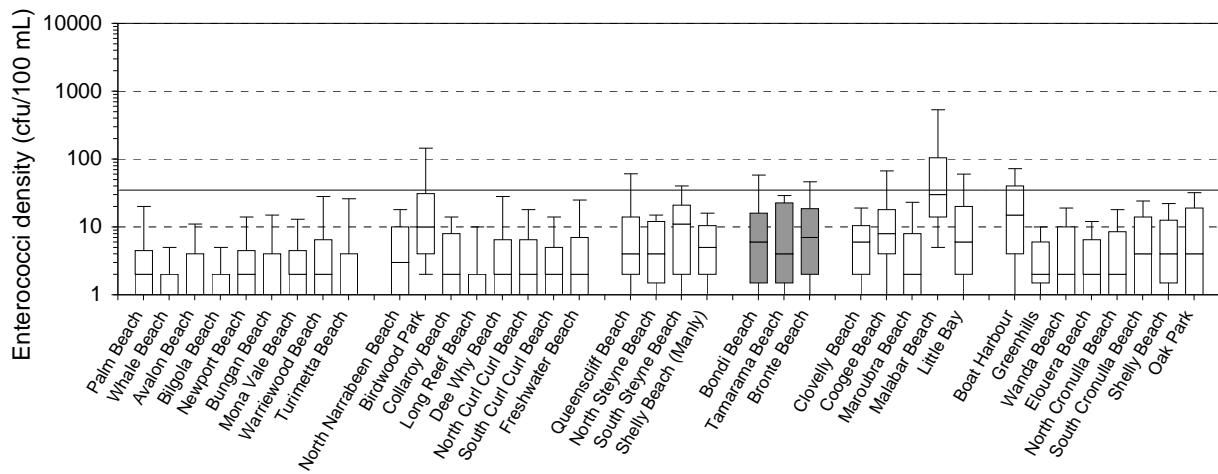
Figure 9: Range of Bacterial Levels at Sydney Beaches during Summer 2008–2009

The range of bacterial levels measured at Sydney beaches during summer 2008–2009 is shown in Figure 9, with Waverley Council beaches highlighted in grey. Levels of both faecal coliforms and enterococci were within the range of values measured at other city beaches in Sydney.

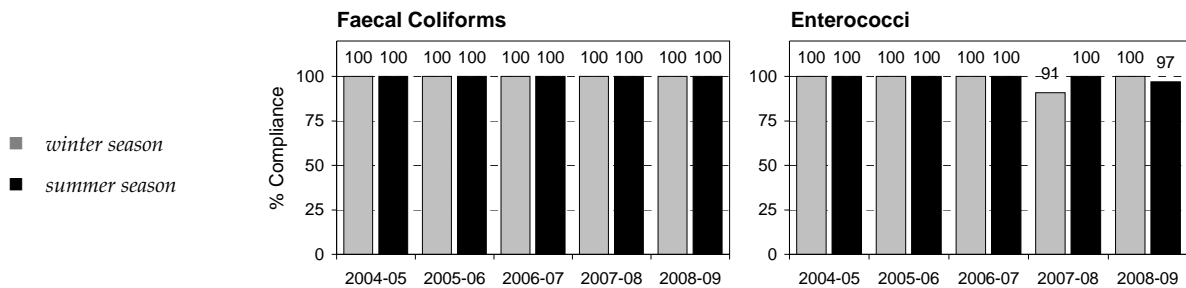
Faecal coliform levels complied with swimming guidelines 100% of the time over the last five years. Enterococci compliance has ranged from 91% to 100% over the last five years.

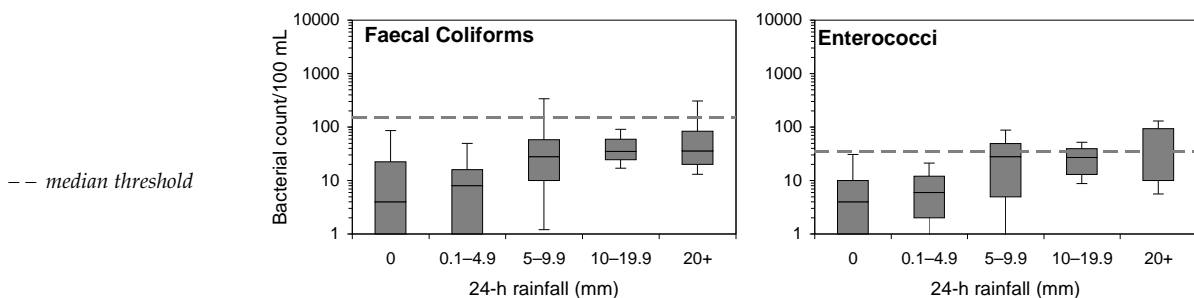
Response to rainfall

Bacterial densities generally increased with increasing rainfall. Faecal coliform levels occasionally exceeded the median guideline limit in response to five millimetres of rain or more in the previous 24 hours. Enterococci levels often exceeded the median guideline limit after five millimetres of rain or more in the previous 24 hours.

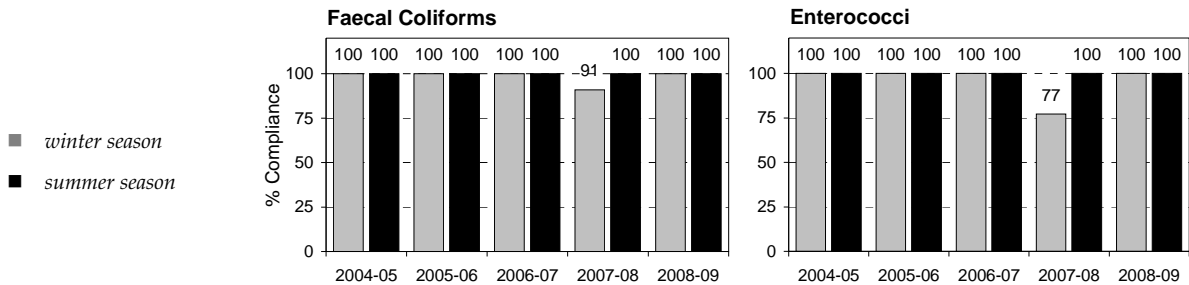
Compliance

With the exception of winter 2007, faecal coliform and enterococci levels complied with swimming guidelines 100% of the time over the last five years.

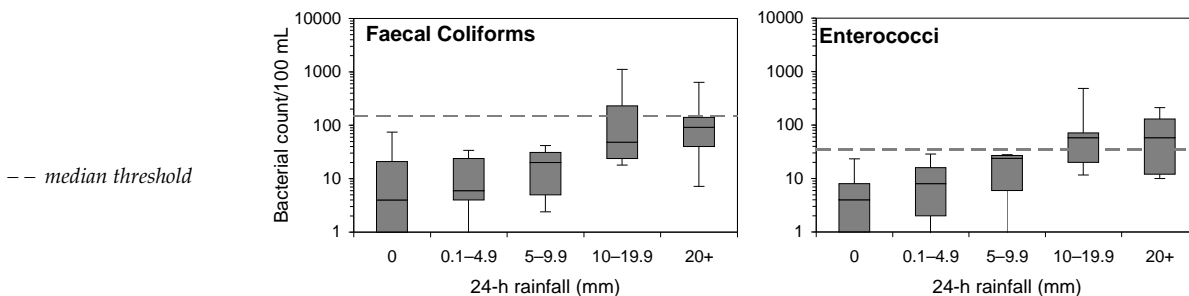
Response to rainfall

Bacterial densities generally increased with increasing rainfall. Faecal coliform levels often exceeded the median guideline limit in response to ten millimetres of rain or more in the previous 24 hours. Enterococci levels regularly exceeded the median guideline limit after ten millimetres of rain or more in the previous 24 hours.

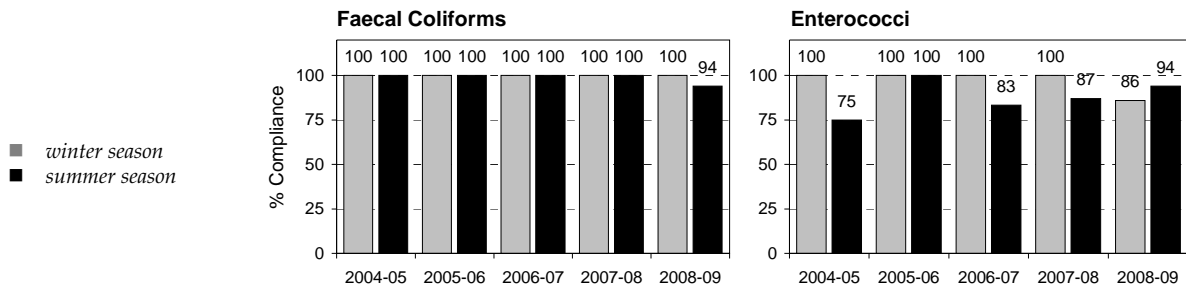
Compliance

With the exception of summer 2008–2009, faecal coliform levels complied with swimming guidelines 100% of the time over the last five years. Enterococci compliance has been more varied, ranging from 75% to 100%, with higher levels of compliance usually recorded in winter seasons.

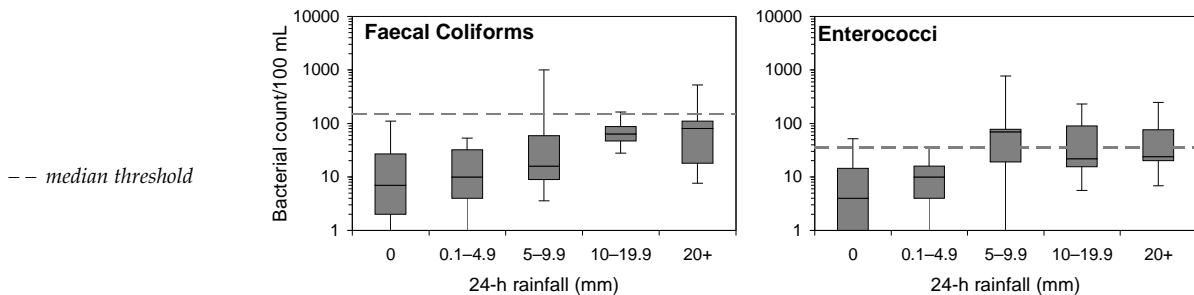
Response to rainfall

Bacterial densities generally increased with increasing rainfall. Faecal coliform densities occasionally exceeded the median guideline limit in response to five millimetres of rain or more in the previous 24 hours. Enterococci levels occasionally exceeded the median guideline limit in response to no rain, and regularly exceeded the median guideline after five millimetres of rain or more in the previous 24 hours. Bacterial levels exceeding the median guideline limit after little to no rain indicate a dry-weather contamination problem.

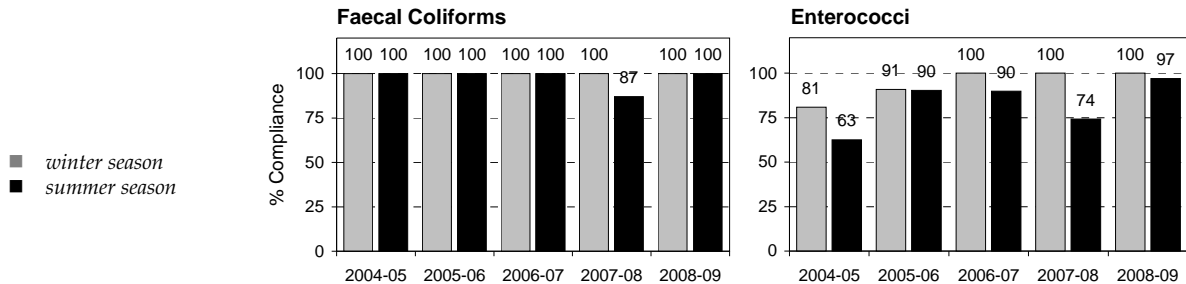
With the exception of summer 2007–2008, faecal coliform compliance with swimming guidelines occurred 100% of the time over the last five years. Enterococci compliance has been more varied, ranging from 63% to 100% over the last five years.

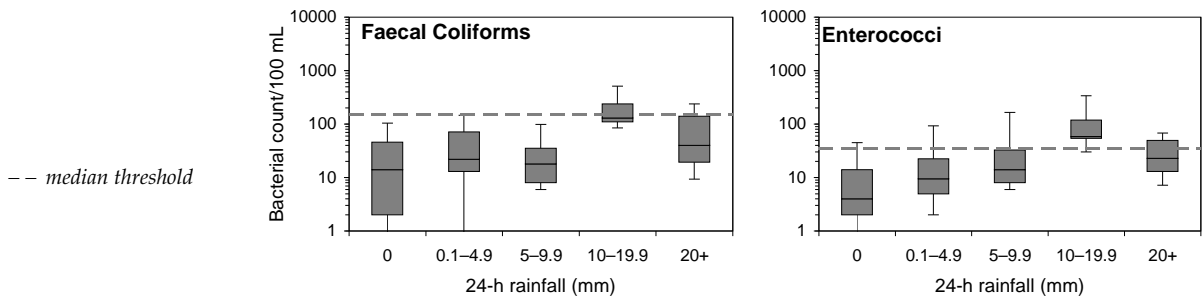
Response to rainfall

Bacterial densities tended to increase with increasing rainfall. Faecal coliform densities often exceeded the median guideline limit in response to ten millimetres of rain or more in the previous 24 hours. Enterococci densities occasionally exceeded the median guideline limit after no rain, and frequently exceeded the median guideline limit after ten millimetres of rain or more in the previous 24 hours. A dry-weather contamination problem is indicated.

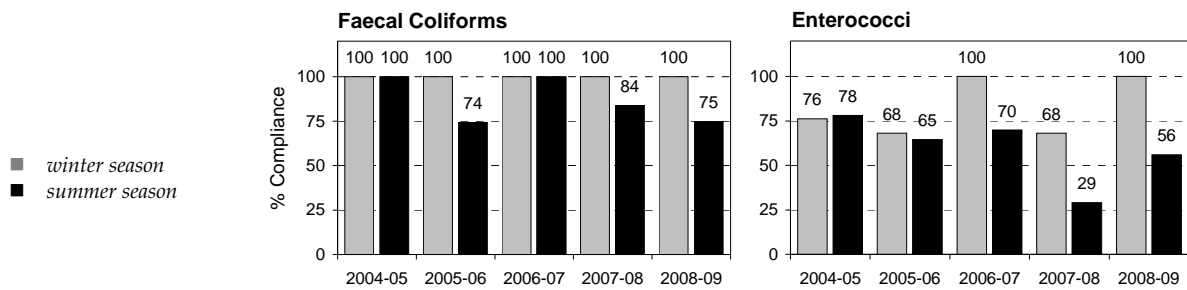
Compliance

Faecal coliform compliance has ranged from 74% to 100% over the last five years. Enterococci compliance has been more variable, ranging from 29% to 100% over the last five years.

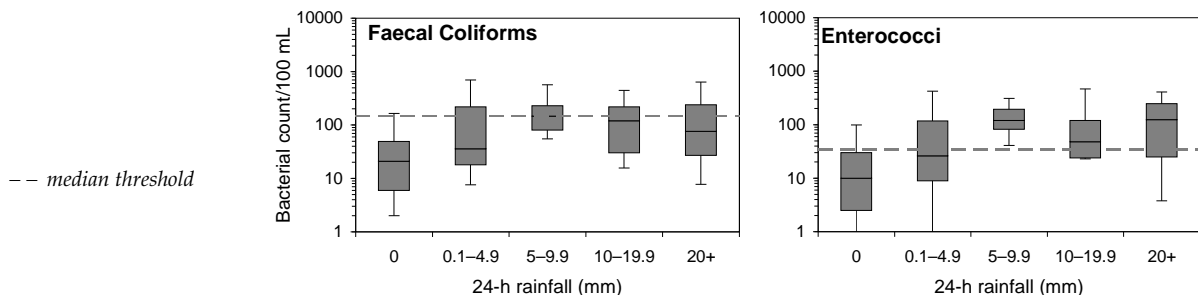
Response to rainfall

Bacterial densities increased with increasing rainfall and occasionally exceeded the median guideline limits after little or no rainfall, indicating a dry-weather contamination problem. Enterococci levels usually exceeded the median guideline limit in response to five millimetres of rain or more in the previous 24 hours.

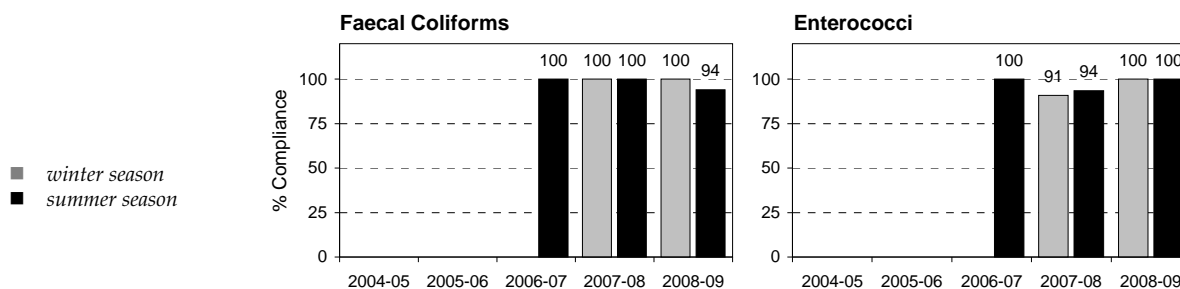
Compliance Monitoring at Little Bay began in December 2006. Since then faecal coliform compliance has ranged from 94% to 100% and enterococci compliance has ranged from 91% to 100%.

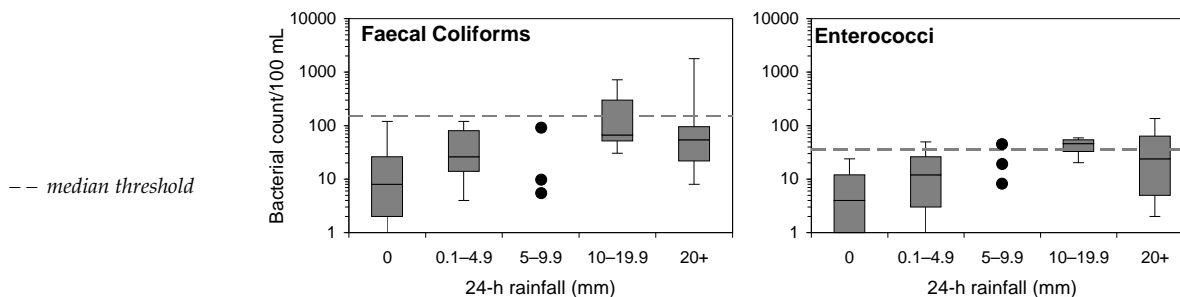
Response to rainfall Bacterial densities generally increased with increasing rainfall. Faecal coliform levels often exceeded the median guideline limit after ten millimetres of rain or more in the previous 24 hours, and enterococci levels regularly exceeded the median guideline limit in response to ten millimetres of rain or more in the previous 24 hours.

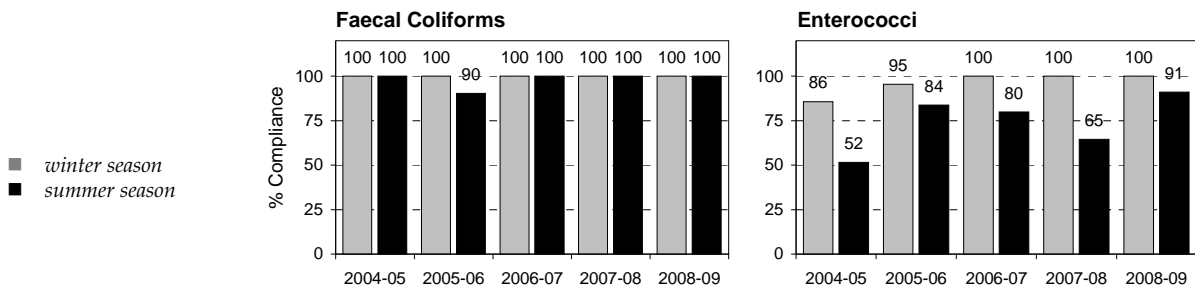
With the exception of summer 2005–2006, faecal coliform levels complied with swimming guidelines 100% of the time over the last five years. Compliance with enterococci has been more varied, ranging from 52% to 100%, with higher compliance occurring during the winter seasons over the last five years.

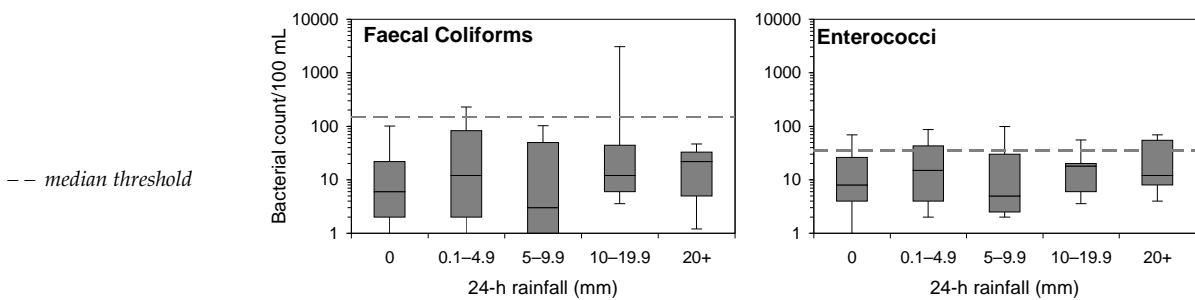
Response to rainfall

Bacterial densities displayed a slight response to rainfall. Faecal coliform densities occasionally exceeded the median guideline limit after little rainfall, and enterococci densities exceeded the median guideline limit after no rain in the previous 24 hours, indicating a dry-weather contamination problem.

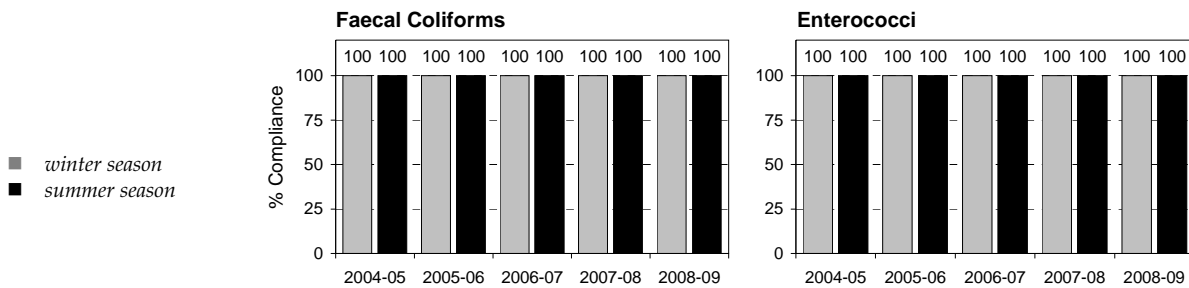
Compliance

Faecal coliform and enterococci levels complied with swimming guidelines 100% of the time over the last five years.

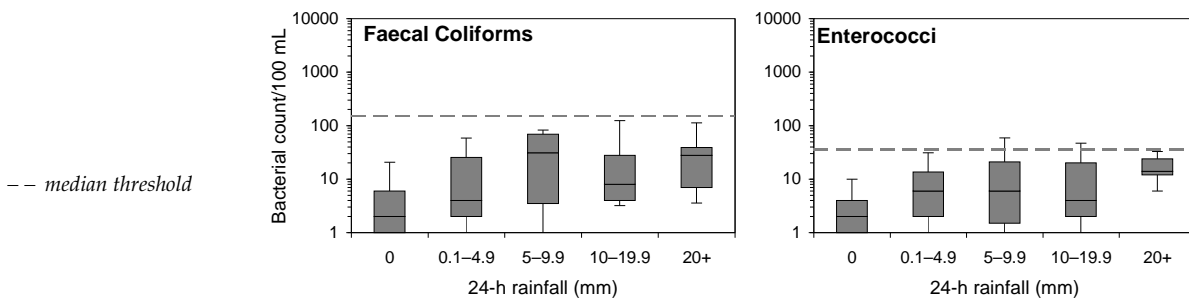
Response to rainfall

Bacterial densities tended to increase with increasing rainfall. Faecal coliform levels generally remained below the median guideline limit across all rainfall categories. Enterococci levels occasionally exceeded the median guideline limit in response to five millimetres of rain or more in the previous 24 hours.
