Sydney Metropolitan Area Harbour Swimming Sites

Lower Georges River

Sites: Jew Fish Bay Baths, Como Baths, Oatley Bay Baths, Carss Point Baths, Sandringham Baths and Dolls Point Baths

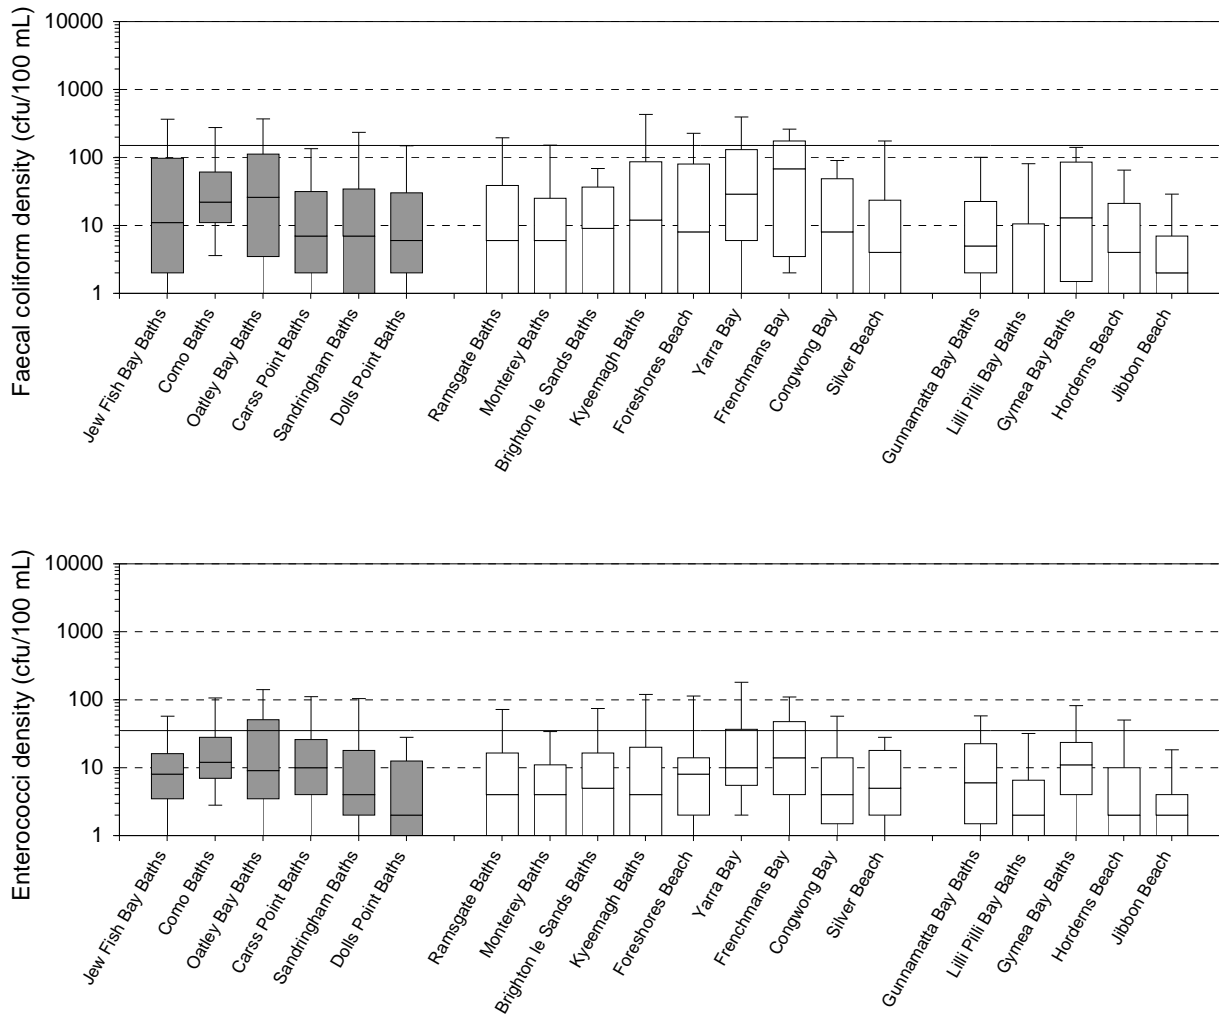
Figure 28: Bacterial Levels at Lower Georges River, Botany Bay and Port Hacking Sites during Summer 2008–2009

The range of indicator bacteria levels measured at Botany Bay, lower Georges River and Port Hacking swimming areas during summer 2008–2009 is shown in Figure 28. Lower Georges River sites are highlighted in grey. The levels of faecal coliforms and enterococci tended to be similar to the range of values measured across the local estuaries.

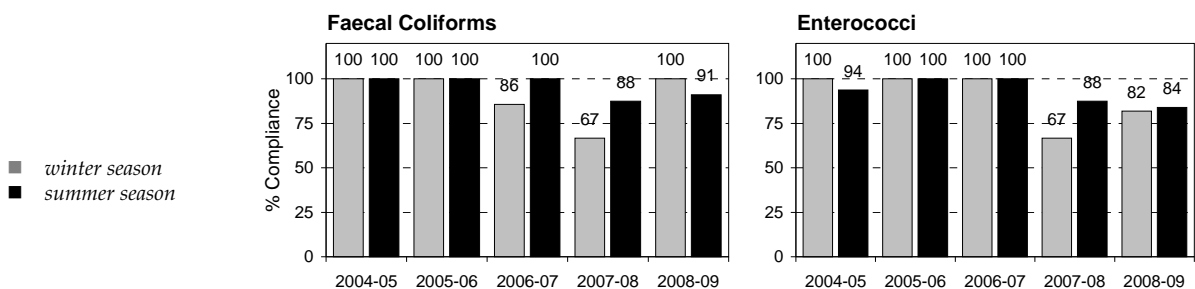
Compliance Faecal coliform and enterococci compliance with swimming guidelines has varied over the last five years, both ranging from 67% to 100%.

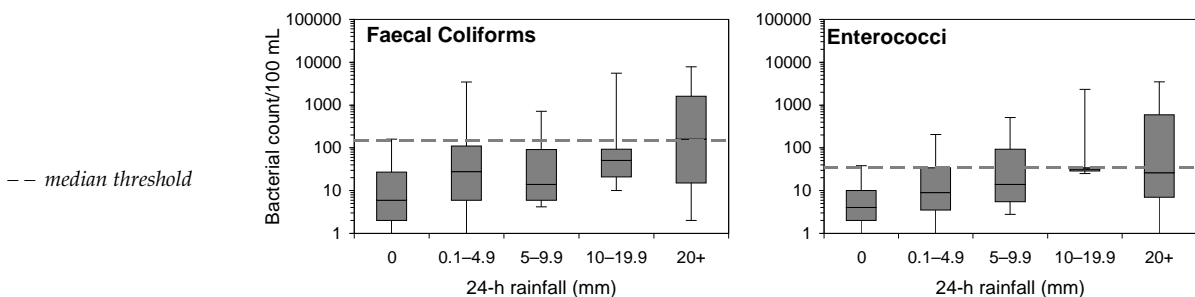
Response to rainfall Bacterial densities increased with increasing rainfall, occasionally exceeding median guideline limits after no rain, indicating a possible dry-weather contamination problem. Faecal coliform levels often exceeded the median guideline limit in response to 20 millimetres of rain in the previous 24 hours. Enterococci levels often exceeded the median guideline limit in response to light rain in the previous 24 hours.

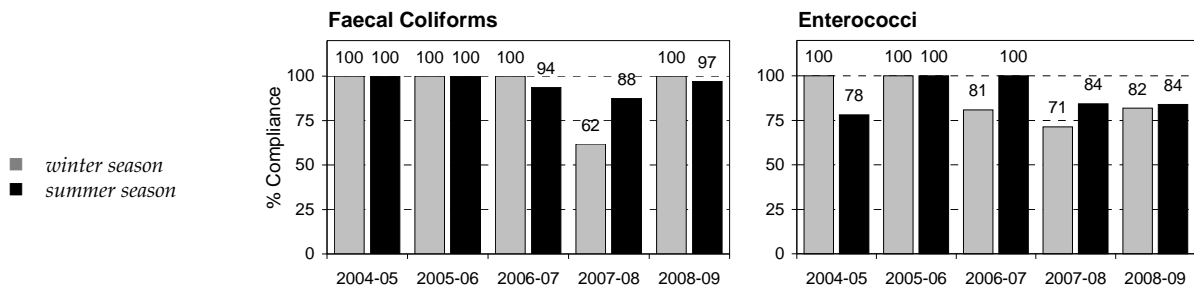
Faecal coliform compliance with swimming guidelines has varied, ranging from 62% to 100% over the last five years. Enterococci compliance with swimming guidelines also varied, ranging from 71% to 100% over the last five years.

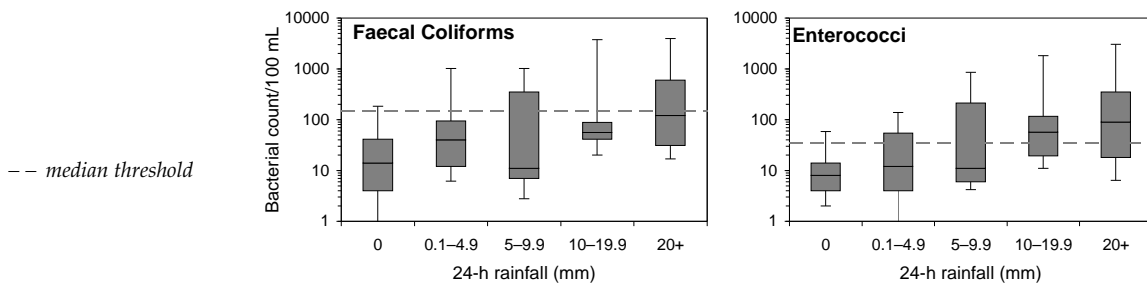
Faecal coliform and enterococci densities increased with increasing rainfall occasionally exceeding median guideline limits after no rain, indicating a possible dry-weather contamination problem. Faecal coliform levels often exceeded the median guideline limit in response to five millimetres of rain or more in the previous 24 hours. Enterococci levels often exceeded the median guideline limit after light rain and frequently exceeded the median guideline limit in response to ten millimetres of rain or more in the previous 24 hours.

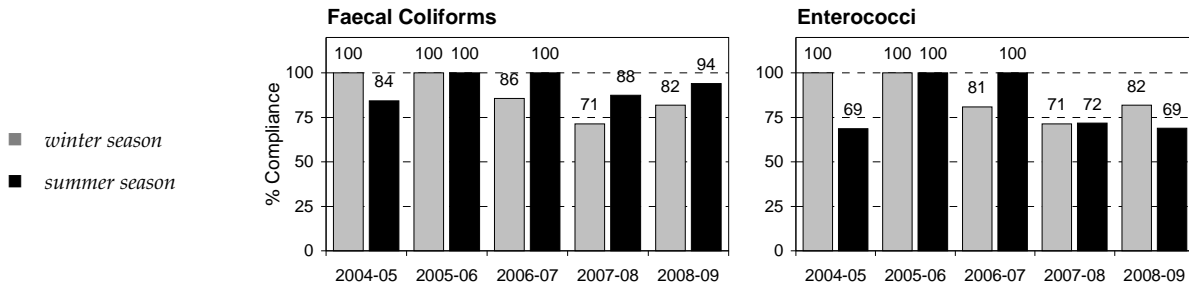
Faecal coliform compliance with swimming guidelines has been variable, ranging from 71% to 100% over the last five years. Enterococci compliance has also varied, ranging from 69% to 100% over the last five years.

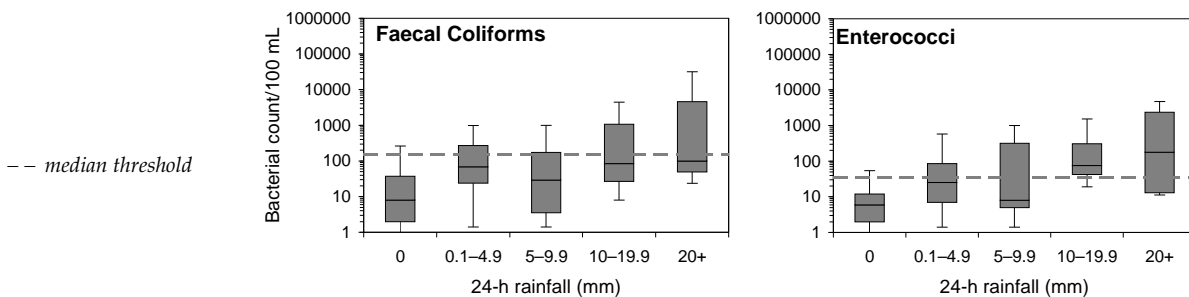
Faecal coliform and enterococci densities increased with increasing rainfall and regularly exceeded the median guideline limits in response to even light rain in the previous 24 hours. Bacterial densities occasionally exceeded median guideline limits in response to no rain in the previous 24 hours, indicating a possible dry-weather contamination problem.

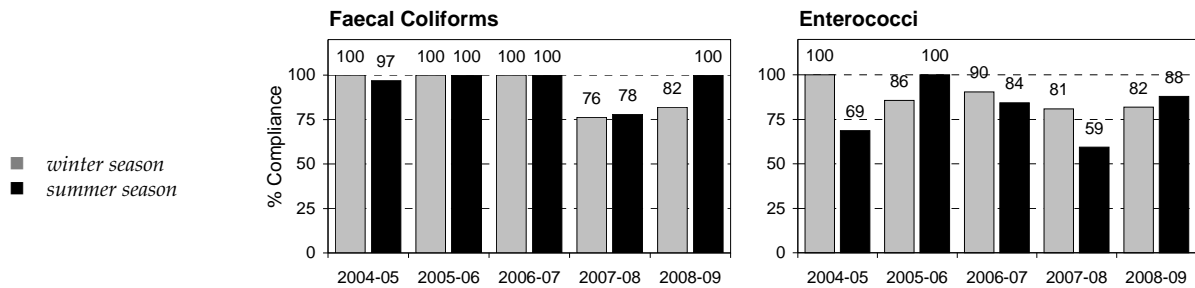
Compliance Faecal coliform compliance with swimming guidelines has ranged from 76% to 100% over the last five years. Enterococci compliance with swimming guidelines has varied considerably, ranging from 59% to 100% over the last five years.

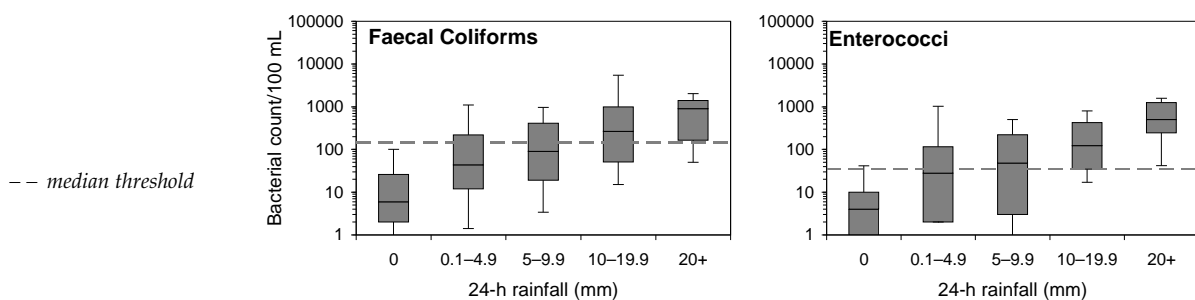
Response to rainfall Faecal coliform densities often exceeded the median guideline limit in response to light rain and frequently exceeded the median guideline limit in response to ten millimetres of rain or more in the previous 24 hours. Enterococci densities occasionally exceeded the median guideline limit after no rain, indicating a possible dry-weather contamination problem. Enterococci densities usually exceeded the median guideline limit in response to 20 millimetres of rain or more in the previous 24 hours.

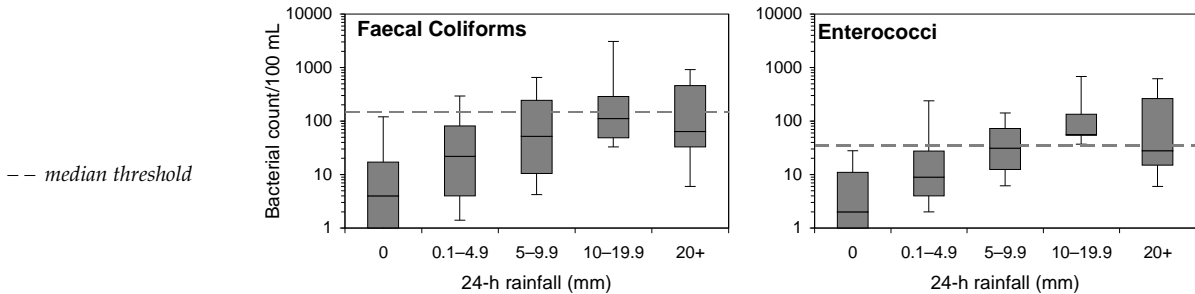
Faecal coliform and enterococci densities generally increased with increasing rainfall and occasionally exceeded the median guideline limits in response to light rain. Bacterial densities regularly exceeded the median guideline limit in response to five millimetres of rain or more in the previous 24 hours.

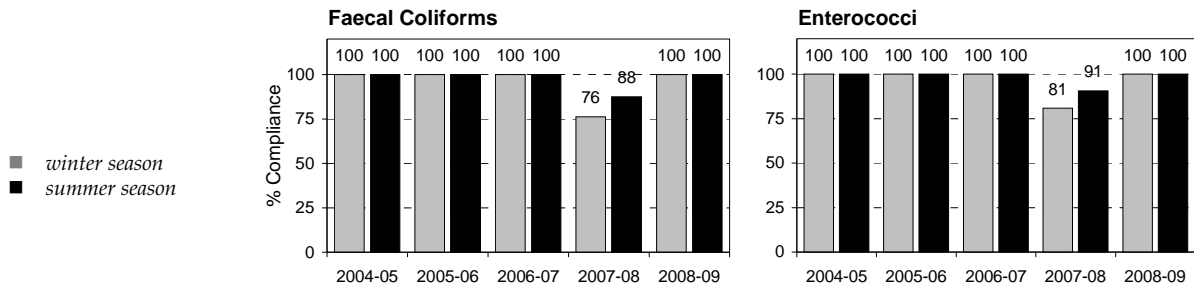
Compliance With the exception of 2007–2008, faecal coliform and enterococci levels complied with swimming guidelines 100% of the time over the last five years.

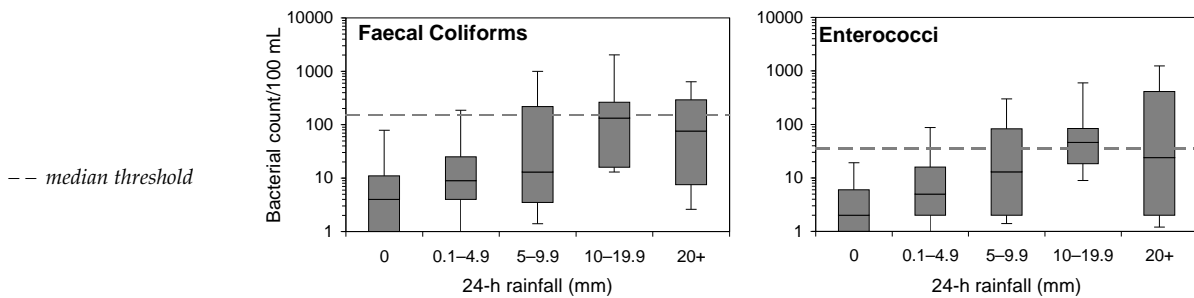
Response to rainfall Faecal coliform and enterococci densities generally increased with increasing rainfall, occasionally exceeding the median guideline limits in response to light rain and often exceeding the median guideline limits in response to five millimetres of rain or more in the previous 24 hours.

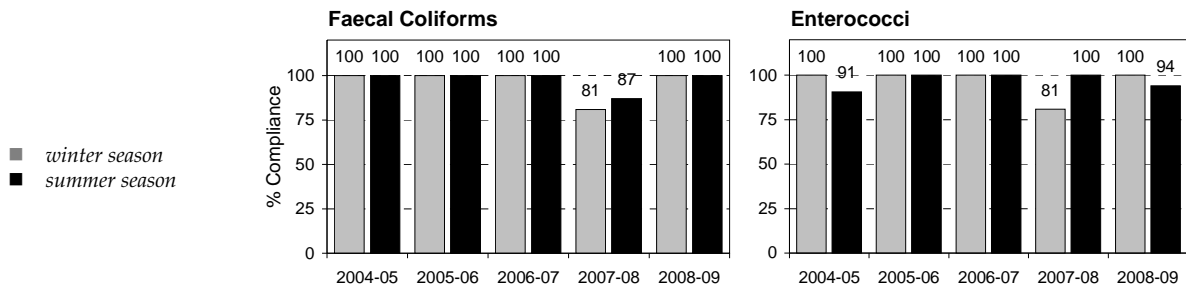
With the exception of 2007–2008, faecal coliform levels complied with swimming guidelines 100% of the time over the last five years. Enterococci compliance with swimming guidelines has ranged from 81% to 100% over the last five years.

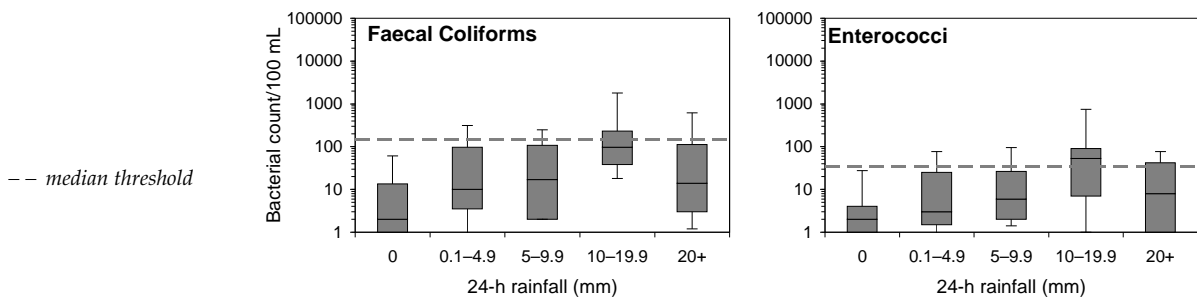
Bacterial densities occasionally exceeded median guideline limits in response to light rain and often exceeded the median guideline limit in response to 10 millimetres of rain or more in the previous 24 hours.

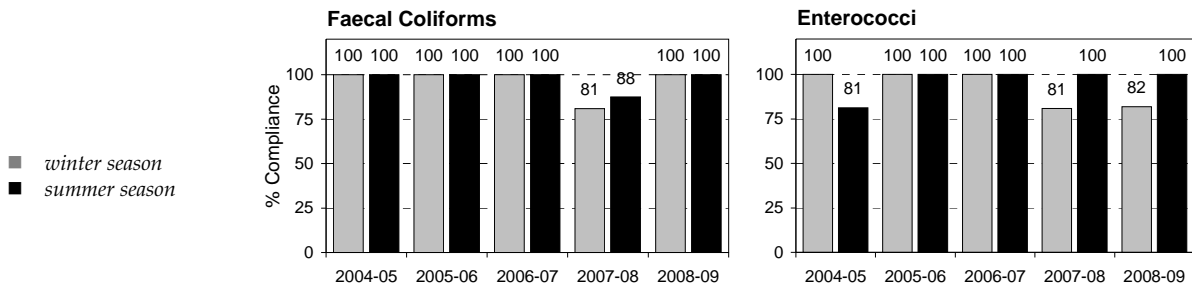
With the exception of 2007–2008, faecal coliform levels complied with swimming guidelines 100% of the time over the last five years. Enterococci compliance with swimming guidelines has ranged from 81% to 100% over the last five years.

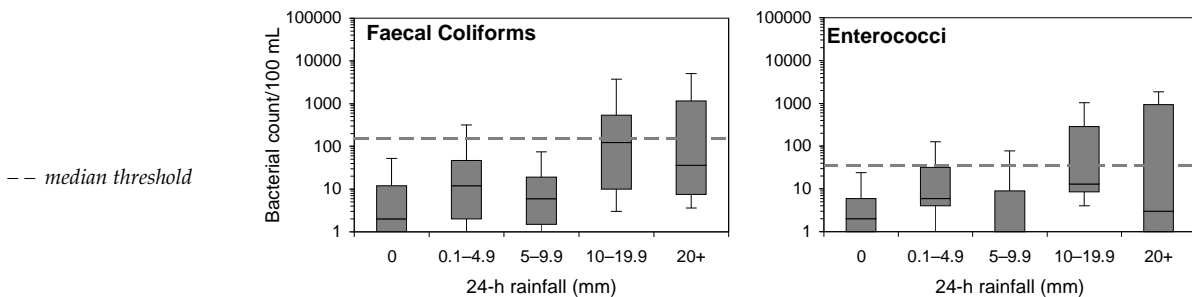
Faecal coliform and enterococci densities generally increased with increasing rainfall, occasionally exceeding median guideline limits after light rain and often exceeding the median guideline limit in response to ten millimetres of rain or more in the previous 24 hours.

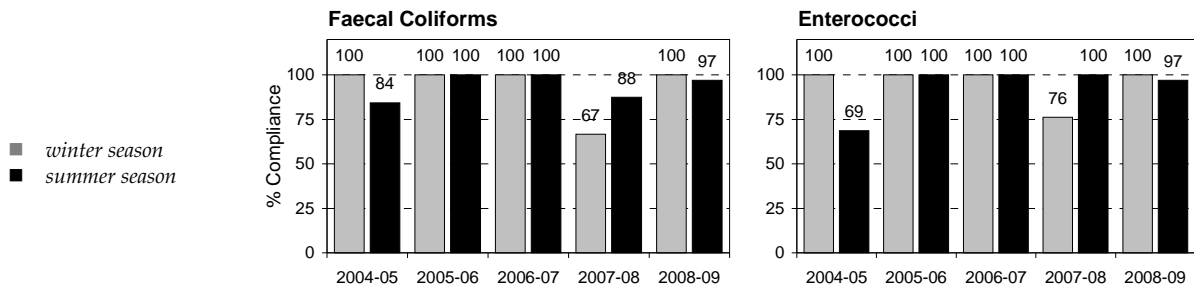
Faecal coliform and enterococci compliance with swimming guidelines has varied, ranging from 67% to 100% for faecal coliforms, and 69% to 100% for enterococci over the last five years.

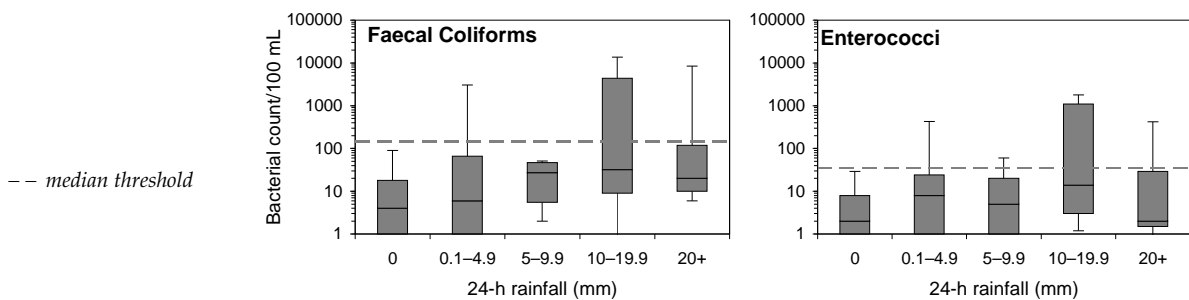
Bacterial densities occasionally exceeded median guideline limits after light rain and often exceeded the median guideline limits after ten millimetres of rain or more in the previous 24 hours.

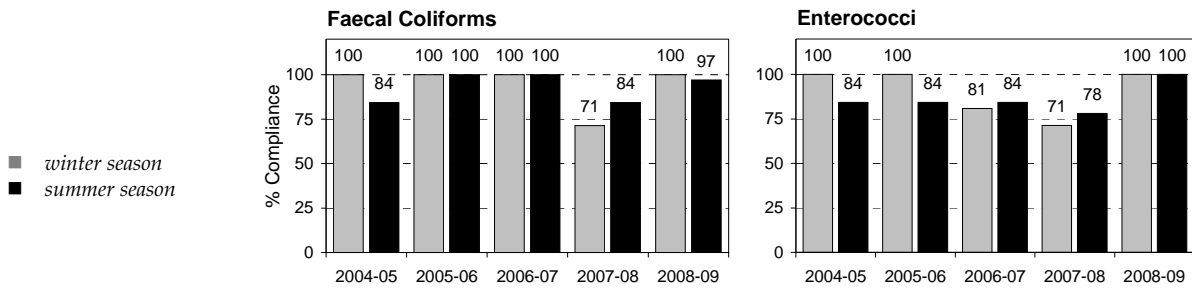
Faecal coliform and enterococci compliance with swimming guidelines has varied, ranging from 71% to 100% over the last five years.

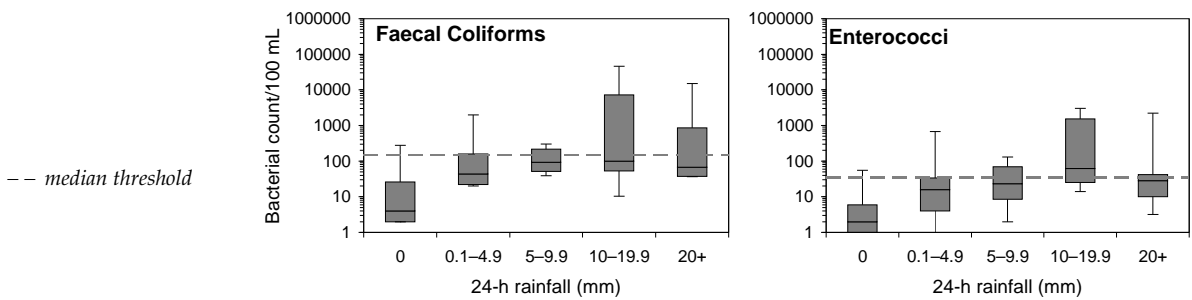
Bacterial densities tended to increase with increasing rainfall, occasionally exceeding the median guideline limits during dry weather, indicating a possible dry-weather contamination problem. Faecal coliform and enterococci densities often exceeded median guideline limits in response to even light rain in the previous 24 hours.

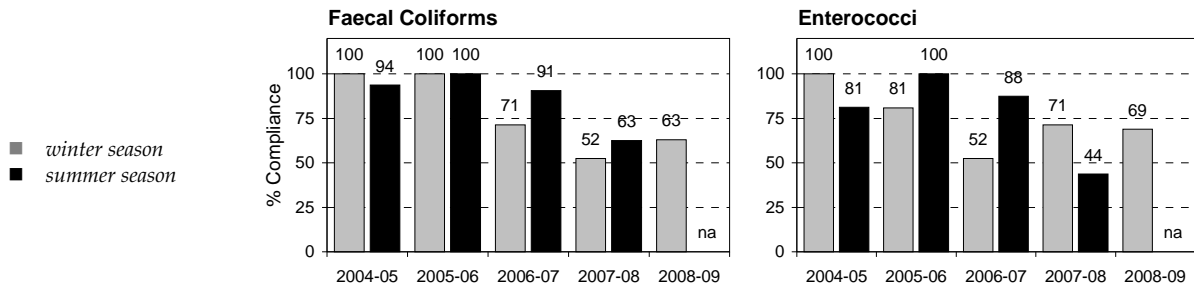
Faecal coliform and enterococci compliance with swimming guidelines has varied considerably, ranging from 52% to 100% for faecal coliforms, and from 44% to 100% for enterococci over the last five years. Compliance could not be calculated for summer 2008–2009 because of an insufficient number of samples.

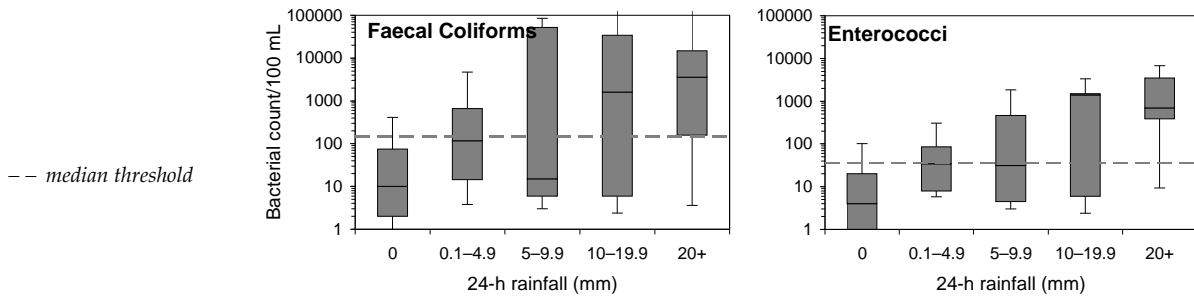
Faecal coliform and enterococci densities increased with increasing rainfall, occasionally exceeding median guideline limits after no rain, indicating a possible dry-weather contamination problem. Bacterial densities often exceeded median guideline limits in response to light rain and frequently exceeded median guideline limits after ten millimetres of rain or more in the previous 24 hours.

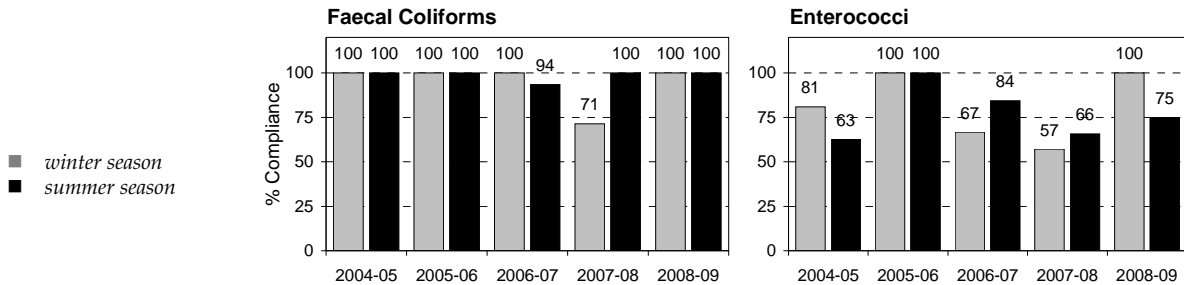
Faecal coliform compliance with swimming guidelines has ranged from 71% to 100% over the last five years. Enterococci compliance with swimming guidelines has been more variable, ranging from 57% to 100% over the last five years.

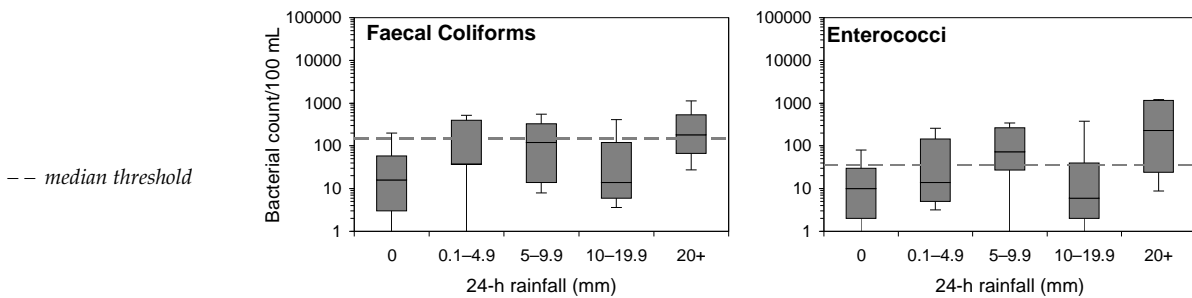
Faecal coliform and enterococci densities occasionally exceeded median guideline limits after no rain, indicating a possible dry-weather contamination problem. Faecal coliform levels often exceeded the median guideline limit after light rain in the previous 24 hours. Enterococci levels often exceeded the median guideline limit after light rain and frequently exceeded the median guideline limit after five millimetres of rain or more in the previous 24 hours.

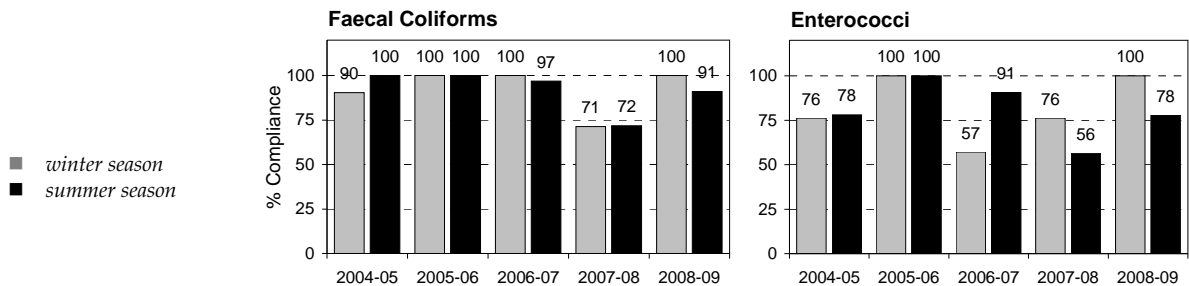
Faecal coliform compliance with swimming guidelines has ranged from 71% to 100% over the last five years. Enterococci compliance with swimming guidelines has been more variable, ranging from 56% to 100% in the last five years.

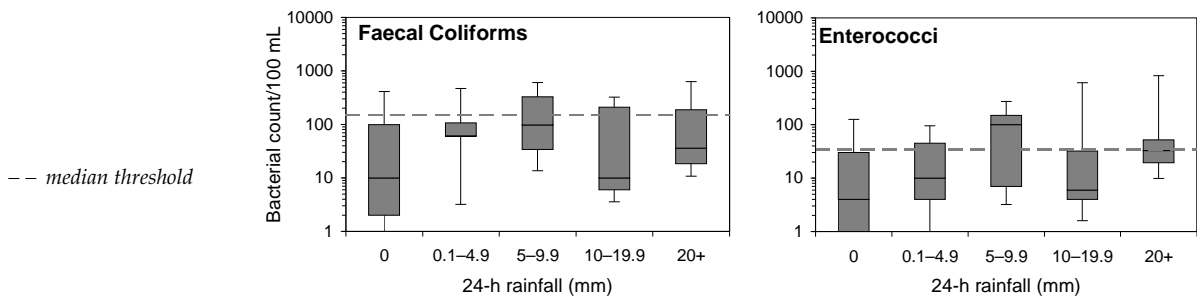
Bacterial densities occasionally exceeded median guideline limits in response to no rain, indicating a possible dry-weather contamination problem. Faecal coliform densities often exceeded the median guideline limit in response to five millimetres light rain and enterococci densities regularly exceeded the median guideline limit after light rain in the previous 24 hours.

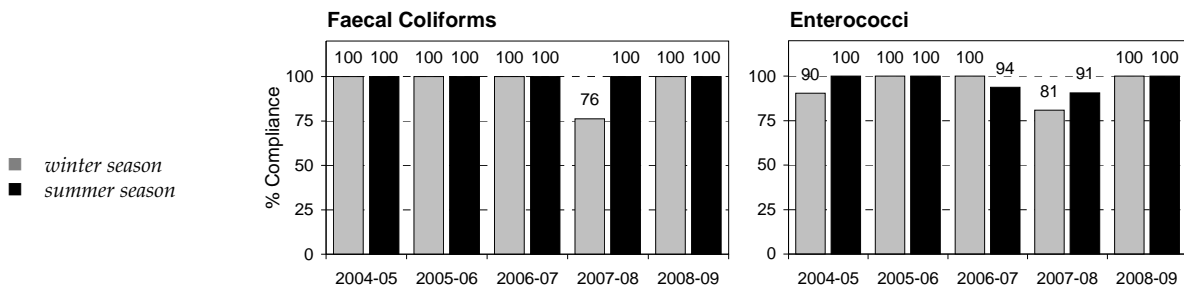
Compliance With the exception of winter 2007, faecal coliform levels have complied 100% of the time with swimming guidelines over the last five years. Enterococci compliance with swimming guidelines has been more variable, ranging from 81% to 100% over the last five years.

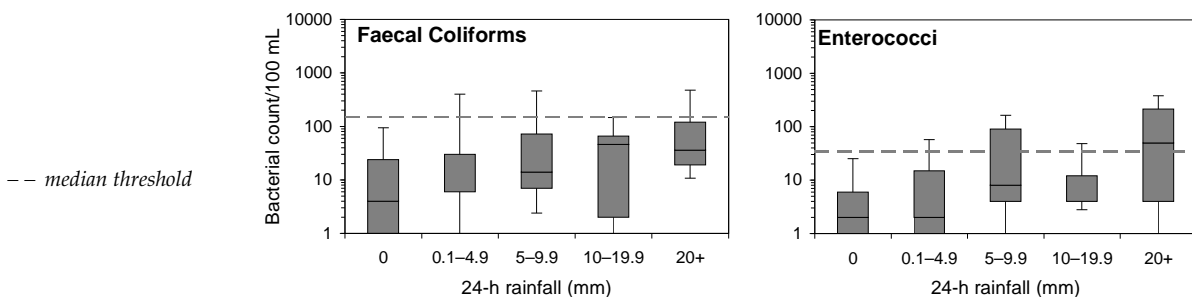
Response to rainfall Bacterial densities increased slightly with increasing rainfall, with faecal coliform densities occasionally exceeding the median guideline limits after light rain in the previous 24 hours. Enterococci densities often exceeded the median guideline limits in response to five millimetres of rain or more in the previous 24 hours.

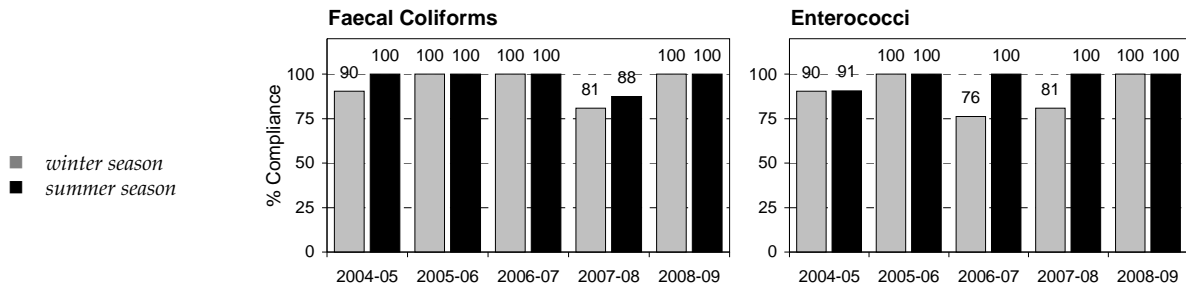
Faecal coliform compliance with swimming guidelines has generally been high, ranging from 81% to 100% over the last five years. Enterococci compliance with swimming guidelines has ranged from 76% to 100% over the last five years.

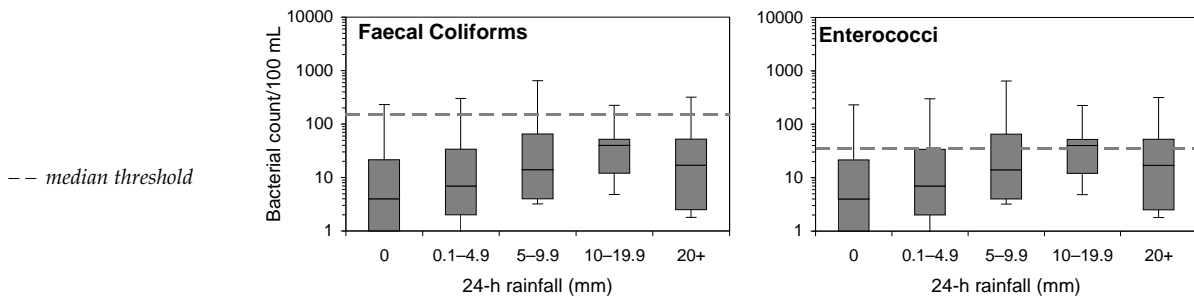
Faecal coliform and enterococci densities increased slightly with increasing rainfall, occasionally exceeding median guideline limits after no rain, indicating a possible dry-weather contamination problem. Enterococci densities often exceeded the median guideline limit in response to five millimetres of rain or more in the previous 24 hours.

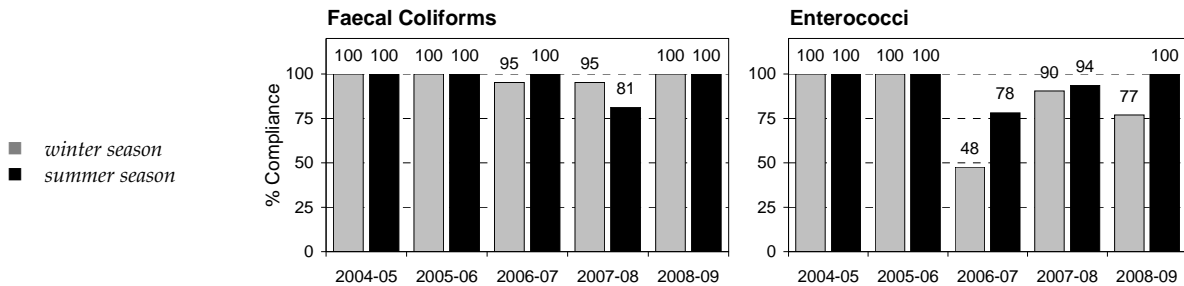
Faecal coliform compliance has generally been high ranging from 81% to 100% over the last five years. Enterococci compliance has been more variable, ranging from 48% to 100% over the last five years.
