Sydney Metropolitan Area Harbour Swimming Sites

Sydney Harbour – Port Jackson

Sites: Hayes Street Beach, Little Sirius Cove, Clifton Gardens, Redleaf Pool, Watsons Bay, Parsley Bay, Nielsen Park and Rose Bay Beach

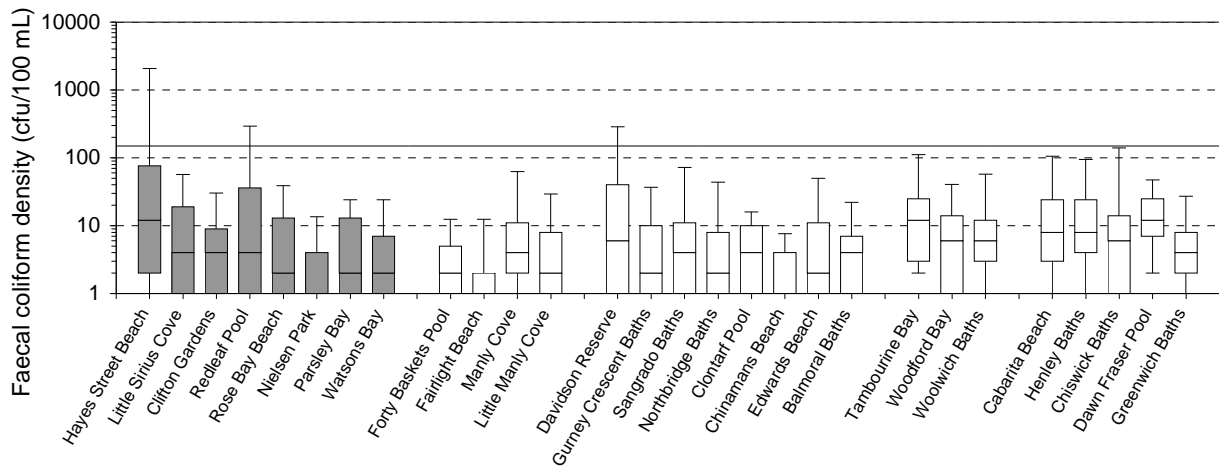
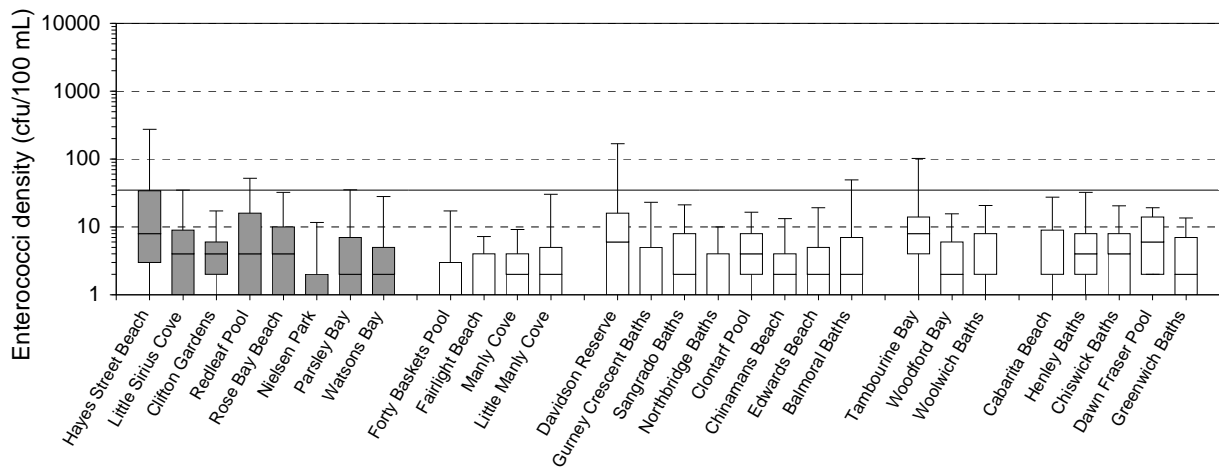
Figure 23: Bacterial Levels at Sydney Harbour Sites during Summer 2008–2009

The range of indicator bacteria levels measured at Sydney Harbour swimming areas during summer 2008–2009 is shown in Figure 23, with Port Jackson sites highlighted in grey. Levels of faecal coliforms and enterococci were within the ranges measured in other swimming sites in Sydney Harbour, with the exception of Hayes St Beach where the levels were slightly higher than most other sites.

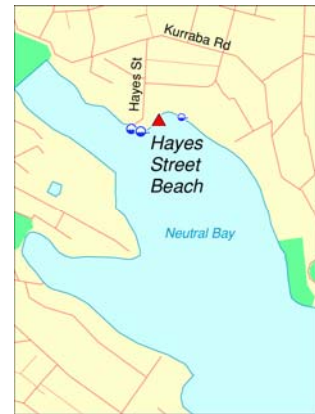
Faecal coliform compliance with swimming guidelines ranged from 59% to 100% over the last five years. Enterococci compliance ranged from 55% to 100% over the last five years.

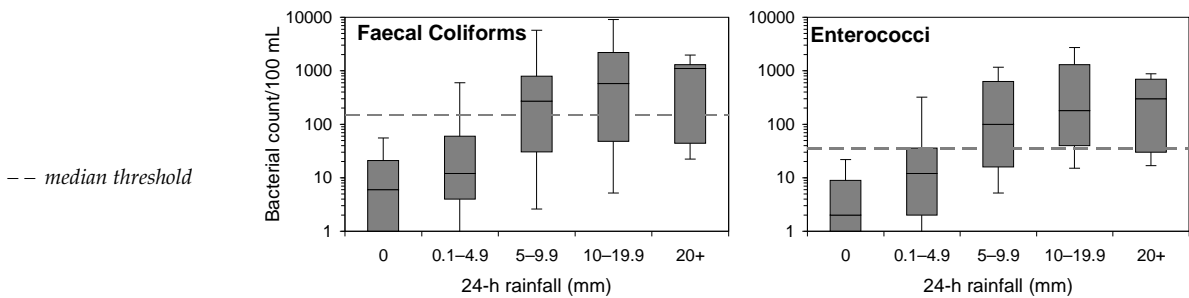
Response to rainfall

Faecal coliform and enterococci densities generally increased with increasing rainfall. Both bacterial levels regularly exceeded the median guideline limits in response to five millimetres of rain or more in the previous 24 hours. Enterococci densities occasionally exceeded the median guideline limits after light rain.

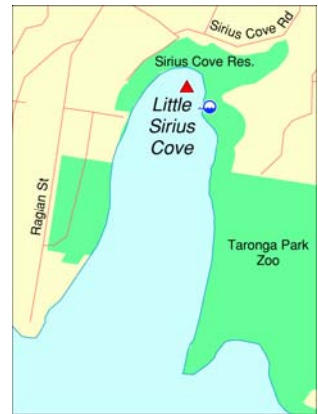
Faecal coliform compliance with swimming guidelines ranged from 72% to 100% over the last five years. Enterococci compliance has been more variable, ranging from 23% to 100% over the last five years.

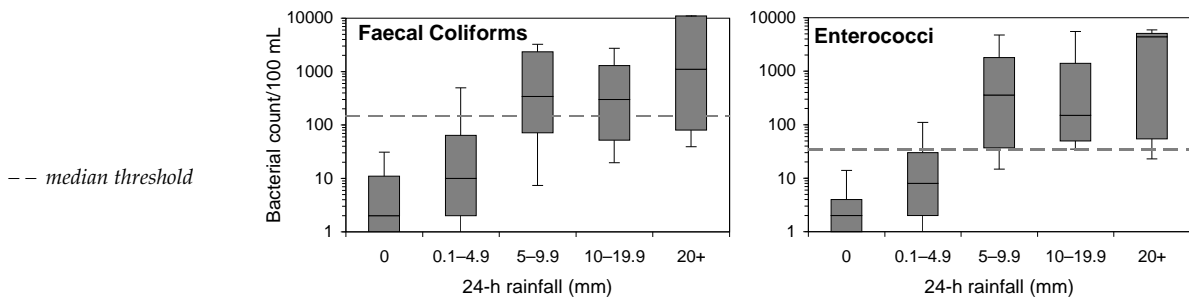
Response to rainfall

Faecal coliform and enterococci densities increased with increasing rainfall. Both bacterial indicators occasionally exceeded the median guideline limits in response to light rain. Faecal coliform levels regularly exceeded the median guideline limit in response to five millimetres of rain or more in the previous 24 hours. Enterococci levels frequently exceeded the median guideline limit in response to five millimetres of rain or more in the previous 24 hours.

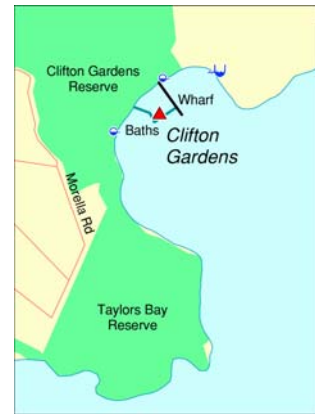
With the exception of winter 2007–2008, faecal coliform levels complied 100% of the time over the last five years. Enterococci compliance has ranged from 91% to 100% over the last five years.

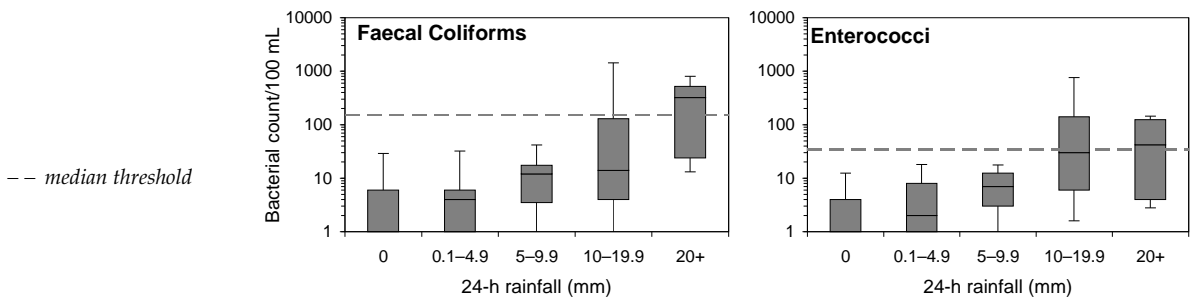
Response to rainfall

Bacterial densities tended to slightly increase with increasing rainfall. Faecal coliform levels often exceeded the median guideline limit in response to ten millimetres of rain or more in the previous 24 hours. Enterococci levels regularly exceeded the median guideline limit in response to ten millimetres of rain or more in the previous 24 hours.

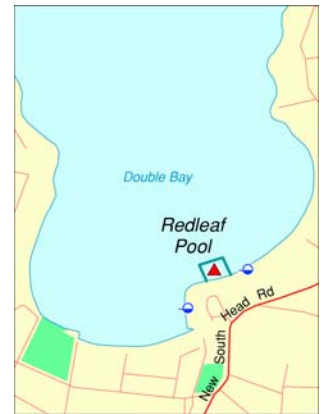
Faecal coliform compliance with swimming guidelines ranged from 77% to 100% over the last five years. Enterococci compliance has been more variable, ranging from 61% to 100% over the last five years.

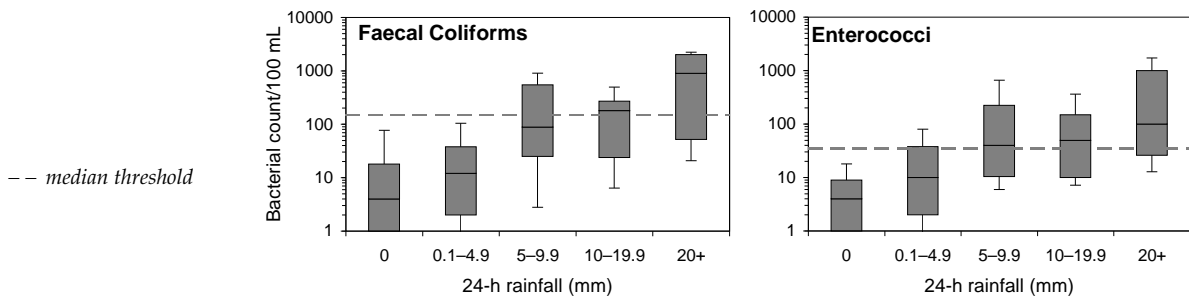
Response to rainfall

Faecal coliform densities increased with increasing rainfall, often exceeding the median guideline limit after five millimetres of rain or more in the previous 24 hours. Enterococci densities increased with increasing rainfall and regularly exceeded the median guideline limit in response to five millimetres of rain or more in the previous 24 hours.

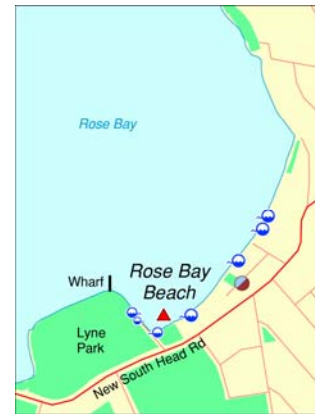
With the exception of winter 2006–2007, faecal coliform levels complied with swimming guidelines 100% of the time over the last five years. Compliance with enterococci swimming guidelines has been more variable, ranging from 40% to 100% over the last five years.

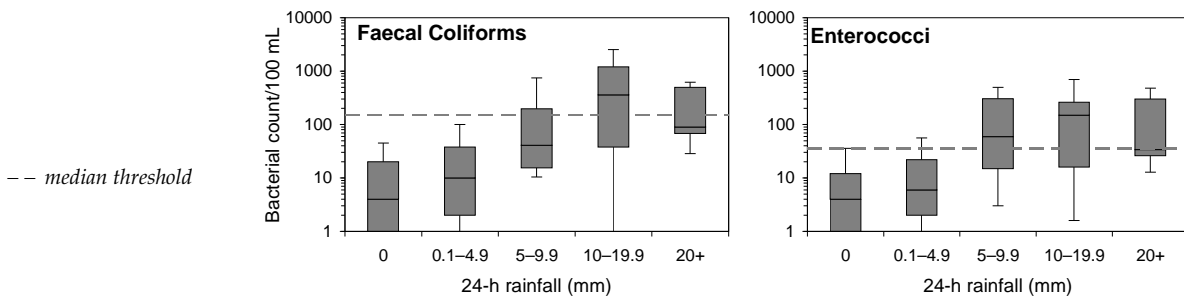
Response to rainfall

Faecal coliform and enterococci densities generally increased with increasing rainfall. Faecal coliform densities often exceeded the median guideline limit in response to five millimetres of rain or more and regularly exceeded the median guideline limit in response to ten millimetres of rain or more in the previous 24 hours. Enterococci densities occasionally exceeded the median guideline limit after no rainfall indicating a possible dry-weather contamination problem.

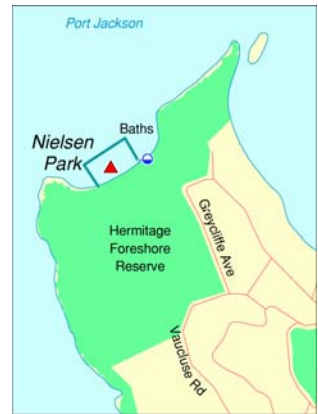
Faecal coliform and enterococci levels complied with swimming guidelines 100% of the time over the last five years.

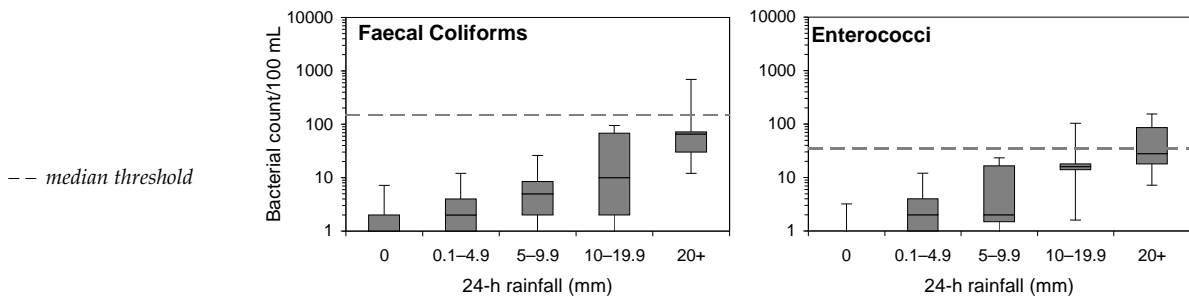
Response to rainfall

Faecal coliform and enterococci densities increased slightly with increasing rainfall. Faecal coliform densities occasionally exceeded the median guideline limit in response to 20 millimetres of rain or more in the previous 24 hours. Enterococci densities occasionally exceeded the median guideline limit in response to ten millimetres of rain or more and regularly exceeded the median guideline limit in response to 20 millimetres of rain or more in the previous 24 hours.

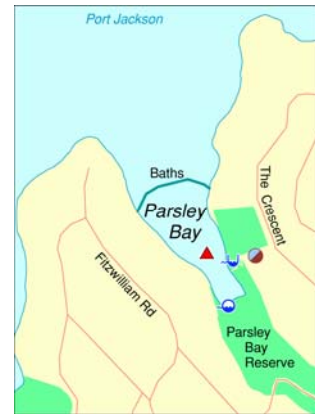
Compliance Faecal coliform levels complied with swimming guidelines 100% of the time over the last five years. Compliance with the enterococci criteria has been more varied, ranging from 85% to 100% over the last five years.

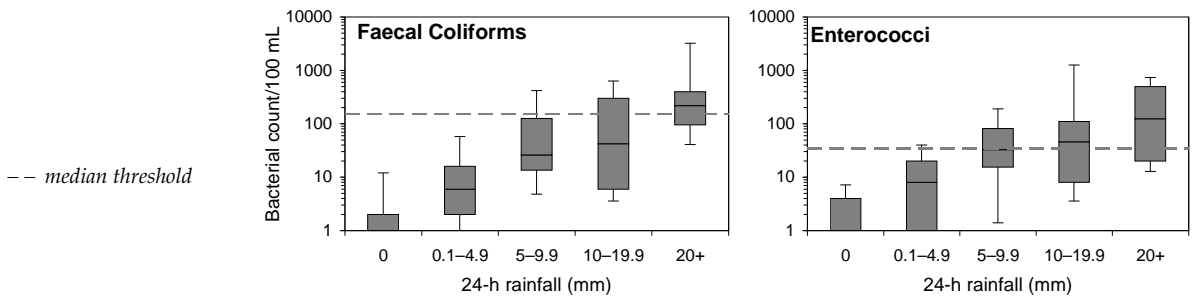
Response to rainfall Faecal coliform and enterococci densities generally increased with increasing rainfall. Faecal coliform densities often exceeded the median guideline limits after five millimetres of rain or more in the previous 24 hours. Enterococci densities often exceeded the median guideline in response to light rain and regularly exceeded the median guideline limits after five millimetres of rain or more in the previous 24 hours.

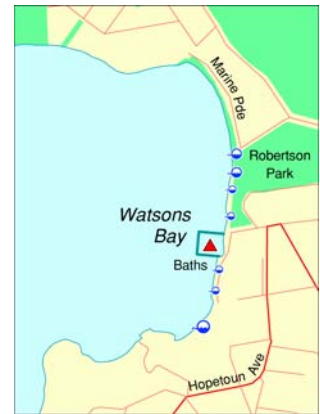
Compliance Faecal coliform levels complied with swimming guidelines 100% of the time over the last five years. Enterococci compliance has been more varied, ranging from 83% to 100% over the last five years.

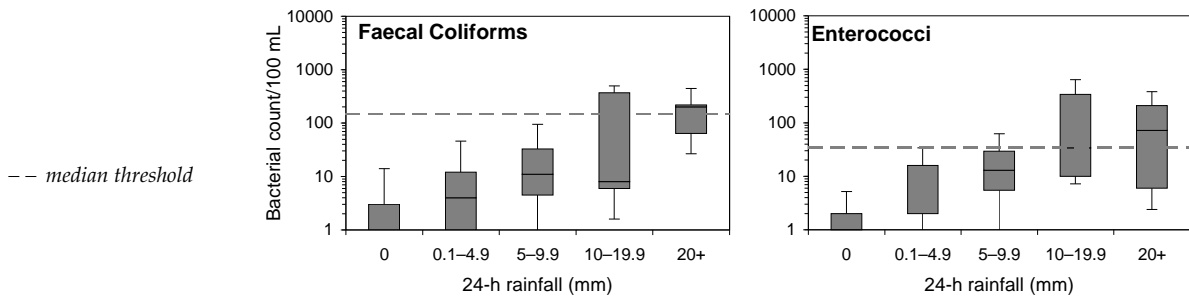
Response to rainfall Bacterial densities generally increased with increasing rainfall. Faecal coliform densities often exceeded the median guideline limit in response to ten millimetres or rain or more in the previous 24 hours. Enterococci densities occasionally exceeded the median guideline limit after light rain and regularly exceeded the median guideline limit in response to ten millimetres of rain or more in the previous 24 hours.

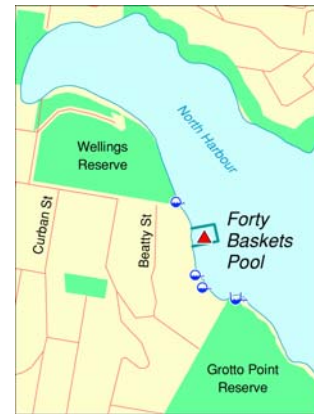
Compliance With the exception of summer 2007–2008, faecal coliform levels complied with swimming guidelines 100% of the time over the last five years. Enterococci compliance with swimming guidelines was more varied, ranging from 80% to 100% over the last five years.

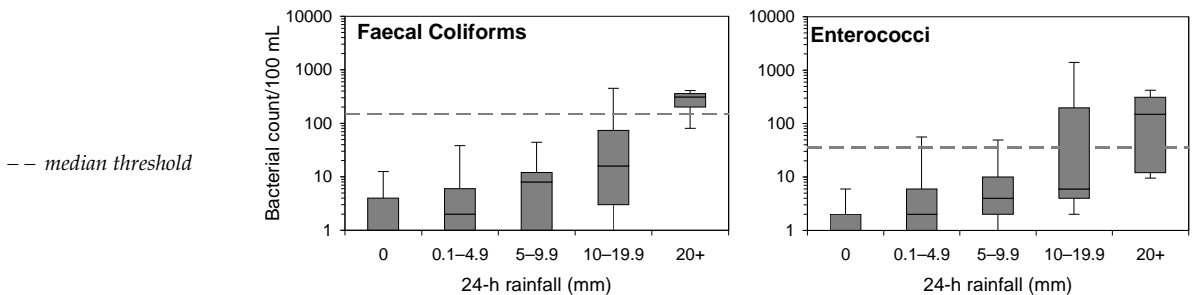
Response to rainfall Bacterial densities increased with increasing rainfall. Faecal coliform densities occasionally exceeded the median guideline limits in response to ten millimetres of rain and usually exceeded the median guideline limit after 20 millimetres of rain or more in the previous 24 hours. Enterococci densities occasionally exceeded the median guideline limits after light rain and often exceeded the median guideline limit after ten millimetres of rain or more in the previous 24 hours.

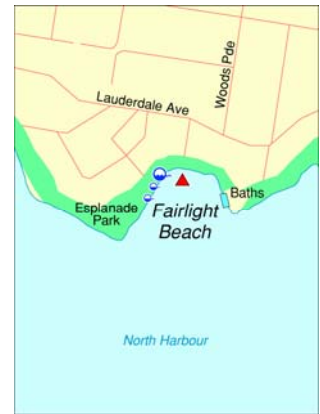
Faecal coliform levels complied with swimming guidelines 100% of the time over the last five years. With the exception of winter 2004–2005, enterococci levels complied with swimming guidelines 100% of the time over the last five years.

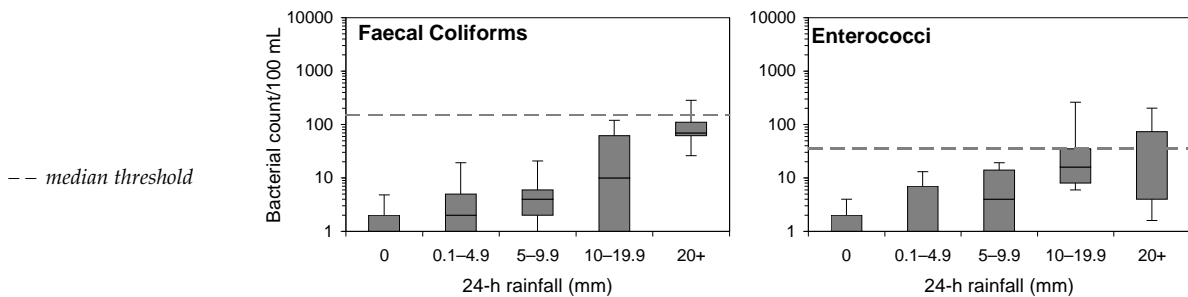
Response to rainfall

Faecal coliform and enterococci densities slightly increased with increasing rainfall. Faecal coliform densities occasionally exceeded the median guideline limit in response to 20 millimetres of rain or more in the previous 24 hours. Enterococci densities often exceeded the median guideline limit in response to ten millimetres of rain or more in the previous 24 hours.

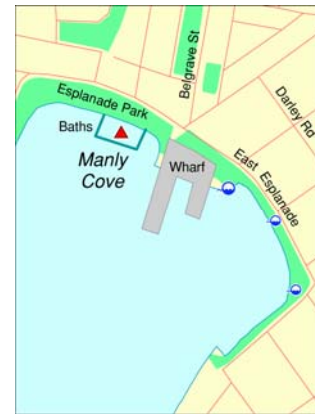
Faecal coliform levels complied with swimming guidelines 100% of the time over the last five years. Enterococci compliance has generally been high, ranging from 94% to 100% over the last five years.

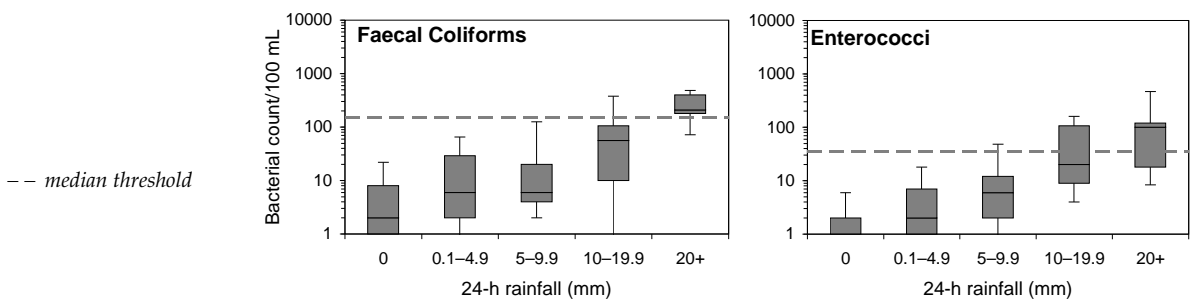
Response to rainfall

Bacterial densities generally increased with increasing rainfall. Faecal coliform levels occasionally exceeded the median guideline limit in response to ten millimetres of rain and frequently exceeded the limit following 20 millimetres or more in the previous 24 hours. Enterococci levels occasionally exceeded the median guideline limit after five millimetres of rain and often exceeded it in response to ten millimetres of rain or more in the previous 24 hours.

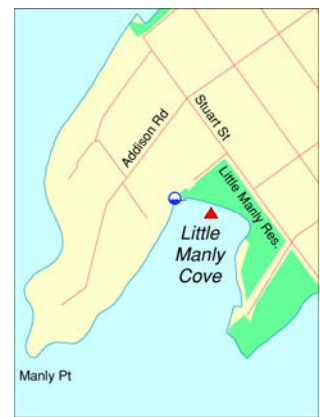
With the exception of summer 2007–2008, faecal coliform levels complied with swimming guidelines 100% of the time over the last five years. Enterococci compliance has been more varied, ranging from 84% to 100% over the last five years.

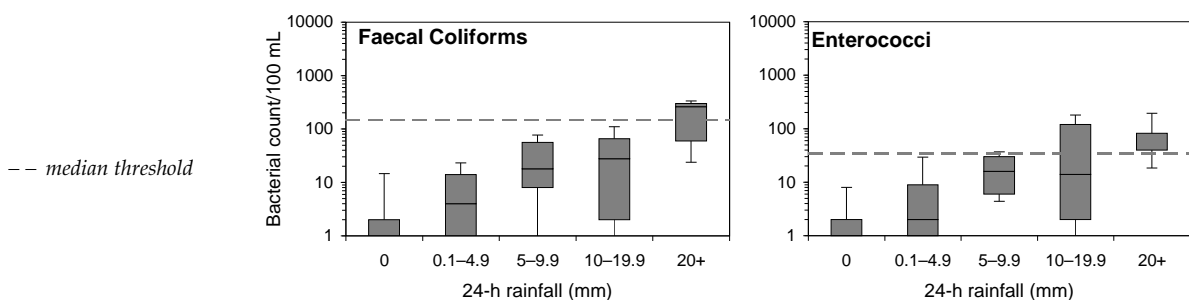
Response to rainfall

Faecal coliform and enterococci densities generally increased with increasing rainfall. Faecal coliform densities often exceeded the median guideline limit after 20 millimetres of rain or more in the previous 24 hours. Enterococci densities occasionally exceeded the median guideline limit after five millimetres of rain and frequently exceeded the median guideline limit in response to 20 millimetres of rain or more in the previous 24 hours.

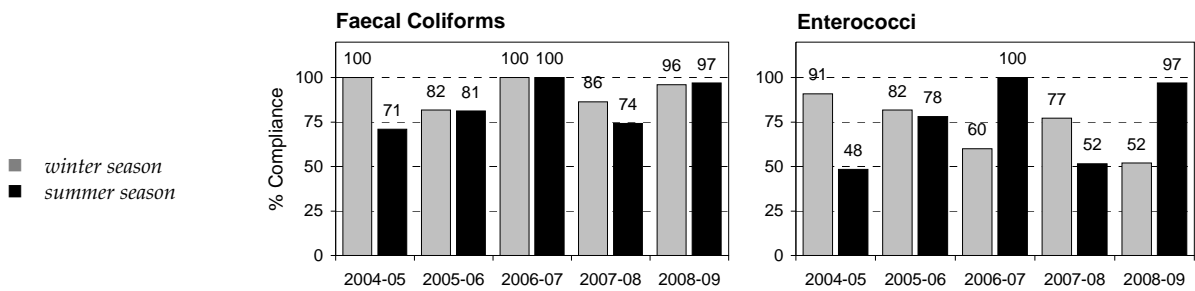
Compliance Faecal coliform compliance with swimming guidelines varied over the last five years, ranging from 71% to 100%. Enterococci compliance also varied, ranging from 48% to 100% over the last five years.

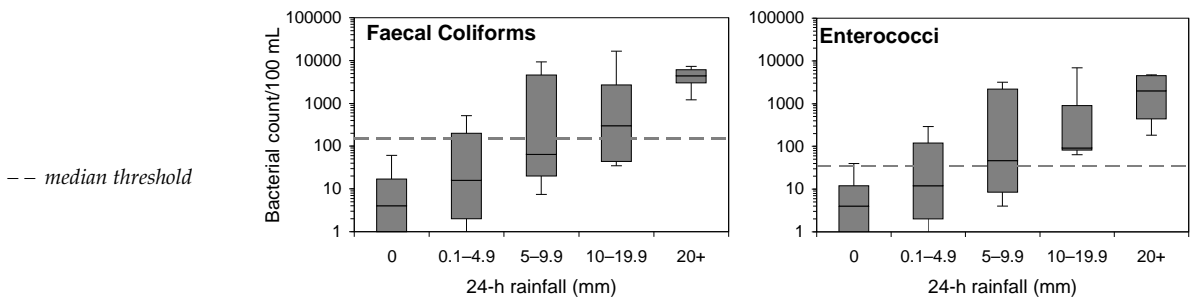
Response to rainfall Faecal coliform and enterococci densities increased with increasing rainfall. Faecal coliform densities often exceeded the median guideline limit in response to light rain and usually exceeded the median guideline limit in response to five millimetres of rain or more in the previous 24 hours. Enterococci densities occasionally exceeded the median guideline limit in response to no rain and indicate a possible dry-weather contamination problem. The median guideline limit was frequently exceeded in response to light rain in the previous 24 hours.

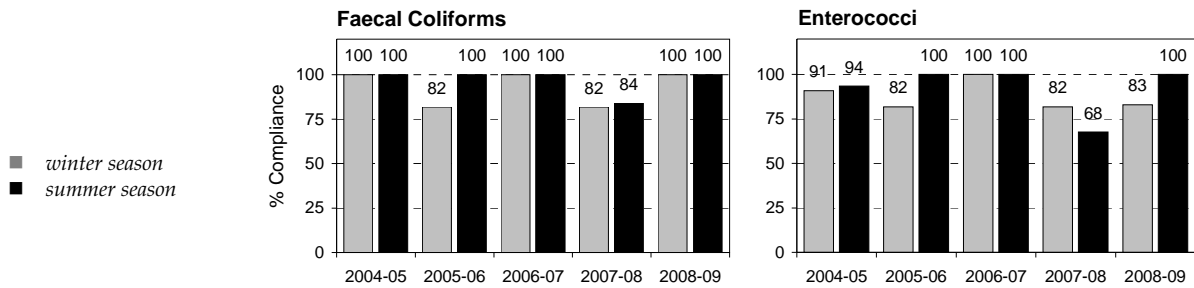
Faecal coliform compliance with swimming guidelines ranged from 82% to 100% over the last five years. Enterococci compliance has been more varied, ranging from 68% to 100% over the last five years.

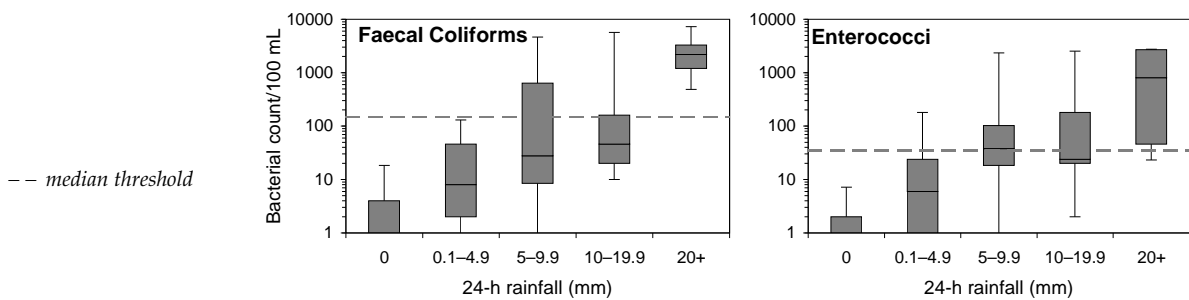
Response to rainfall

Faecal coliform and enterococci densities increased with increasing rainfall and usually exceeded median guideline limits after 20 millimetres of rain or more in the previous 24 hours. Bacterial densities occasionally exceeded the median guideline limits after light rain and often exceeded median guideline limits in response to five millimetres of rain or more in the previous 24 hours.

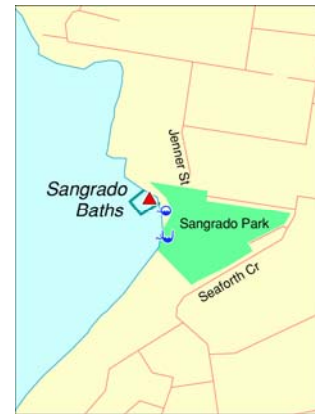
Compliance Faecal coliform compliance with swimming guidelines has varied over the last five years, ranging from 55% to 100%. Enterococci compliance also varied considerably, ranging from 40% to 100% over the last five years.

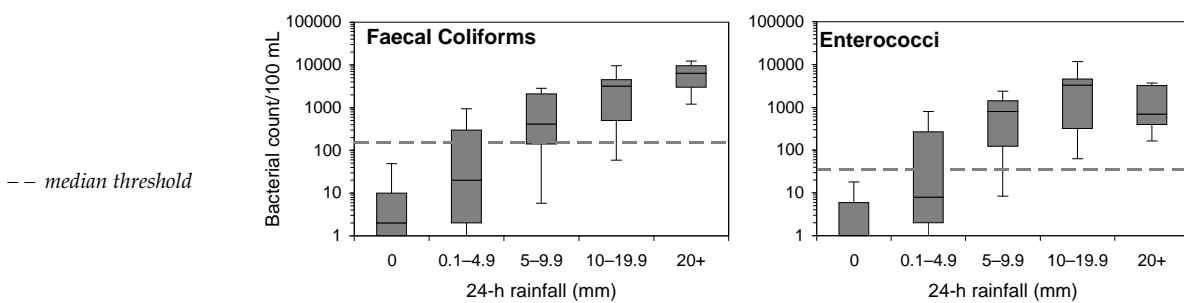
Response to rainfall Faecal coliform and enterococci densities increased with increasing rainfall. Bacterial densities regularly exceeded the median guideline limit after light rain and usually exceeded the median guideline limit in response to 20 millimetres of rain or more in the previous 24 hours.

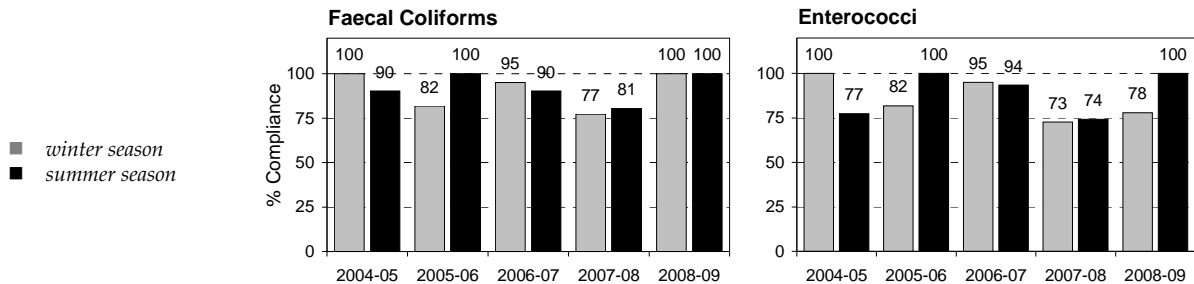
Faecal coliform compliance with swimming guidelines ranged from 77% to 100% over the last five years. Enterococci compliance has varied, ranging from 73% to 100% over the last five years.

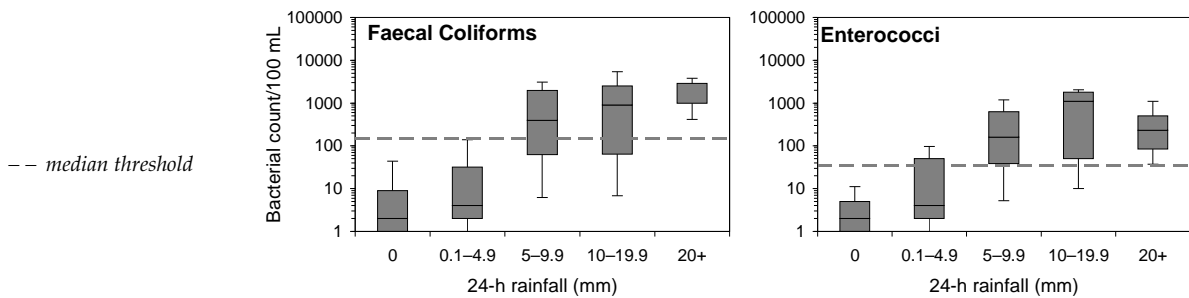
Response to rainfall

Bacterial densities of both indicators increased with increasing rainfall. Faecal coliform levels occasionally exceeded the median guideline limit in response to light rain and usually exceeded the median guideline limit in response to 20 millimetres of rain or more in the previous 24 hours. Enterococci densities often exceeded the median guideline limit after light rain and usually exceeded the median guideline limit in response to 20 millimetres of rain or more in the previous 24 hours.

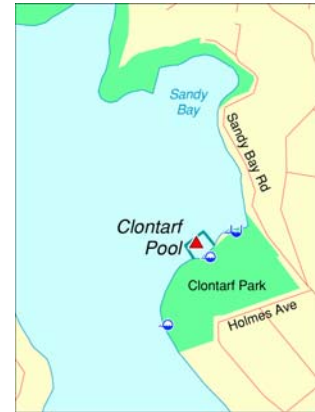
Compliance Faecal coliform and enterococci compliance with swimming guidelines has ranged from 71% to 100% over the last five years.

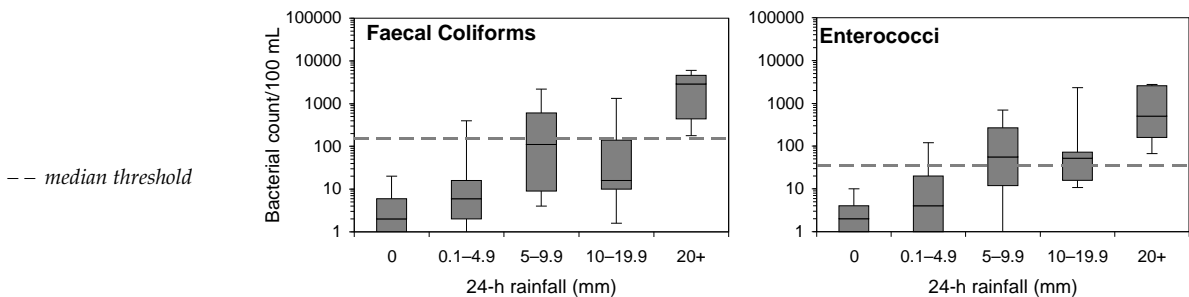
Response to rainfall Bacterial densities increased with increasing rainfall, usually exceeding the median guideline limit after 20 millimetres of rain or more in the previous 24 hours. Faecal coliform and enterococci densities occasionally exceeded the median guideline limit in response to light rain in the previous 24 hours.

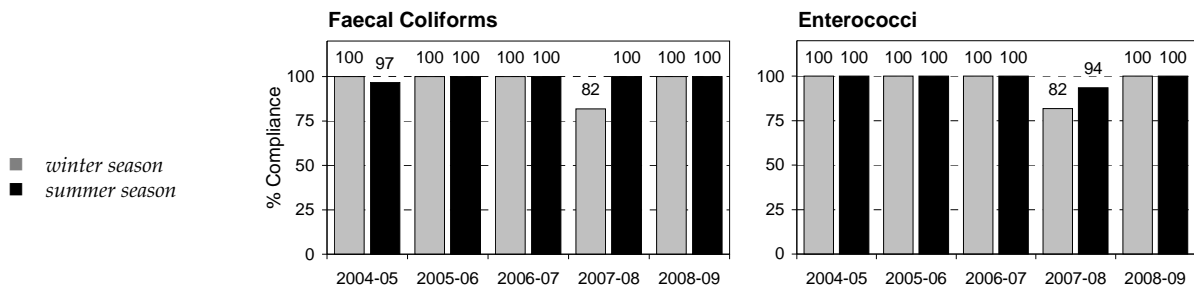
Faecal coliform and enterococci compliance with swimming guidelines has generally been high, ranging from 82% to 100% over the last five years.

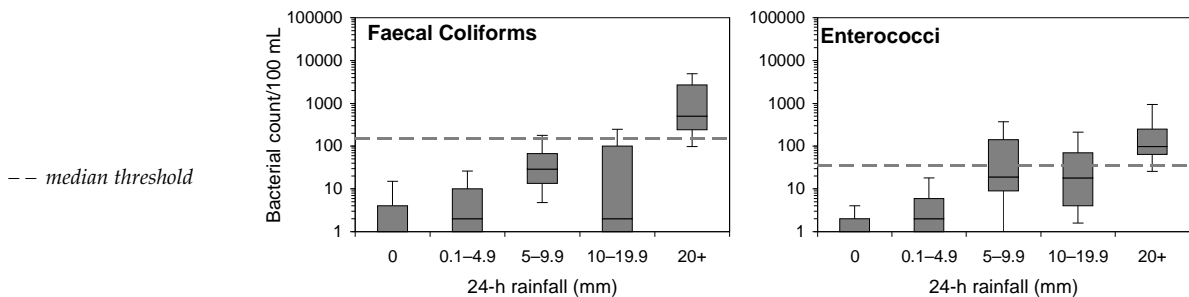
Response to rainfall

Bacterial densities tended to increase with increasing rainfall, usually exceeding the median guideline limits after 20 millimetres of rain or more in the previous 24 hours. Faecal coliform densities occasionally exceeded the median guideline limit after five millimetres of rain or more in the previous 24 hours. Enterococci densities regularly exceeded the median guideline limit after five millimetres of rain or more in the previous 24 hours.

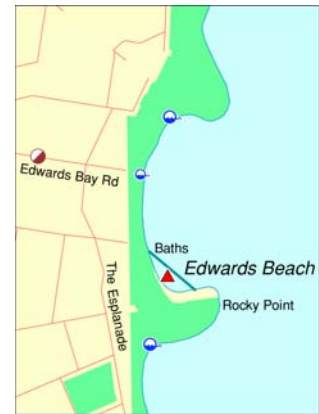
Compliance Faecal coliform levels complied with the swimming guidelines 100% of the time over the last five years. With the exception of summer 2007–2008, enterococci levels complied 100% of the time over the last five years.

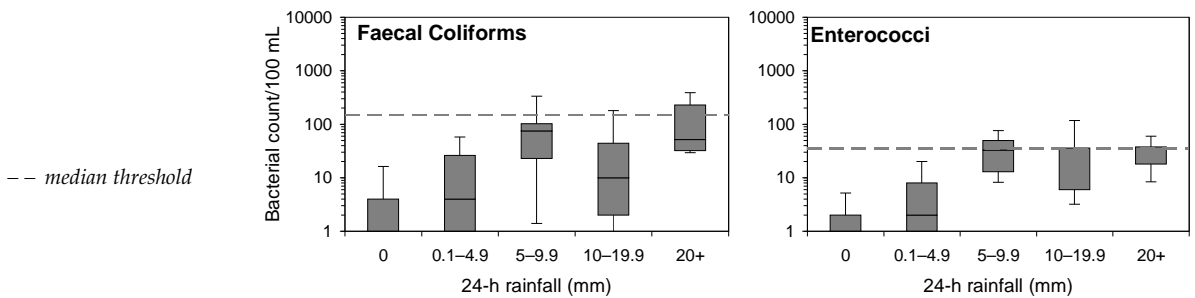
Response to rainfall Faecal coliform and enterococci densities tended to increase with increasing rainfall. Faecal coliform densities occasionally exceeded the median guideline limit in response to five millimetres of rain or more and often exceeded the median guideline limit in response to 20 millimetres of rain or more in the previous 24 hours. Enterococci levels regularly exceeded the median guideline limit in response to five millimetres of rain or more in the previous 24 hours.

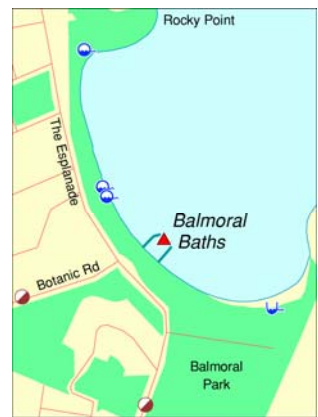
Faecal coliform levels have complied 100% of the time with swimming guidelines over the last five years. With the exception of summer 2007–2008, enterococci levels complied 100% of the time over the last five years.

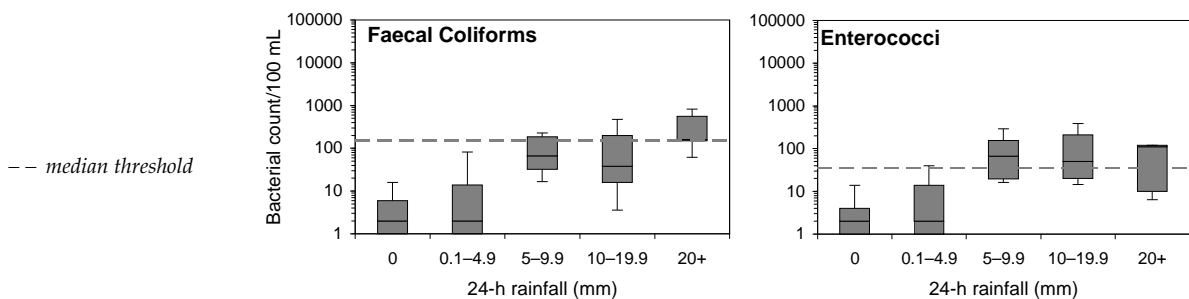
Response to rainfall

Bacterial densities increased with increasing rainfall. Faecal coliform densities regularly exceeded the median guideline limit after five millimetres of rain or more and frequently exceeded the median guideline limit in response to 20 millimetres of rain or more in the previous 24 hours. Enterococci densities occasionally exceeded the median guideline limit after light rain and often exceeded the median guideline limit in response to five millimetres of rain or more in the previous 24 hours.

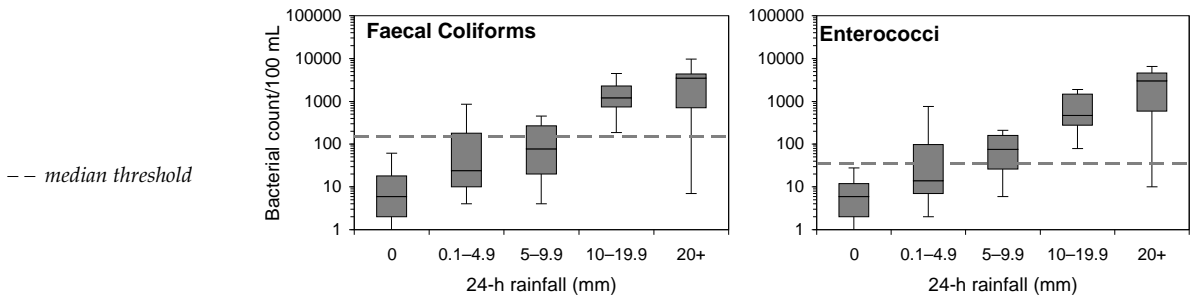
Response to rainfall Faecal coliform and enterococci densities increased with increasing rainfall and often exceeded the median guideline limits after light rain in the previous 24 hours. Faecal coliform levels usually exceeded the median guideline limit in response to 10 millimetres of rain or more in the previous 24 hours. Enterococci levels usually exceeded the median guideline limit in response to 10 millimetres of rain or more in the previous 24 hours.

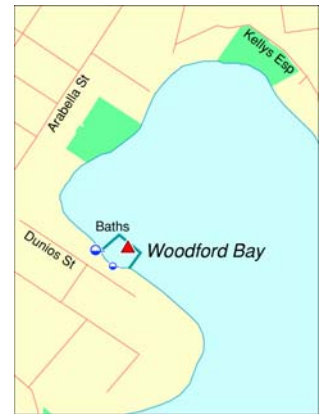
With the exception of 2007–2008, faecal coliform levels complied 100% of the time over the last five years. Enterococci compliance with swimming guidelines was more varied, ranging from 77% to 100% over the last five years.

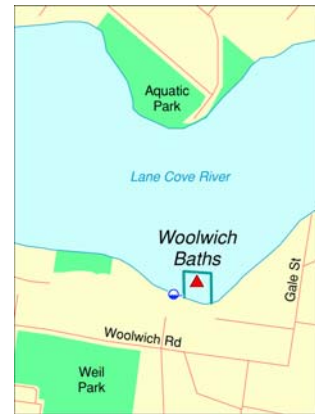
With the exception of 2007–2008, faecal coliform levels complied 100% of the time over the last five years. Enterococci compliance with swimming guidelines has been variable, ranging from 71% to 100% over the last five years.

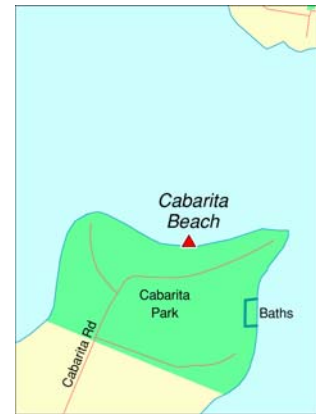
With the exception of 2007–2008, faecal coliform levels complied 100% of the time over the last five years. Enterococci compliance with swimming guidelines has been more variable, ranging from 68% to 100% over the last five years.

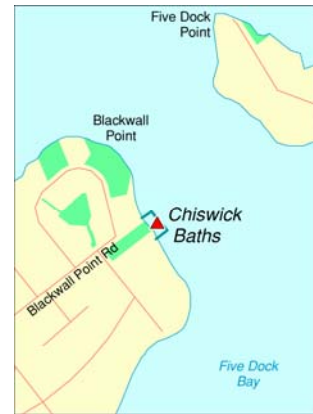
Faecal coliform and enterococci compliance with swimming guidelines has varied over the last five years, ranging from 77% to 100%.

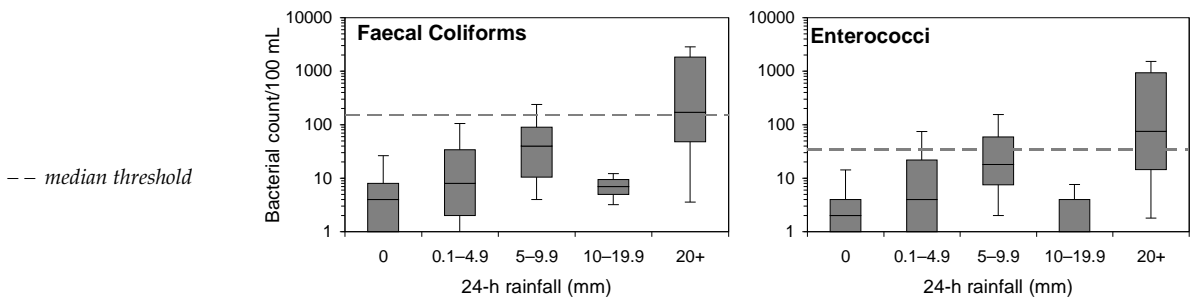
Response to rainfall Faecal coliform and enterococci densities tended to increase with increasing rainfall. Faecal coliform densities occasionally exceeded the median guideline limits in response to five millimetres of rain in the previous 24 hours. Enterococci densities occasionally exceeded the median guideline limit after light rain in the previous 24 hours. Densities of both bacterial indicators regularly exceeded the median guideline limits in response to 20 millimetres of rain or more in the previous 24 hours.

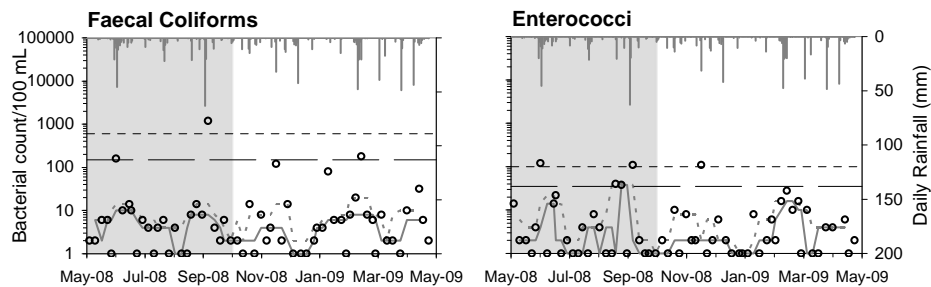
Season data

- | rainfall
 - o individual result
 - rolling median
 - - - rolling 80th percentile
- Guidelines
(see page 8 for details)
- median threshold
 - - - 80th percentile threshold
