Sydney Estuarine Beaches region

Waterways and councils

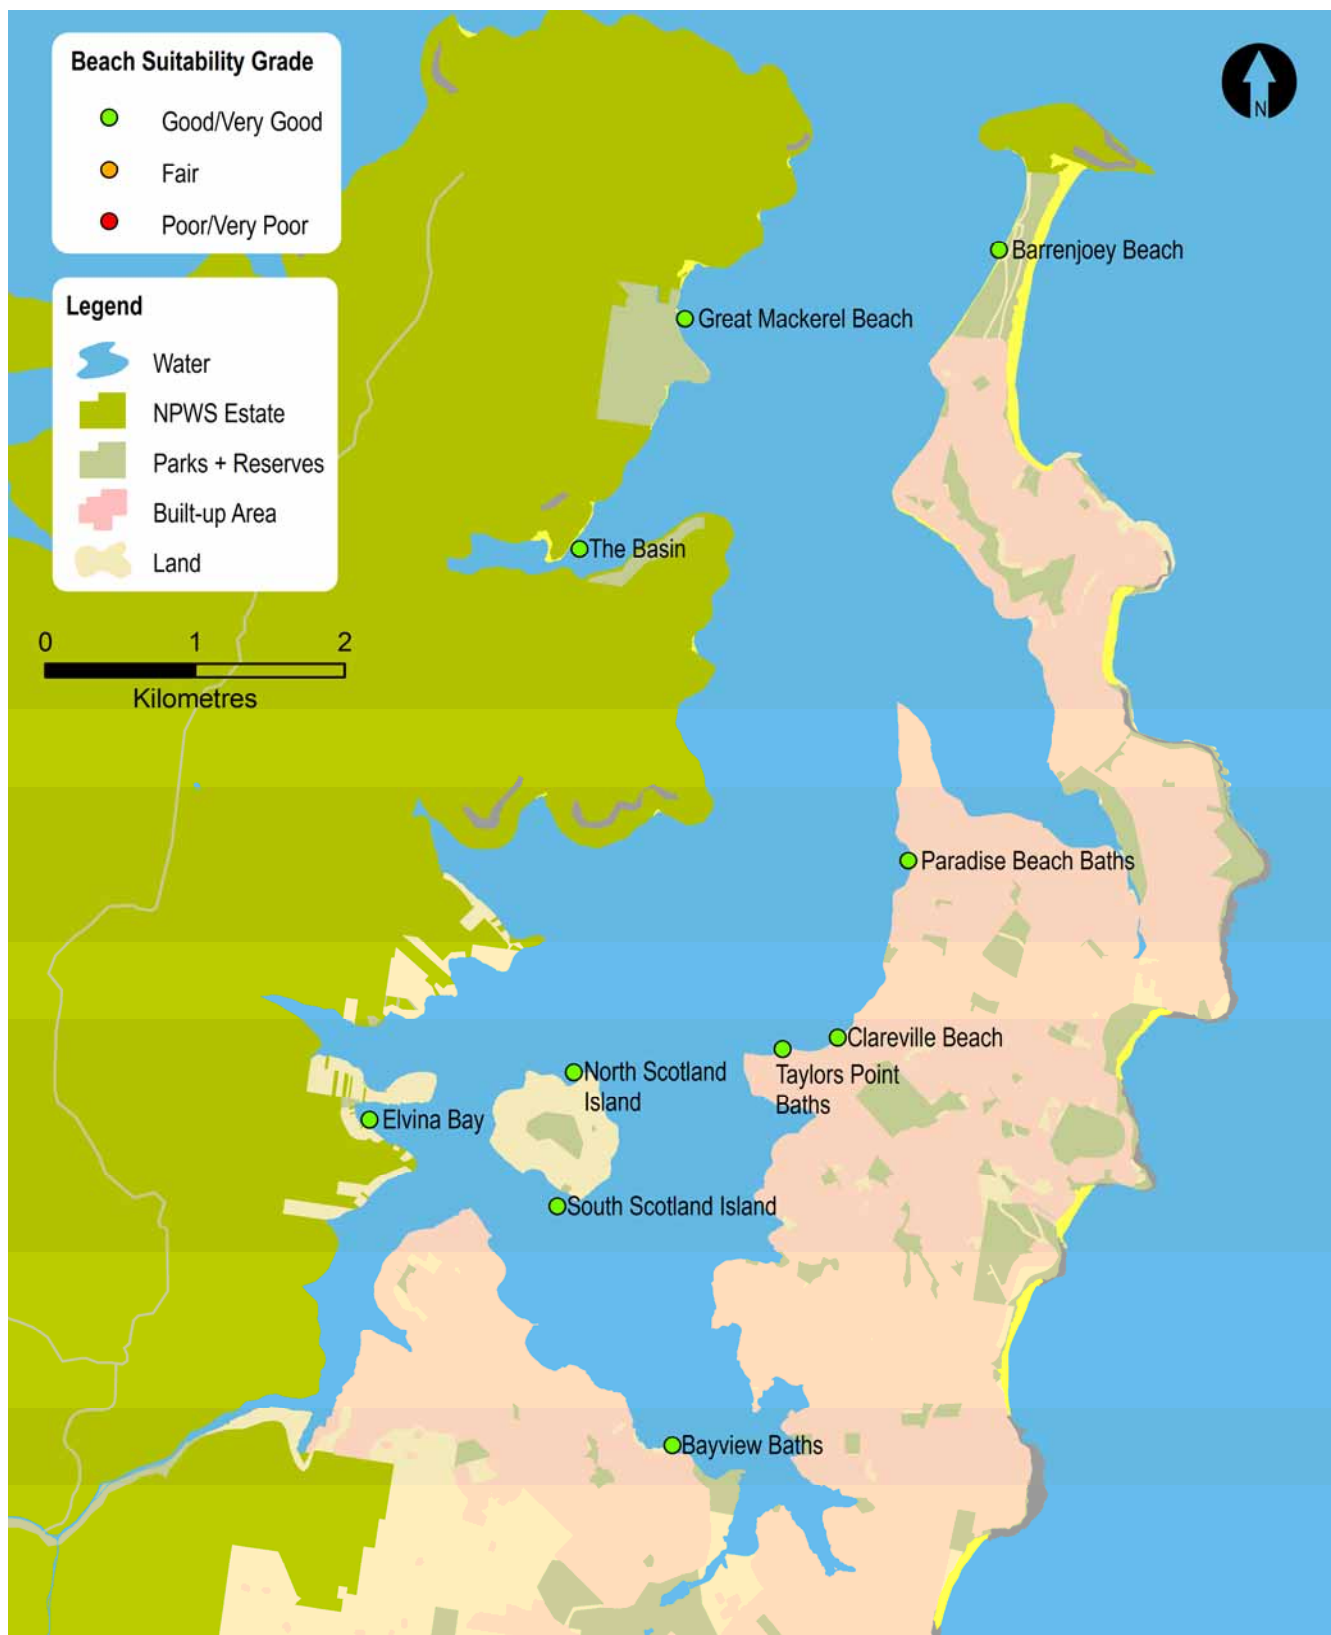
Figure 25: Sampling locations and Beach Suitability Grades in Pittwater

Pittwater was the best-performing waterway in Sydney, with all ten swimming locations graded as Very Good or Good.

The highest-rated swimming locations were Barrenjoey Beach, Elvina Bay and Great Mackerel Beach. These sites were graded as Very Good and had consistently excellent microbial water quality and few potential sources of faecal contamination.

Beaches graded as Good were Paradise Beach Baths, Clareville Beach, Taylors Point Baths, Bayview Baths, North Scotland Island, South Scotland Island and The Basin. These sites had generally very good water quality, but may be susceptible to pollution from a number of potential pollution sources in their catchments.

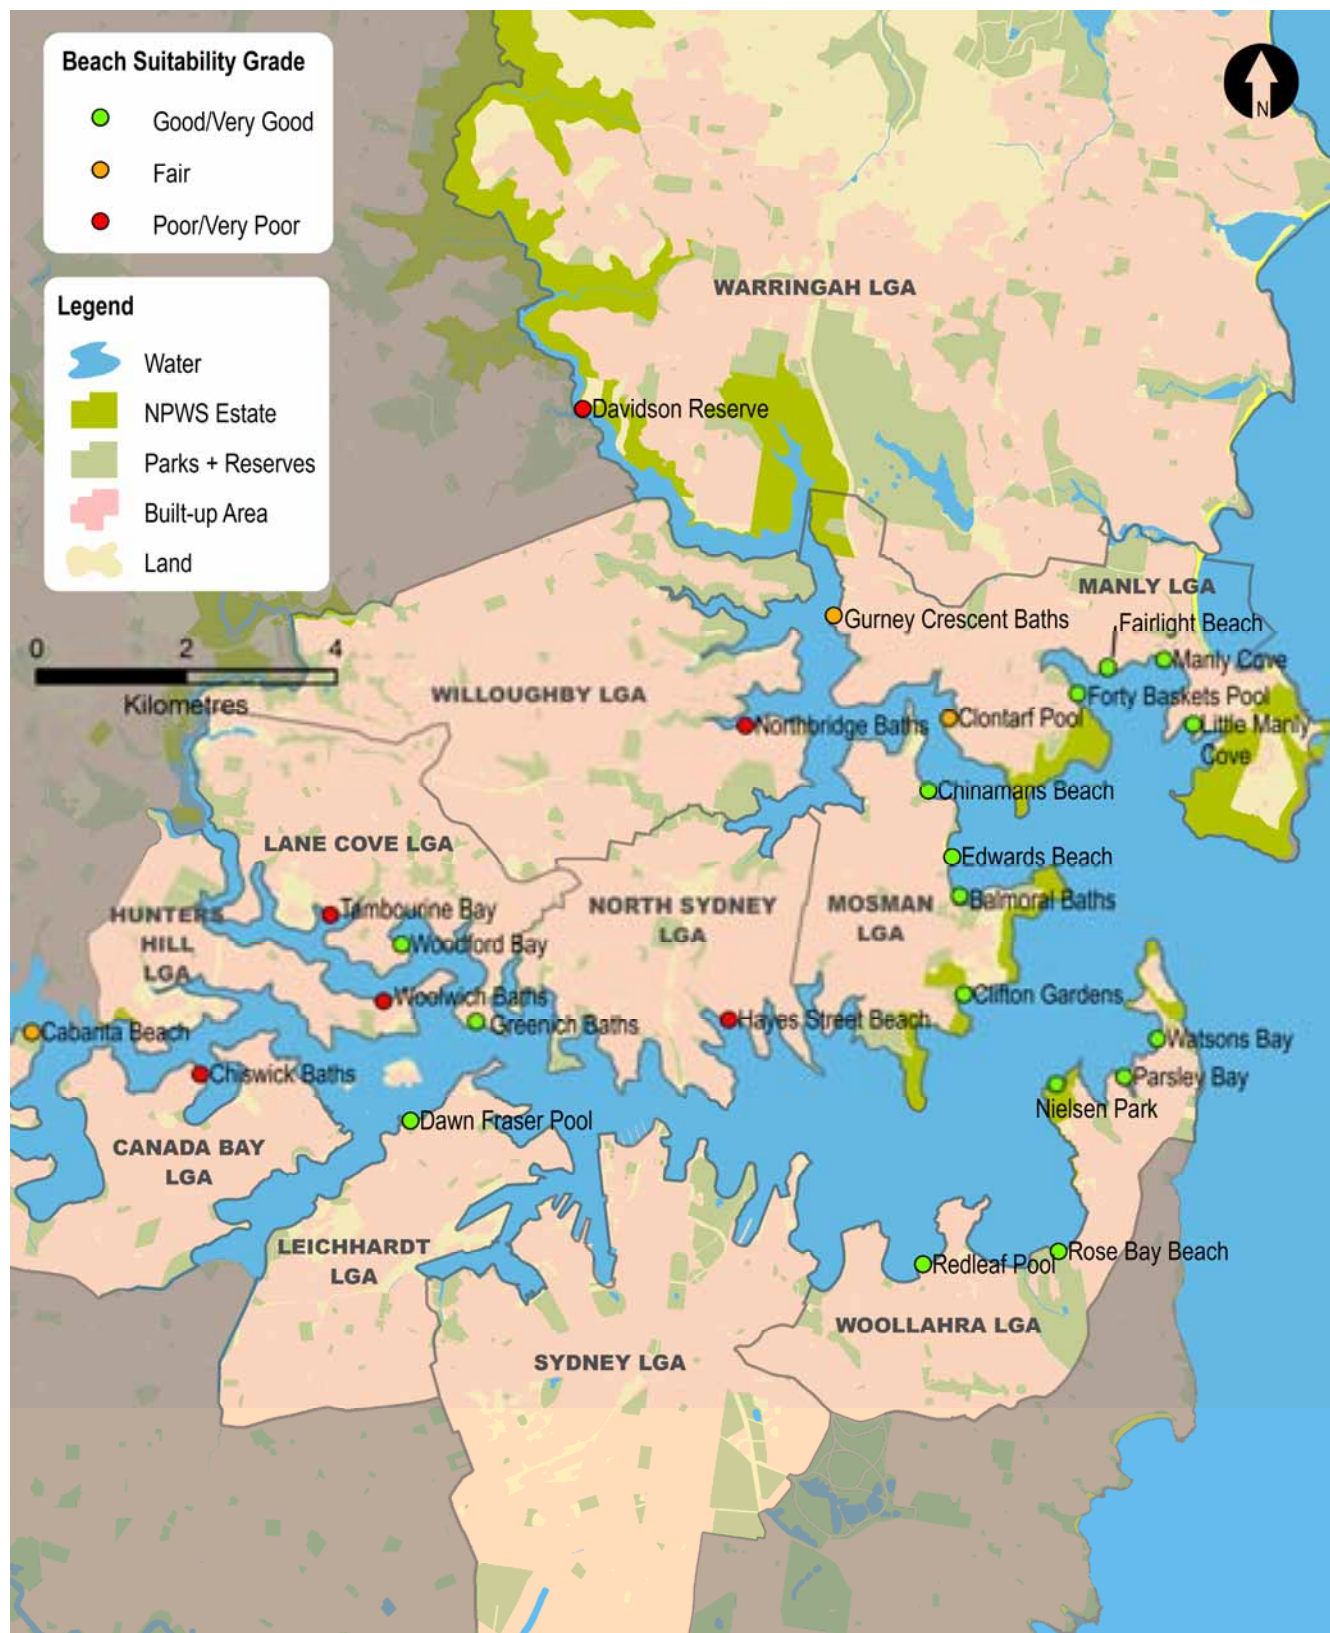
Figure 26: Sampling locations and Beach Suitability Grades in Sydney Harbour

Sixteen of the 25 swimming locations in Sydney Harbour were graded as Very Good or Good.

The highest-rated swimming site was Nielsen Park. This site was graded as Very Good, and had consistently excellent microbial water quality and few potential sources of faecal contamination.

The 15 Sydney Harbour beaches graded as Good were Watsons Bay, Parsley Bay, Rose Bay Beach, Redleaf Pool, Dawn Fraser Pool, Woodford Bay, Greenwich Baths, Clifton Gardens, Balmoral Baths, Edwards Beach, Chinamans Beach, Forty Baskets Pool, Fairlight Beach, Manly Cove and Little Manly Cove. Microbial water quality is generally good at these sites, but there are a number of potential pollution sources in their catchments which could cause contamination.

Three swimming locations were graded as Fair: Cabarita Beach, Gurney Crescent Baths and Clontarf Pool. These sites are generally suitable for swimming during dry weather conditions, but owing to the presence of significant sources of microbial contamination, they are susceptible to pollution following rainfall.

Five swimming locations were graded as Poor: Woolwich Baths and Tambourine Bay in the lower Lane Cove River, Chiswick Baths in the lower Parramatta River, Northbridge Baths in the upper reaches of Middle Harbour and Hayes Street Beach in Port Jackson. These sites are very susceptible to

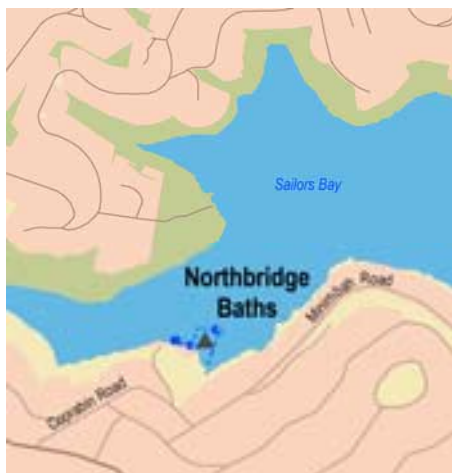
See page 21 for key to map

Northbridge Baths are a 30 by 65 metre enclosed swimming area in Sailors Bay, Middle Harbour. The baths are open year round; however, installed signage advises that swimming is not recommended during rain and up to 48 hours after rainfall.

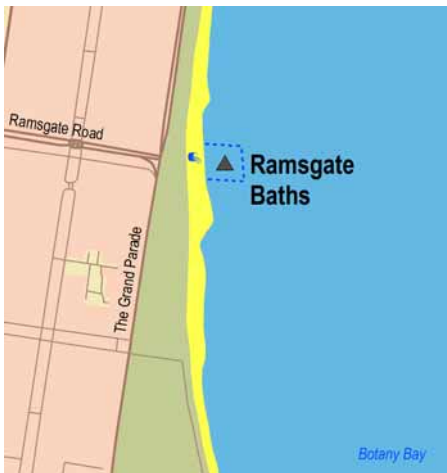
Ramsgate Baths are a 50 metre square swimming enclosure located near the southern end of Lady Robinsons Beach in Botany Bay. The baths are backed by a sandy beach, a promenade and a small park.

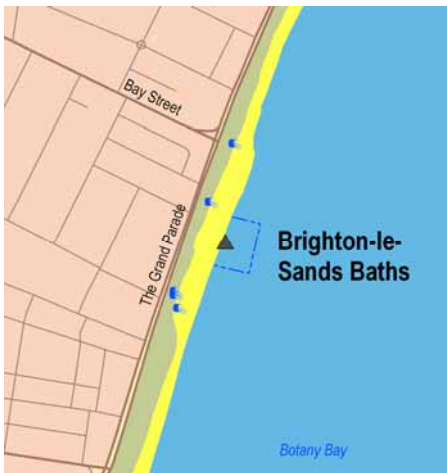
Brighton-Le-Sands Baths are located towards the centre of Lady Robinsons Beach. The baths are netted and backed by a sandy beach and restaurant.

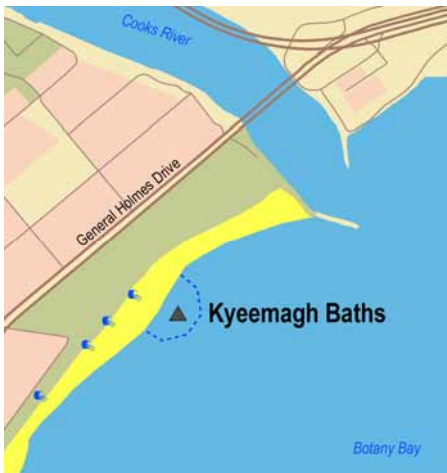
Kyeemagh Baths are located at the northern end of Lady Robinsons Beach. The baths are netted and backed by a sandy beach and reserve.

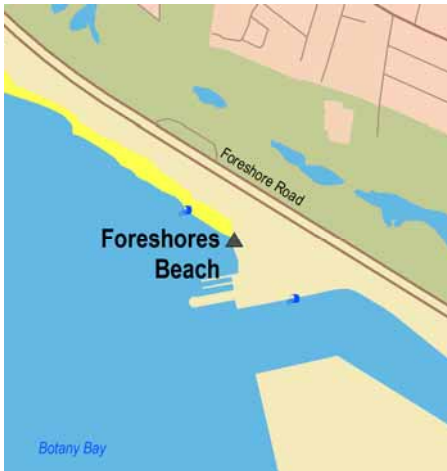
Foreshores Beach is located adjacent to Sydney Airport's third runway and the Port Botany Terminal 3 due for completion in 2013. The swimming area is not netted and has recently been redeveloped to include toilet facilities, a car park and boat launching facilities.

Foreshores Beach was graded as Very Poor. Although microbial water quality was often suitable for swimming during dry weather conditions, the site is very susceptible to faecal contamination from the sewage overflows which discharge into Mill Pond Creek. To reduce the risk of contracting swimming related illnesses at this site, carefully follow the pollution advisories in the Beachwatch Daily Bulletin (www.environment.nsw.gov.au/beach), avoid swimming during and up to three days following light rainfall, and check Sydney Water's website for sewage overflow notifications (www.sydneynwater.com.au).

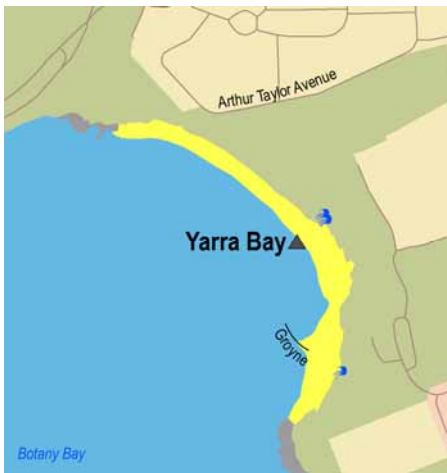
Yarra Bay is approximately 750 metres long, with a rock groyne 100 metres from the southern end. The swimming area is not netted. The southern half of the beach is bordered by Yarra Bay Bicentennial Park and Yarra Bay Sailing Club.

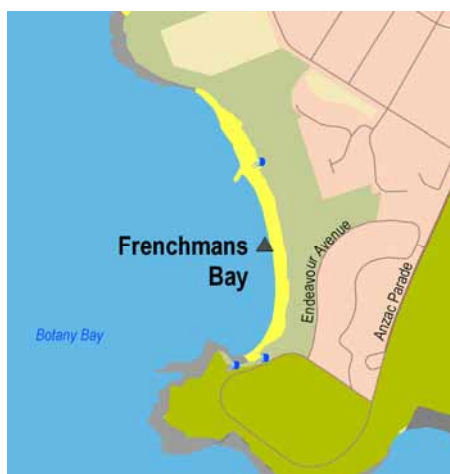
Frenchmans Bay is approximately 500 metres long, with a rock wall towards the northern end. The swimming area is not netted. A small recreational reserve is located behind the southern end of the beach.

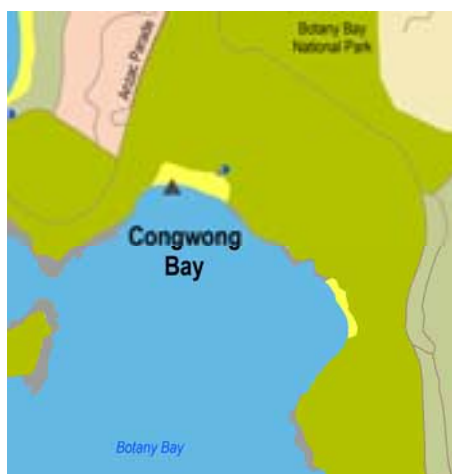
Congwong Bay is located near the mouth of Botany Bay and is backed by the Botany Bay National Park. The beach is approximately 150 metres long and the swimming area is not netted.

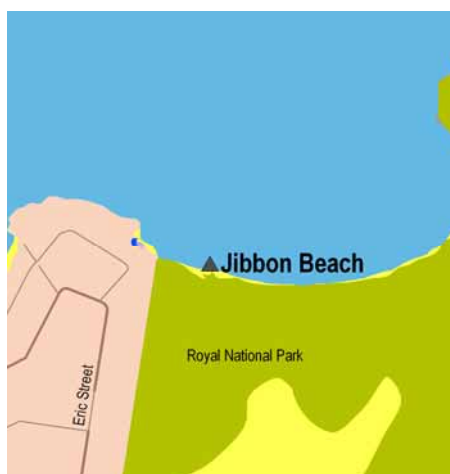
See page 21 for key to map

Jibbon Beach is located at the entrance to Port Hacking. The beach is backed by the Royal National Park and accessed from Bundeena. The water is deep, making it a popular boating destination. Beach conditions are safest in the eastern corner.

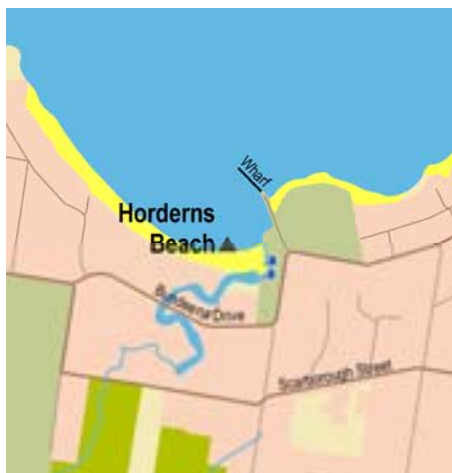
Horderns Beach is located on the southern shore of Port Hacking and is backed by the town of Bundeena. The Cronulla–Bundeena wharf is located at the eastern end of the beach.

Gymea Bay Baths and Horderns Beach were graded as Poor. Although microbial water quality was suitable for swimming during dry weather conditions, enterococci levels increased with increasing rainfall and often became unsuitable for swimming following light rainfall. These swimming locations are very susceptible to pollution from stormwater runoff, and these impacts are amplified at Gymea Bay Baths by the relatively low level of flushing at the site. Swimming should be avoided during and for up to three days following rainfall or if there are signs of stormwater pollution, such as discoloured water or odour or floating debris.

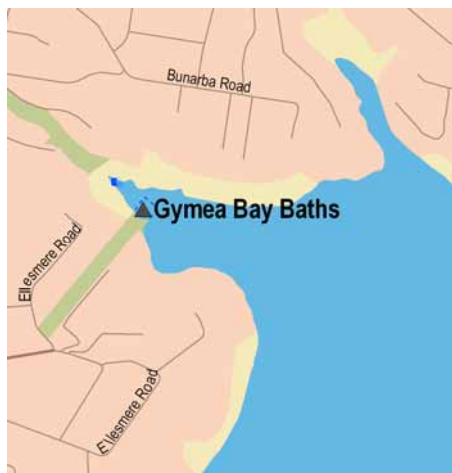
Gymea Bay Baths are an enclosed tidal swimming area backed by a narrow sandy beach in the upper reaches of Port Hacking. Two small recreation reserves lead to the beach.

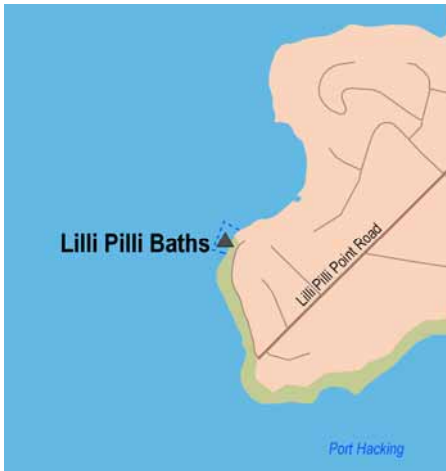
Lilli Pilli Baths is a tidal swimming area located on the western side of Lilli Pilli Point in the middle reaches of Port Hacking. The pool is netted and is backed by a narrow strip of recreation reserve.

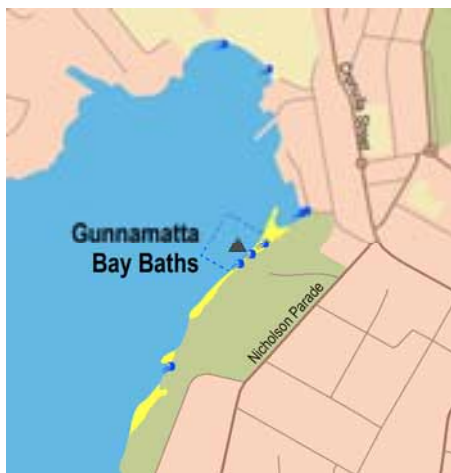
Gunnamatta Bay Baths are an enclosed tidal swimming area located in Gunnamatta Bay. The baths are backed by a narrow sandy beach and a large reserve with picnic facilities.
