NSW Coastal Panel

Coastal erosion at Kingscliff

Advice to the Minister for the Environment

December 2011

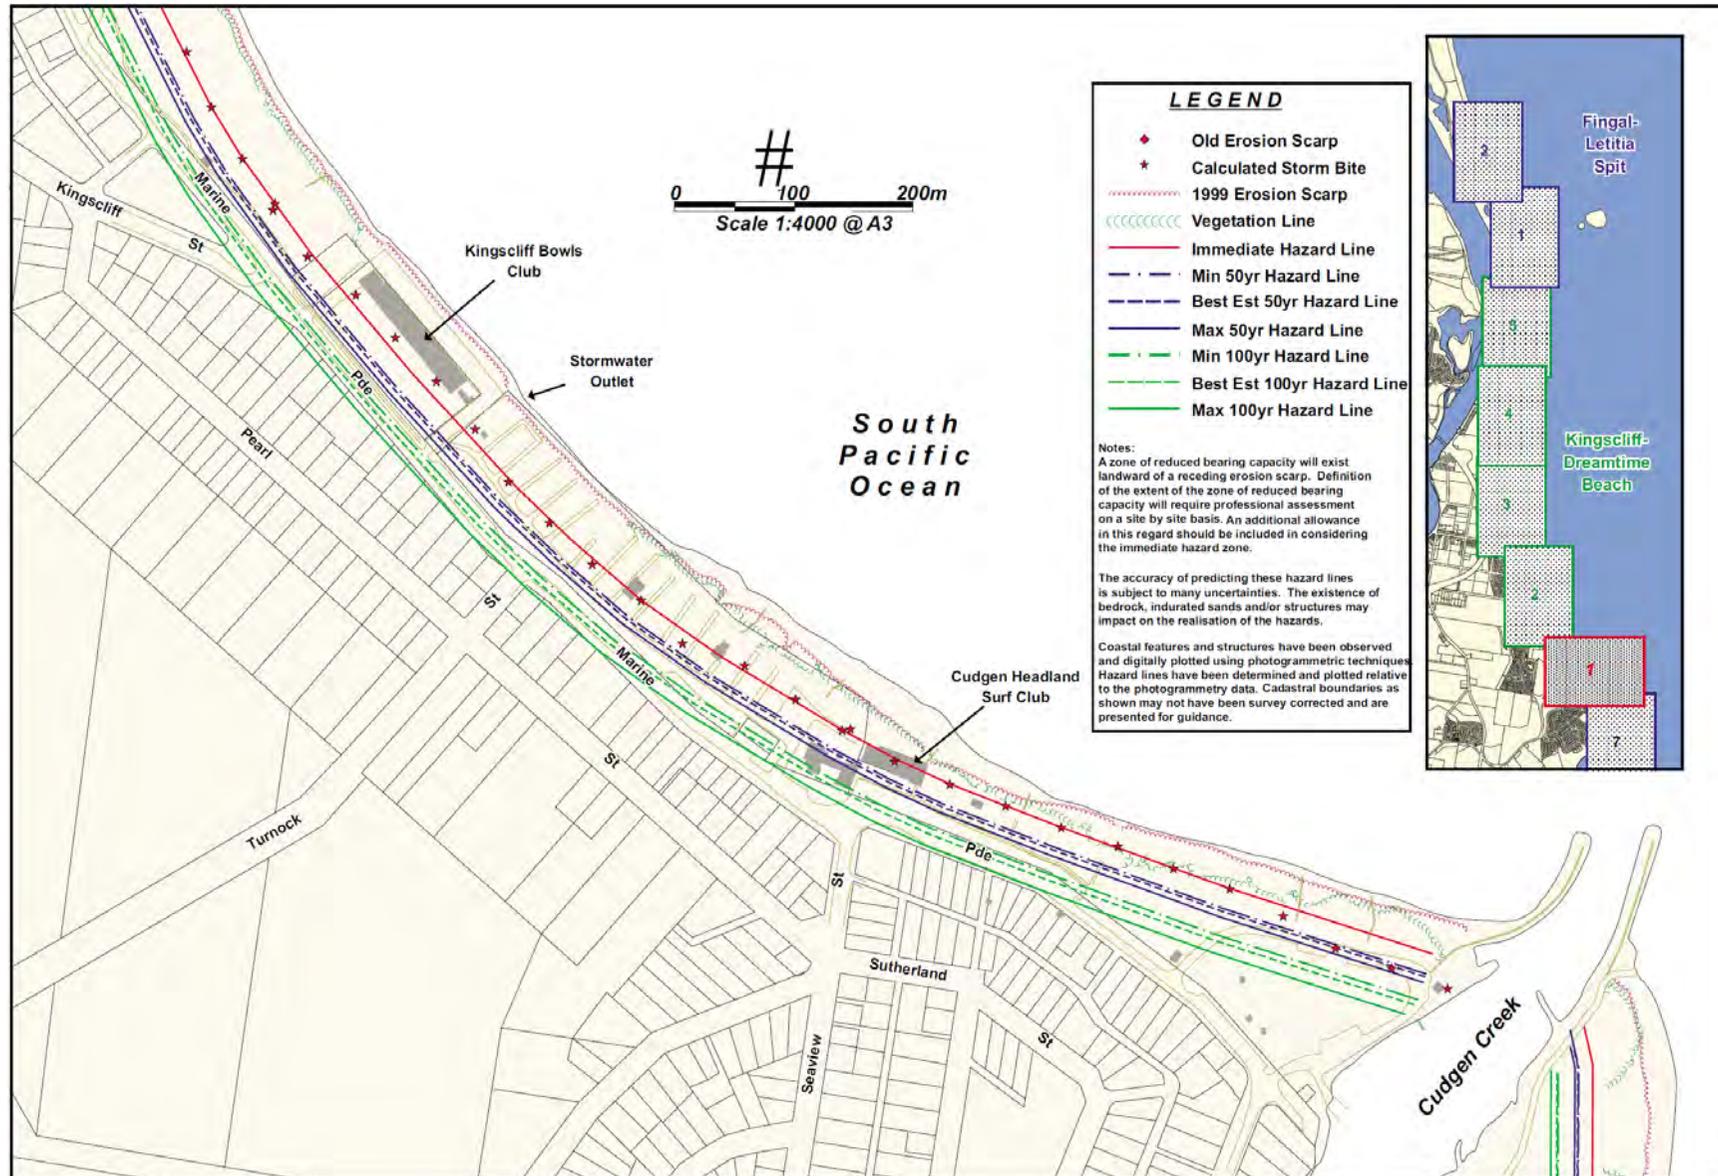
Figure 2 - Hazard lines identifying the immediate, 50 year and 100 year hazard areas (WBM, 2001).

As part of the 2001 CHDS, a number of assets at Kingscliff were identified as being within the Immediate Coastal Erosion Hazard area (Figure 2 and Figure 3). These included the Bowls Club, Cudgen Headland Surf Club and the Kingscliff Holiday Park. In addition, the Kingscliff Amenities Hall was found to be within the 50 year hazard area. Parts of Marine Parade (including parts of Kingscliff Village and private dwellings) are also under threat in the 50 year and 100 year hazard areas. In response, the 2005 CMP identified five potential management options. These were investigated in terms of their technical feasibility and cost effectiveness, and were the subject of public consultation. Each of these options are discussed below.

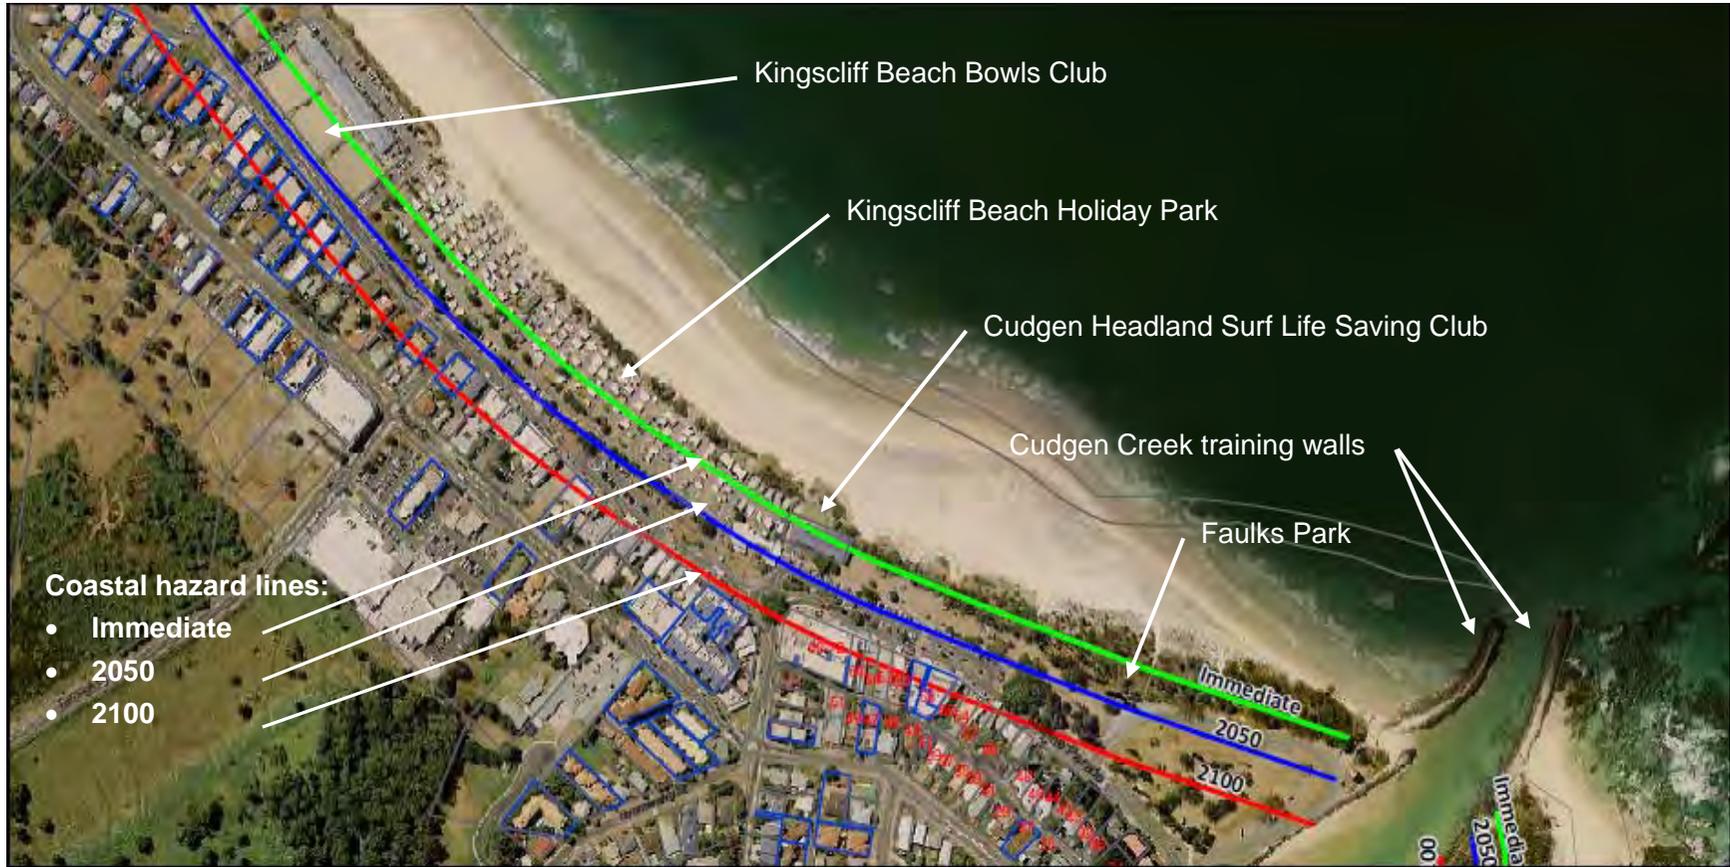
Figure 3 - Kingscliff Coastal Hazard Lines (Immediate, 2050 and 2100) overlaid on aerial image of the area (image courtesy of Tweed Shire Council), based on updated calculation (WRL, 2010).

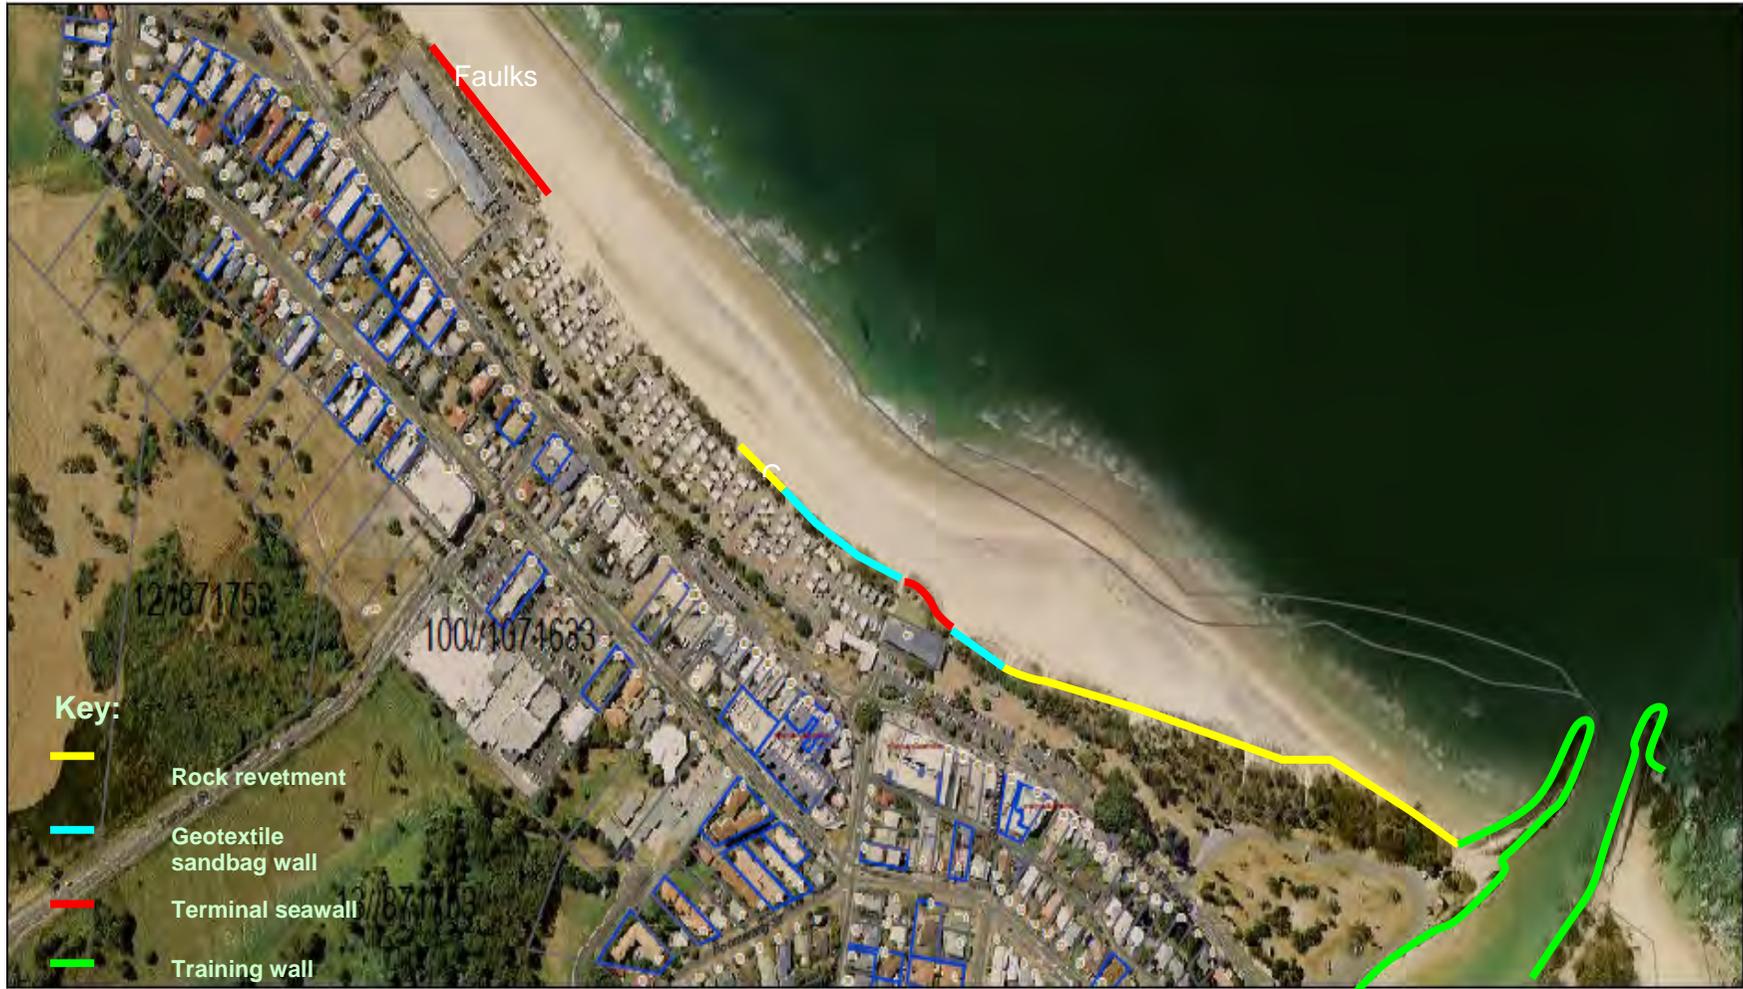
Figure 4 - Indicative location of protection works on Dreamtime Beach at Kingscliff as at December 2011.

- the more recent 2010-11 protection works (as shown in Figure 4). This includes:
 - a vertically piled concrete seawall in front of the Cudgen Headland SLSC (as recommended after completion of the 2005 Tweed Shire Coastline Management Plan, constructed in June 2010);

Although in the 2005 CMP a series of long-term management options for Kingscliff were considered, it appears that a preference for protection was effectively established in the 1960s, through the construction of the Bowls Club seawall. This preference appears to have continued through the subsequent construction of various emergency and temporary works noted in section 3.3. Only a small proportion of the beach between Cudgen Creek and the Bowls Club has no protection works in place (see Figure 4).

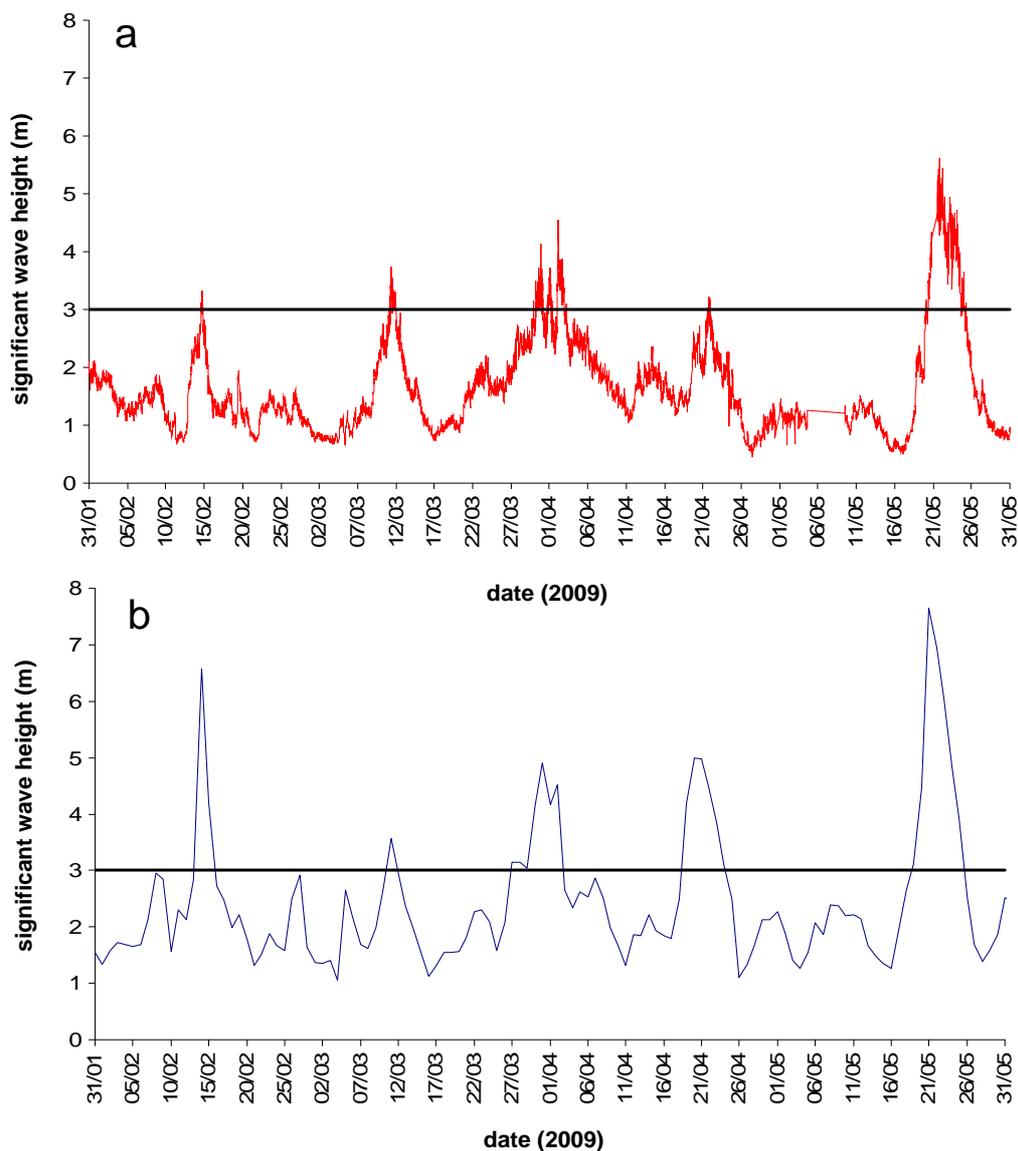
Figure 5 - Significant wave heights during the 2009 erosion period (January - May) measured at (a) the Tweed Waverider Buoy and (b) the Byron Bay Waverider Buoy. Differences in heights between figures can be attributed to possibly sheltering of the Tweed Buoy due to areas of extensive offshore reef. The horizontal black line illustrates the 5 events with a significant wave height of over 3m.

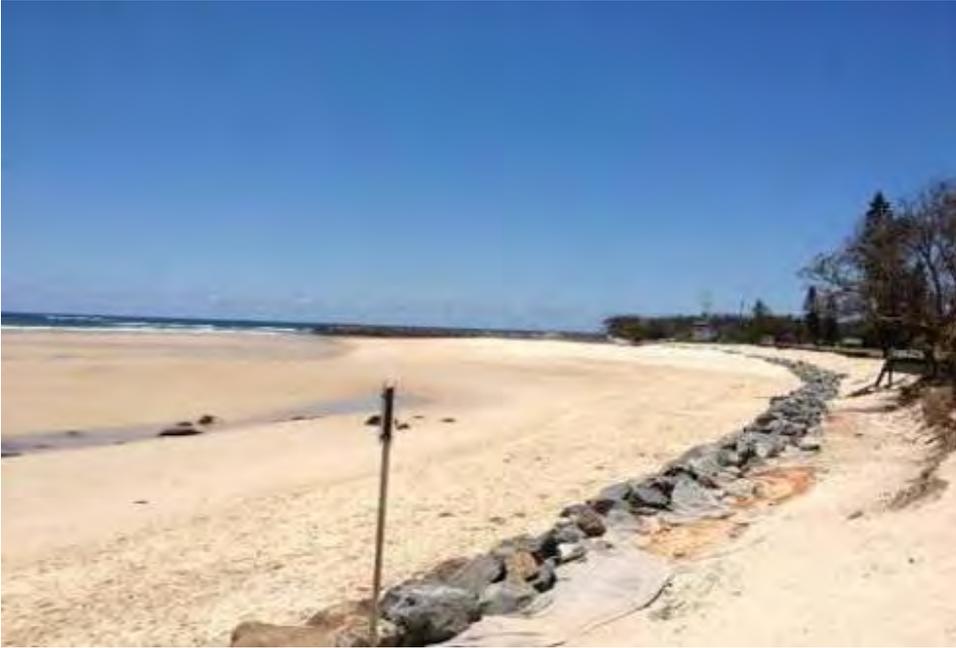
Figure 6 - Terminal rock revetment between Cudgen Headland SLSC and the Cudgen Creek training wall (present in the background). The photo shows the current sand pulse that has recently moved into the embayment and now resides at the southern end of the compartment in front of the wall.
Photo M. Daley 8 November 2011.

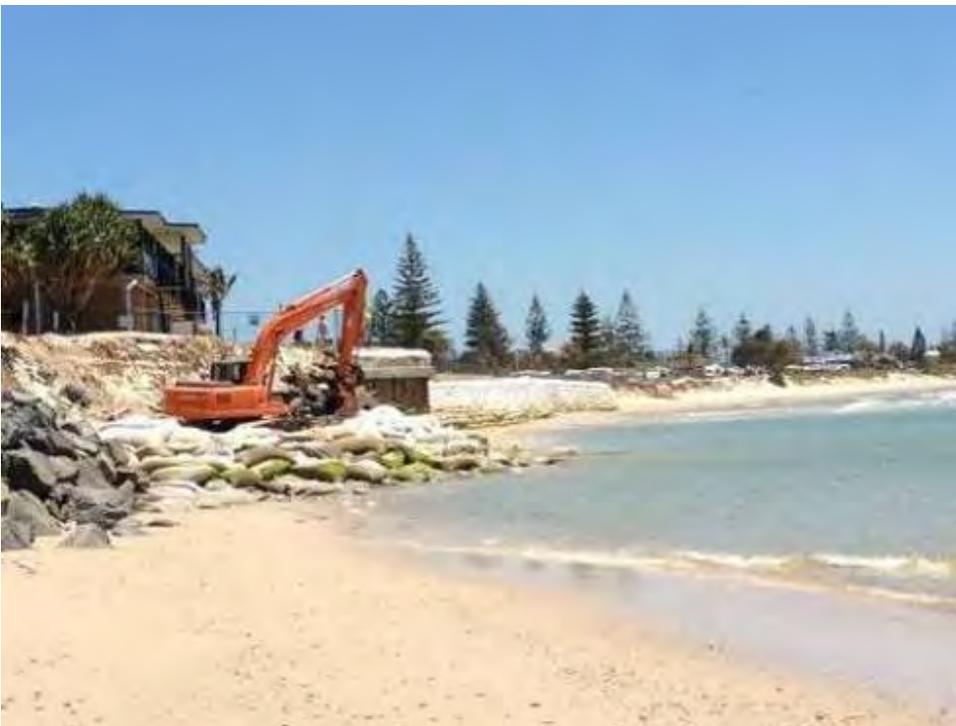
Figure 7 - Looking north from the terminal rock revetment towards Cudgen Headland SLSC and the Holiday Park showing both the piled concrete foundations and temporary geotextile sandbag wall.
Photo: M Daley 8 November 2011.

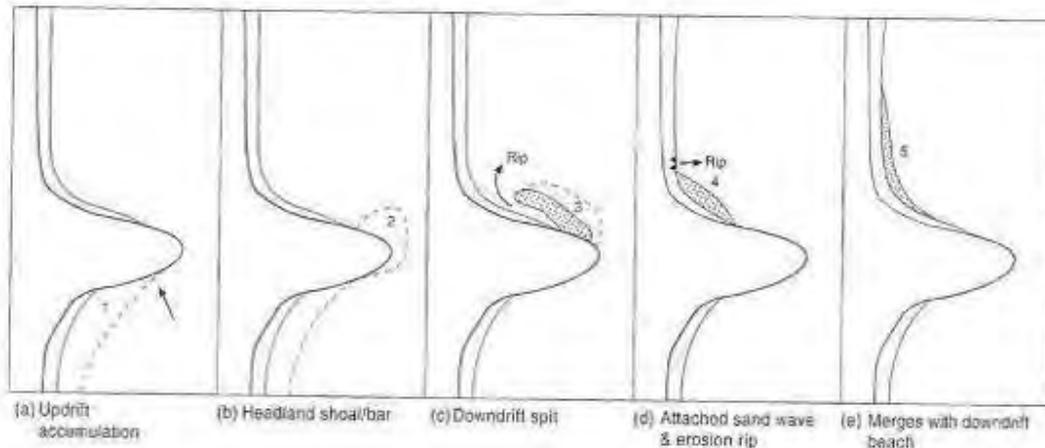
Figure 8 - Schematic illustration of headland sand bypassing. (a) Initially longshore sand transport, causes sand to accumulate updrift of a headland. (b) The sand manifests itself as a substation subaqueous sand wave on the tip and immediately downdrift of the headland. (c) The sand moves around the headland and along the downdrift beach, attaching as an elongate spit. (d) As the sand attaches to the beach it initiates a topographically controlled rip that migrates in advance of the wave, often causing localised beach erosion. (e) The sand finally merges with the beach causing slight accretion. From Short (1999).

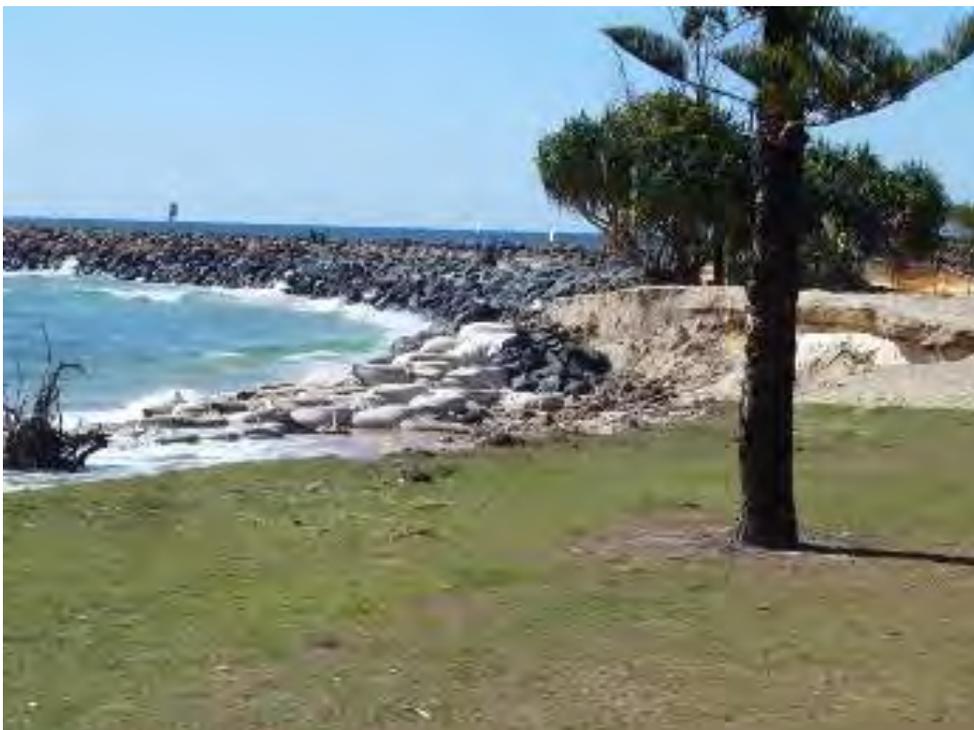
Figure 9 - Looking south from Faulks Park following erosion events of 2010. Also evident are the end effects of Cudgen Creek training walls. Photo: B Gibbs 12 August 2010.

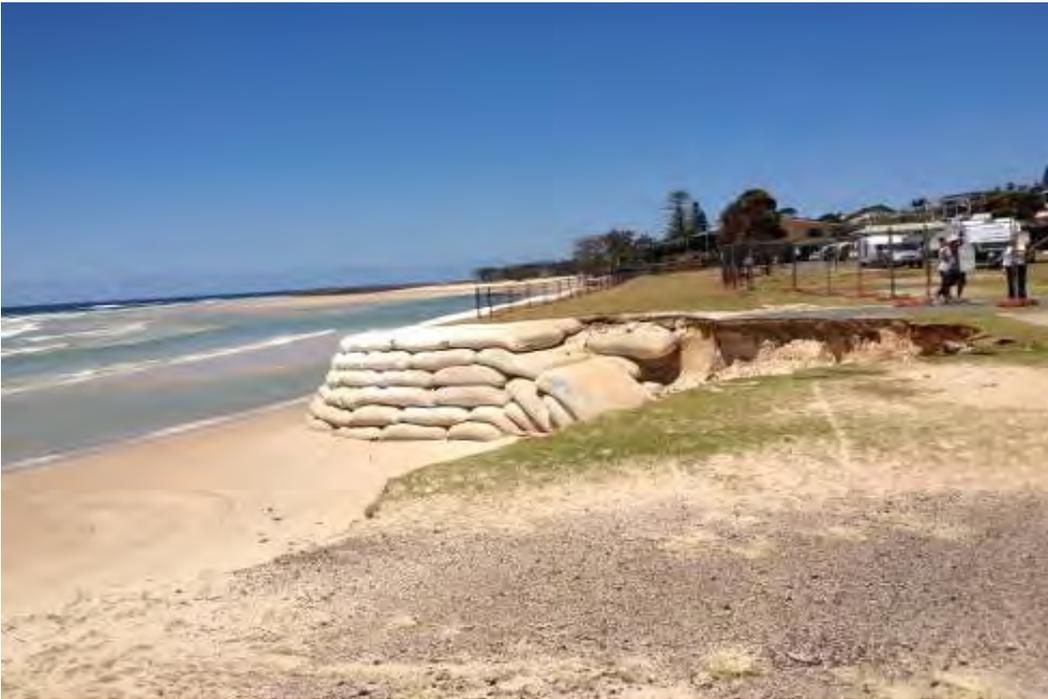
Figure 10 - Northern end of the geotextile sandbag seawall (looking south) showing both collapse of the wall and end effects which have produced further erosion of the Holiday Park. Photo: M Daley 8 November 2011.

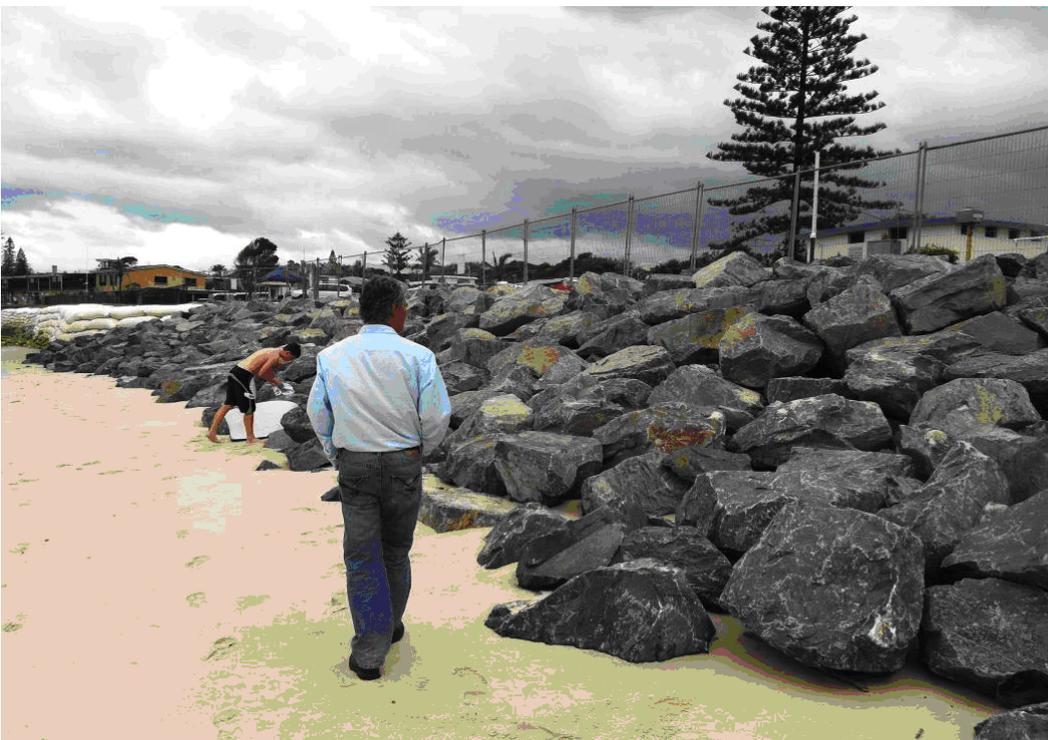
Figure 11 – Most recent (60 metre) rock extension in front of the further part of the Holiday Park and the amenities block. Photo: B. Fitzgibbon 14 December 2011.

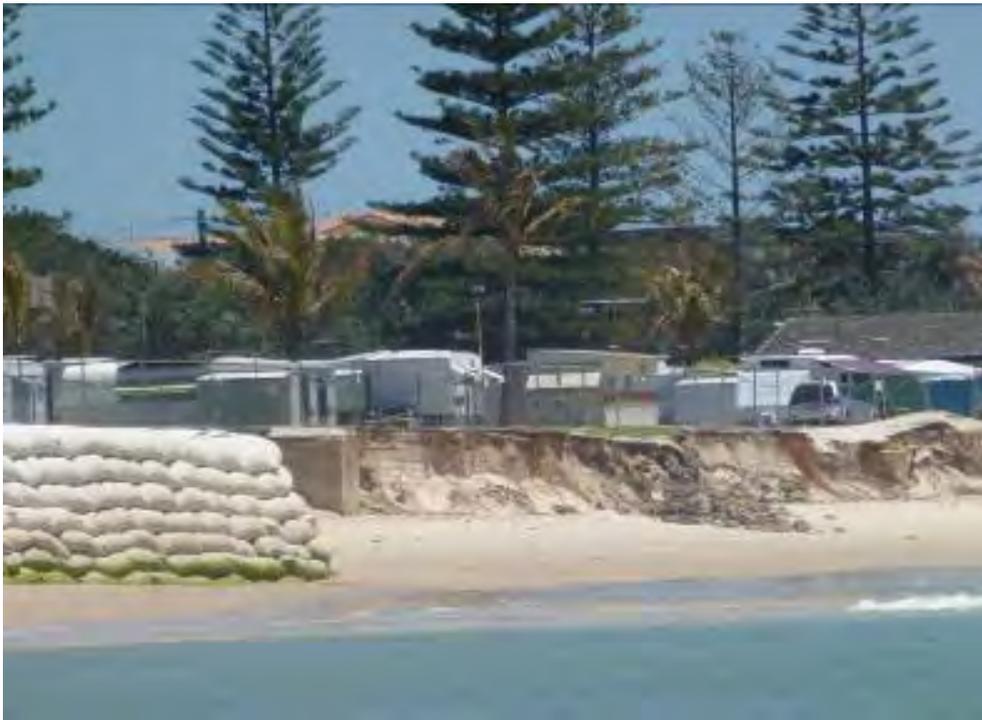
Figure 12 – Looking towards the Holiday Park showing end effects of temporary protection works and the current risk posed to the amenities block and pumping station located immediately behind the escarpment. Photo: G Pezzimenti 8 November 2011.

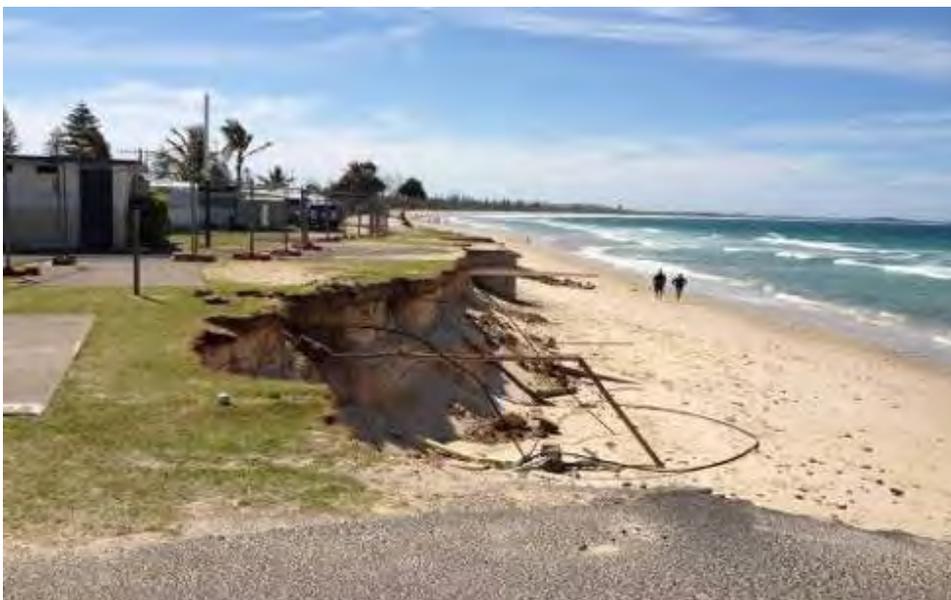
Figure 13 – Cable and Piping Infrastructure currents protruding from the erosion escarpment adjacent to the Holiday Park. Photo: M. Daley 8 November 2011.

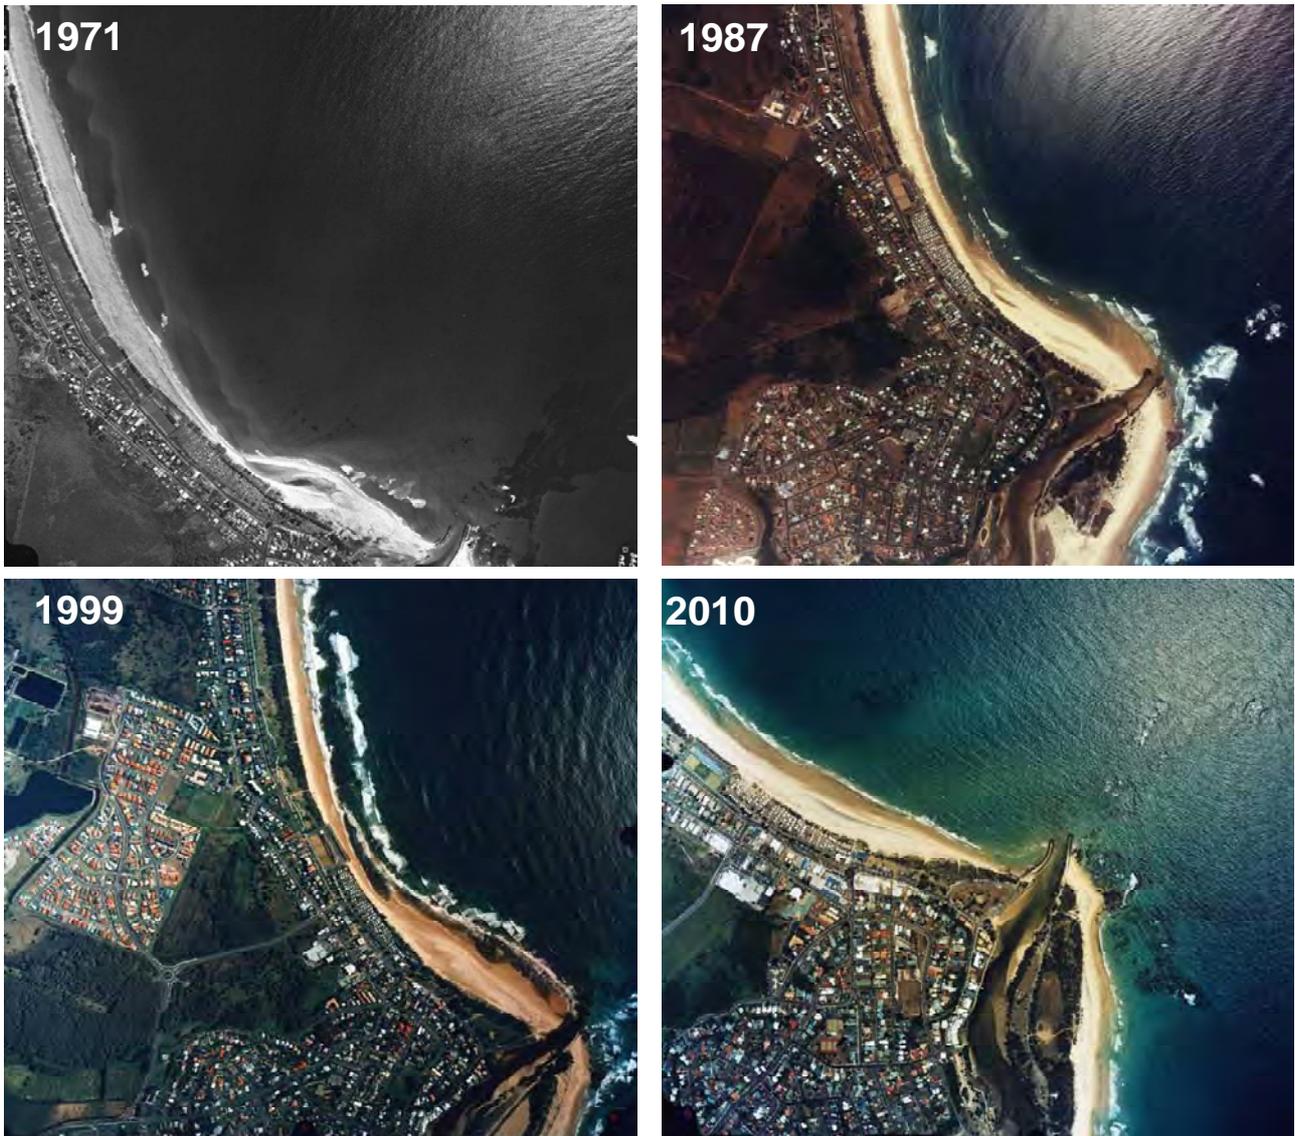
Figure 14 – Previous sand wave events that have occurred at Kingscliff. Three prior events on photographic record show the impacts of sand waves in 1971, 1987 and 1999 with erosion occurring along Kingscliff beach in front of the wave. The 2010 photo shows the beach state prior to the most recent 2011 sand wave, with sand shown to be building up on the southern side of Cudgen Headland, before its subsequent movement into the embayment.

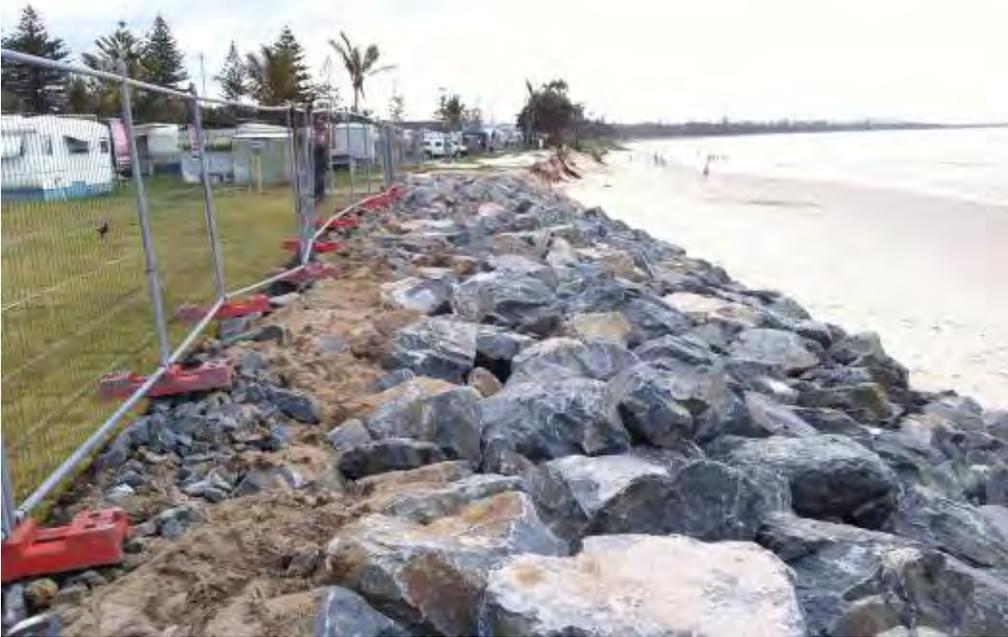
Figure 15 – Recent (December 2011) rock revetment works installed to protect the amenities block and sewer pumping station of the Kingscliff Holiday Park. Photo: B. Fitzgibbon 14 December 2011.
