2.0 DESCRIPTION OF THE PRECINCT

2.1 PRECINCT BOUNDARIES

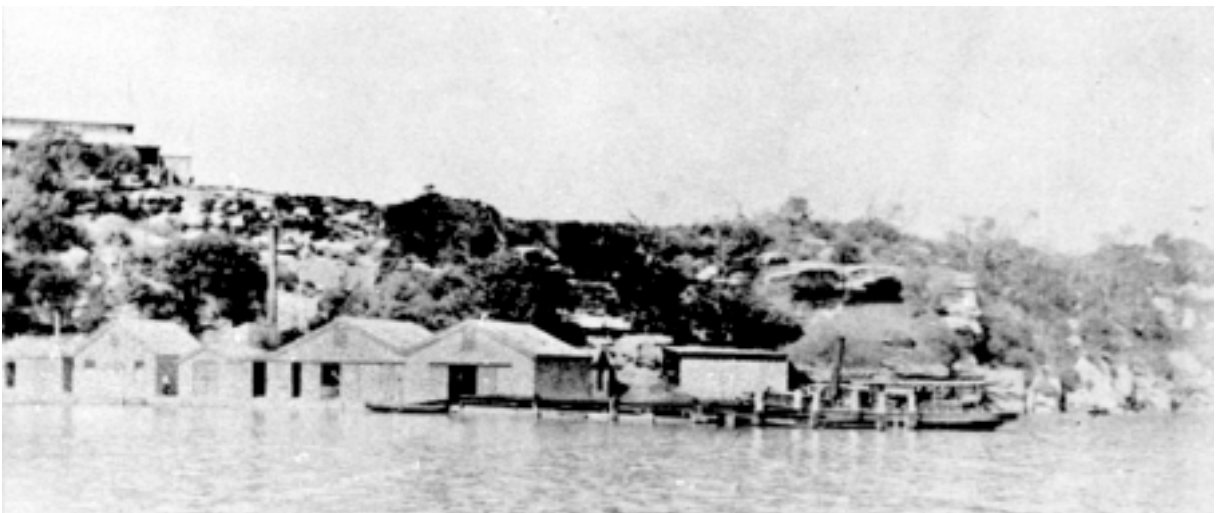
jetty and receiving rooms early 1880s

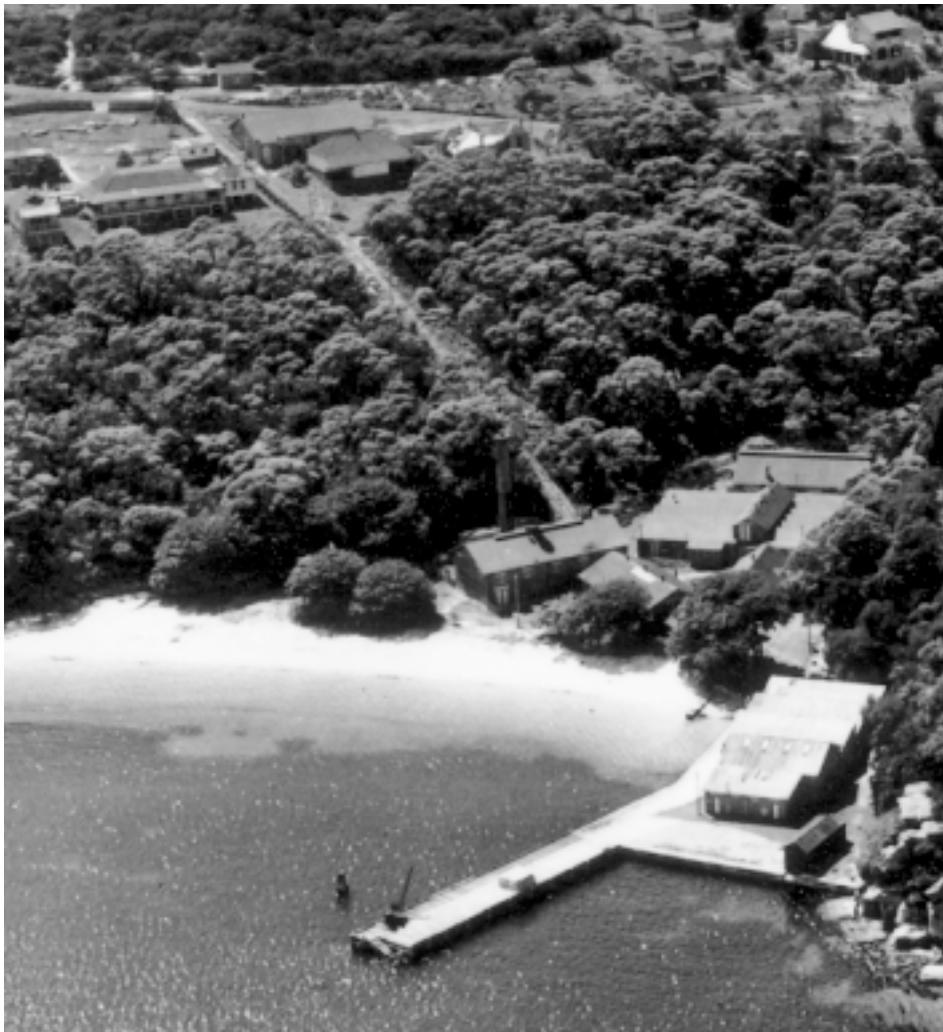
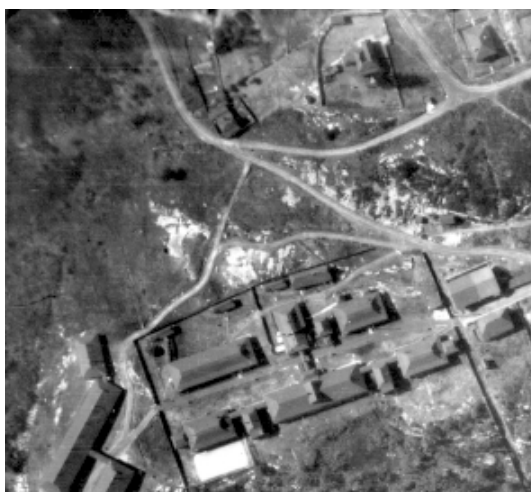
Funicular railway system

aerial showing funicular track from the Wharf Precinct to 1st/2nd Class late 1940s

The rails of the former 2ft 4in (70cm) narrow gauge railway track system are discontinuous in areas where they have disintegrated due to corrosion or where they have been removed. There is however sufficient evidence of their location to clearly indicate the operation of the railway system. The Funicular Railway provided tram access up the sandstone escarpment from the Wharf Precinct to the 1st/2nd Class Precinct and then on to the 3rd Class/Asiatics Precinct. It was constructed in 1912, as part of a suite of capital works recommended by the new Federal Director of Quarantine, Dr W P Norris.

Remnants of rail tracks run along the jetty, branch through the Luggage Sheds (A14-A17), pass through the Autoclaves (A7) and around to the Bath Houses (A11, A12) and Laundry (A9) and then proceed up the escarpment. The remnant escarpment sections are heavily rusted. The original stone ramp to the 'tramway' at the escarpment remains, although the tracks and funicular are discontinuous at two points. The cutting is now heavily overgrown and the original route of the tramway is obscured.

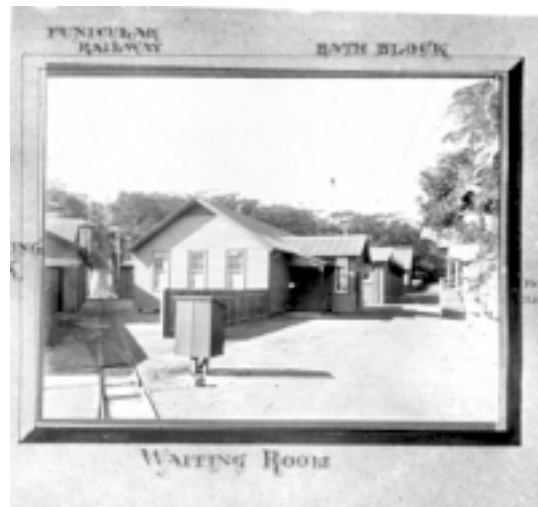
1919

Funicular railway system

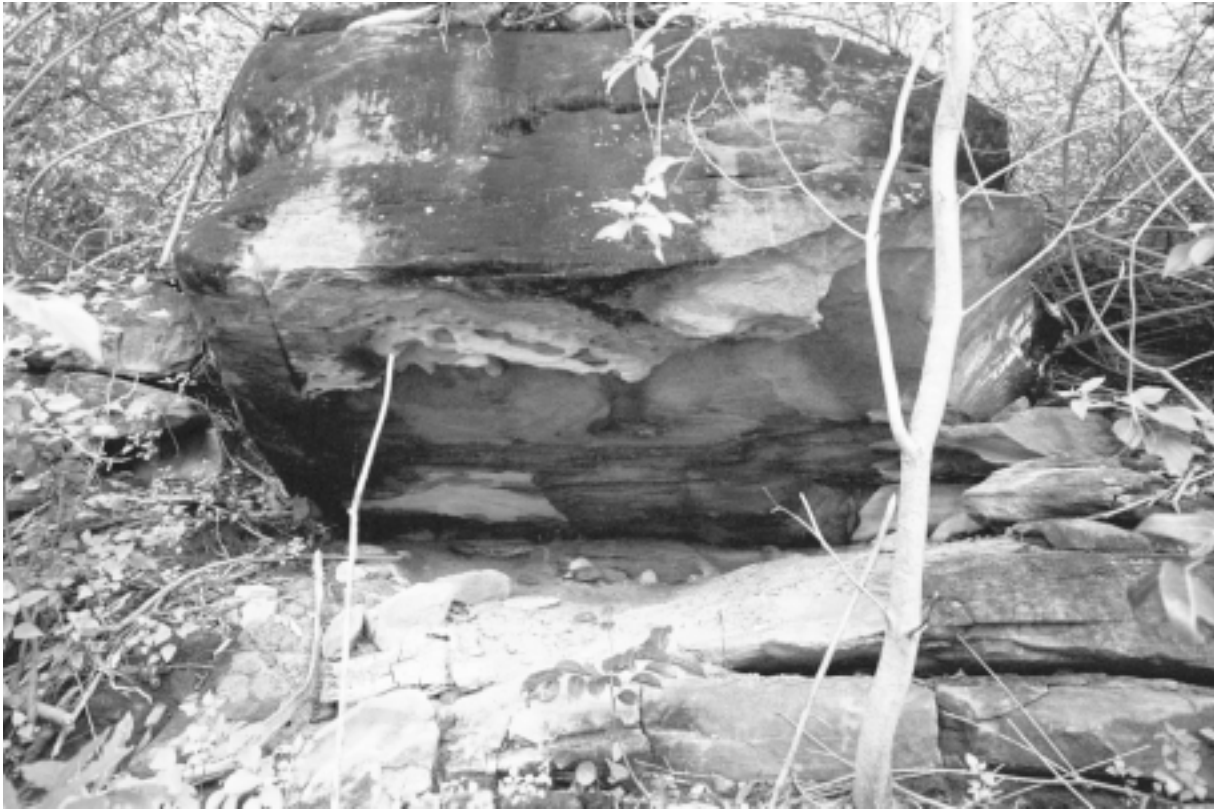
rock overhang in the Wharf Precinct that may have been used as a sleeping platform during Aboriginal occupation of the site 2001
