Quarantine Station
Detailed Area Conservation Management Plans
Archaeological Data Sheet

Quarantine Station

Detailed Area Conservation Management Plans

Archaeological Data Sheet

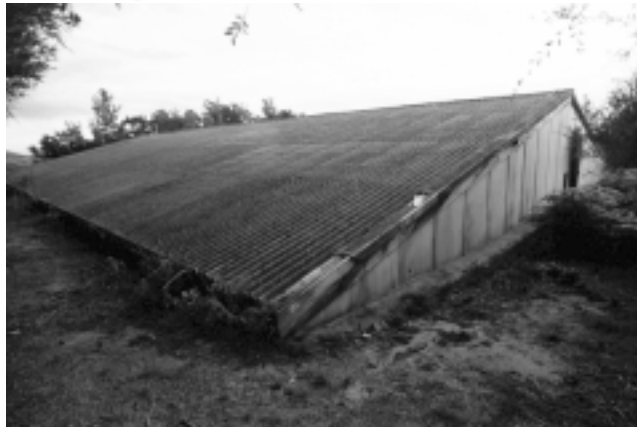
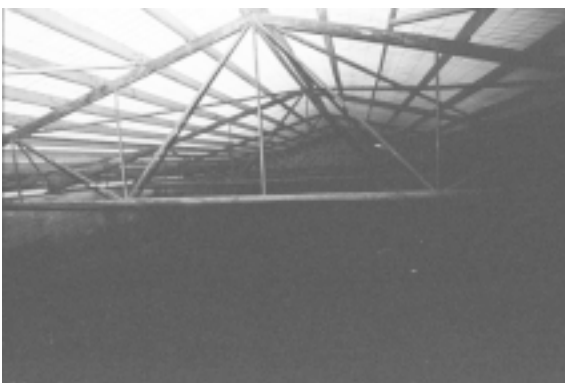
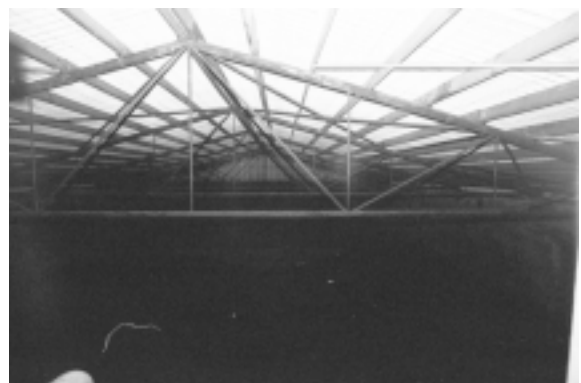
Building Number:
L02

The area is secured by a wire fence that is accessible without keys, consequently providing a security hazard, particularly as access is available to the water area.

Materials: Corrugated AC sheet
Condition: Fair

Currently under water appears in fair condition.

Poor condition requires repair.

The condition of pipework is not known. It appears that water can be removed from the reservoir.

The site within the fenced area is subject to regrowth. This has obscured the structure from the entry road which is desirable. There are remnants of steps and retaining structures between the reservoir and pump house. These are in poor condition. Surface pipework is evident around the structure.

The perimeter fence requires some repair and securing.

The roof structure may be adapted to replace the present AC cladding with a more appropriate material. Extreme care should be exercised in removal of the cladding to prevent Asbestos entering the water supply. The roof structure and a form of compatible cladding should be retained.

- 1 Repair and lock door to reservoir
- 2 Check operational status of equipment
- 3 Clear access path to reservoir
- 4 Secure perimeter fence

- 1 Test water for quality of supply
- 2 Replace roof and wall cladding or seal to prevent contamination

1 Check adequacy of structure when empty, clean as required and carry out repairs

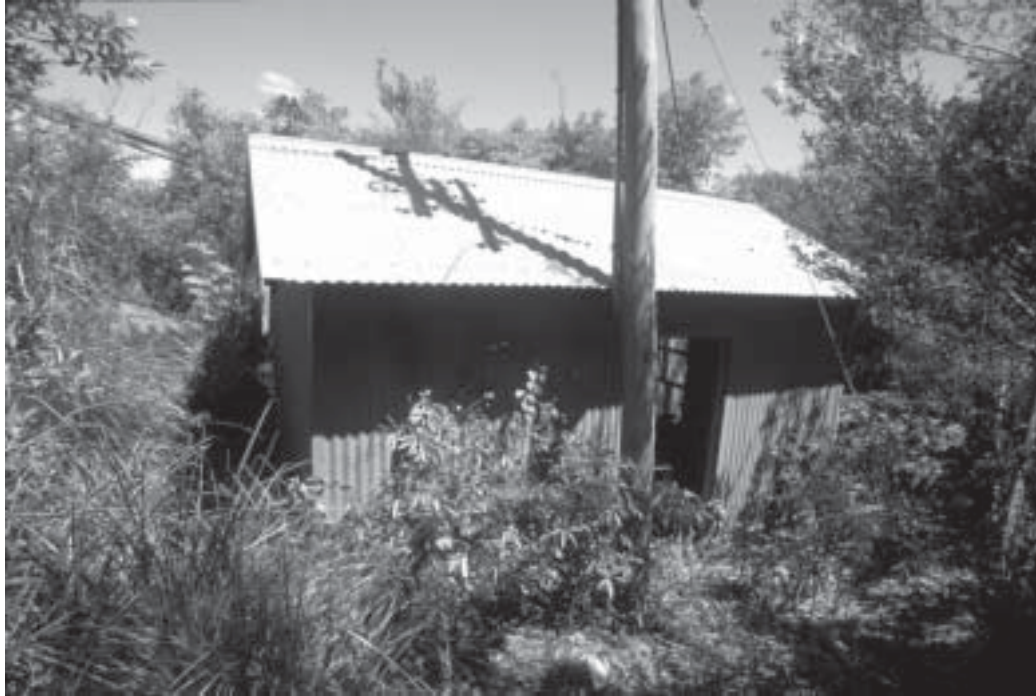
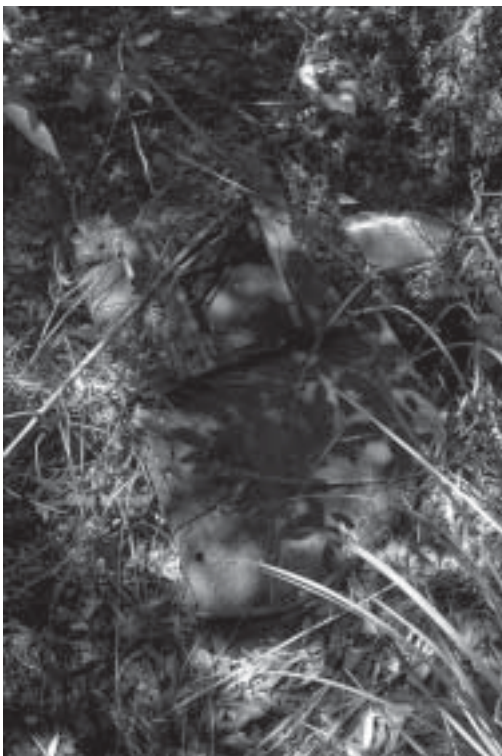
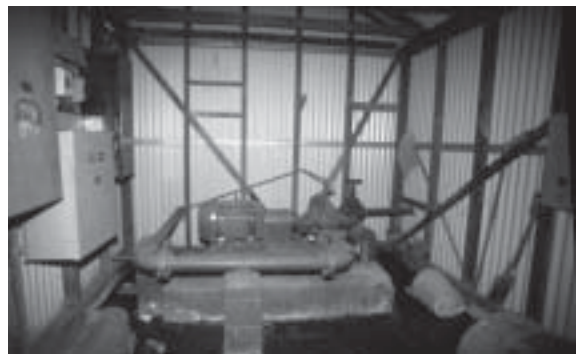
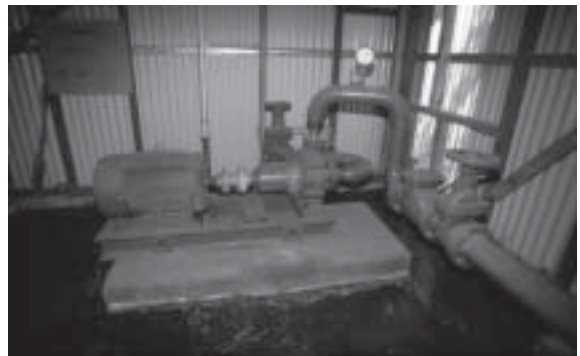
L02

The building is small, rectangular with a concrete floor with perimeter edge beam onto which the frame is built. The frame appears original but the cladding is recent fixed on steel top hat sections, the window has been removed (framing indicates its location) and a translucent sheet fixed to provide light. The solid core door is in poor condition and has a bolt fixing.

The building is in poor overall condition despite the recent recladding.

Recently replaced. No gutters.

Door requires replacement and securing.

There is a build up of material around the building that requires clearing. The steps and path have deteriorated making access difficult.

Despite the level of change to the cladding and the removal of the window, it would be appropriate to reinstate the window and claddings to the original form. As the cladding has recently been replaced it would be acceptable to make this change when the cladding requires maintenance.

- 1 Clear around building and provide drainage access.
- 2 Check electrical system and repair as required
- 3 Replace entry door and lock
- 4 Paint exterior timberwork

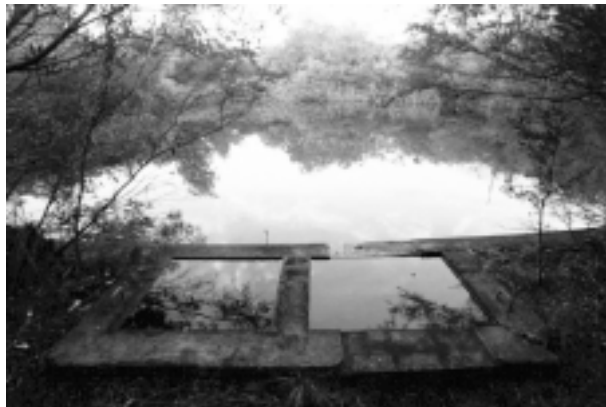
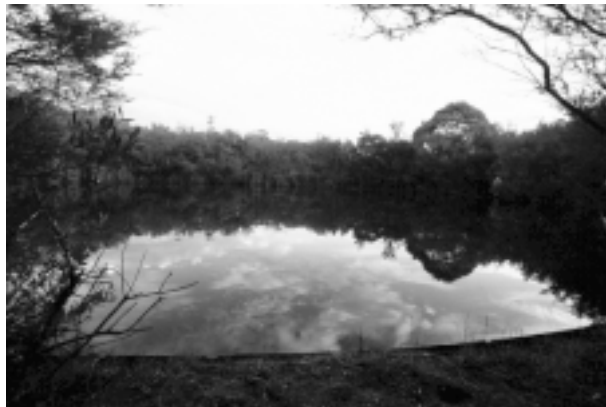
L08

The area is secured by a wire fence that is accessible without keys, consequently providing a security hazard, particularly as access is available to the water area.

Currently under water appears in fair condition.

The condition of pipework is not known. It appears that water can be removed from the reservoir.

The perimeter fence requires some repair and securing.

1 Check adequacy of structure when empty, clean as required and carry out repairs

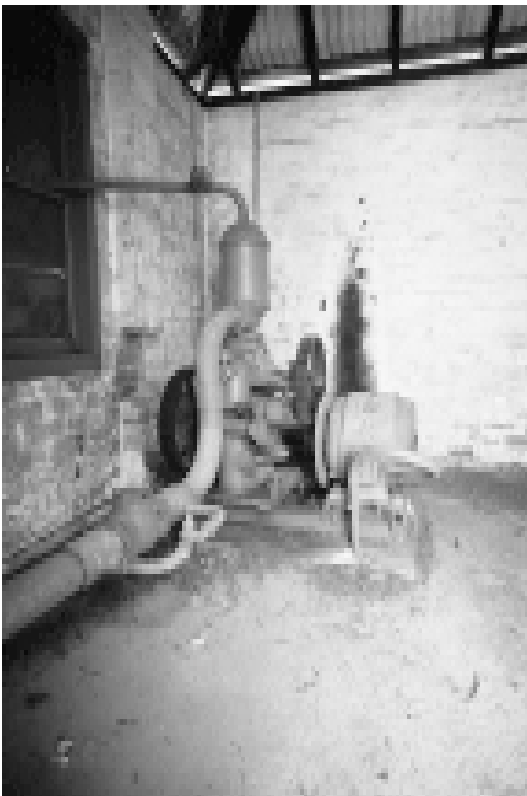
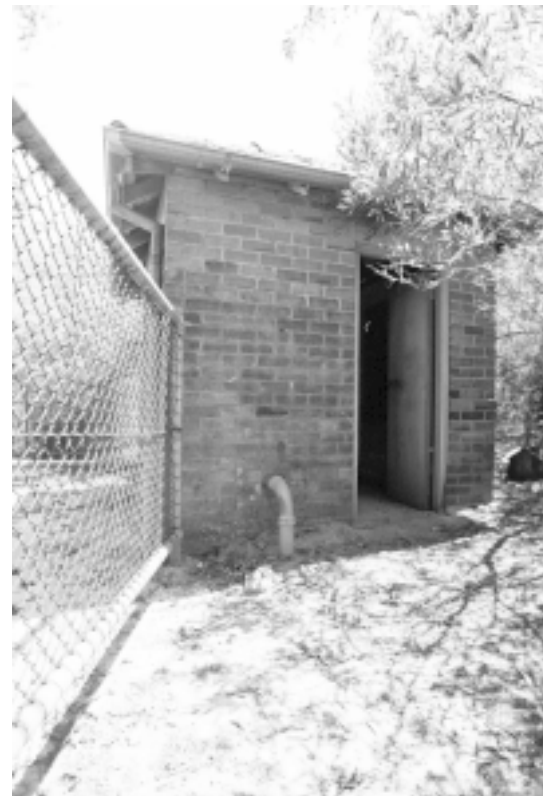
Building Number:
L8a

The building overall is in fair condition considering its location and lack of use. There is however severe cracking in the front corner which requires stabilising.

The roof appears to have replaced an earlier galvanised iron roof. The gutters and downpipes remain in galvanised iron. They are in poor condition and require reconnection and generally replacement. They discharge onto the ground at the base of the building.

The concrete floor survives in reasonable condition.

The original pump equipment is in place (type unknown) with its associated pipework. It requires oiling and painting to prevent deterioration.

The entry door is in good condition but requires painting and urgent maintenance to prevent deterioration. The bolt is original but rusted requiring stabilisation.

The windows are double paned casements, one with casement hold-open catch. They have no glass and are boarded. They are capable of repair and restoration.

The exterior of the building, apart from cracked brickwork, is fair. Timberwork requires painting as a matter of urgency and the brickwork requires repair.

The building fabric should be retained principally in its planned form. The AC roof sheeting could be replaced with corrugated metal roofing to demonstrate the planned form as this building is remote from the main complex and retains its galvanised iron gutters and downpipes.

- 1 Remove external bush encroachment, lower the ground level around the building and ensure that gradients fall away from the building. Remove encroaching soil from within the building
- 2 Repair and repaint the windows and door, remove the temporary boarding and reglaze
- 3 Paint the other external timber elements
- 4 Secure the building with a padlock

- 1 Repair the damaged brickwork
- 2 Stabilise internal equipment
