Notice Number DOC12/47686
File number FIL 09/15781
Date 26 November 2012

DIRECTION TO CARRY OUT REMEDIAL WORK

Thredbo Downhill Mountain Bike Trail Environment Condition Assessment May 2009

Thredbo Downhill Mountain Bike Trail – Environment Condition Assessment, May 2009

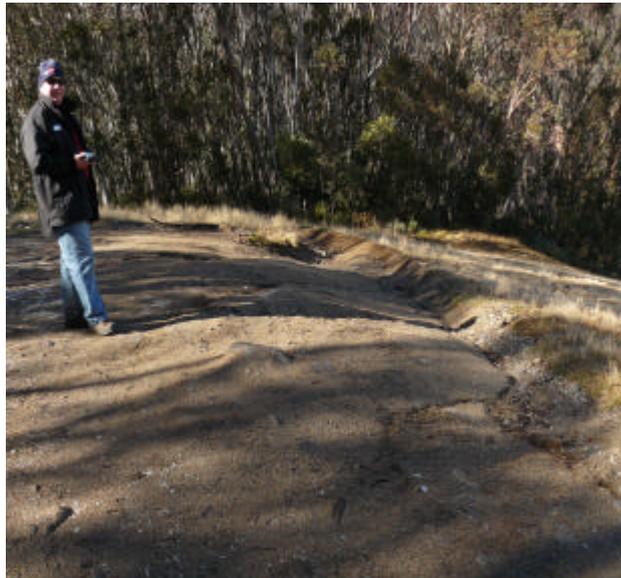
The main issue on the trail is scouring from water movement and rut formation along steep sections of the trail (Refer to Photo 1 and 2). This has led to tree roots being exposed and the edge of the trail increasing in depth thus increasing water movement. Rutting has also occurred on the trail where it traverses the ski slopes. Erosion in these areas is likely to be increased due to the type of vegetation present (shallow fibrous rooted grasses) and rock removal to allow for slashing and grooming of the ski slopes.

photo1: Erosion from water channelling along the edge of the trail

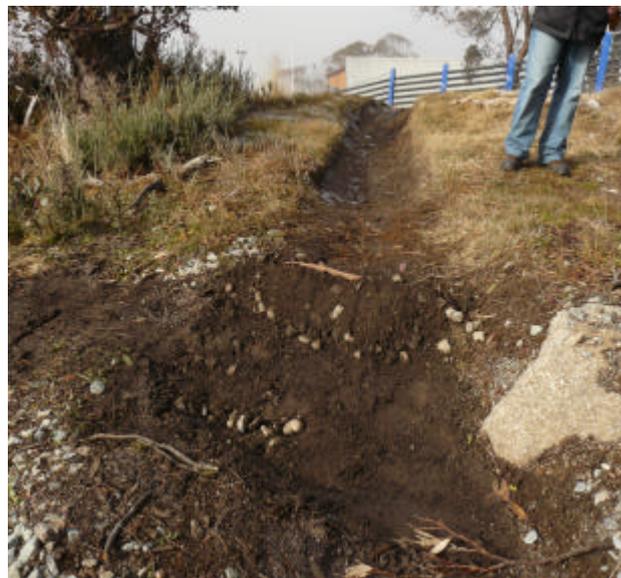
photo 2: Track rutting

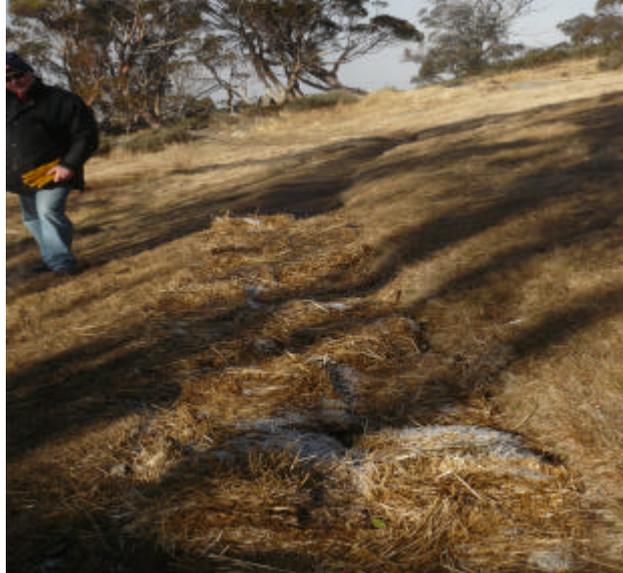
Temporary remediation works were implemented following the closure of the 2009 season. This included the use of hay spread across the trail in areas where soil erosion had occurred.

Monitoring in December will determine the effectiveness of placing hay on the trail between seasons and whether this technique assists in protecting the exposed soil from low winter temperatures and ongoing erosion.

photo 3 and 4 : Hay spread across trail to prevent soil erosion

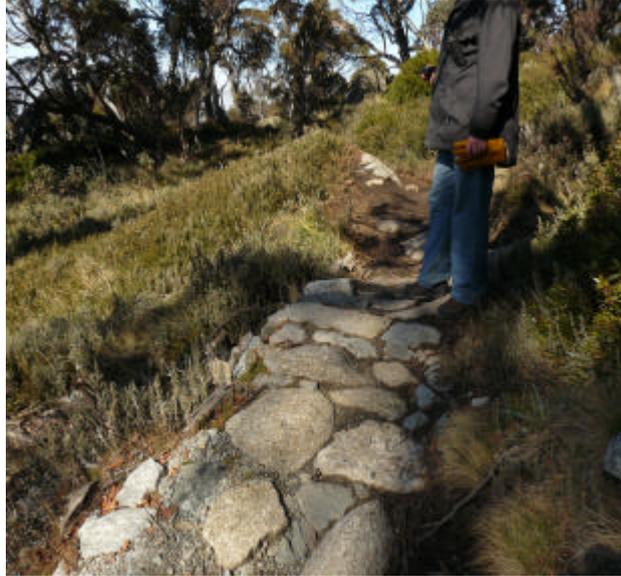
The use of rocks placed on concrete (photo 5) in the steeper section of the track has worked effectively in reducing erosion and provides a more aesthetic outcome.

photo 5: Use of rock laid on concrete

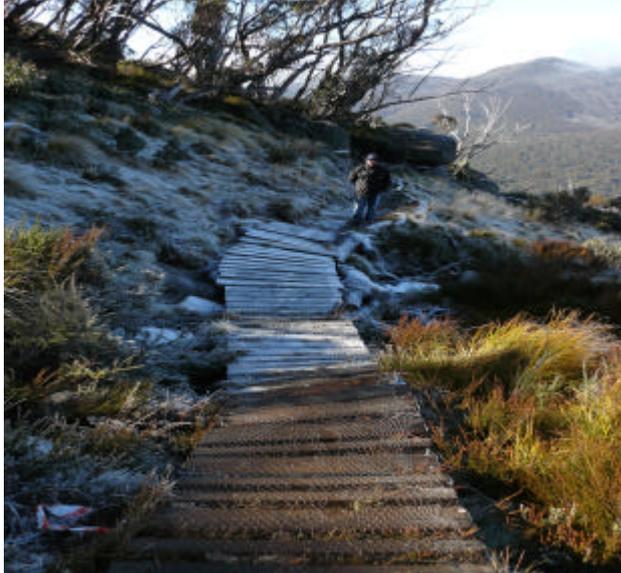
The use of board and chain has also been effective in protecting the soil and allowing native vegetation to re-establish either side of the area. Photo 6 shows a section of board and chain.

photo 6 – Board & Chain

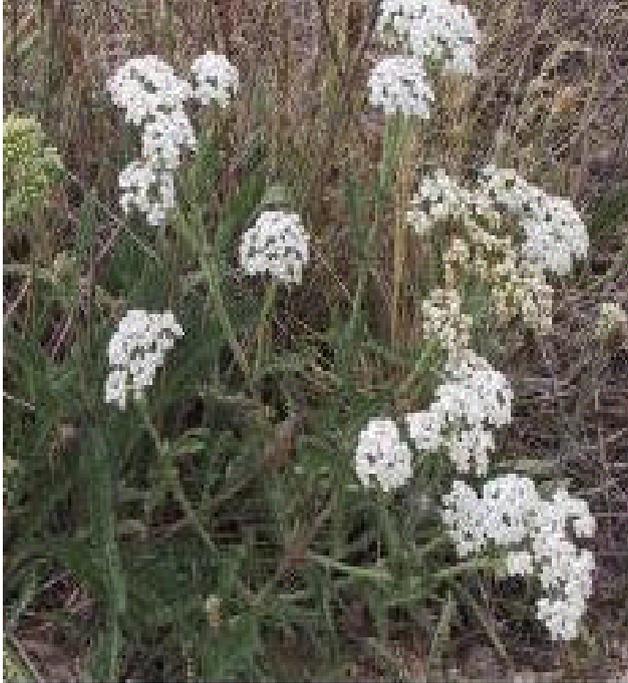
At the start of the track a number of weeds are prevalent including Yarrow (*Achillea millefolium*) photo 7, which is an environmental weed and identified as a high priority for treatment in the KNP Pest Management Strategy (DECC 2008). This weed is currently treated in the Thredbo village and other areas of KNP. The location of the weed close to track edges could lead to the transport of seed (through soil movement in tyres) downhill to other non-infested areas.

photo 7: Yarrow

- Weed control at the head of the trail should be undertaken to prevent seed dispersal at the commencement of flowering of weed species (January – February).
- Construct permanent built structures using natural materials where possible in vegetated areas, particularly where tree roots are exposed.
- Consideration should be given to closing the trail during periods of wet weather (during the season) for a period of time until the surface has sufficiently drained. Riding on the wet surface may lead to increased compaction and soil movement.

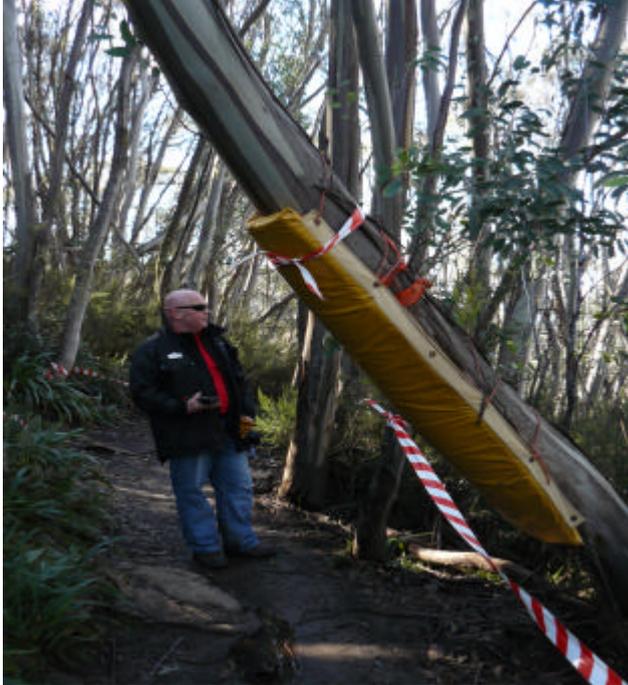
The location of some trees along the trail that traverses the sub-alpine open forest need to be annually assessed for their risk to riders and treated as per their risk level. KT should be responsible for completing the risk assessment. Photo 8 identifies a tree in a dangerous position (refer to map1 for location). KT requires approval from DECC for tree removal.

photo 8: Problem tree

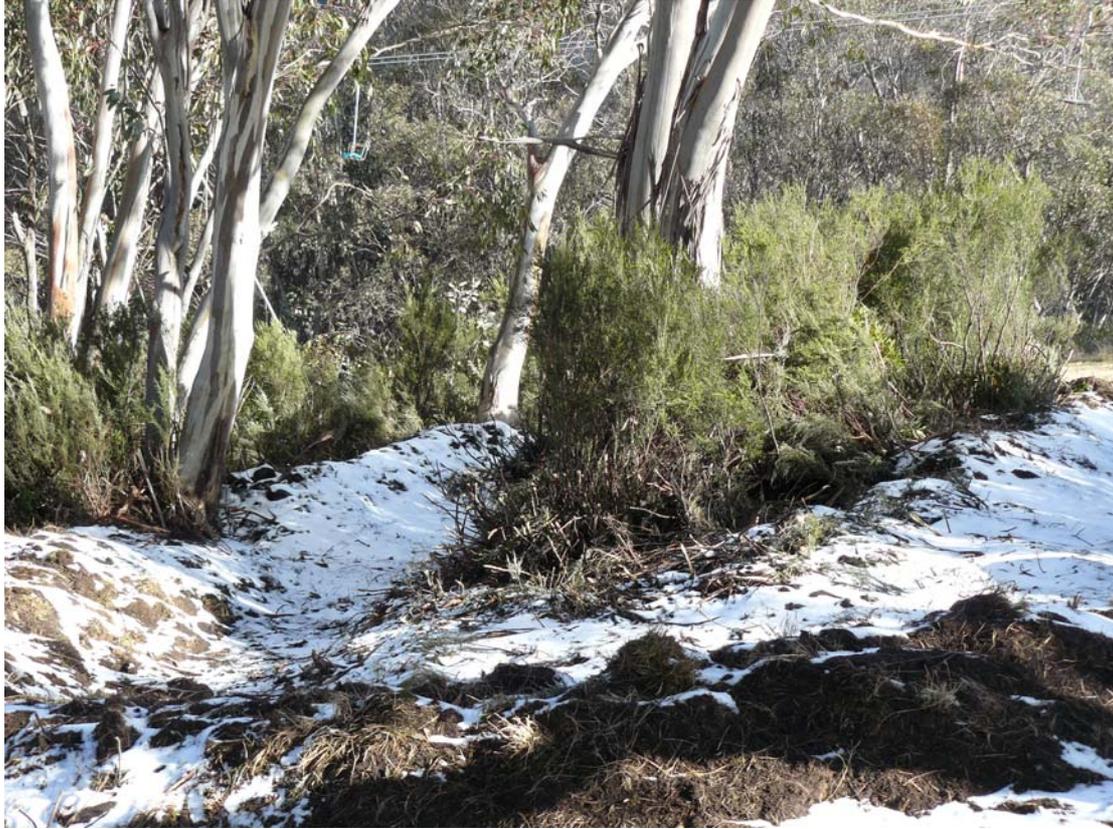
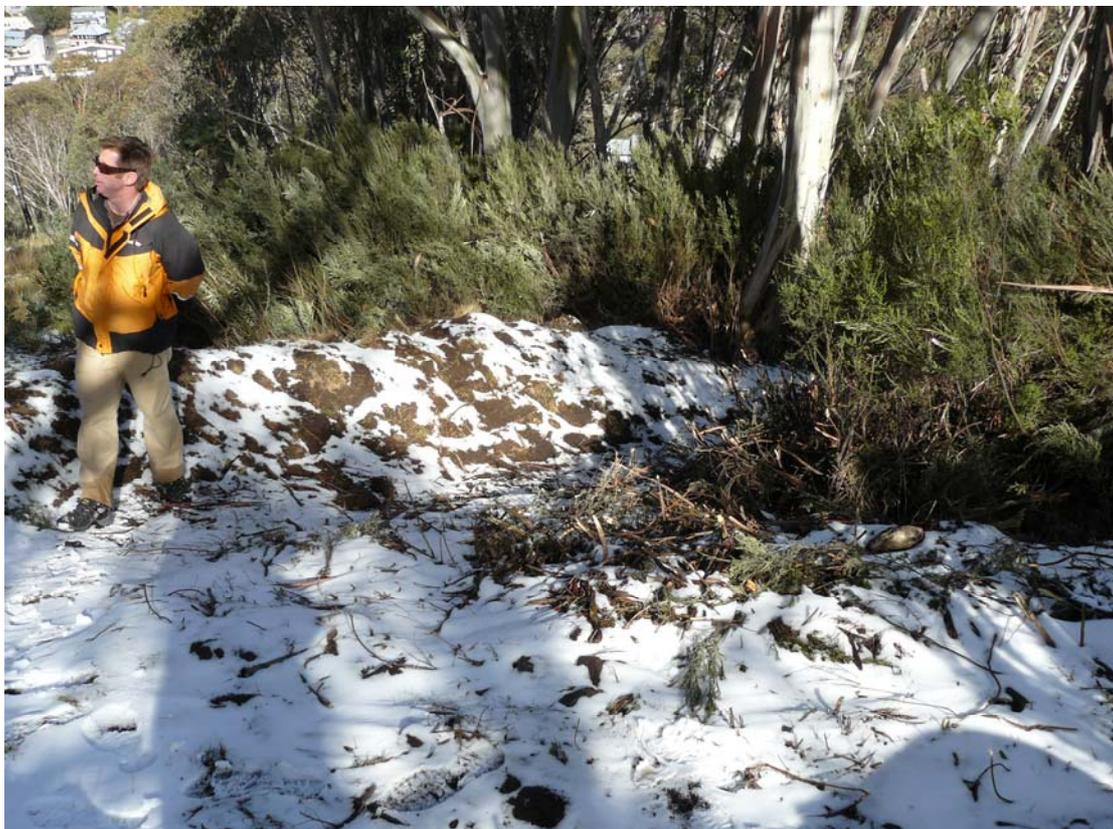
- I. On 6 February 2012 OEH and the Lessee inspected the Thredbo Downhill.
- J. On 14 May 2012 OEH and the Lessee inspected the Thredbo Downhill.
- K. The 6 February and 14 May 2012 inspections found that the Lessee had cleared three separate areas adjacent to the Thredbo Downhill ("the activity") being an area of land approximately 363m² ("the Cleared Area") for new mountain bike tracks. The cleared area is marked red and labelled as upper section, middle section and lower section in Attachment 4 of this Direction. The cleared area was cleared back to exposed soil. The cleared area in the middle and lower sections is shown in photographs, two for each section in Attachment 5 of this Direction.

Below: Middle Section Heath disturbance

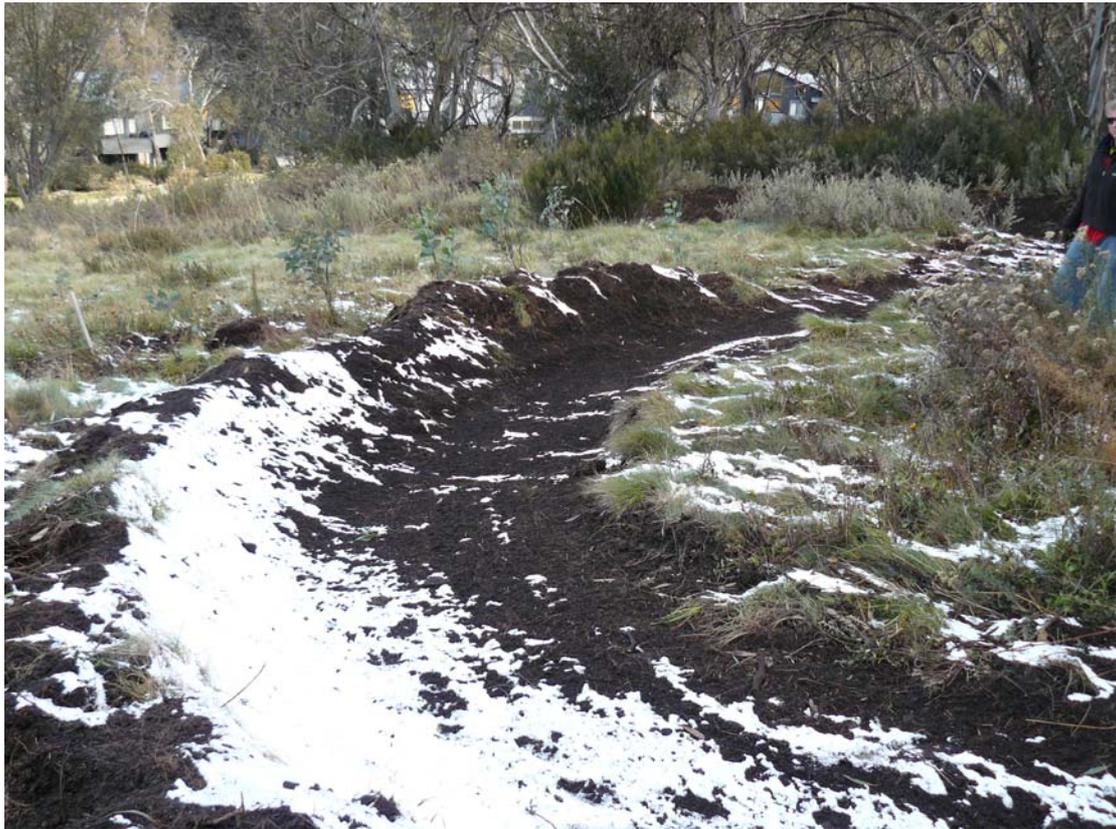
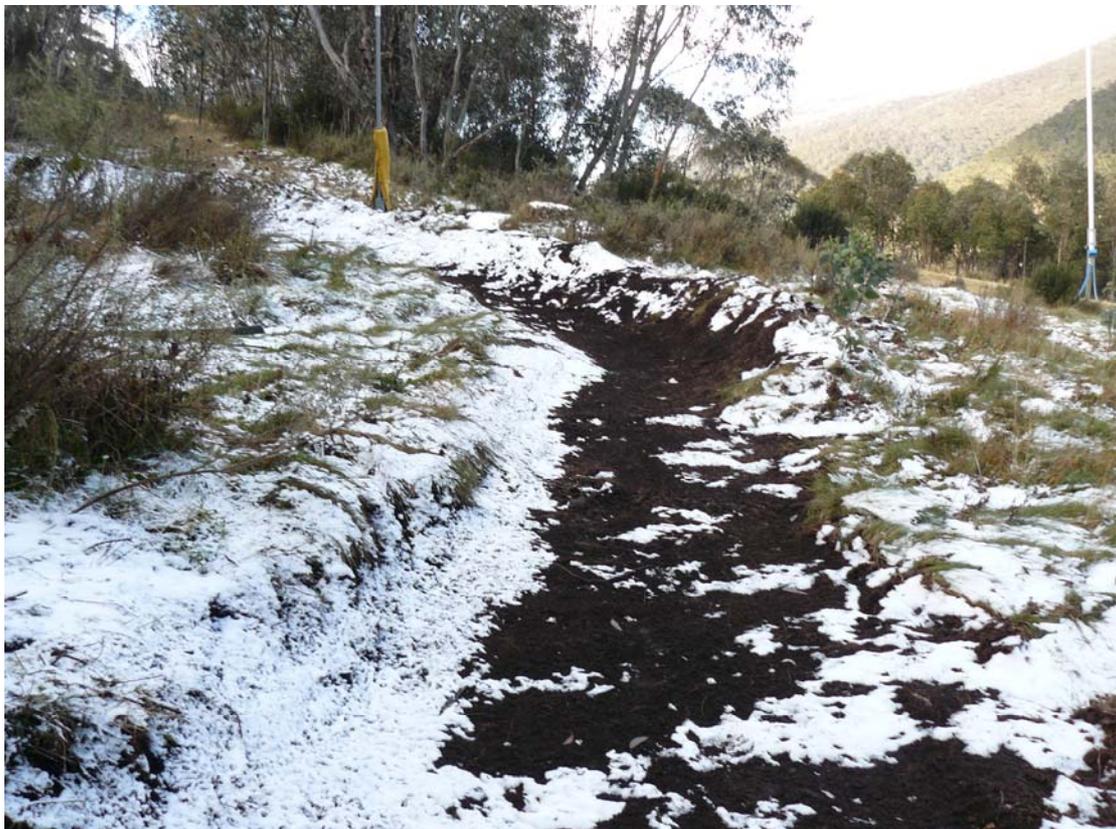
Below: Lower Section Native Grass and Heath disturbance

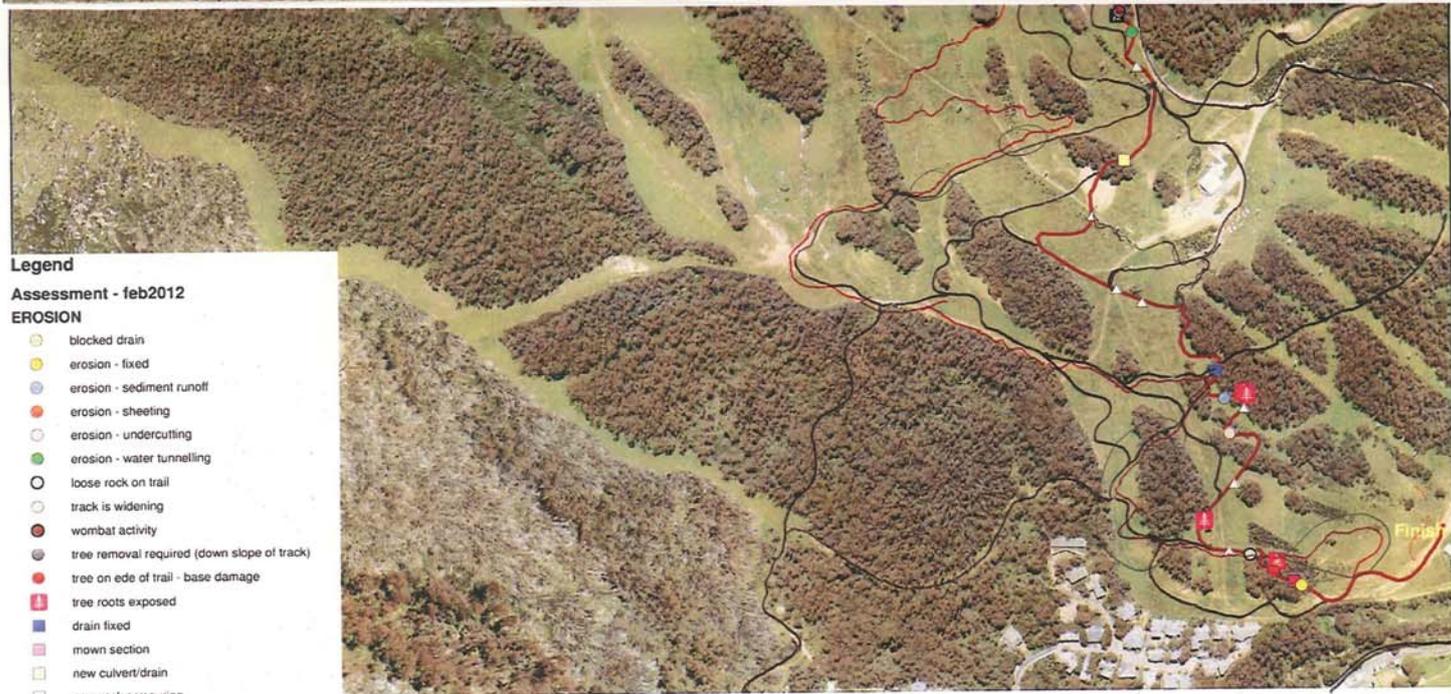
**Thredbo
Downhill Mountain bike trail
February 2012**

Assessment - feb2012
EROSION
