# Chapter 5

## Maintaining and Enhancing Ecosystem Health

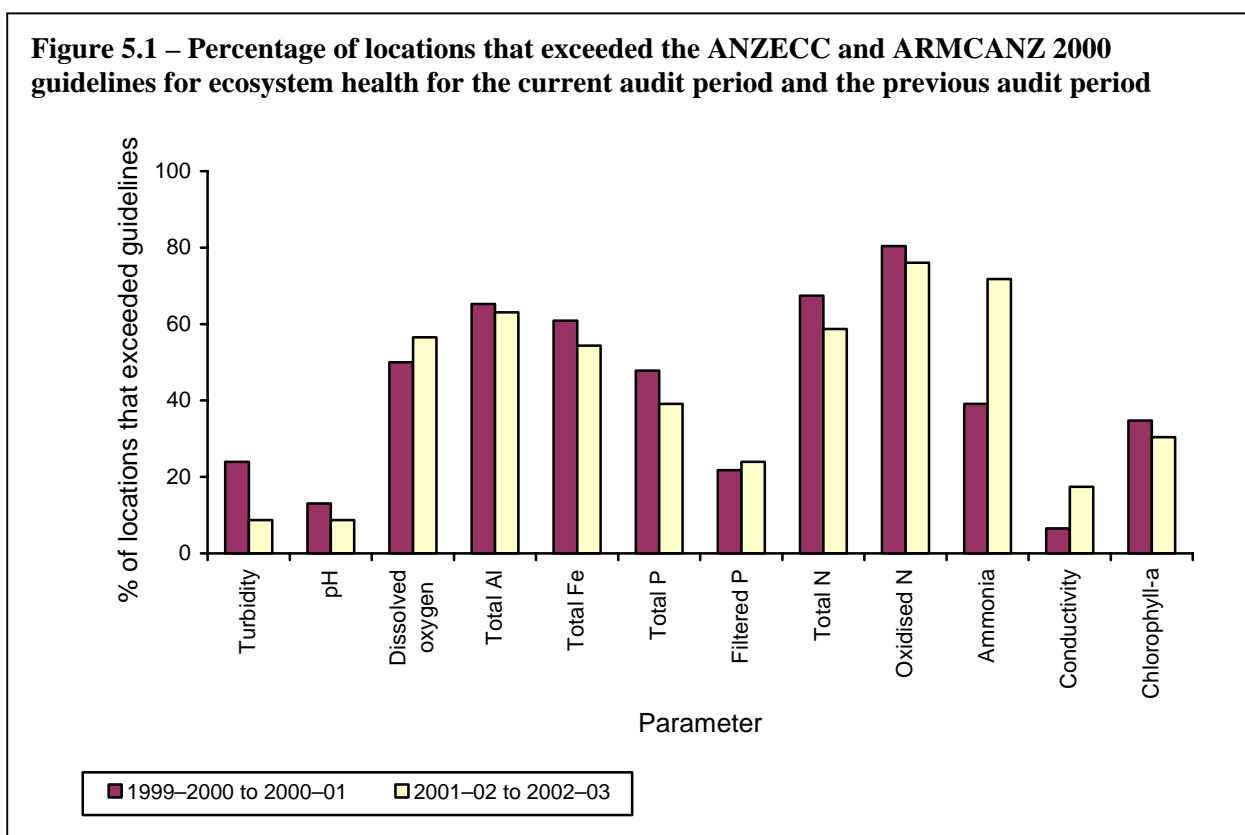
The percentage of locations that exceeded the guidelines was lower in the current audit period for 8 out of the 12 parameters tested than in the previous audit period (Figure 5.1). The parameters that had a greater percentage of locations in exceedence of the guidelines in the current audit period were dissolved oxygen, filtered phosphorus, ammonia and conductivity (Figure 5.1).

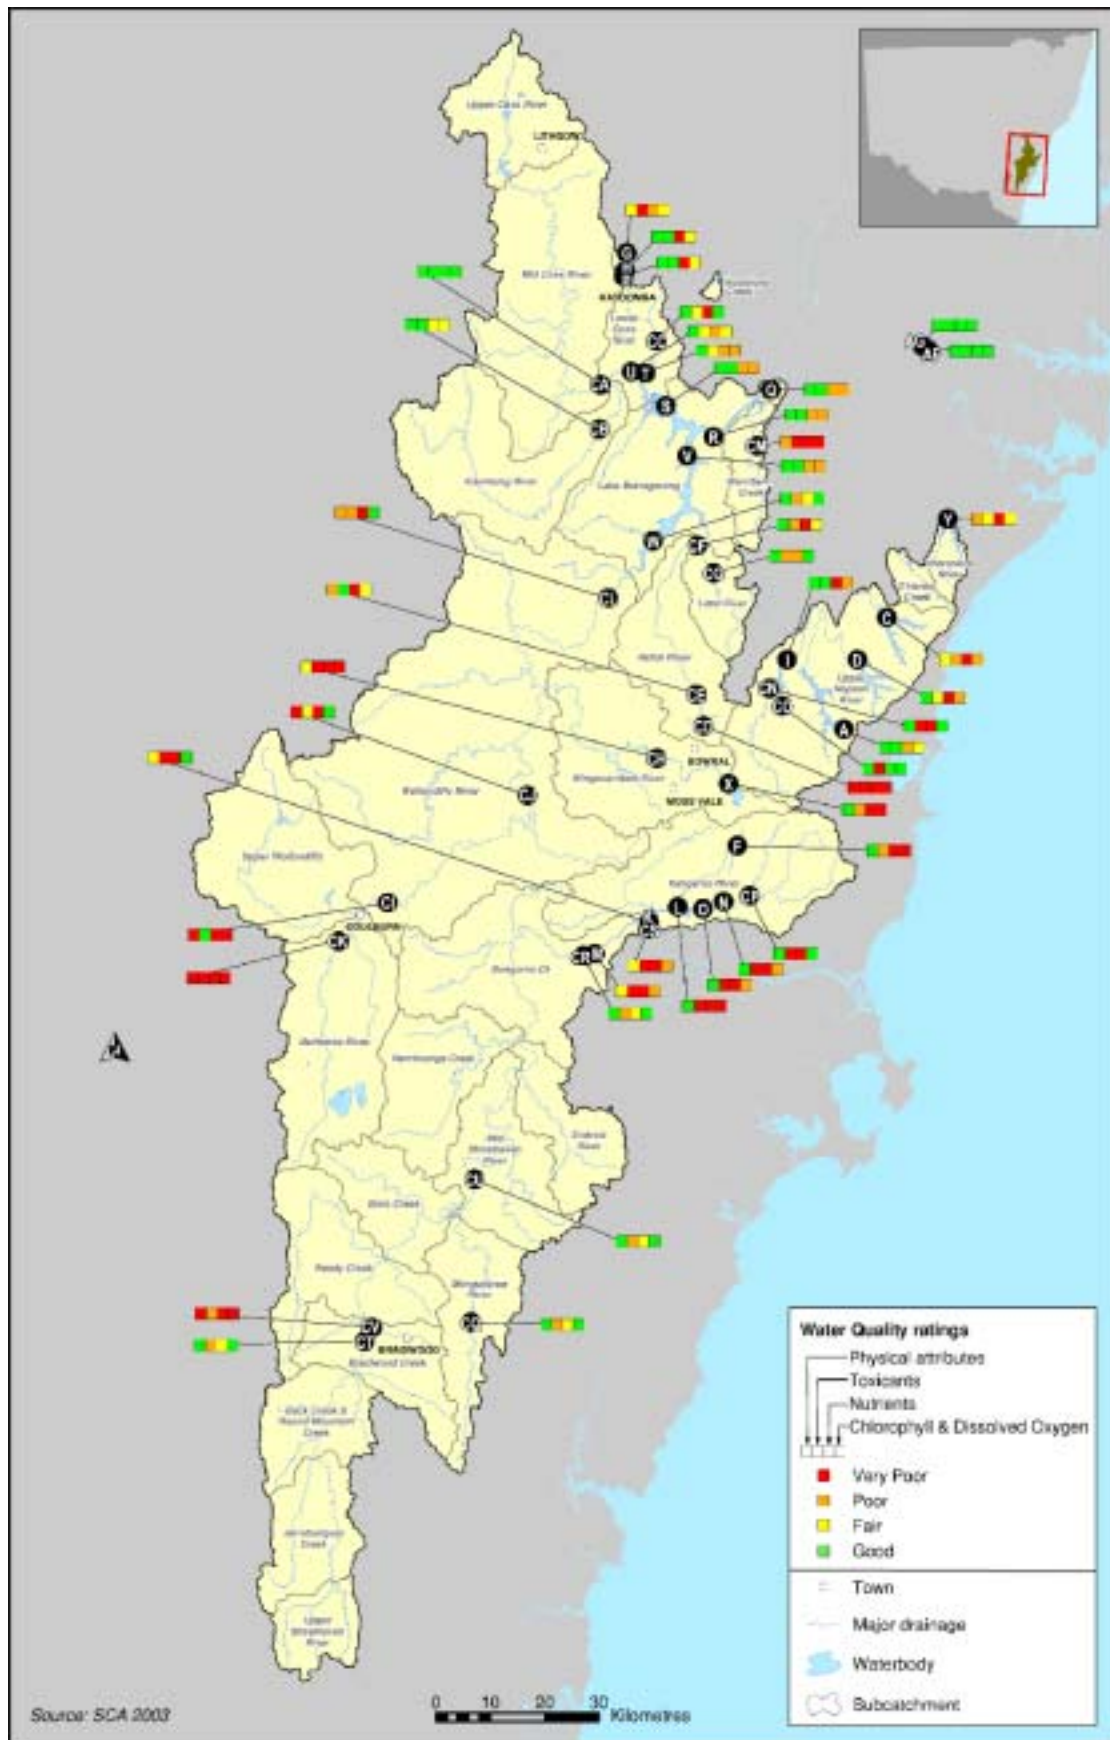
**Figure 5.2 – Map of water quality monitoring sites showing the 4 parameter groups and the colour code in the Sydney Drinking Water Catchment**

As described above, Figure 5.2, identifies water quality rating for four groups of water quality parameters at locations across the Catchment. Two locations were rated very poor for all 4 groups. They were Gibbergunyah Creek (CD) and Mulwaree River (CK). A number of other locations had three groups rated very poor. They were Gillamatong Creek (CV), Wollondilly River (CI), Lake Yarunga (L), Wingecarribee River (CH) and Werriberri Creek (CM).

The majority of the high exceedences were in the toxicant and nutrient groups (Figure 5.2). There were 33% of locations that exceeded the guideline for physical attributes in both the catchment and lakes and reservoir locations (Figure 5.2). Seventy to ninety percent of locations exceeded the guideline for toxicants and nutrients (see Appendix G Table 3 and 4 for details). The percentage exceedence of the guideline for ammonia increased at 54% of locations from the previous audit period (Indicated by a negative symbol in Appendix G Table 3 and 4).

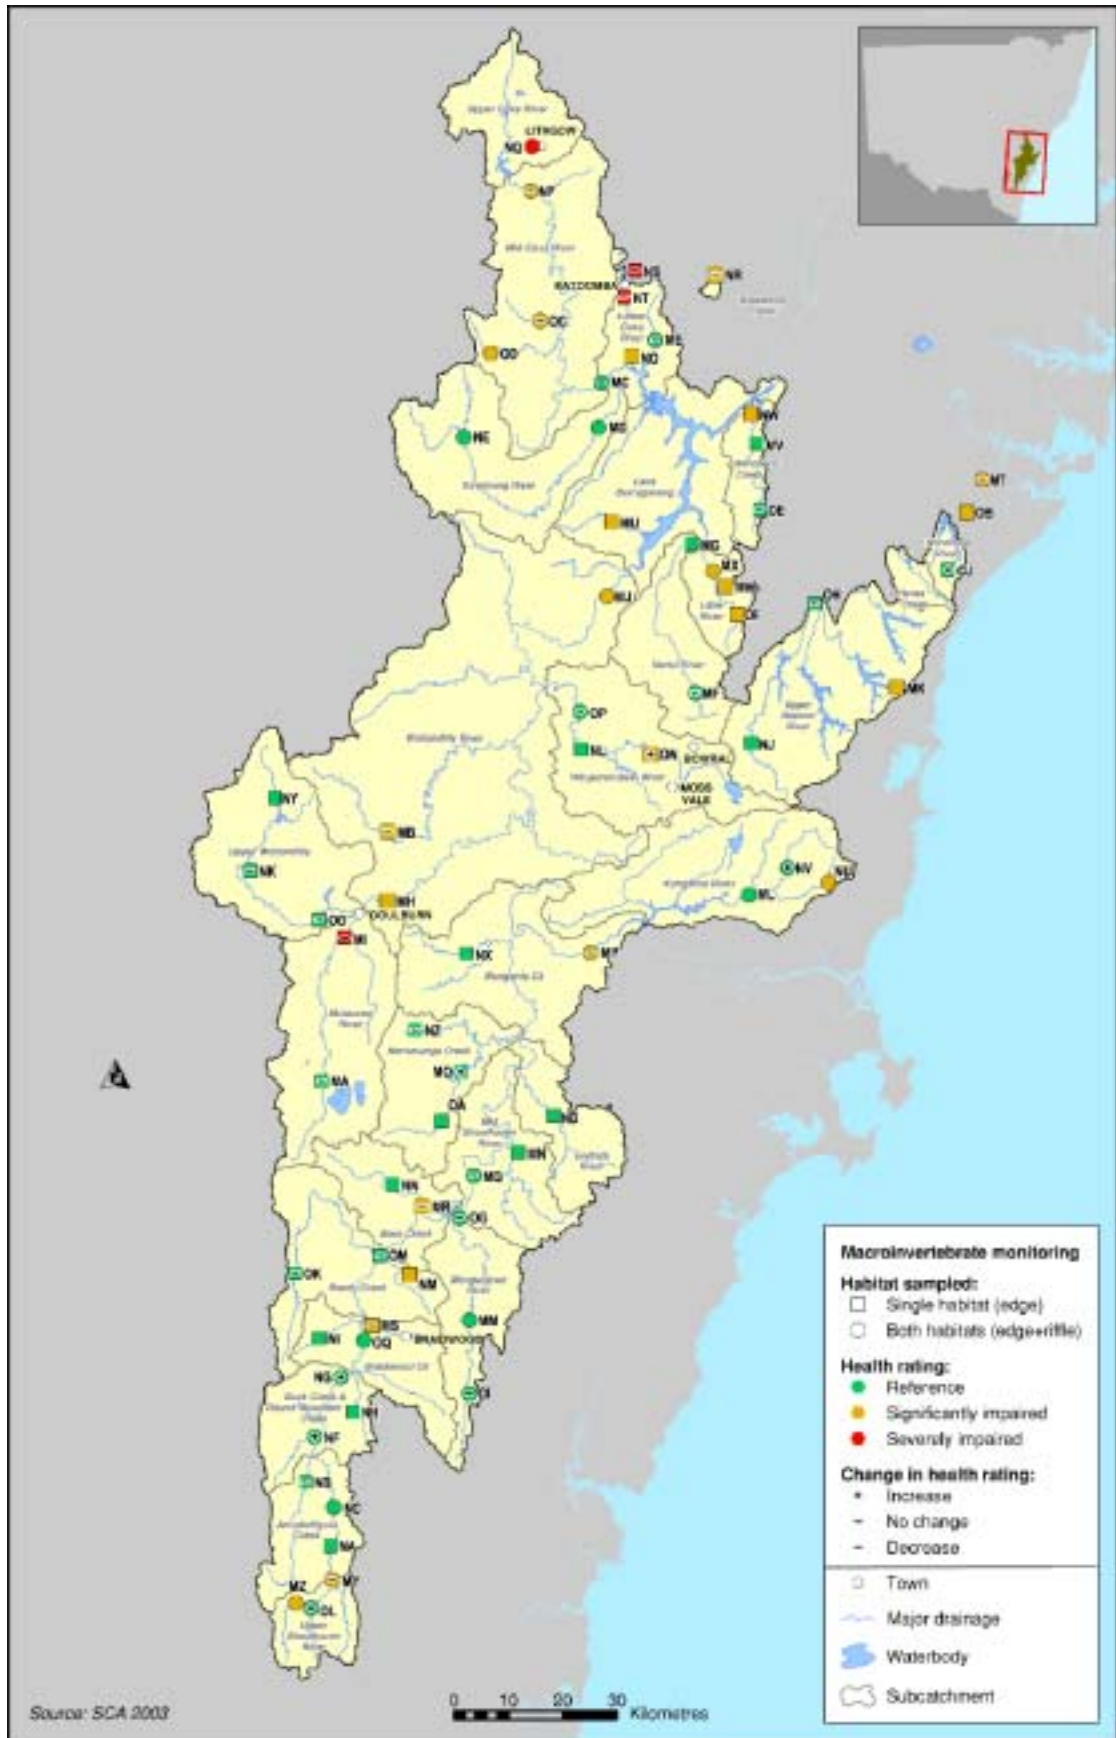
**Figure 5.3 – Map of macroinvertebrate AusRivAS health rating for Spring 2002 and change from Spring 2001**

Four locations were given an AusRivAS health rating of severely impaired: Farmers Creek (NQ), Yosemite Creek upstream of Minnehaha Falls (NS), Kedumba River at Scenic Railway (NT) and Mulwaree River at the Towers (MI).

The AusRivAS health rating decreased from Spring 2001 to Spring 2002 at seven sites: Coxs River at the McKanes Bridge (NP), Woodford Creek at the Woodford Dam (NR), Yosemite Creek upstream of Minnehaha Falls (NS), Little River at the Six Foot Track (OC), Mulwaree River at The Towers (MI), Tarlo River at Tarlo (MB) and Boro Creek at the Marlowe River (MR).

The AusRivAS health rating remained unchanged at the other 19 sites since the 2001-02 survey. A number of locations with a health rating of significantly and severely impaired macroinvertebrate assemblages also exceeded ANZECC and ARMCANZ 2000 guidelines in 3 or 4 groups of physico-chemical water quality (Figure 5.2 and Figure 5.3). These locations include Gillamatong Creek (CV), Mulwaree River (CK), Wollondilly River (CI) and Wingecarribee River (CH).

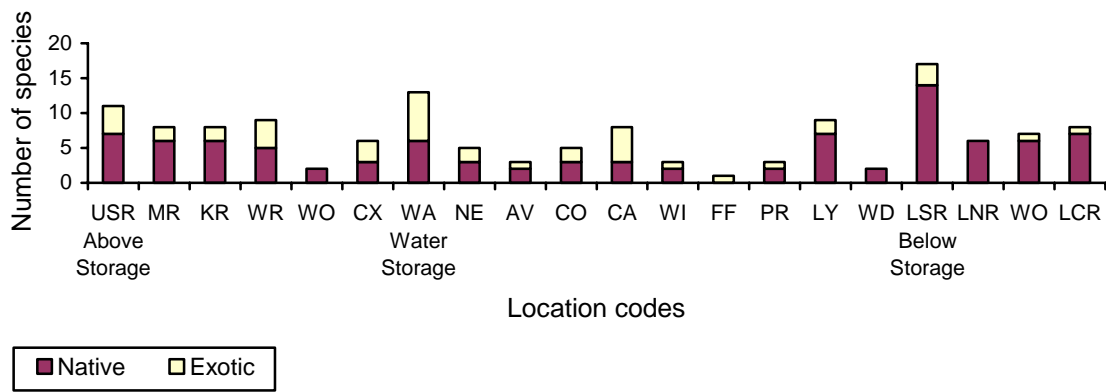
**Figure 5.4 – Number of native and exotic fish species recorded from the Sydney Drinking Water Catchment**

Warragamba Dam had the greatest percentage of exotic species, more than the other locations (Appendix G Table 5 and Figure 5.4). Water storage locations and locations above the water storages had greater ratios of exotic to native species than locations below the dams (Appendix G Table 5). A list of fish species that were expected in the Sydney Drinking Water Catchment was determined from NSW Fisheries and the Australian Museum records pre 1930s (Table 5.5). Using this list and the SCA supplied data, a ratio of fish species observed to those expected was calculated for each location (Figure 5.5 and Appendix G Table 5). The data used for upstream were a combination of upstream and storages where available. Locations downstream of the water storages had a higher ratio (i.e. fish communities closer to what would occur naturally) than water storages and locations above water storages.

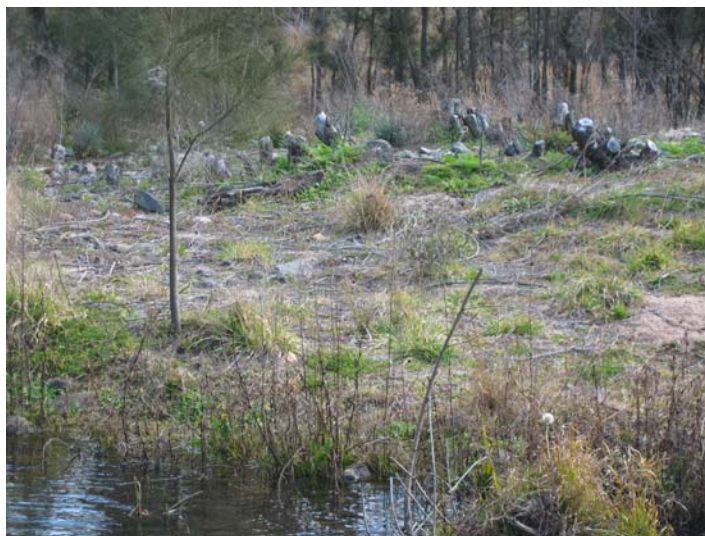
**Figure 5.8 – Willow removal carried out by SCA along the Coxs River at Duddawarra Bridge, August 2003**

A number of clearing applications were approved within the audit period to remove 16.8 hectares of exotic species including willows, from the riparian zone of the Wollondilly River, Mulwaree Ponds, Wingecarribee River, Paddys River and Gillamatong Creek. The SCA also removed 202 hectares of willows within the audit period which was a decrease of 77 hectares from the previous audit period (Figure 5.8).

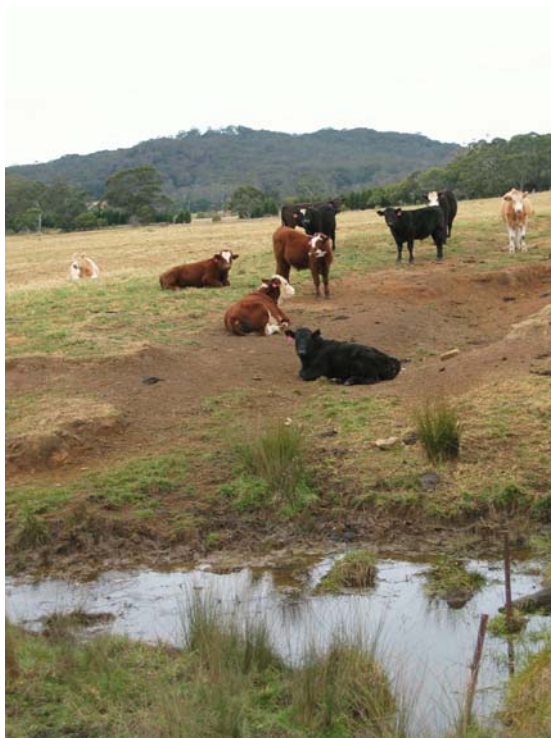
**Figure 5.9 – Stock access to Wallaby Creek causing the removal of vegetation, bank erosion and water contamination, August 2003**

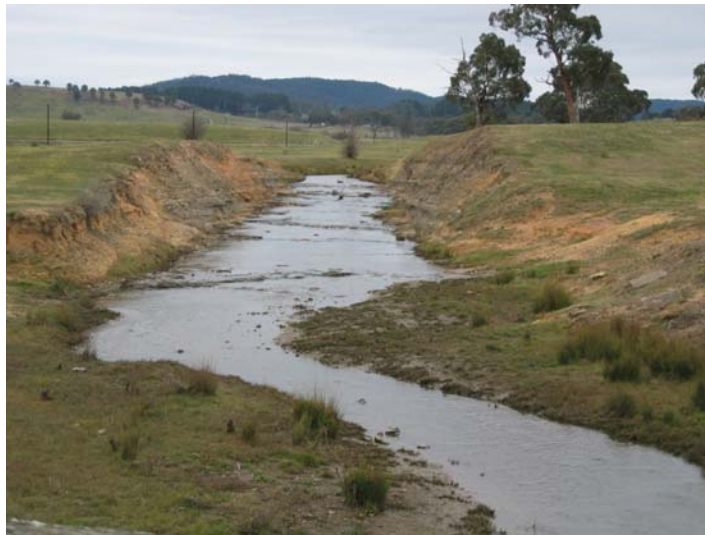
**Figure 5.10 – Degraded section of the Upper Cocks River, August 2003**

- complete the mapping of the extent and condition of riparian zone within the Catchment by June 2006
- reduce the extent of weed infestation
- increase the length fenced where appropriate and practical
- progressive revegetation and regeneration of disturbed riparian zones (Figures 5.10 and 5.11).

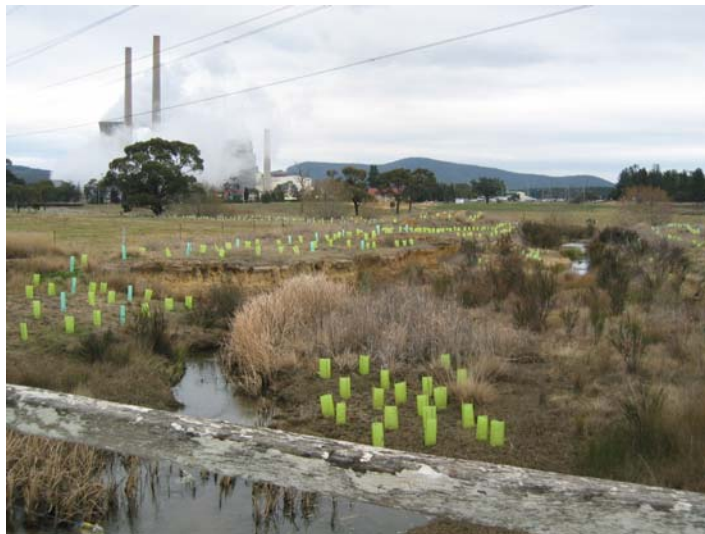
**Figure 5.11 – Section of the Upper Cocks River (immediately downstream of Figure 5.10) undergoing revegetation, August 2003**

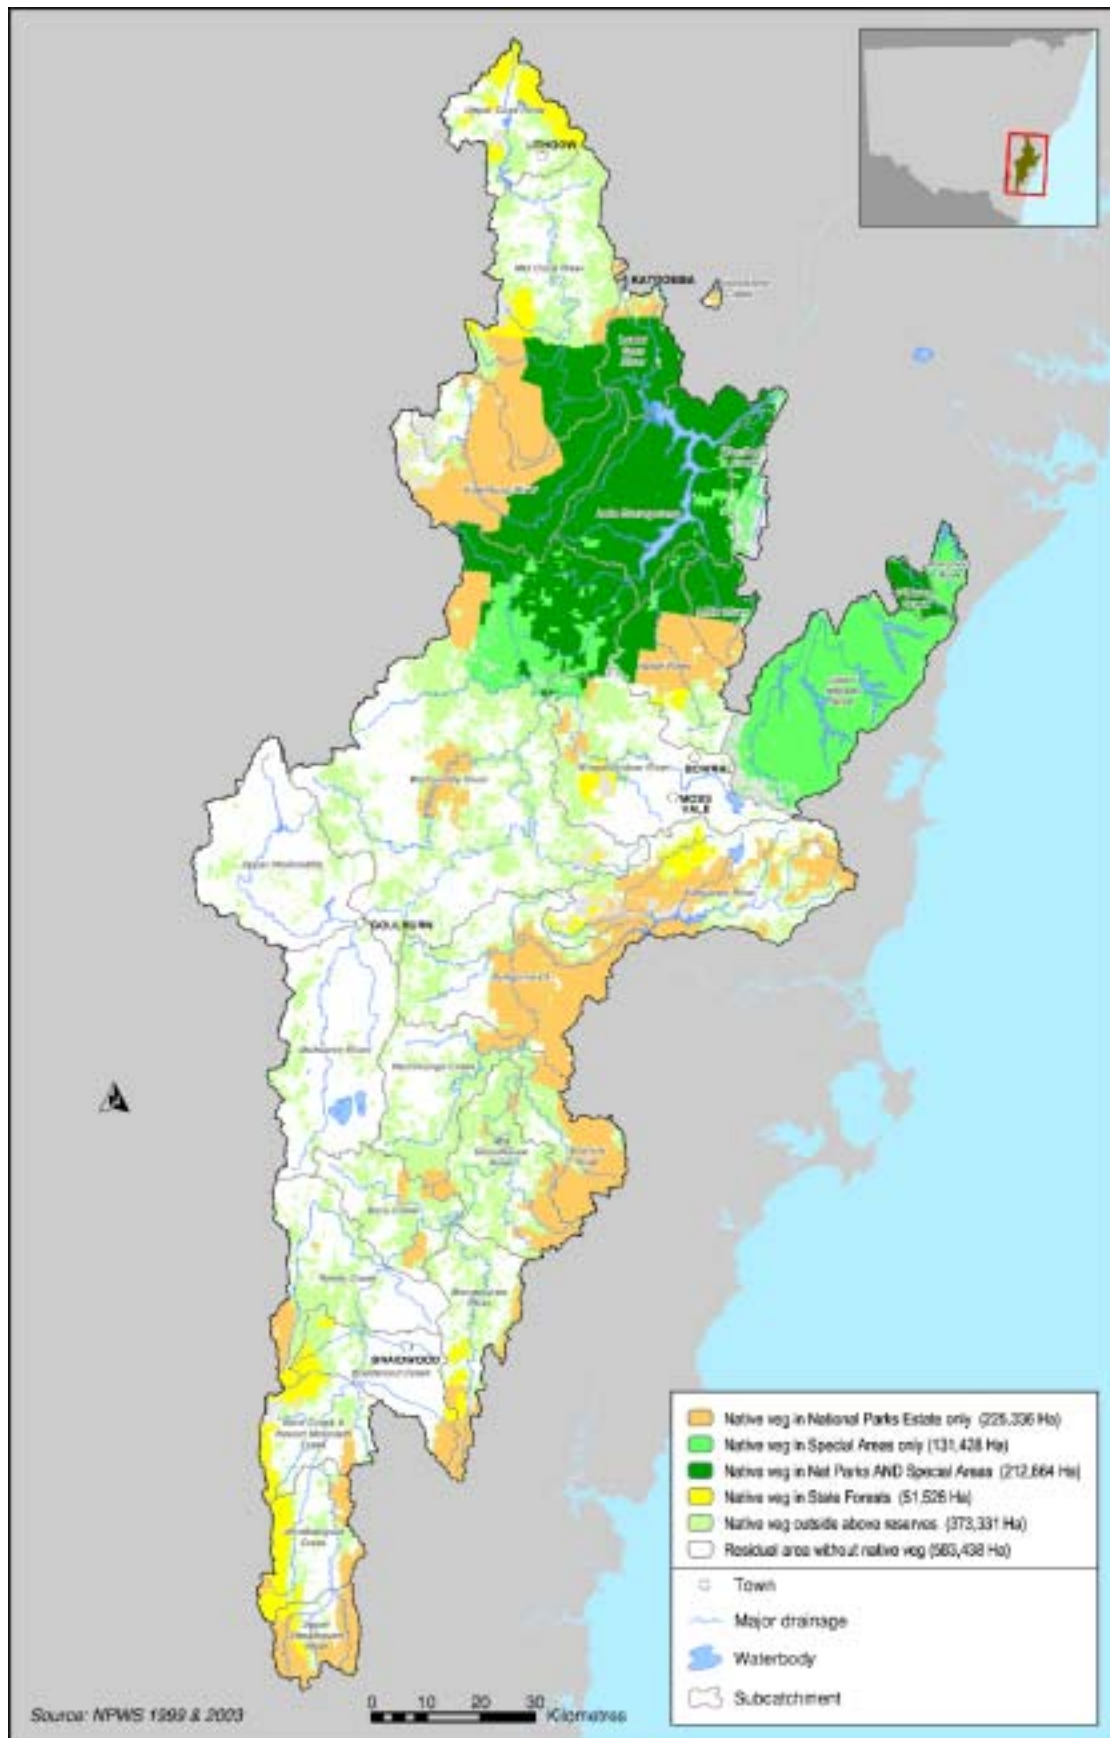
**Figure 5.13 – Map of native vegetation in National Parks, Special Areas and State Forests for the Sydney Drinking Water Catchment**

(Figure 5.13). The majority of this native vegetation is privately owned and the condition and importance of this vegetation is not well understood.
