Beachwatch

State of the beaches 2021–22

Mid-North Coast Region

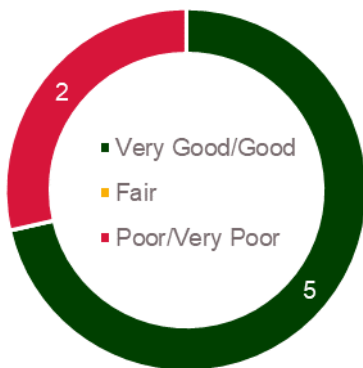
Beach Suitability Grades for Coffs Harbour City Council ocean beaches

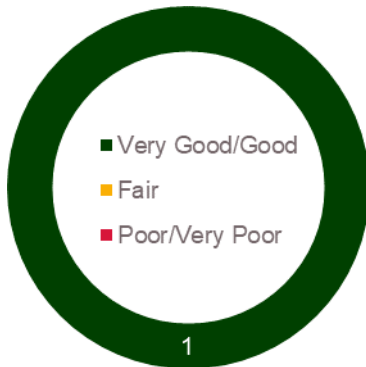
Beach Suitability Grades for Coffs Harbour City Council ocean baths

Sawtell Rockpool was graded as Good in 2021–2022. Water quality at this site was mostly suitable for swimming in dry weather conditions, with 71% of dry weather samples within the safe swimming limit. Elevated enterococci levels were recorded after heavy rainfall.

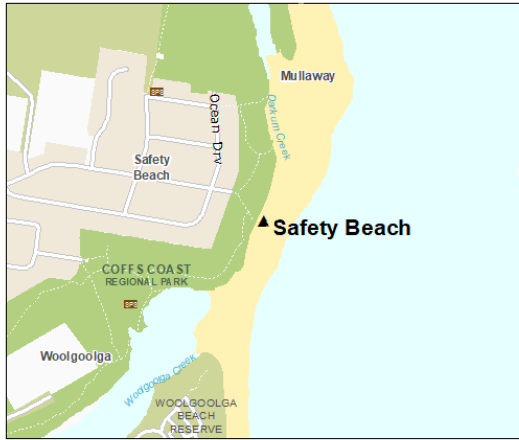
Safety Beach is located north of Woolgoolga Main Beach and lies between Darkum Creek and Woolgoolga Lake. The beach is not patrolled.

The Beach Suitability Grade of Good indicates microbial water quality is considered suitable for swimming most of the time but may be susceptible to pollution after rain, with several sources of potential faecal contamination including Woolgoolga Lake.

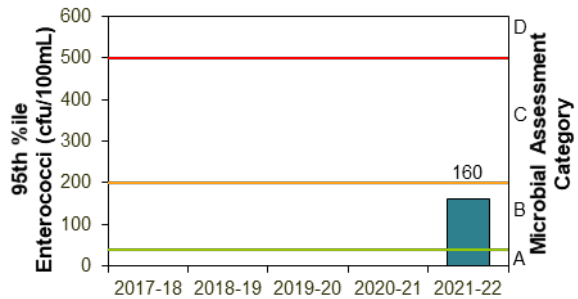
Microbial Assessment Category: B

Enterococci levels increased slightly with increasing rainfall, occasionally exceeding the safe swimming limit after no rain, and after 5 mm or more of rain.

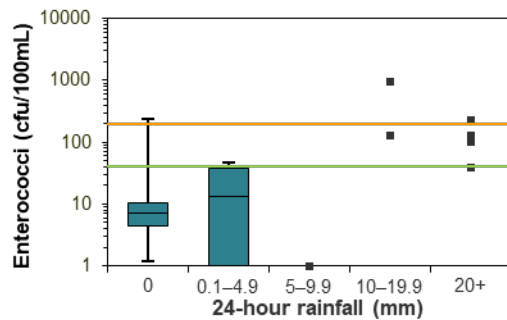
Water quality in response to rainfall

Enterococci levels increased with increasing rainfall, occasionally exceeding the safe swimming limit after no rain, and often after 10 mm or more of rainfall.

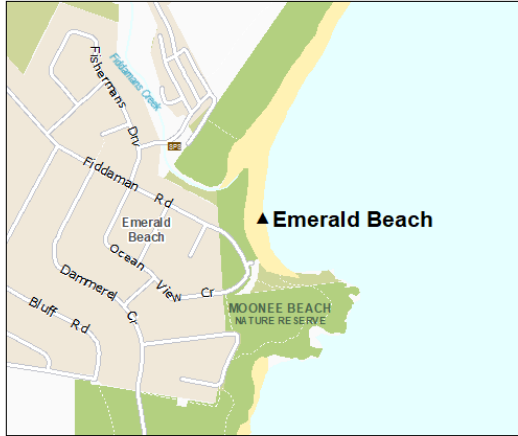
Emerald Beach lies to the north of Dammerels Head and is patrolled in summer. The beach is accessed at the southern end, where there are amenities, picnic facilities and a park.

The Beach Suitability Grade of Poor indicates microbial water quality is susceptible to faecal pollution, particularly after rainfall and occasionally during dry weather conditions, with potential faecal contamination from Fiddamans Creek.

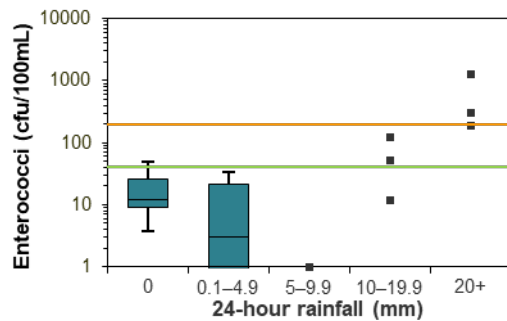
Water quality in response to rainfall

Enterococci levels generally increased with increasing rainfall, occasionally exceeding the safe swimming limit after no rain, and often after 10 mm or more.

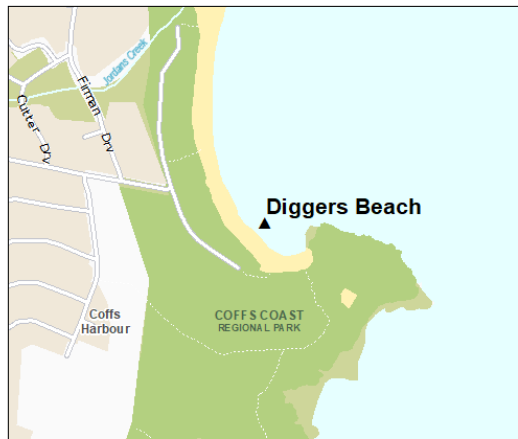
Diggers Beach is positioned between Diggers and Macauleys headlands and is patrolled by lifeguards. The southern end of the beach is a popular swimming and surfing location.

The Beach Suitability Grade of Good indicates microbial water quality is considered suitable for swimming most of the time but may be susceptible to pollution after rain, with several potential sources of faecal contamination including Jordans Creek.

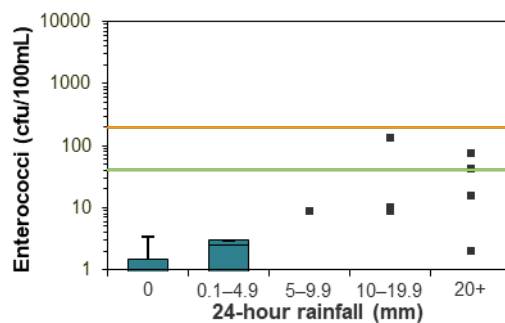
Water quality in response to rainfall

Enterococci levels increased slightly with increasing rainfall, occasionally exceeding the safe swimming limit after 10 mm or more of rain.

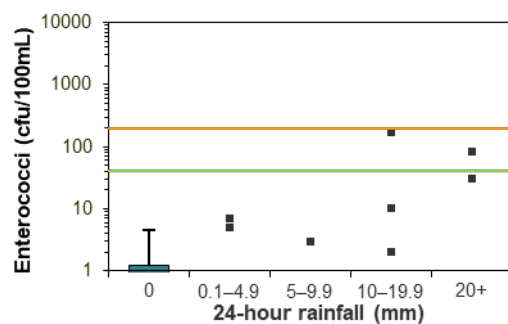
Water quality in response to rainfall

Enterococci levels increased slightly with increasing rainfall, occasionally exceeding the safe swimming limit after 10 mm or more of rain.

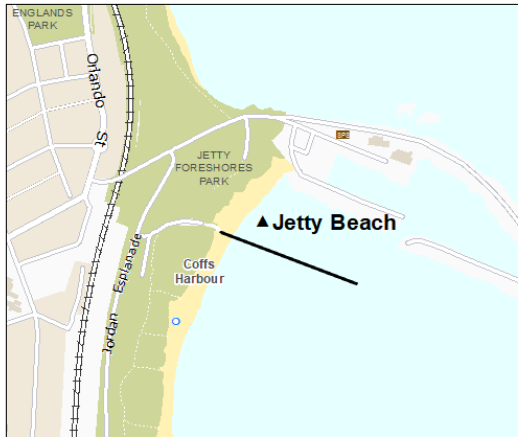
Jetty Beach (Coffs Harbour)

Jetty Beach is approximately 1.4 km long and extends south from a marina to Corambirra Point. The beach is a popular swimming location and is patrolled during summer.

The Beach Suitability Grade of Good indicates microbial water quality is considered suitable for swimming most of the time but may be susceptible to pollution after rain, with several potential sources of faecal contamination.

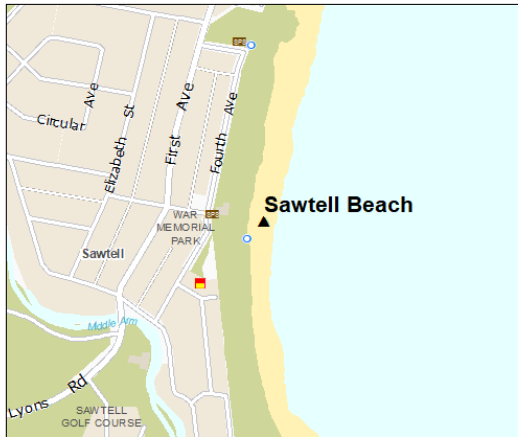
Sawtell Beach is 2 km long and is patrolled during summer. The beach is backed by dunes and urban development.

The Beach Suitability Grade of Very Good indicates microbial water quality is considered suitable for swimming almost all of the time, with few potential sources of faecal contamination.

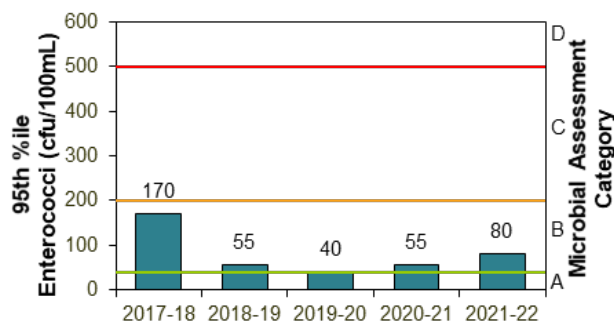
Microbial Assessment Category (MAC) chart

On each beach page, the MACs for the last 5 years are displayed on a simple bar chart. The MAC for the current year is based on enterococci data collected during the assessment period. The bars are labelled with the 95th percentile value for each year and the thresholds dividing the A, B, C and D categories are marked in green, amber and red for reference.

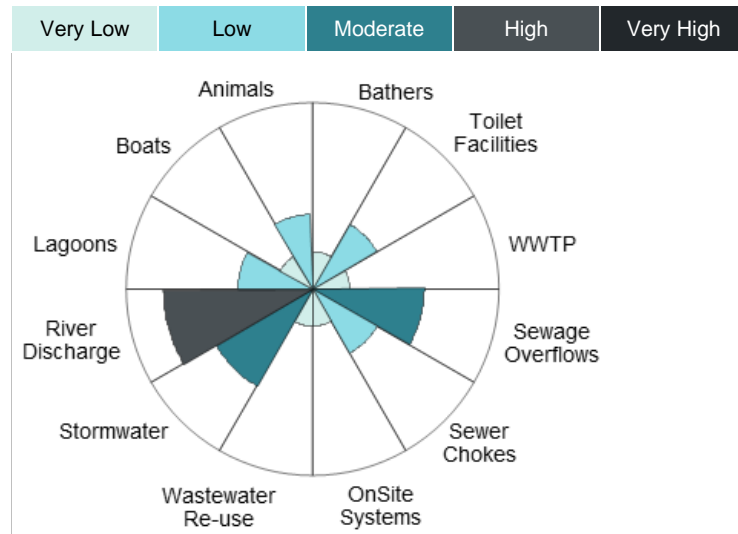
Sanitary Inspection Category (SIC) chart

The results of the sanitary inspection for each swimming location are presented in a radar pie chart. The chart shows the likelihood that each identified pollution source will contribute to faecal contamination at a swimming site, as indicated by the size and colour of the segment, ranging from

very low (lightest colour) to very high (darkest colour) as shown below. The sum of these contributions is the overall likelihood, or Sanitary Inspection Category.

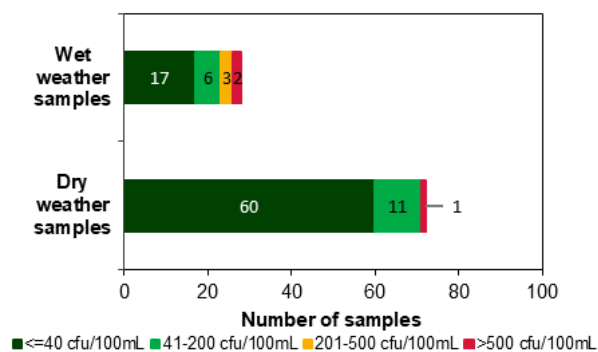
Wet and dry weather water quality chart

Enterococci levels in wet and dry weather conditions are presented for each swimming location as a bar graph. All data collected during the assessment period is included in the analysis. Dry weather is defined as no rainfall recorded in the previous 24 hours. Each bar is colour coded to show the number of enterococci results up to 40 cfu/100 mL, between 41 and 200 cfu/100 mL, between 201 and 500 cfu/100 mL and greater than 500 cfu/100 mL. These categories reflect the Microbial Assessment Category thresholds and are coloured on the graph as dark green, light green, amber and red respectively.

It is expected that swimming sites with lower levels of flushing will show some elevated bacterial results in dry weather samples (no rainfall in the previous 24 hours) due to the longer time needed to recover from a rainfall event. At some estuarine and lake/lagoon swimming locations the impacts of stormwater pollution on beach water quality may be detected up to 3 days after rainfall.

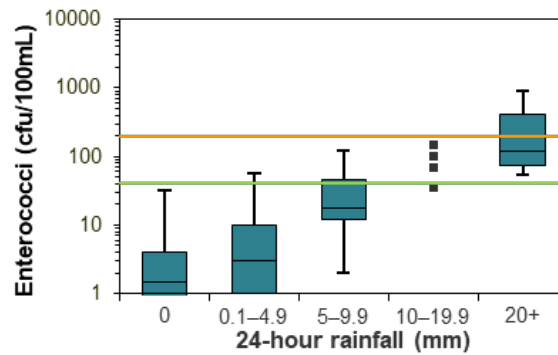
Water quality in response to rainfall

Trends in enterococci levels in response to rainfall are shown using a box plot. For reference, enterococci levels of 40 cfu/100 mL and 200 cfu/100 mL are indicated with a green and orange line, respectively. The 40 cfu/100 mL level is referred to as the 'safe swimming limit'. The enterococci data were obtained from the last 5 years of monitoring. Rainfall data were obtained from rain gauges situated close to the sample site and are 24-hour totals to 9am on the day of sampling. If there are fewer than 5 enterococci data points in a rainfall category, individual data points are presented instead of a box plot. At sites where many results are below the detection limit (1 cfu/100 mL), only the upper portion of the box plots will be visible.
